### ***Bok Singing Tower Roof Restoration and Replacement***

# Bok Singing Tower Conditions Assessment

T.Y. Lin (formerly Silman) was contracted to perform a conditions assessment of the Bok Singing Tower at Bok Tower Gardens in Lake Wales, Florida. The Singing Tower stands 205 feet tall at the southwest corner of the gardens. A moat surrounds the base of the tower with two bridges to access the island. The tower houses a 60-bell carillon, associated carillonneur studio and library spaces, the Bok Tower Gardens Chao Research archive, and the Founder's Room. It is a steel frame construction clad in a masonry exterior of coquina and Georgia pink Etowah marble with brick masonry at the interior.

## **Bok Tower Focused Condition Assessment**

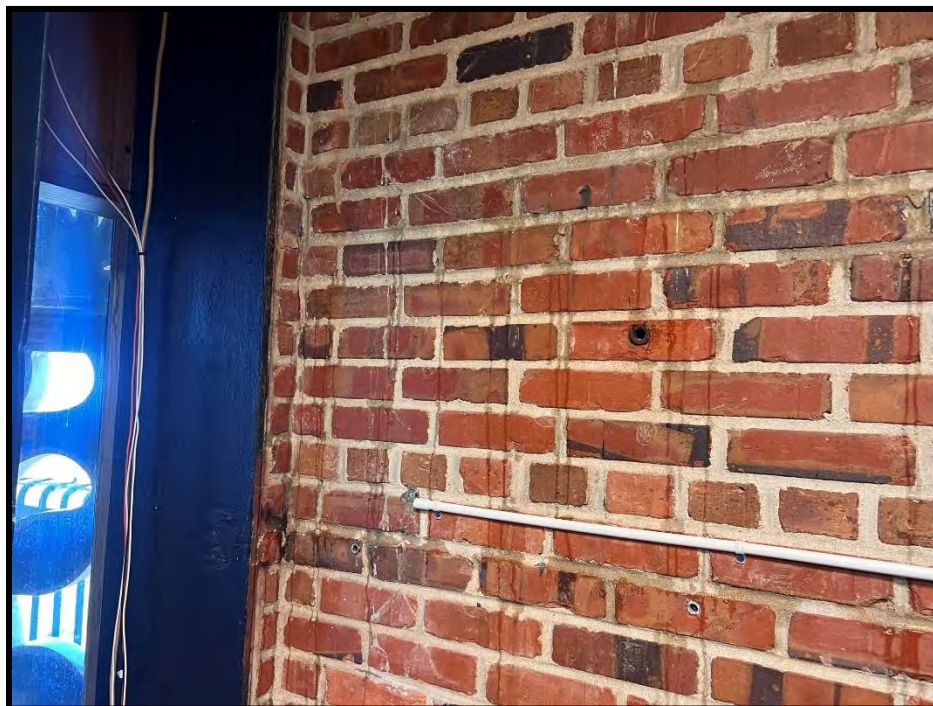
appear, and additional leaks appeared shortly after. Infrared imaging confirmed the masonry became saturated at and below the spray rack (**Figure 11**). A full discussion of the test methods and results can be found in the ANA report included in the Appendix.

The test shows that the tower masonry is permeable enough for water to pass from the exterior to interior. Relatively brief, driven rains in the Florida climate are sufficient to transport water into the conditioned spaces of the tower. Water intrusion is not limited to plumbing, drainage and sealant failures in the tower.

**Figure 11** Leaks on the interior masonry aligned with the spray rackVisual Conditions Assessment

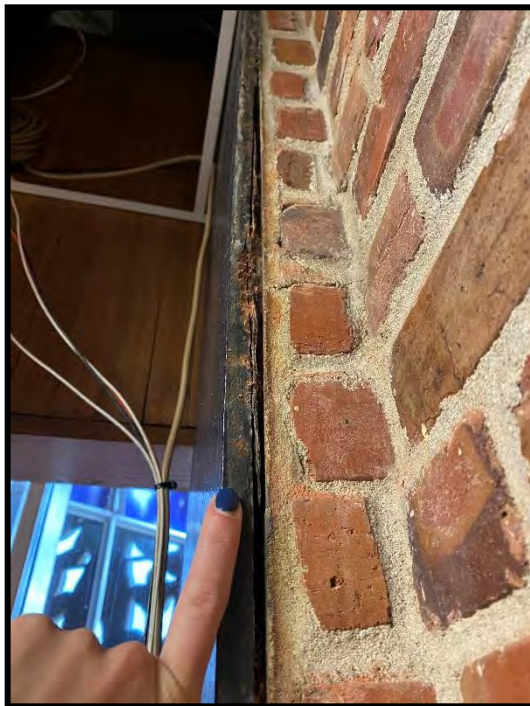
The exposed tower superstructure steel was observed to be in good condition with localized areas of deterioration. The deteriorated regions are typically in contact with the masonry or slab of the floor above (**Figure 12**) where water can sit on the steel surface.

**Figure 12** Deteriorated steel column flange permanently against interior masonry

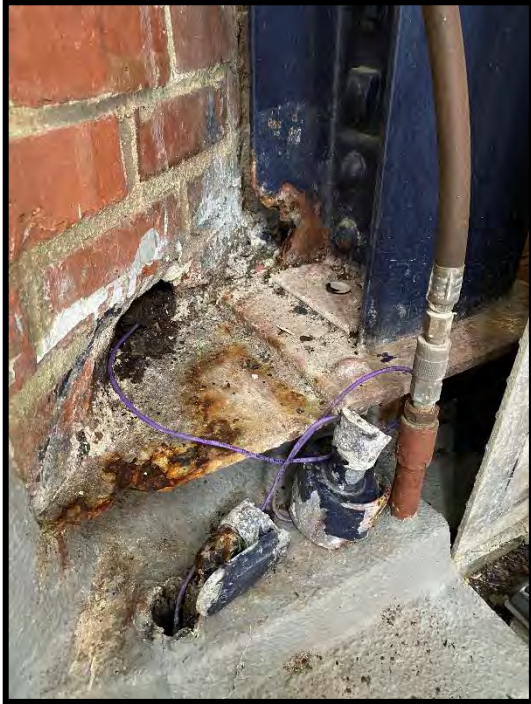
Growth of the cracks may indicate that the cathodic protection system needs maintenance and/or that it may not be sufficient to mitigate steel deterioration. Part of the cathodic protection system was observed to be loose and somewhat corroded. Rust stains were observed around the connection point in the wall (**Figure 13**). The cathodic protection system should be reviewed by a corrosion engineer to confirm it remains effective.

**Figure 13** Part of the cathodic protection system visible at Level 7 outside of the Playing Cabin

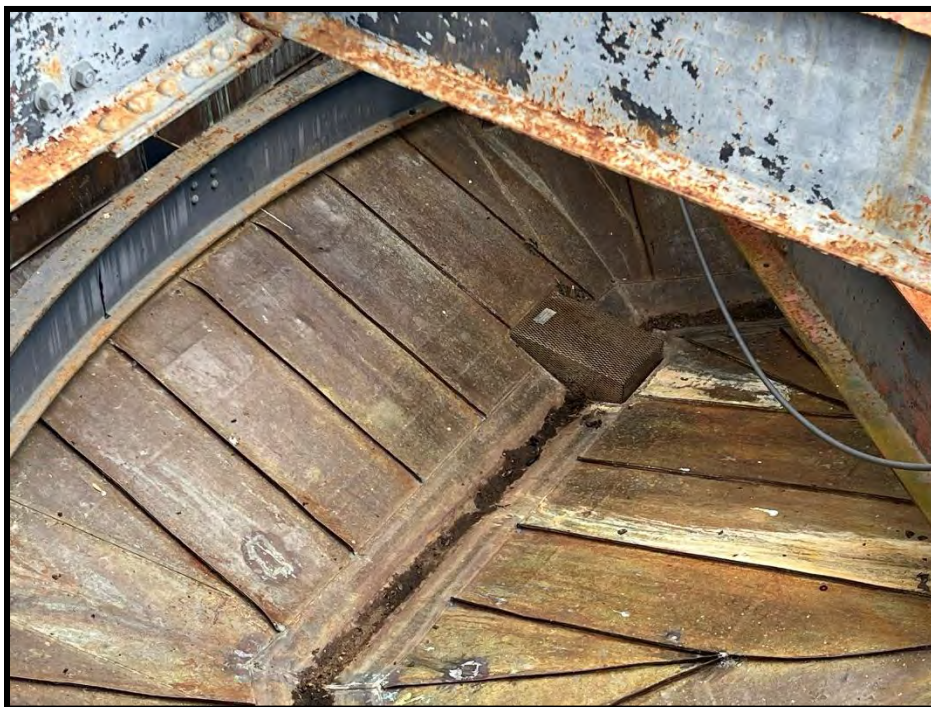
The Upper Roof is octagonal and slopes to form a gutter that feeds to a single drain (**Figure 14**). Staining on the roofing may be an indicator that the single drain is not sufficient for the roof area; staining may be the result of water sitting or perching in the low gutter. The roofing has failed and is allowing water to sit on the steel (HSS) roof framing. The HSS members supporting the low point of the roof have significant section loss. Typically, the top flange is fully lost (**Figure 15**).

**Figure 14** Metal seam upper roof

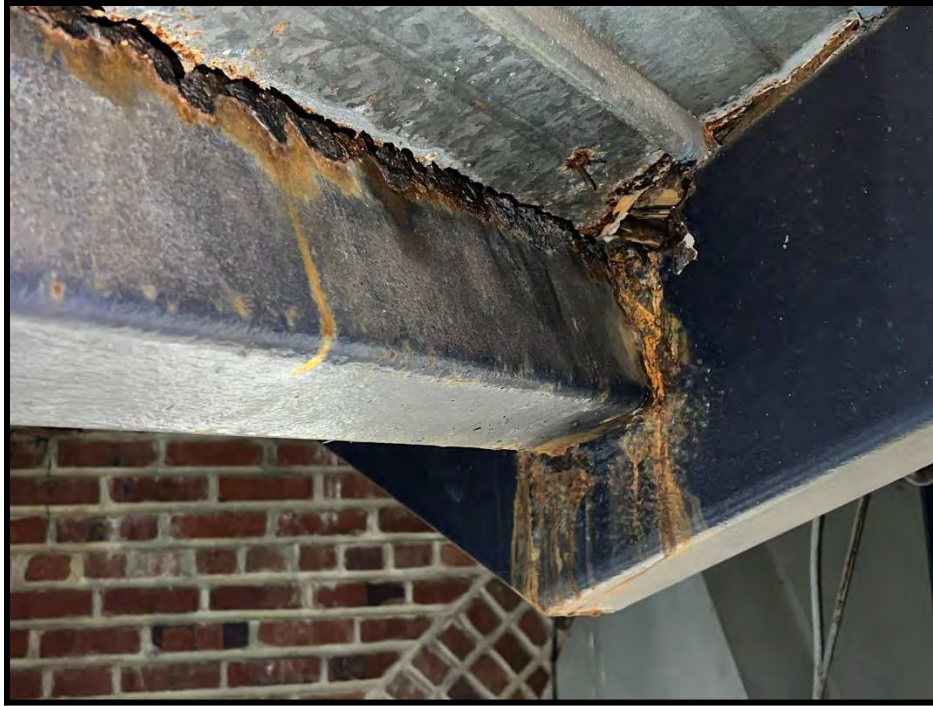
**Figure 15** Corrosion of roof steel framing

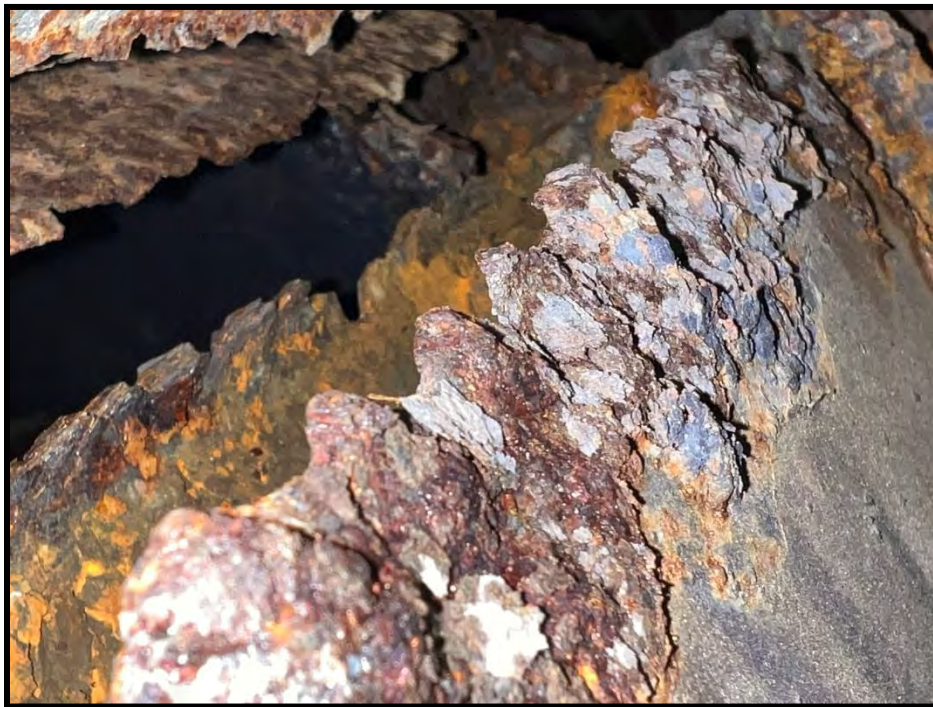
**Figure 16** Corrosion of roof steel framing

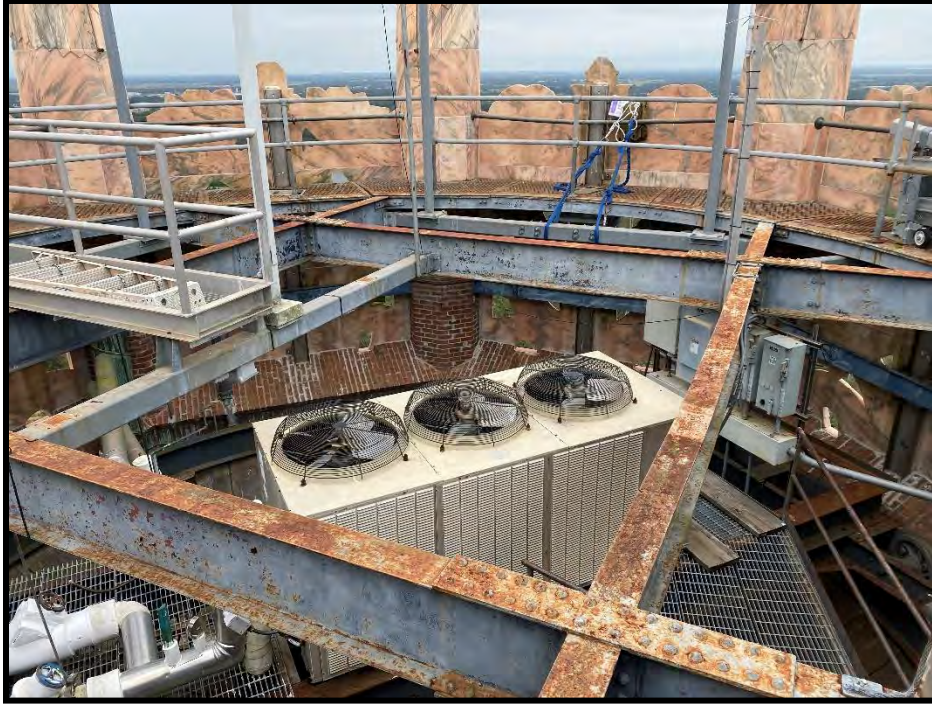
Above the roofs, steel with moderate corrosion supports grating and mechanical equipment (**Figure 17**). The grating exhibits corrosion and is missing bolts at its perimeter. The railing at the grating also exhibits limited corrosion and has missing or deteriorated bolt connections.

**Figure 17** Exposed steel framing above the roof level

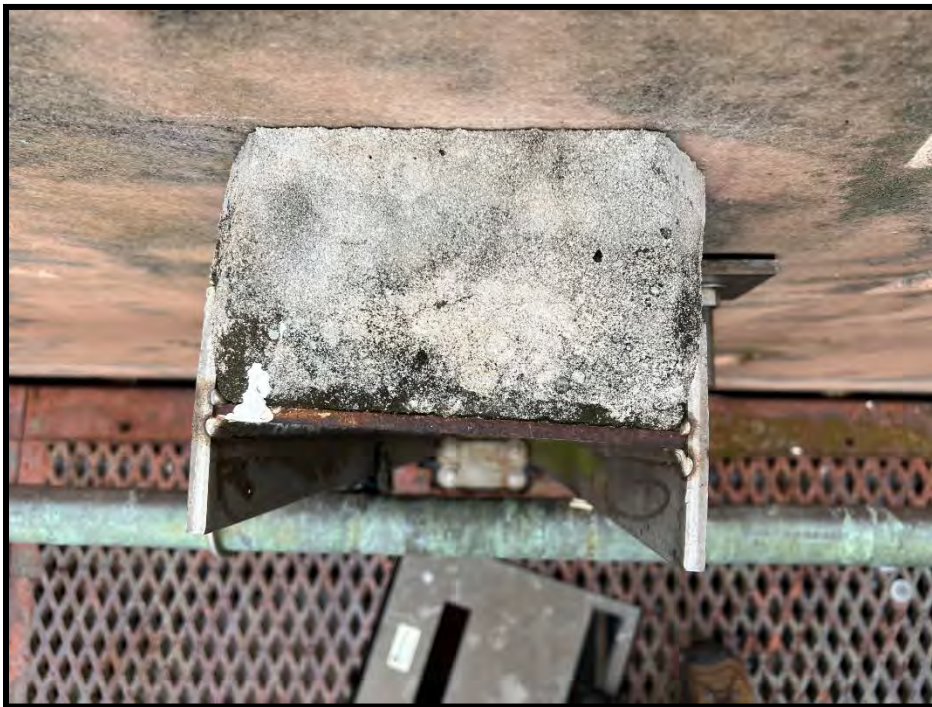
The stainless-steel parapet support installed circa 2011 is in good condition. There is limited corrosion on the end of the web plate of the built-up steel section that should be addressed (**Figure 18**).

**Figure 18** Minor corrosion observed at ends of stainless-steel parapet columns

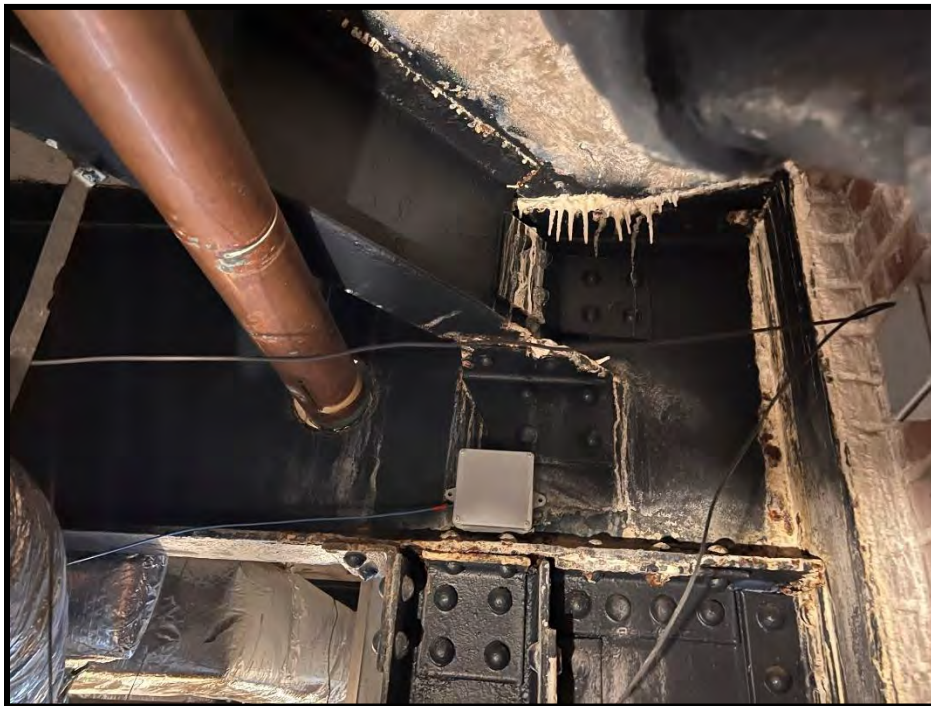
Evidence of water intrusion is visible at the underside of the Level 7 slab where efflorescence and stalactites have formed at corners and beam connections from water permeating the slab (**Figure 19**). At some locations, long term water exposure has caused concrete spalls at the beam-to-slab interface (**Figure 20**).

**Figure 19** Efflorescence and stalactites forming below seventh level slab

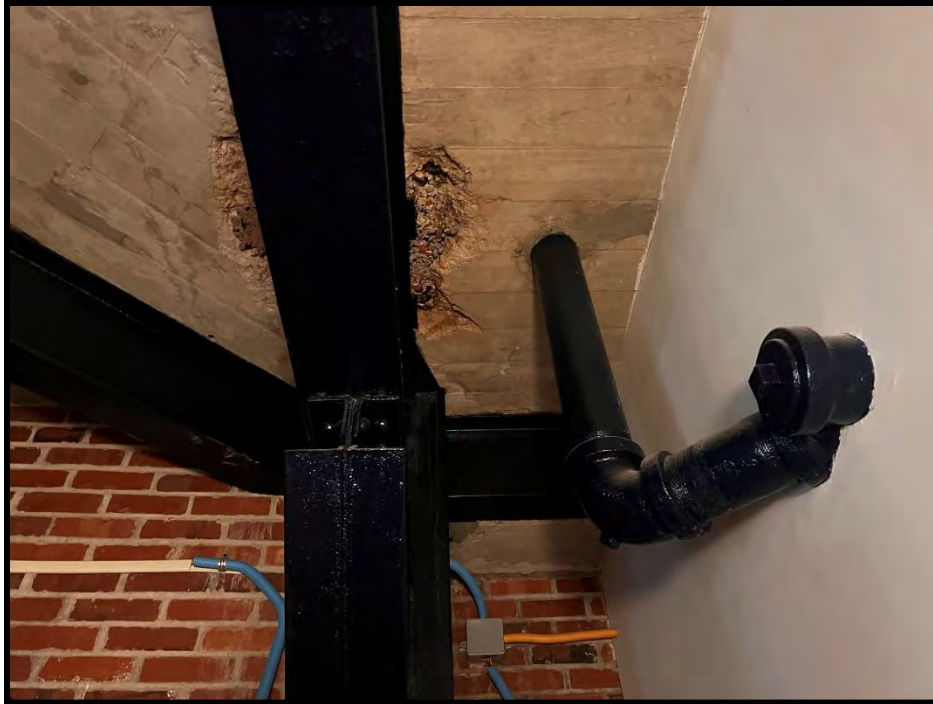
**Figure 20** Spalled concrete where steel meets underside of wet slab

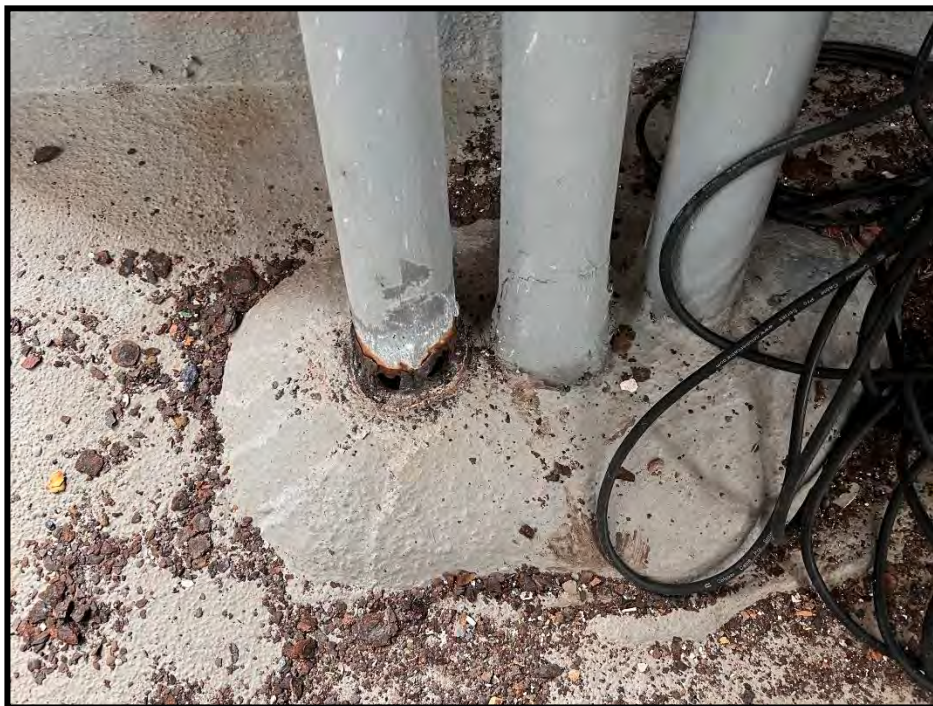
Leaks have been reported by tower staff throughout the tower where pipes penetrate slabs. Some pipes are corroded through and release water directly onto slabs (**Figure 21**). Refer to the Nondestructive Evaluation section for more information on water intrusion through drains.

**Figure 21** Drain pipes with complete section loss

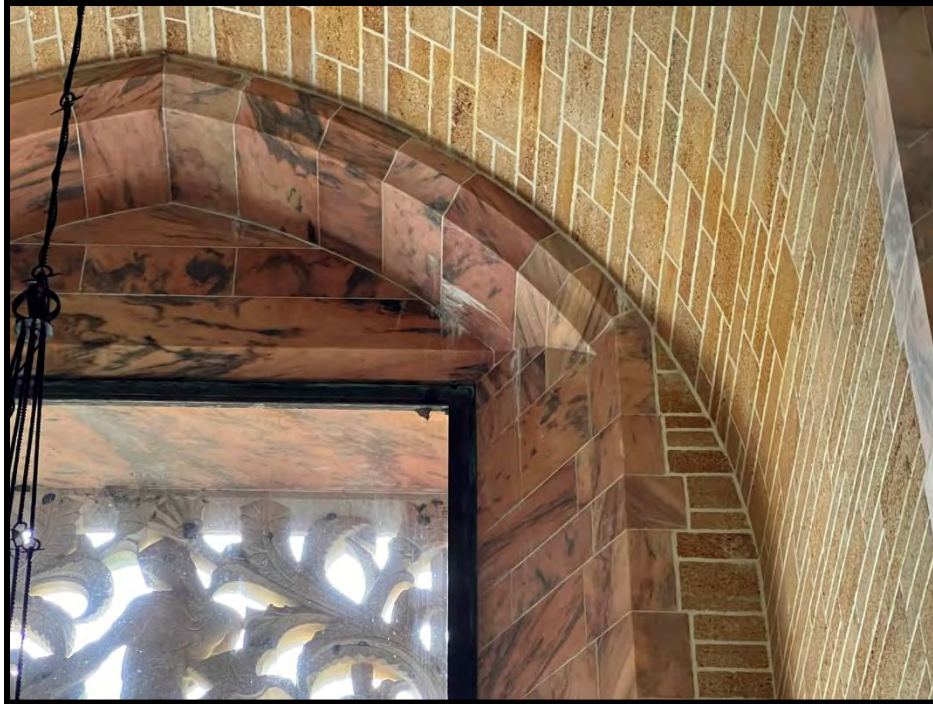
We observed one location of efflorescence in the Founder's Room directly below the Level 2 exterior balcony (**Figure 22**). Water is likely permeating the roof membrane of the balcony above and flowing through the interior masonry. The condition of the roof membrane is discussed later in this section.

**Figure 22** Efflorescence in the Founders Room at Level 1, just below an exterior balcony

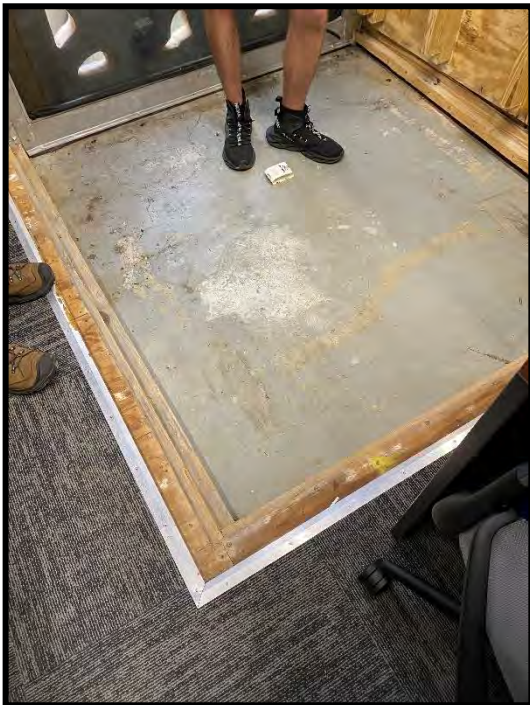
At Level 5, the Library Addition archival drawings show that rainwater from the exterior balconies is channeled inside and below a raised floor system to interior drains. This was confirmed on site through a hatch in the floor. The water is corroding steel elements of the raised floor system and effecting the conditioned environment of the library (**Figure 23** and **Figure 24**).

**Figure 23** Hatch in the Library floor build up, water passes through storefront to reach interior drains

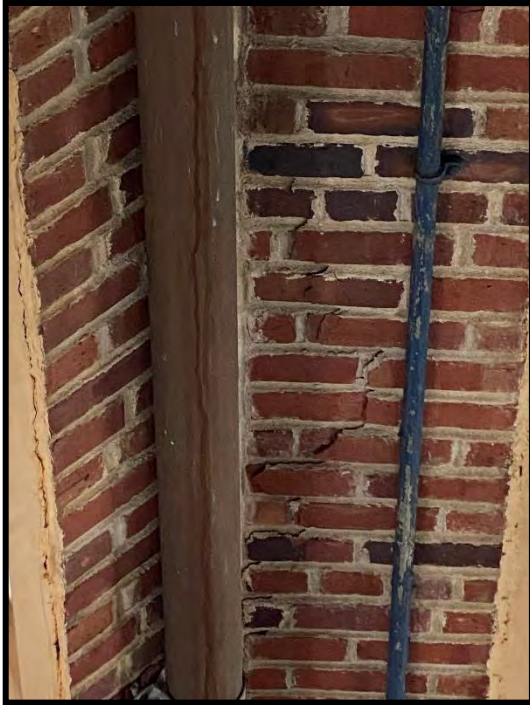
We observed flaking and spalling of the interior brick masonry in localized regions in the open-air Carillon chamber (**Figure 25** and **Figure 26**). This condition was observed in some locations where embedded steel was visible and at some locations where no steel is expected.

**Figure 25** Spalled interior masonry within the Carillon chamber

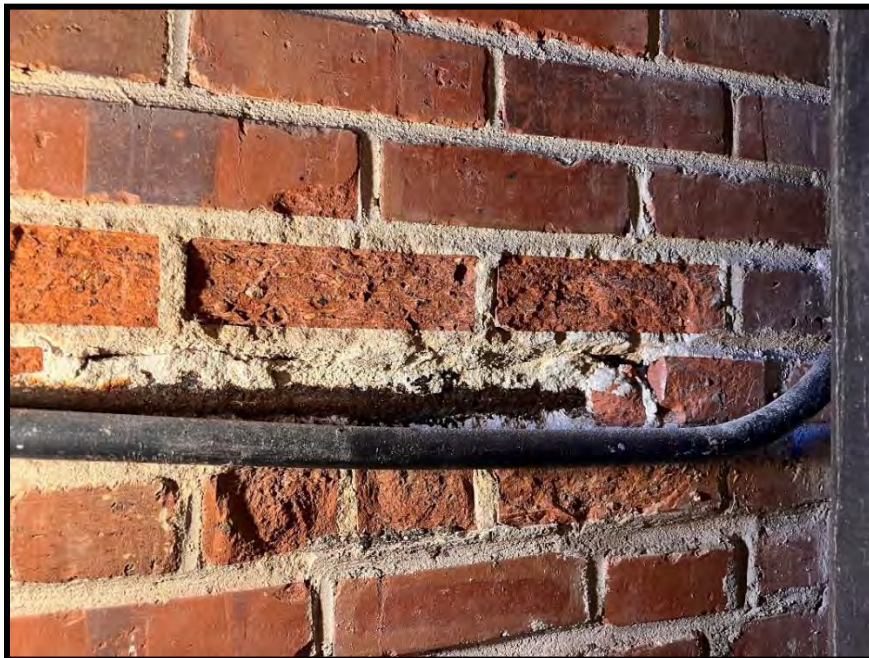
**Figure 26** Spalled interior masonry and exposed embedded steel

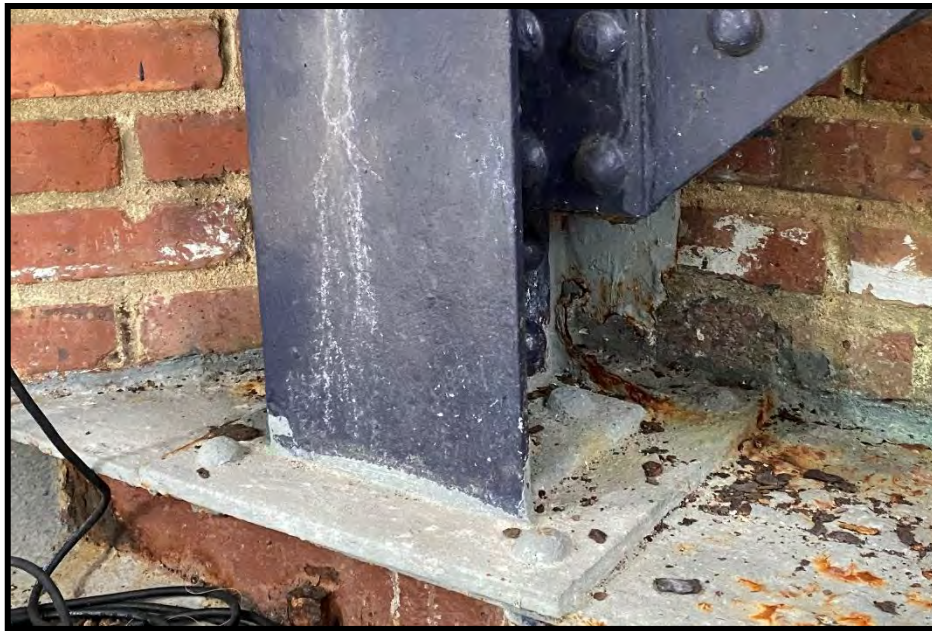
The Carillon Framing is in fair condition with localized areas of corrosion and section loss. The largest area of concern is significant section loss at the base of the columns where they bear on the transfer girder. Six columns had one to two square inches of loss at least one flange (**Figure 27**).

**Figure 27** Section loss at base of bell tower column

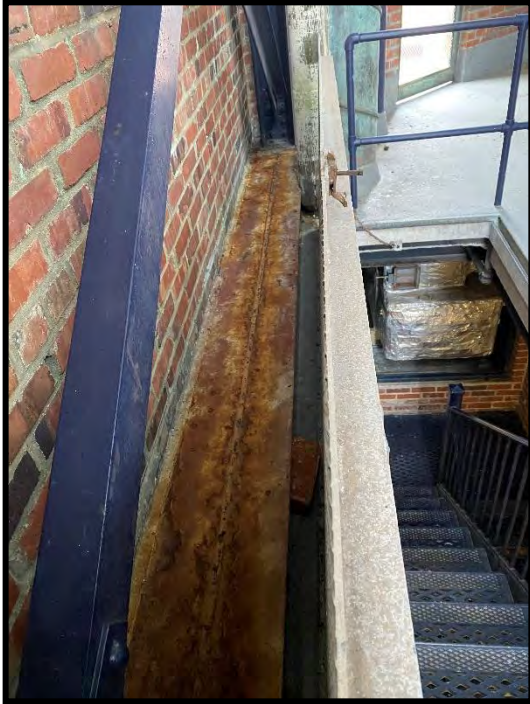
The transfer girders that support the columns exhibit rust staining indicative of corrosion (**Figure 28**). Water appears to pool on the flat surface of the girder and splash back onto the columns, causing the deterioration.

**Figure 28** Corrosion of Carillon framing transfer girder at Level 7.

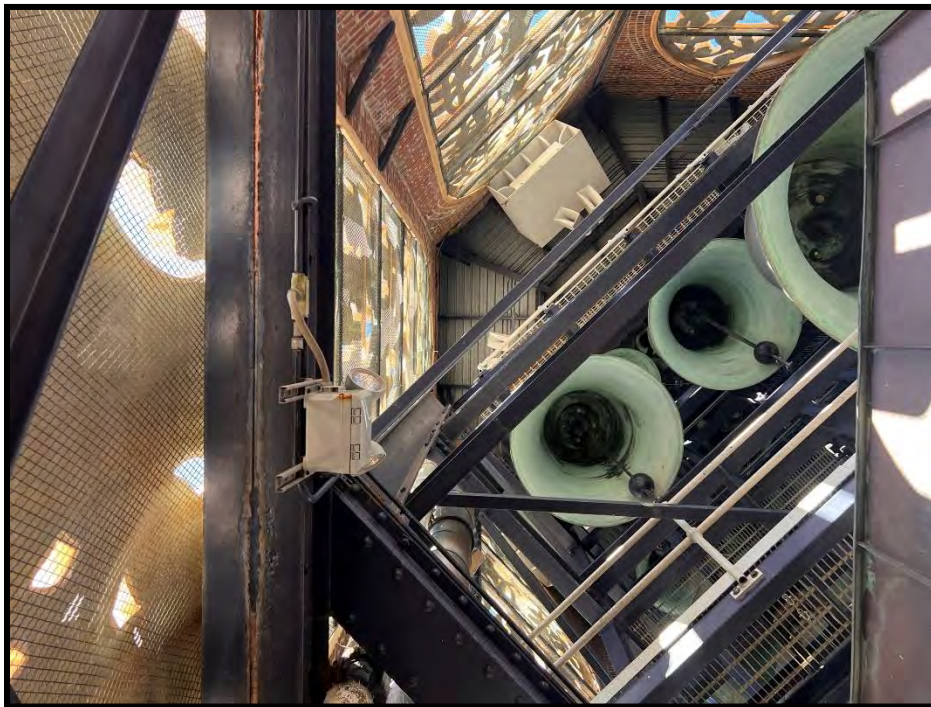
Some of the higher girders are also corroding (**Figure 29** and **Figure 30**). They appear to be built up sections with grout between them. We expect that water passes through the grout and stays saturated long enough that the interior of the sections and bottom flange are corroded.

**Figure 29** Carillon framing, at left built up girder at left exhibits corrosion between elements.

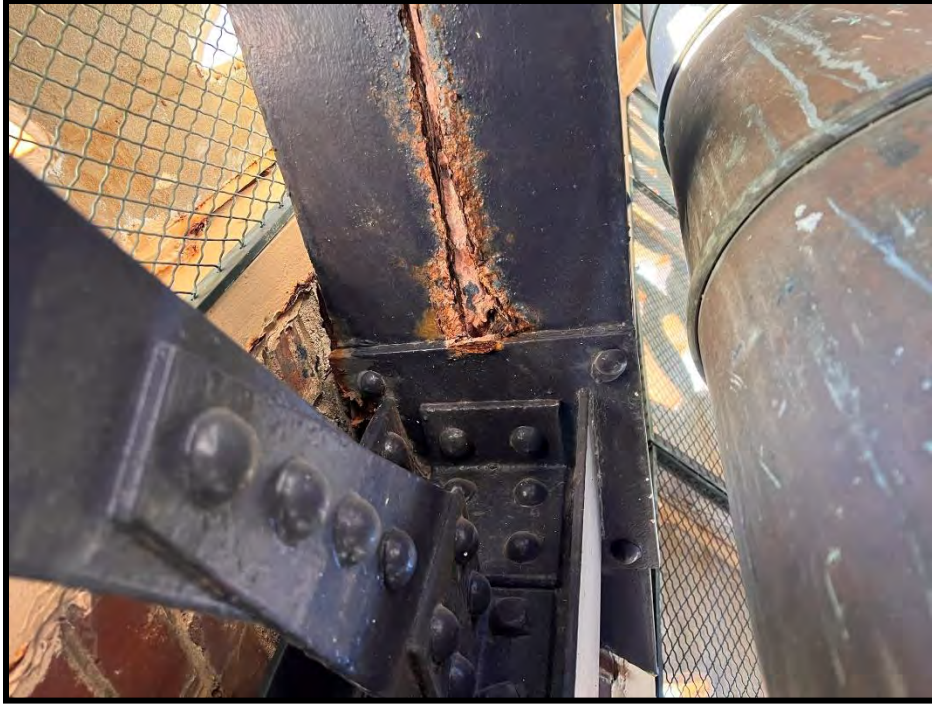
**Figure 30** Close up view of deterioration of Carillon framing

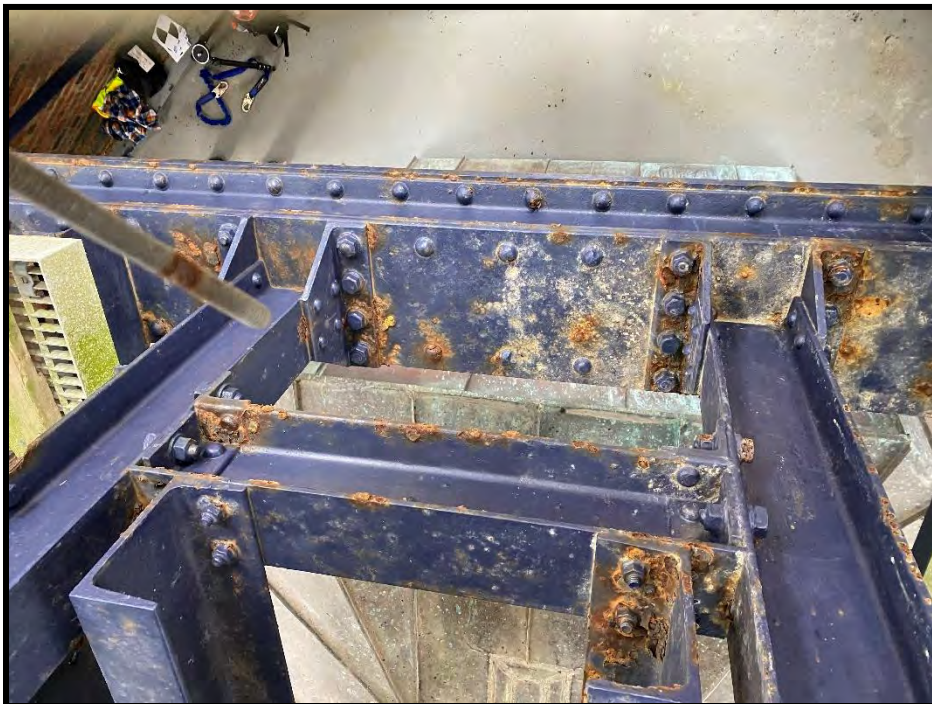
Limited corrosion was observed on other horizontal surfaces and splash zones of the Carillon framing (**Figure 31**). The channel supporting the first run of stairs to access the bells is in poor condition with significant corrosion (**Figure 32**).

**Figure 31** Carillon framing above the Playing Cabin, viewed from above.

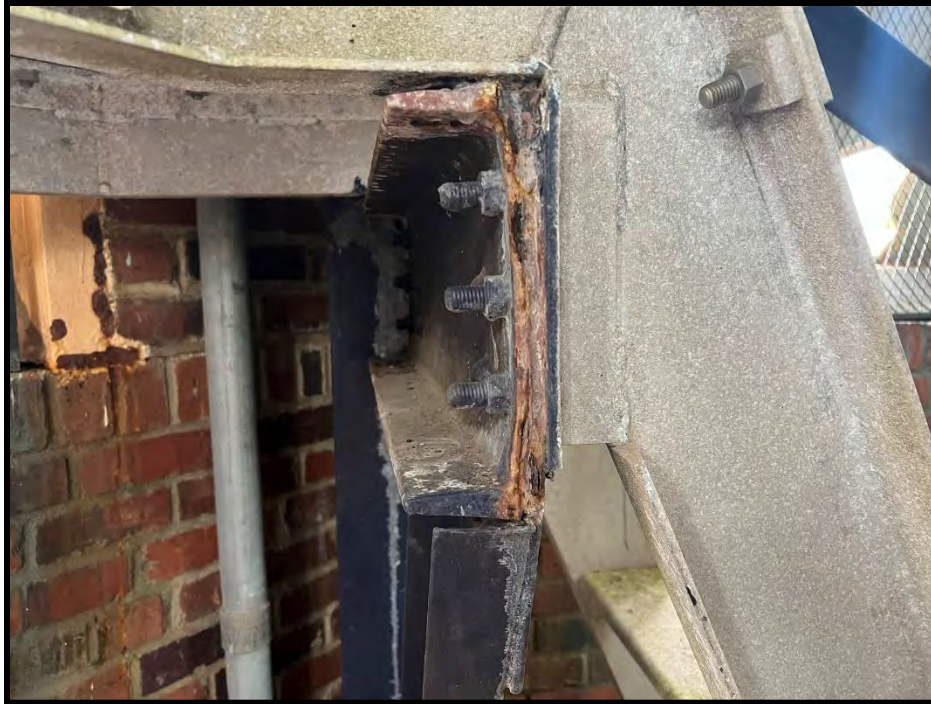
**Figure 32** Corrosion at Carillon access stair

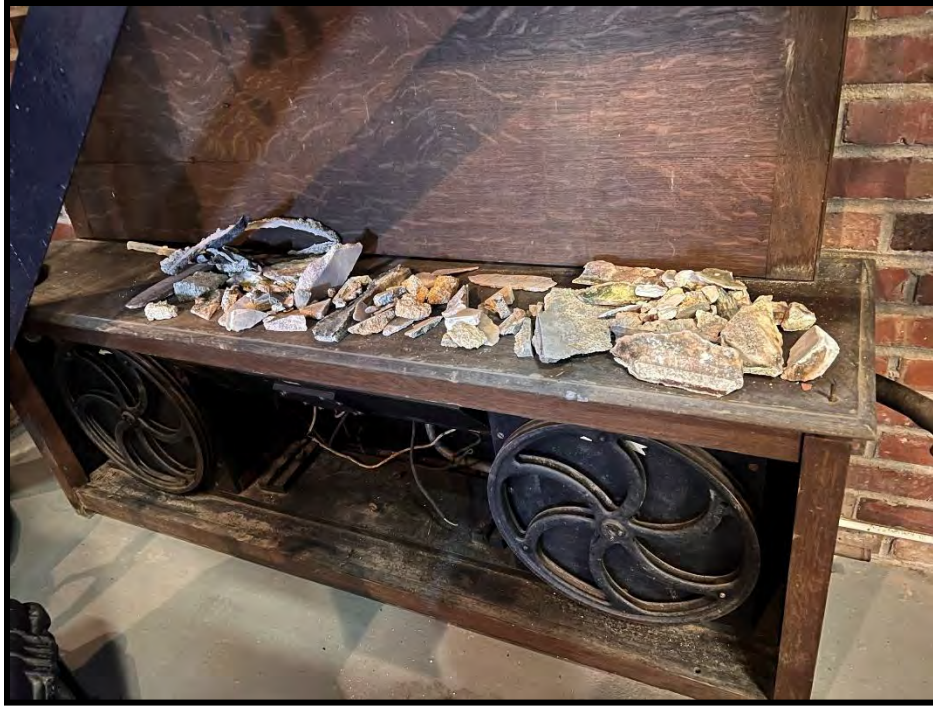
Spalls and chips in the masonry are primarily concentrated above the seventh floor low roof, above which the tower is open air. VA removed any loose spalls and failed mortar. A portion of what was removed is shown in **Figure 33**.

**Figure 33** Loose material removed from the tower façade by Vertical Access

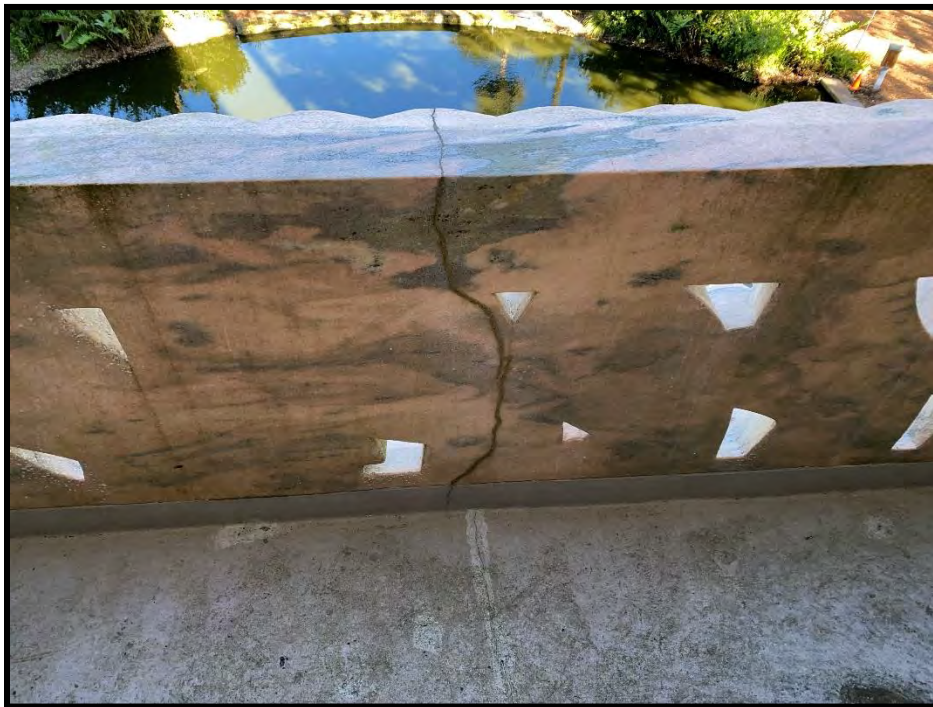
T.Y. Lin and LAS observed the exterior from grade and from roof surfaces and balconies. A large vertical crack was observed in the marble guardrail at the Level 2 balcony (**Figure 34**). Cracks were observed in some of the exterior paving at the entrance to the tower (**Figure 35**) and bridge over the moat.

**Figure 34** Crack in stone guardrail at 2<sup>nd</sup> level balcony

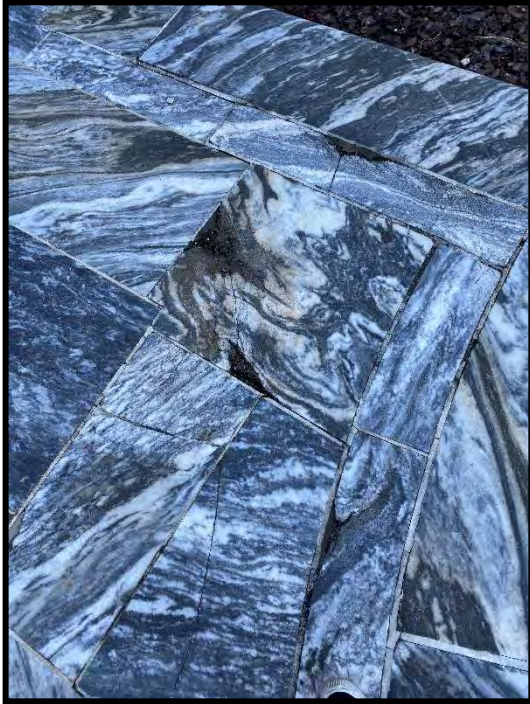
**Figure 35** Cracks and staining of Creole marble at tower exterior

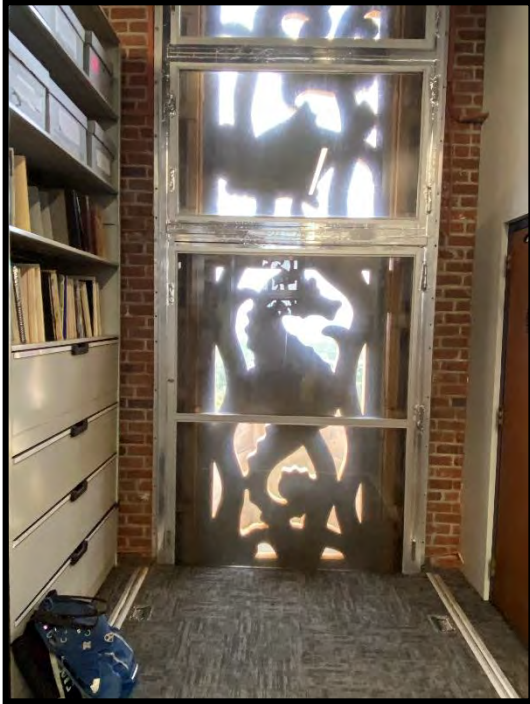
Storefront glazing was added in front of window and door openings at upper levels of the tower (**Figure 36**). These coverings have primarily reached the end of their useful life. Staff who work in the building have reported leaks through the storefronts at some locations. In the Carillon Studio, seals in the storefront glazing have failed. At the Library, the storefront is designed to allow water into the building, as discussed in the Water Intrusion section of this report.

**Figure 36** Library storefront window behind the mosaic window covering

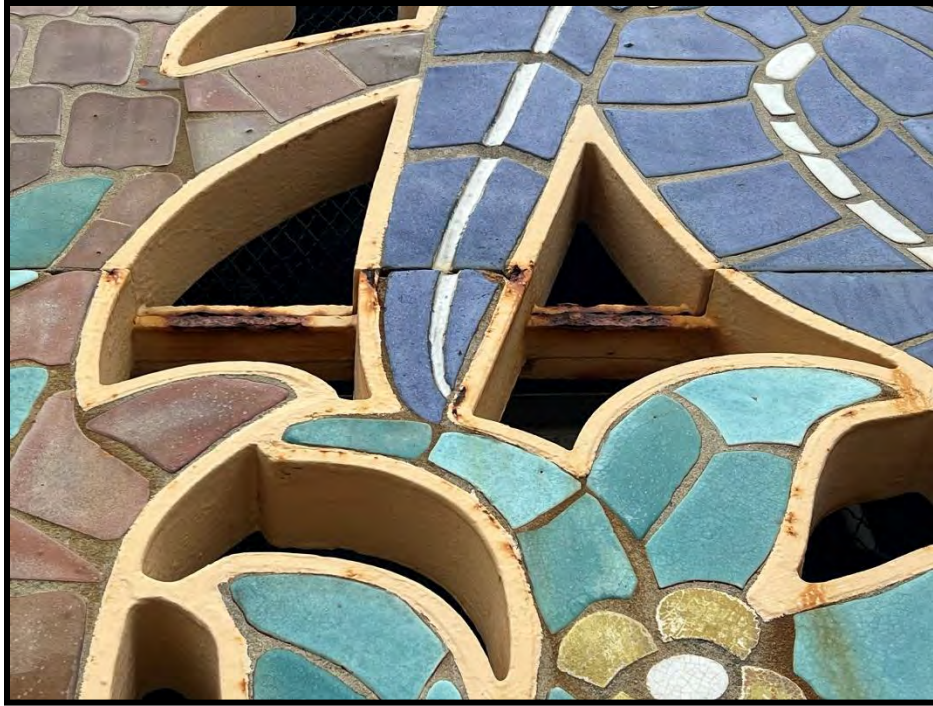
**Figure 37** Terra cotta screens with cast iron frames. Corrosion is visible at the joint between cast iron frames pieces

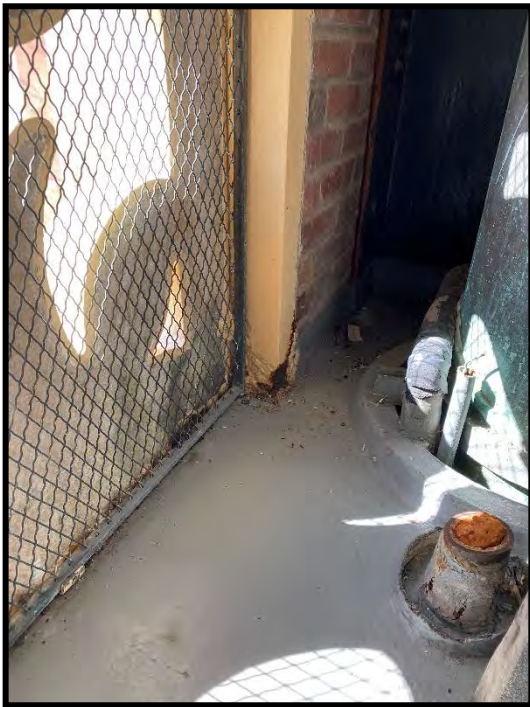
The tiles are in good condition with localized areas of cracks, spalls, missing tiles, and glaze loss. Refer to the VA drawings included in the Appendix for detailed documentation of these conditions. The cast iron frames that surround the mosaics are typically corroded where the protective coating has failed. The corrosion is typical at horizontal joints between the cast iron pieces that make up the frames, as shown in **Figure 37**. Corrosion is also typical at the interior frame bases where water continually splashes off the floor onto the jamb (**Figure 38**).

**Figure 38** Corrosion at interior mosaic frame

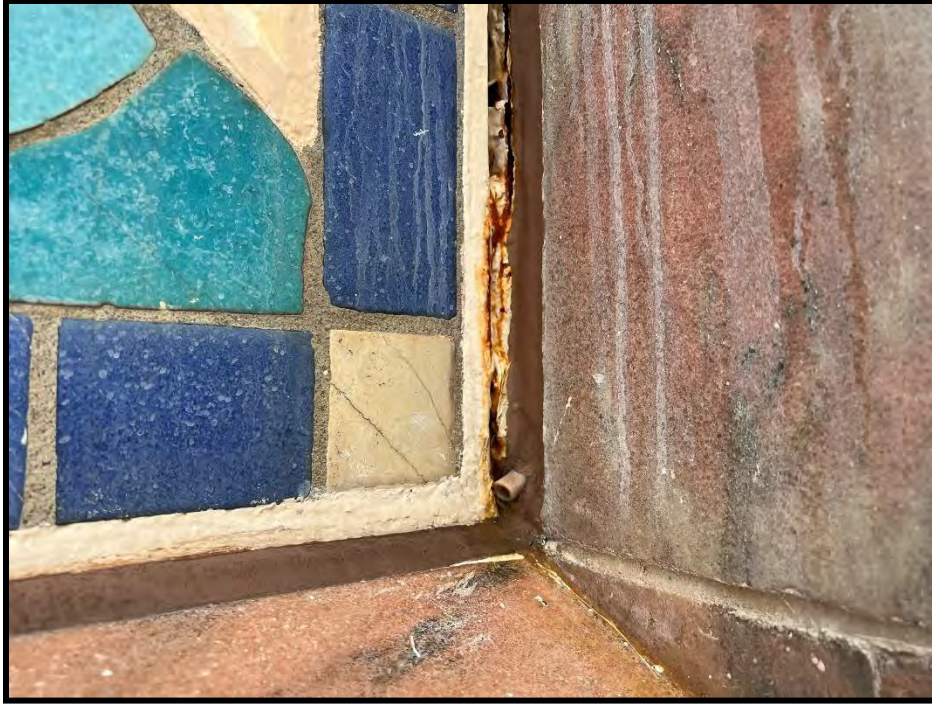
A sealant joint was installed to protect the edges of the frame from corrosion. In some locations that joint has failed and requires replacement (**Figure 39**).

**Figure 39** Failed sealant joint at perimeter of the mosaic

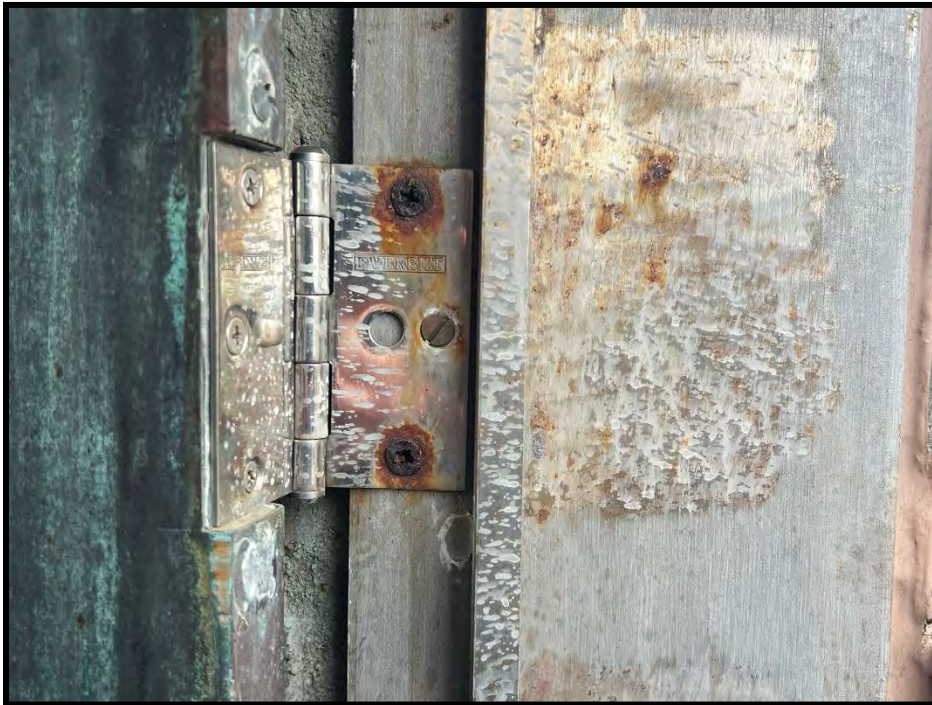
New fasteners in the new stainless-steel door frames have failed and need to be replaced (**Figure 40**). It appears that an incompatible fastener material was used. Stainless steel fasteners should be installed.

**Figure 40** Corroded fasteners require replacement

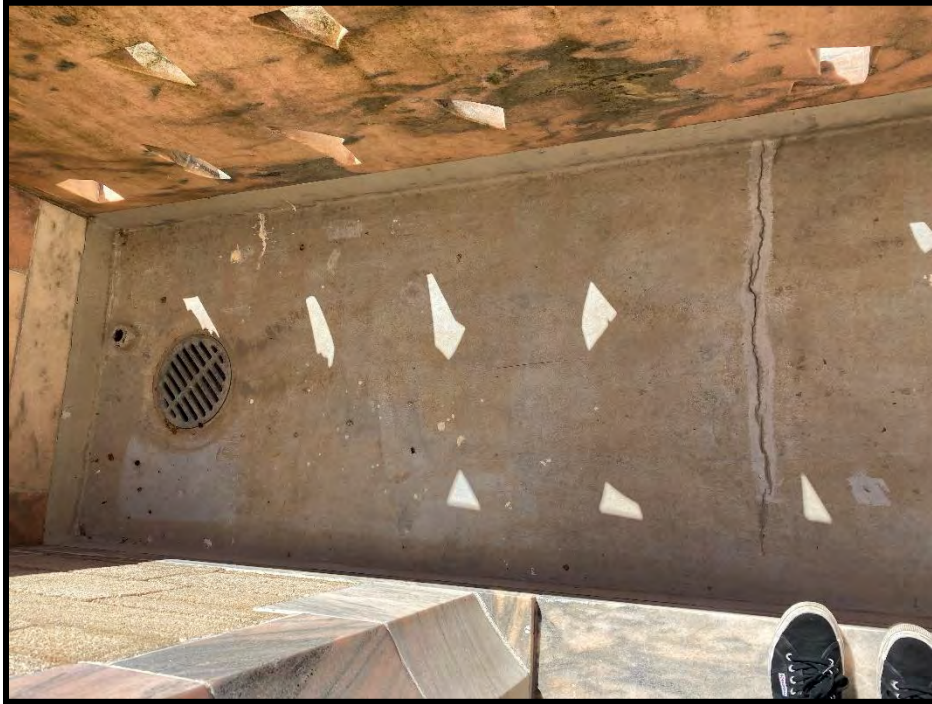
A fluid applied membrane is used as a roof material at the balconies, low roof, and open-air slabs in the tower. The membrane has reached the end of its useful life and started to fail. Larger splits were observed in some locations (**Figure 41**). In other areas, there are bubbles and tight knit crack patterns (**Figure 42**). These failures are opportunities for water to make its way into the tower.

**Figure 41** Large split in a balcony roof membrane

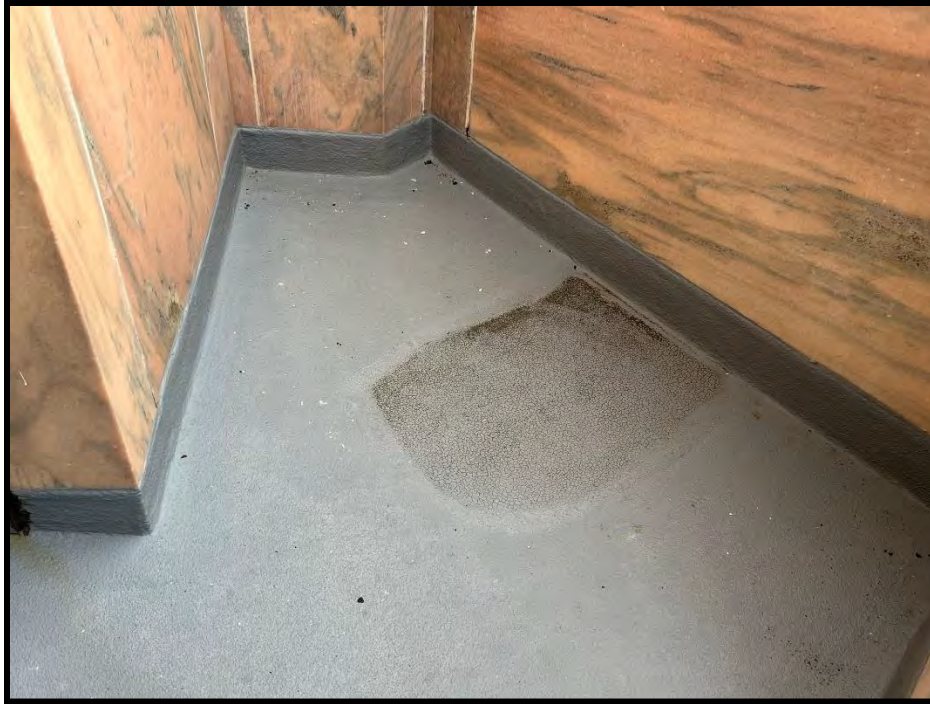
**Figure 42** Cracked roof membrane at the low roof

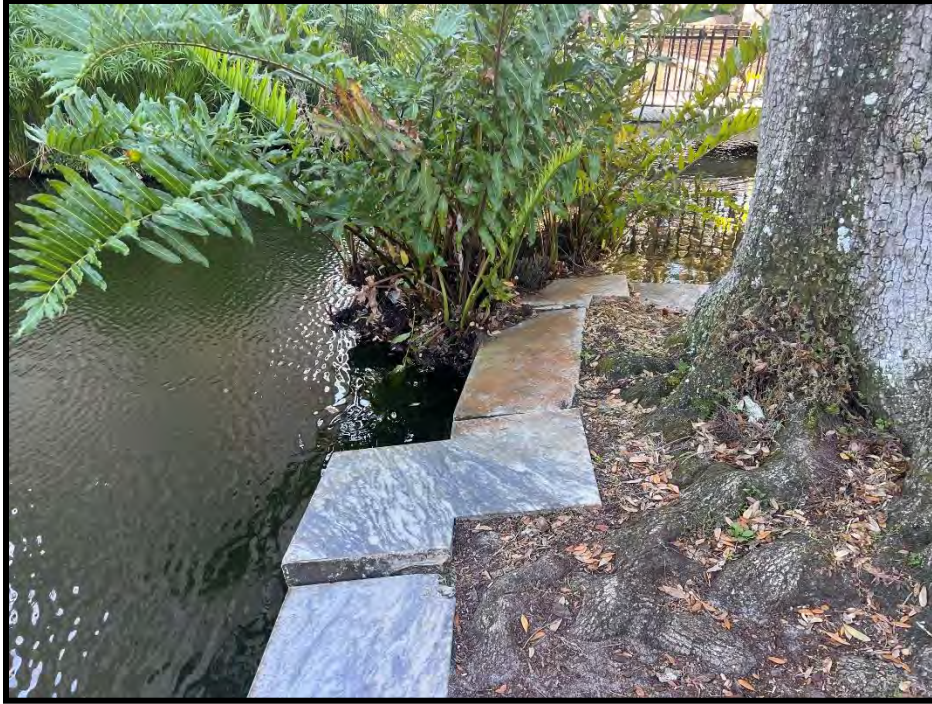
**Figure 43** Displaced coping stones around the moat perimeter

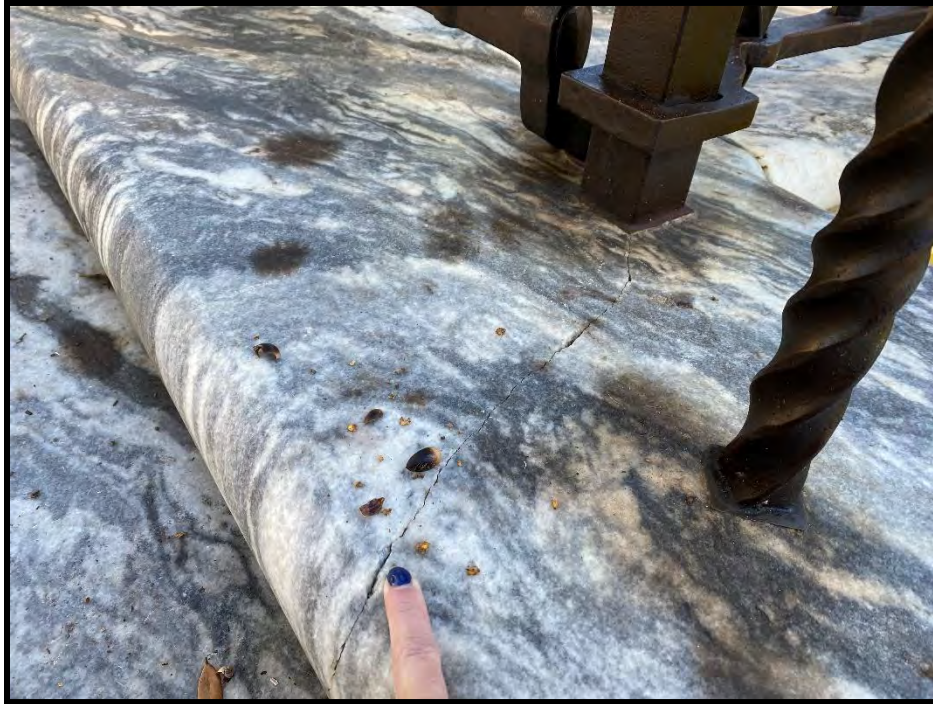
The bridges to the moat are in fair condition with some minor cracking. There are cracks in the marble treads emanating from the inset gate posts (**Figure 45**). The bridge slab should be reviewed further when the moat is drained.

**Figure 45** Crack in Creole marble steps of the moat bridge

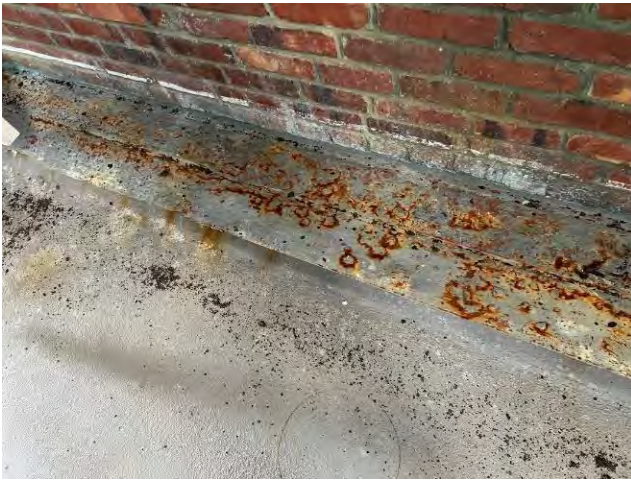
11 Lower Roof surface degradation

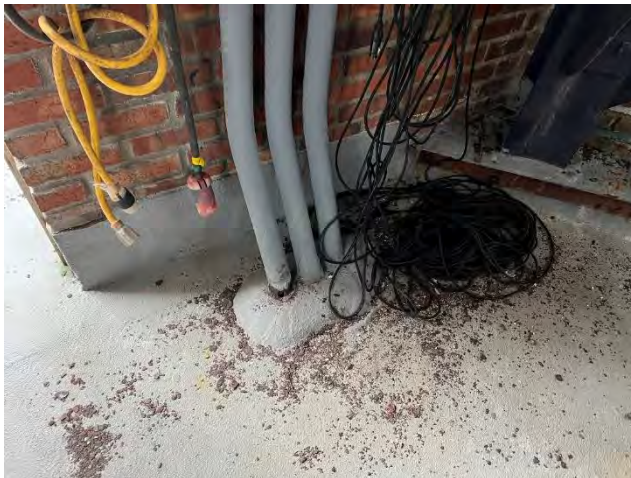
13 Examples of roof penetrations

When the lower roof is replaced, penetrations can be properly and robustly sealed to prevent leaks. Prefabricated boots can be installed to fully protect against water infiltration in conjunction with the lower roof installation.
