### ***Bok Singing Tower Roof Restoration and Replacement***

# Bok Singing Tower Conditions Assessment

T.Y. Lin (formerly Silman) was contracted to perform a conditions assessment of the Bok Singing Tower at Bok Tower Gardens in Lake Wales, Florida. The Singing Tower stands 205 feet tall at the southwest corner of the gardens. A moat surrounds the base of the tower with two bridges to access the island. The tower houses a 60-bell carillon, associated carillonneur studio and library spaces, the Bok Tower Gardens Chao Research archive, and the Founder's Room. It is a steel frame construction clad in a masonry exterior of coquina and Georgia pink Etowah marble with brick masonry at the interior.

## **Bok Tower Focused Condition Assessment**

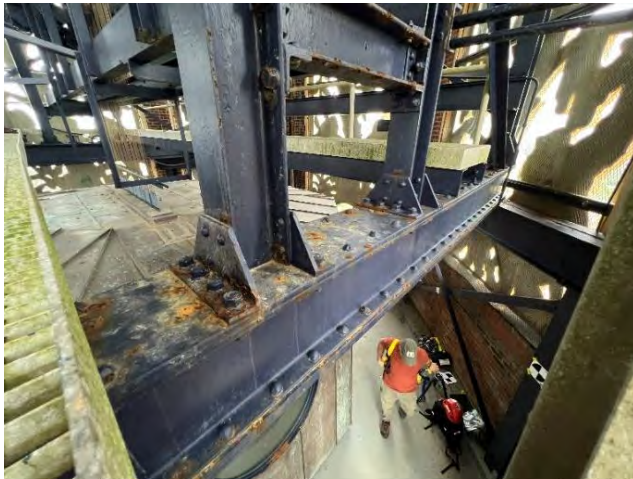
16 Corrosion at bell chamber steel structure

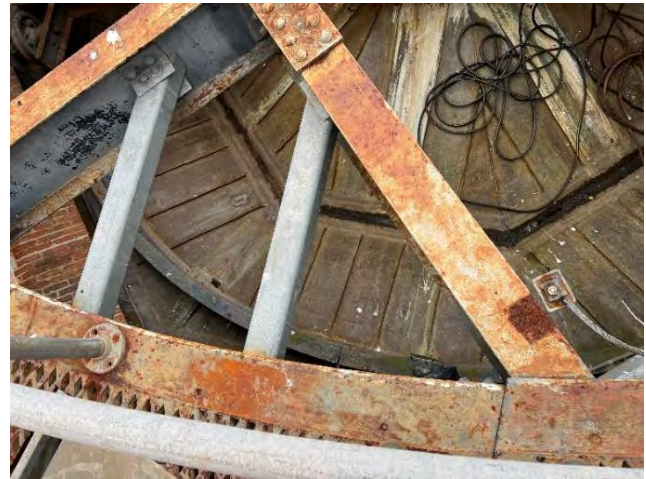
17 Corrosion at roof steel structure

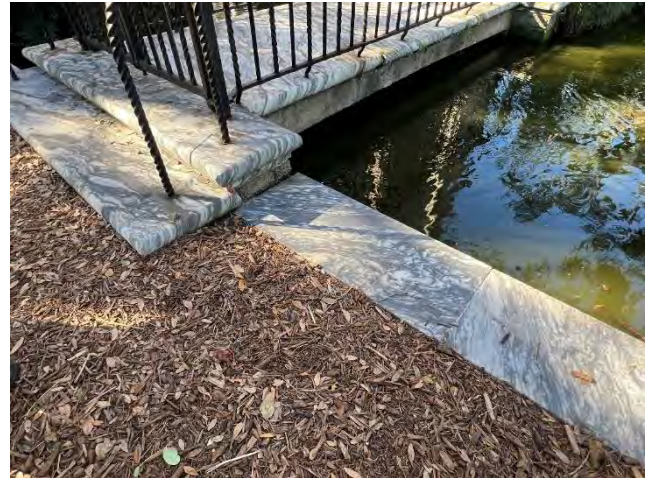
23 Cracked stone at moat edge.

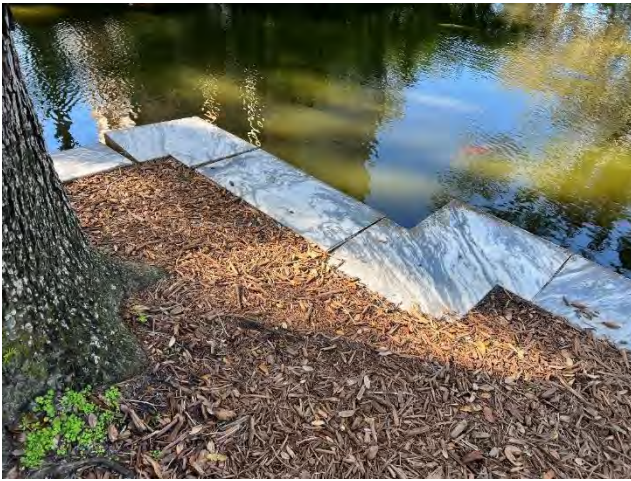
24 Moat edge stones out of plumb.

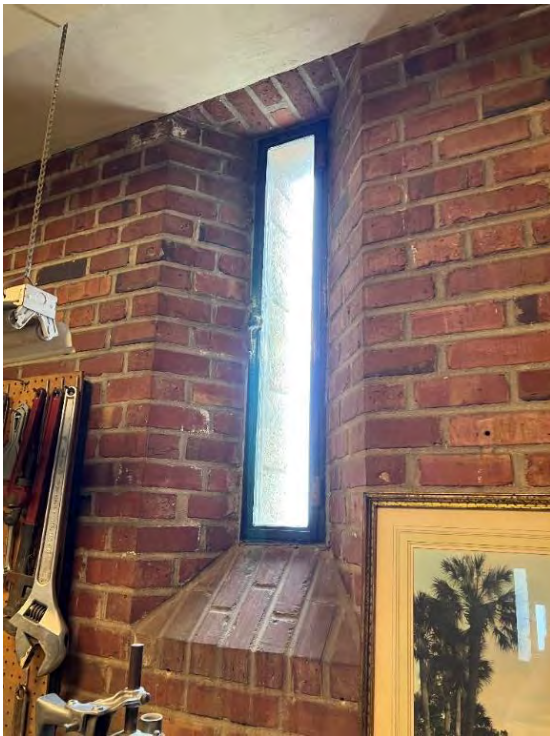
27 Slot window with reported leaks

The slot windows and storefront glazing are recommended to be repaired or replaced. In this case, it is likely to be more cost effective for the storefront to be replaced than repaired. The level of wind resistance of the new storefront is to be confirmed to adequately meet requirements. The condition at the slot windows requires further investigation to determine if this window type can be resealed or is to be replaced.

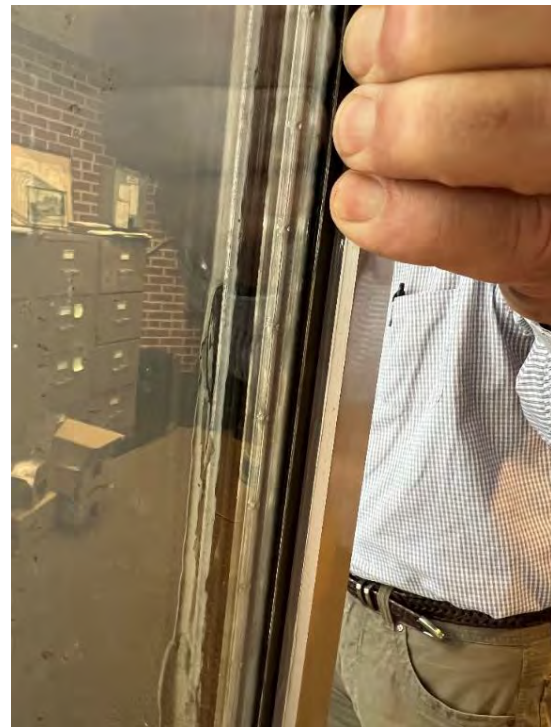
28 Interior storefront seal
