### ***Bok Singing Tower Roof Restoration and Replacement***

# Bok Singing Tower Conditions Assessment

T.Y. Lin (formerly Silman) was contracted to perform a conditions assessment of the Bok Singing Tower at Bok Tower Gardens in Lake Wales, Florida. The Singing Tower stands 205 feet tall at the southwest corner of the gardens. A moat surrounds the base of the tower with two bridges to access the island. The tower houses a 60-bell carillon, associated carillonneur studio and library spaces, the Bok Tower Gardens Chao Research archive, and the Founder's Room. It is a steel frame construction clad in a masonry exterior of coquina and Georgia pink Etowah marble with brick masonry at the interior.

## **Bok Tower Focused Condition Assessment**

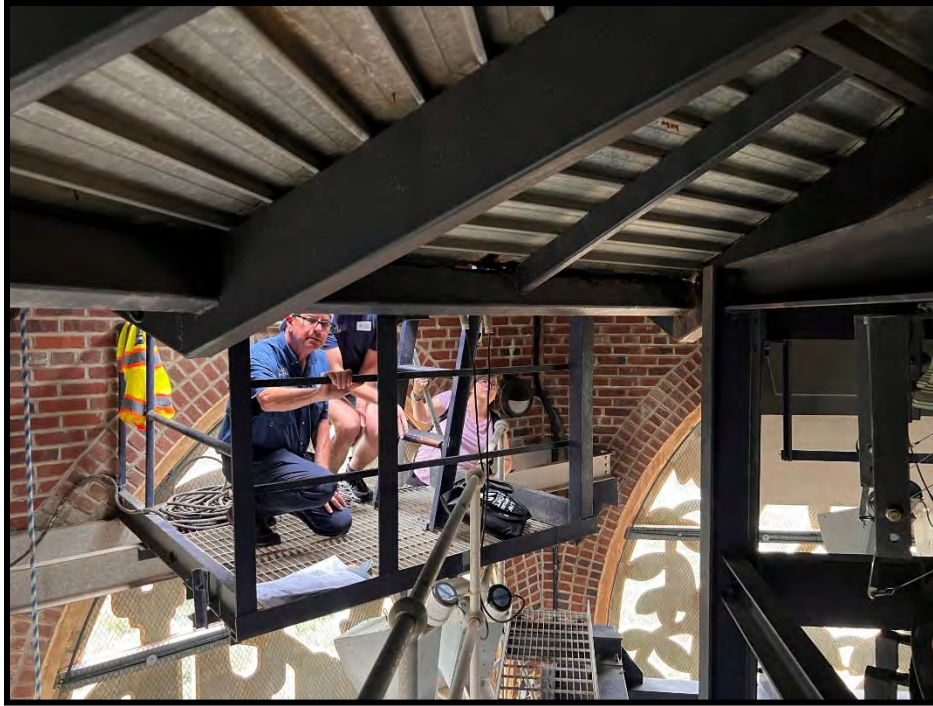
**Figure 6** Upper roof framing

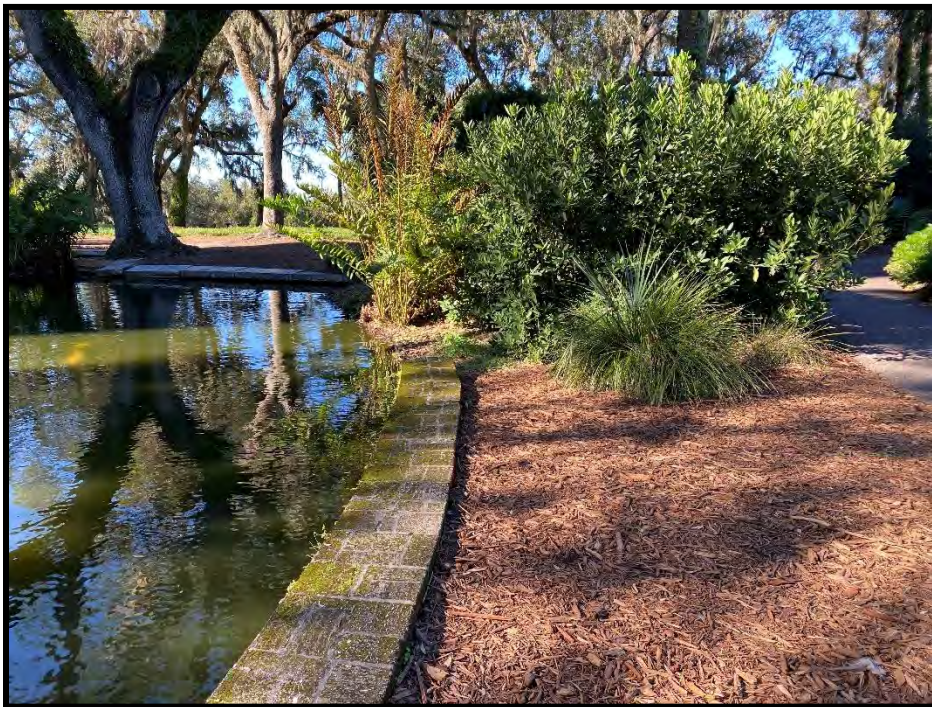
The perimeter of the moat is typically surrounded by Creole gray marble coping stones that have been displaced and are out of plumb and need to be reset (**Figure 43**). In some areas, an alternate cast stone material is used as the coping or there is no coping, and the landscape runs into the edge of the moat (**Figure 44**).

**Figure 44** Alternate material coping stone and unfinished edge of moat

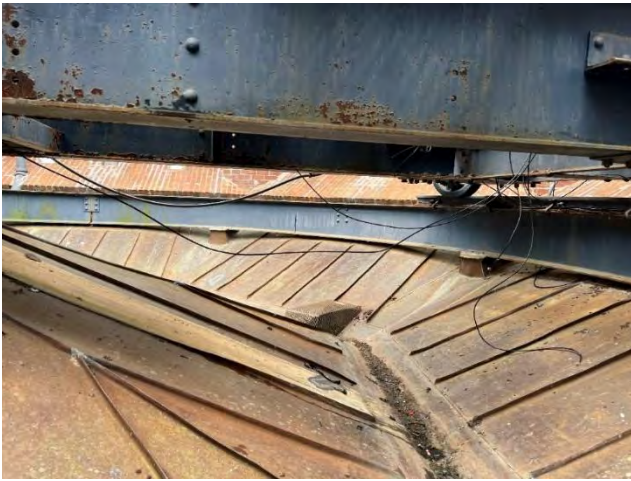
2 Upper Roof. Single drain visible.

The upper copper roof is beyond its serviceable life and requires replacement. The same geometry is to be maintained, and additional drains are to be added. Details are to be used by the Copper Development Association, which represents the best industry standard. A flexible membrane product should be evaluated for the internal gutter.

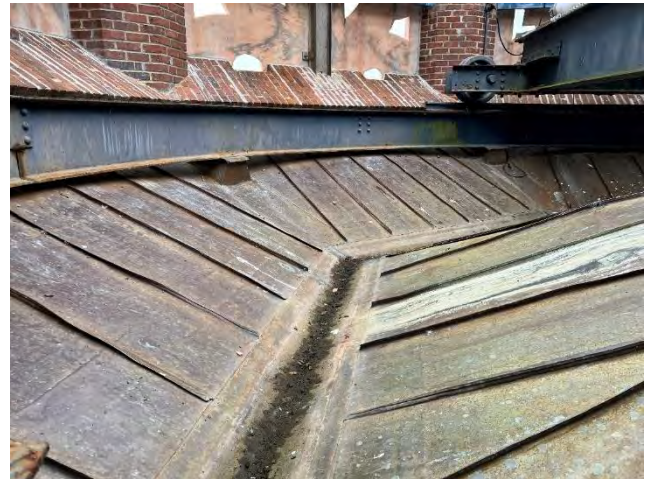
5 Upper roof slopes to an internal gutter

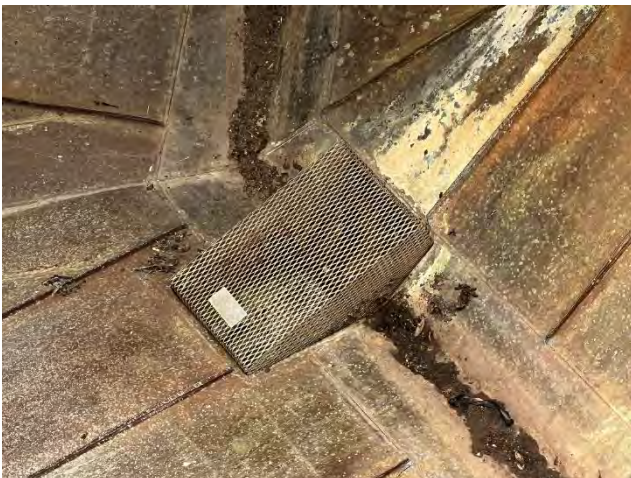
6 Single upper roof drain

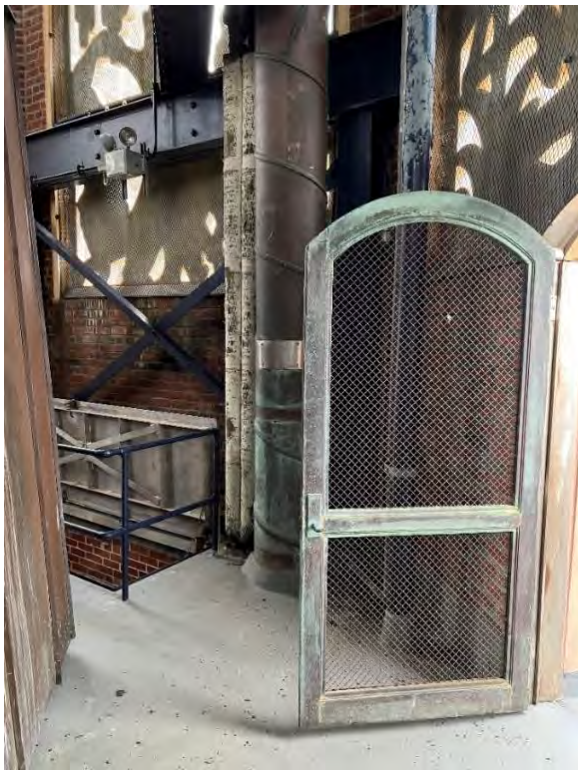
9 Lower roof connection to balcony

A completely new lower roof is recommended. A PMMA (polymethyl-methacrylate) system is recommended. PMMA roof systems, which are liquid applied, are ideal for roofs with irregular geometry or multiple penetrations, and resist ponding. Kemper and Siplast are two manufacturers of PMMA roof systems. A roof surface is to be specified with a texture to prevent slipping.

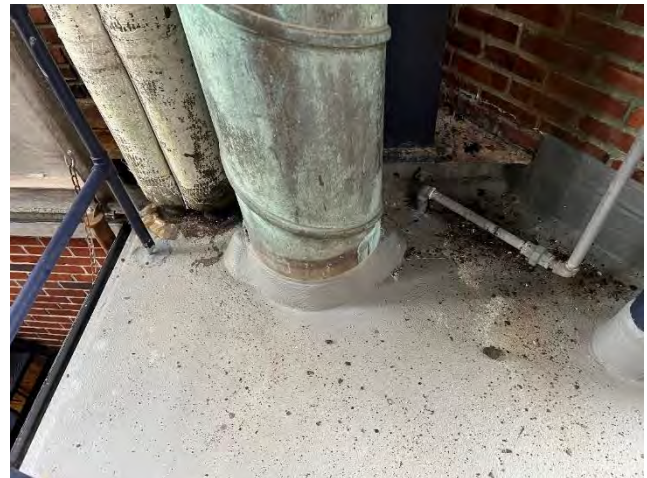
Figure 14 Examples of roof penetrations

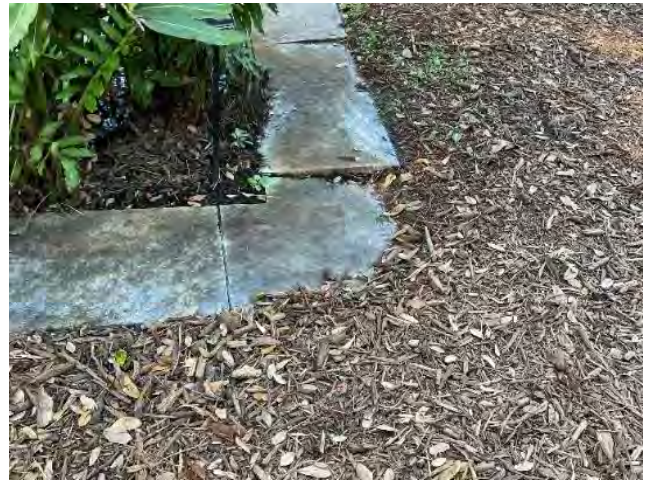
To reset out of plumb coping stones, stones are to be documented, removed, cleaned. The displaced coping stones seem worse at outside and inside corners of the moat perimeter. The supporting walls need to be investigated to make sure they are plumb and have sufficient capacity to receive the re-laid coping stones. The moat wall is to be repaired before replacing the coping stones.

25 Moat coping stones out of plumb.

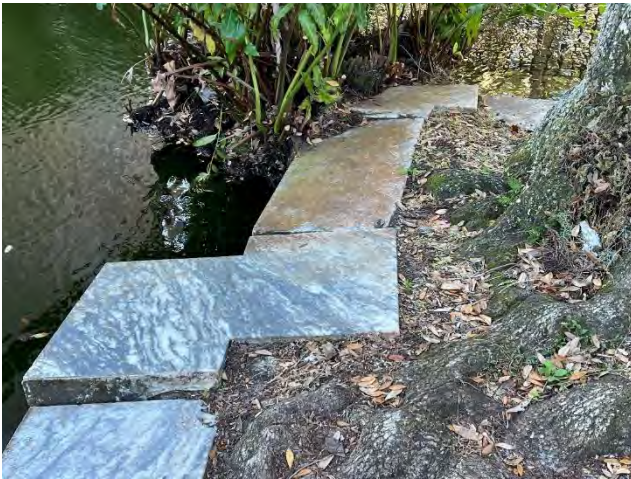
26 Moat coping stones out of plumb.

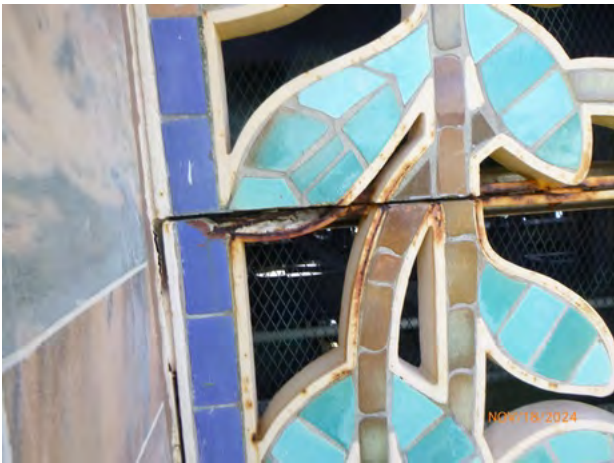
- Overall, the individual polychrome terra cotta tiles that make up the decorative tile panel assemblies located at the 5<sup>th</sup>, 6<sup>th</sup>, and 7<sup>th</sup> levels were observed to be in good condition exhibiting isolated instances of cracks through single units (“C”), missing tile (“M”), and glaze loss (“Glz”) (see photographs 10-155, 9-164, and 313-164 respectively).

9-164 TerraCotta\_Spall Missing + Steel 2024-2.jpg

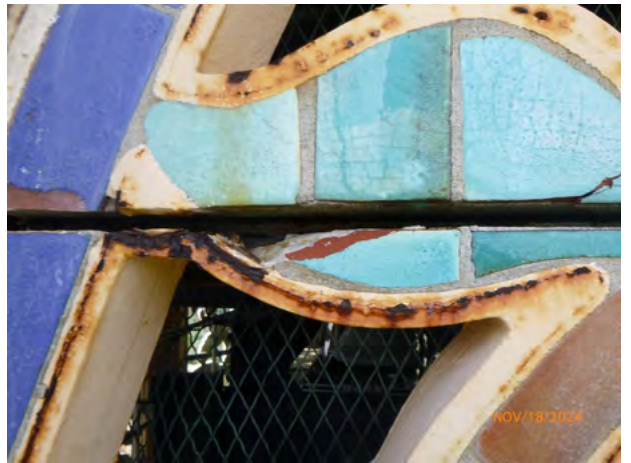
9-164 TerraCotta\_Spall Missing + Steel 2024-3.jpg

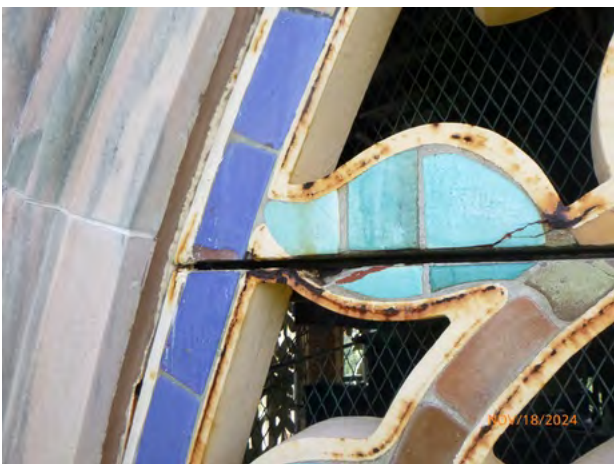
9-173 TerraCotta\_Spall Missing 2024-1.jpg

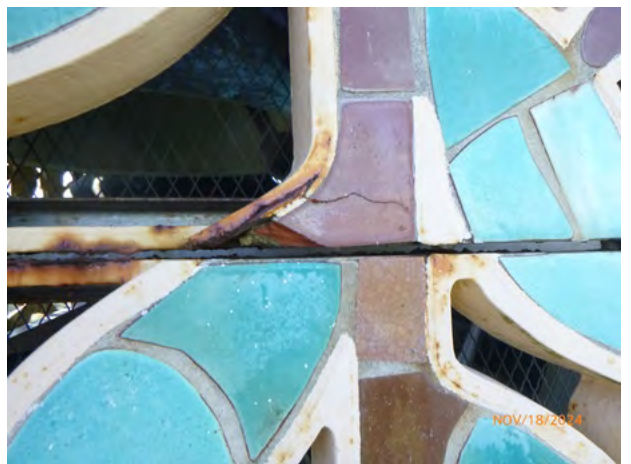
9-173 TerraCotta\_Spall Missing 2024-2.jpg

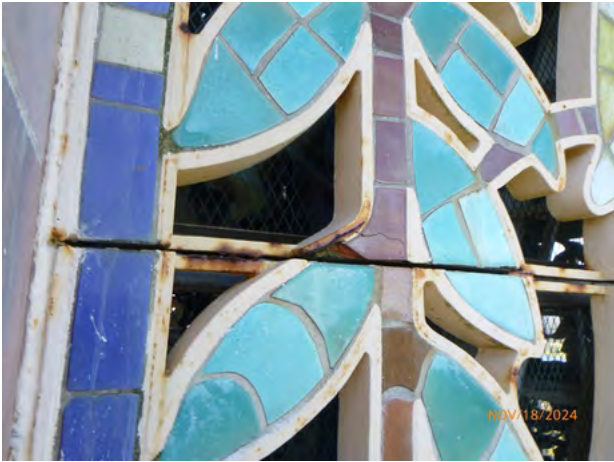
10-154 TerraCotta\_Spall Missing 2024-1.jpg

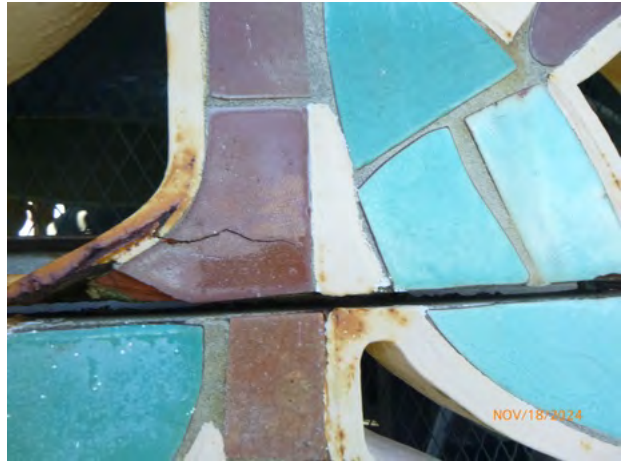
10-154 TerraCotta\_Spall Missing 2024-2.jpg

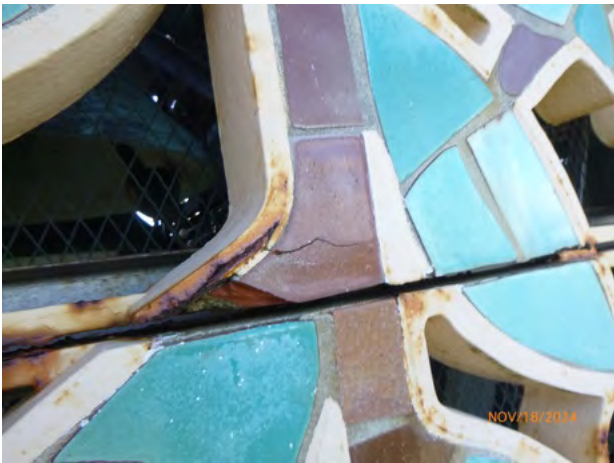
10-155 TerraCotta\_Crack Single unit 2024-1.jpg

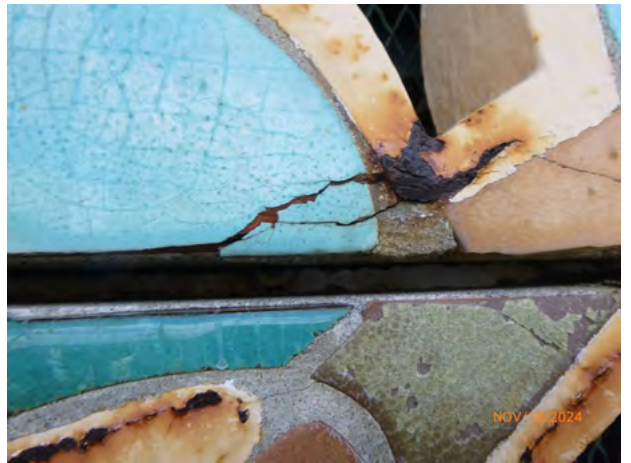
10-155 TerraCotta\_Crack Single unit 2024-2.jpg

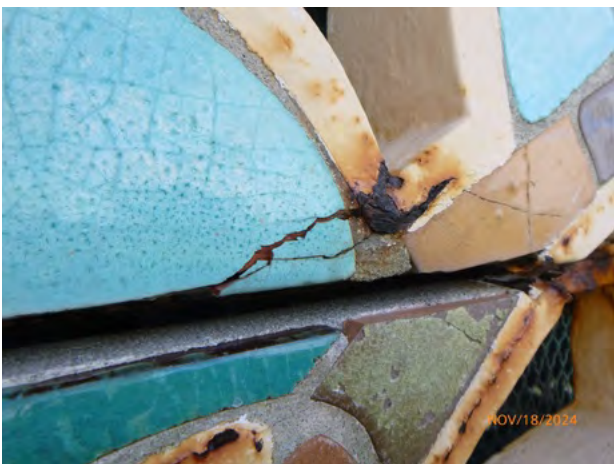
10-173 TerraCotta\_Crack System units and joints 2024-1.jpg

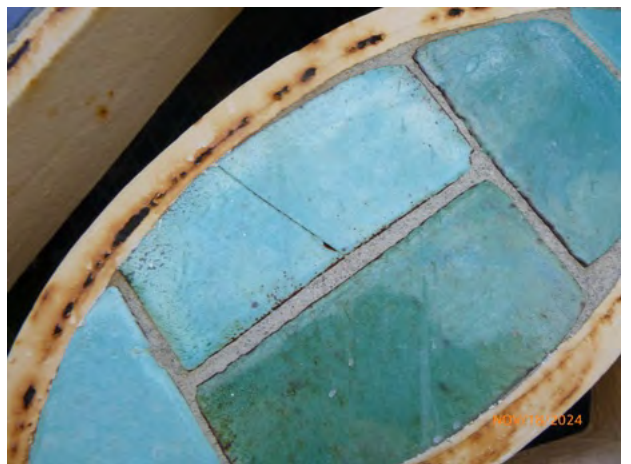
10-173 TerraCotta\_Crack System units and joints 2024-2.jpg

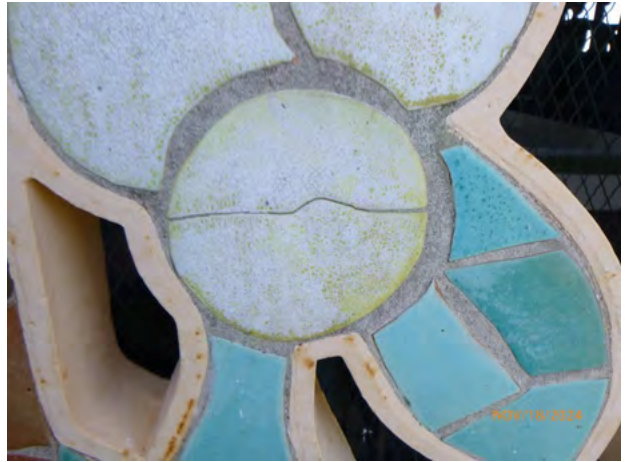
10-175 TerraCotta\_Crack Single unit 2024-2.jpg

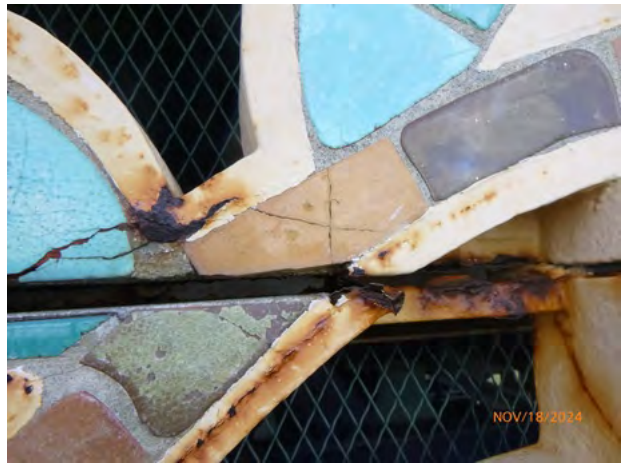
11-160 TerraCotta\_Crack Single unit 2024-2.jpg

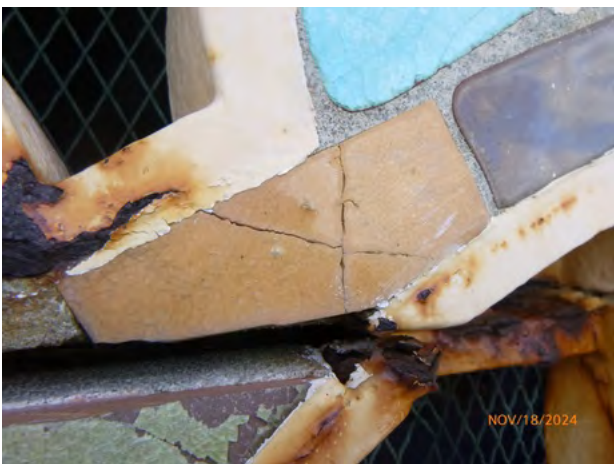
11-173 TerraCotta\_Crack Single unit 2024-1.jpg

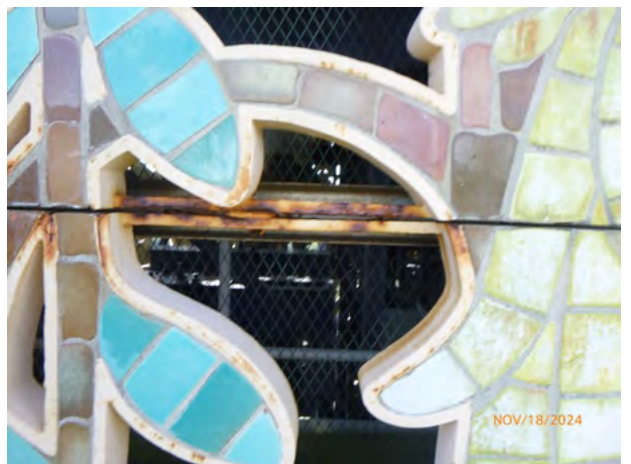
11-173 TerraCotta\_Crack Single unit 2024-2.jpg

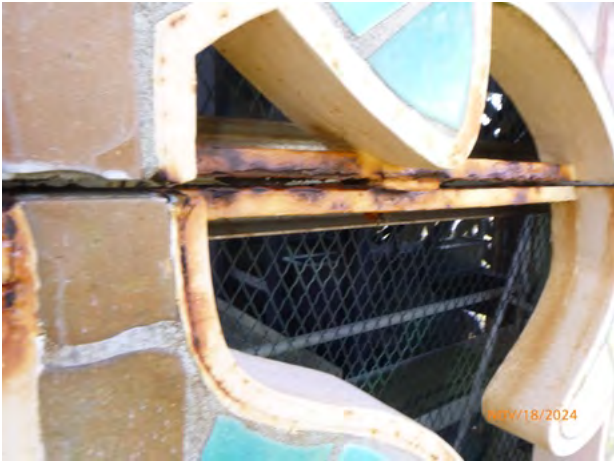
12-163 ArchMetal\_Corrosion Pitted 2024-1.jpg

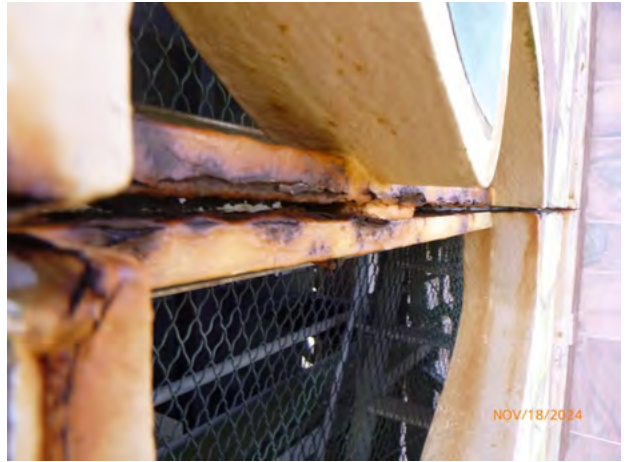
12-163 ArchMetal\_Corrosion Pitted 2024-2.jpg

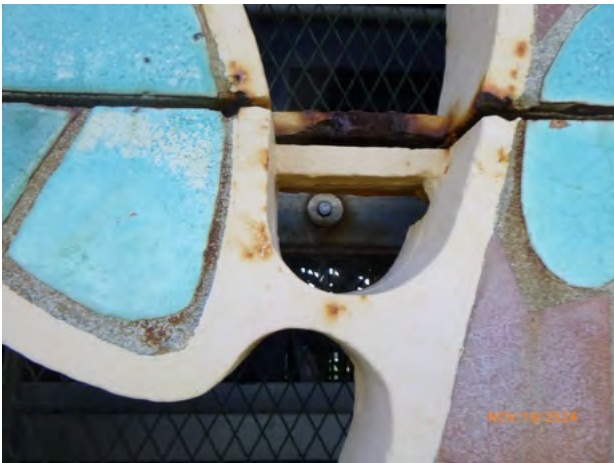
12-163 ArchMetal\_Corrosion Pitted 2024-3.jpg

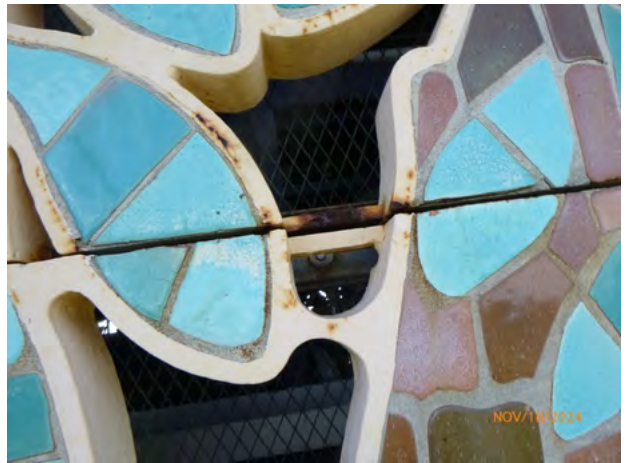
12-168 ArchMetal\_Corrosion Pitted 2024-1.jpg

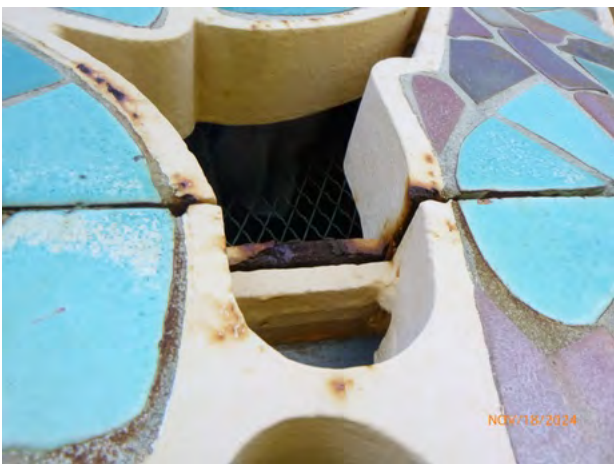
12-168 ArchMetal\_Corrosion Pitted 2024-2.jpg

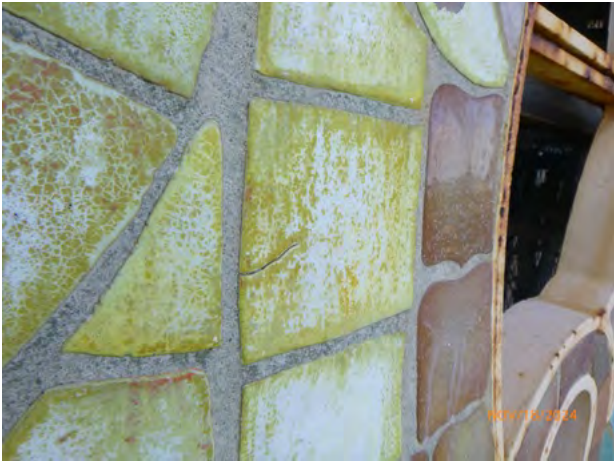
13-163 TerraCotta\_Crack Single unit 2024-1.jpg

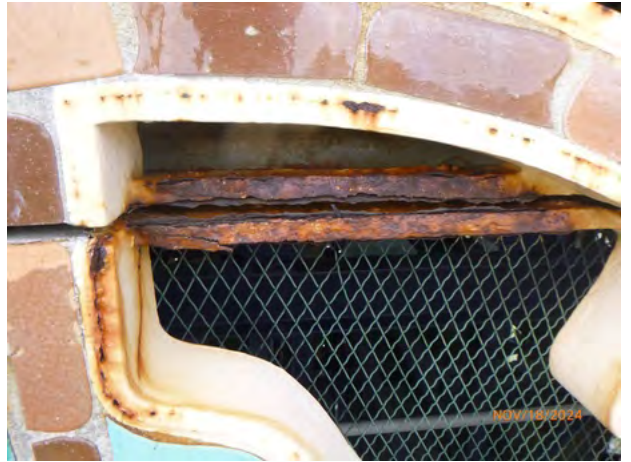
13-163 TerraCotta\_Crack Single unit 2024-2.jpg

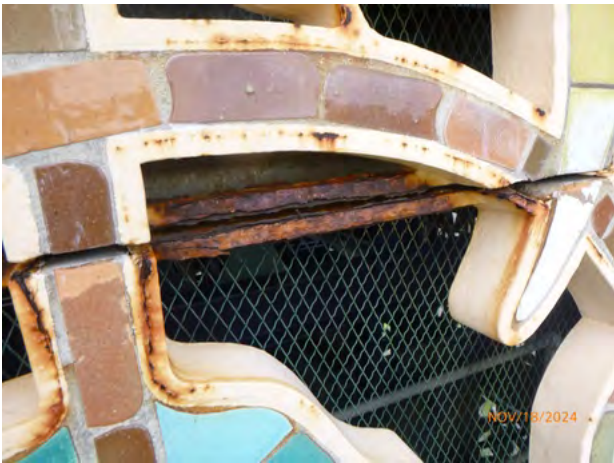
- Surface (“Srf”) and pitted (“Pit”) corrosion and paint coating failure (“CtF”) were widespread on what appears to be cast iron framing into which the polychrome tiles are set (see photographs 13-173, 16-158, and 18-169). Three rusted fasteners (“FstRst”) were also documented (see photographs 15-173, 17-163, and 85-154). In several instances corrosion at the framing is contributing directly to the deterioration of the polychrome terra cotta tiles. The mild steel channels used to frame the perimeter of the decorative tile panel opening also exhibited surface and pitted corrosion (see photographs 181-158, 182-146, and 541-144).

13-173 ArchMetal\_Corrosion Pitted 2024-1.jpg

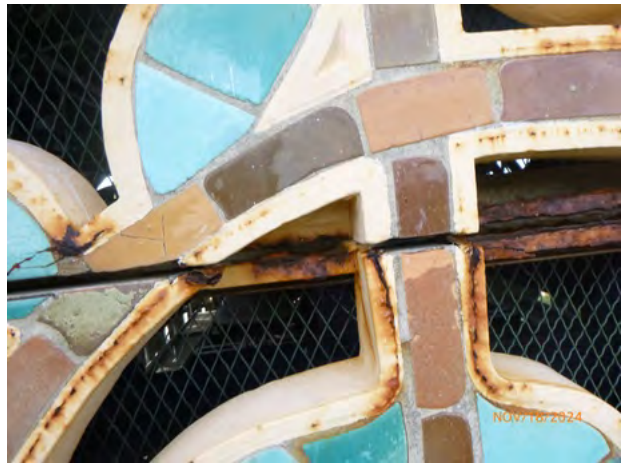
13-173 ArchMetal\_Corrosion Pitted 2024-2.jpg

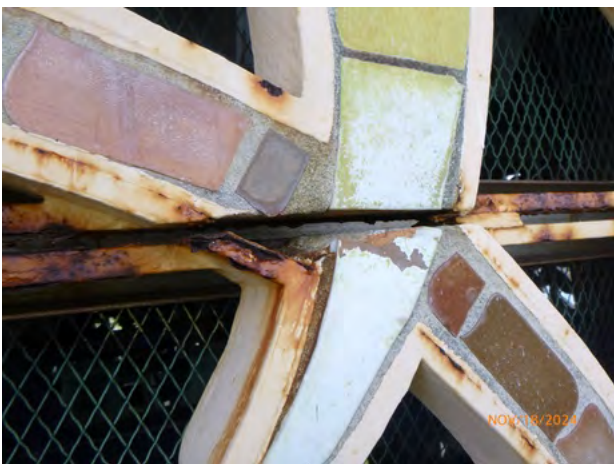
13-173 ArchMetal\_Corrosion Pitted 2024-3.jpg

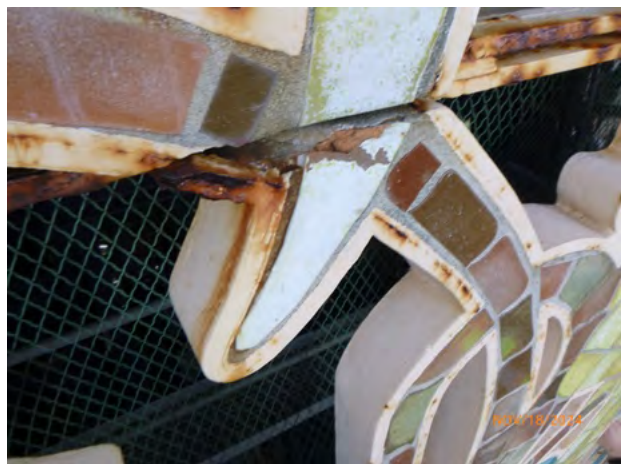
13-173 TerraCotta\_Spall Missing 2024-1.jpg

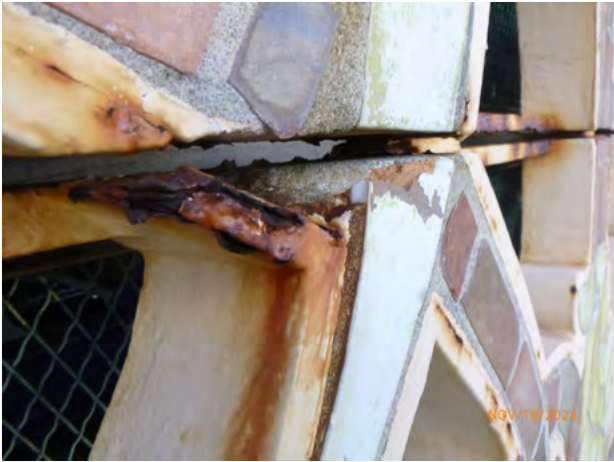
13-173 TerraCotta\_Spall Missing 2024-2.jpg

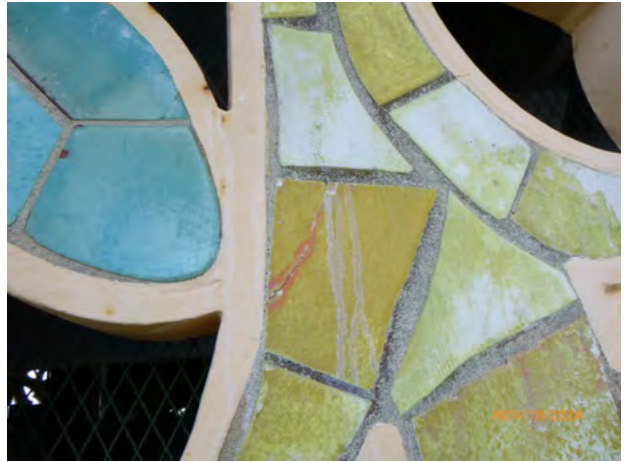
13-173 TerraCotta\_Spall Missing 2024-3.jpg

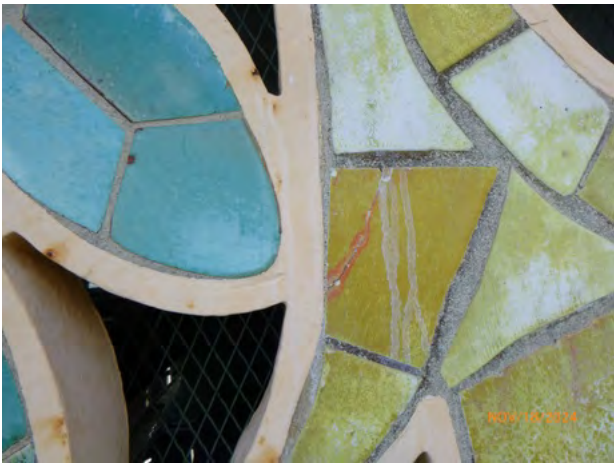
13-175 TerraCotta\_Crack Single unit 2024-1.jpg

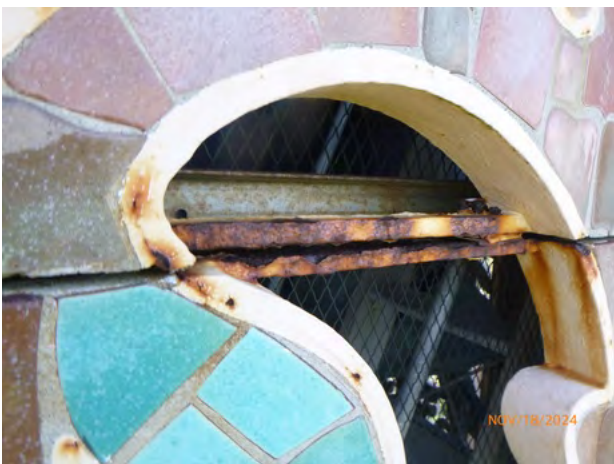
14-158 ArchMetal\_Corrosion Pitted 2024-1.jpg

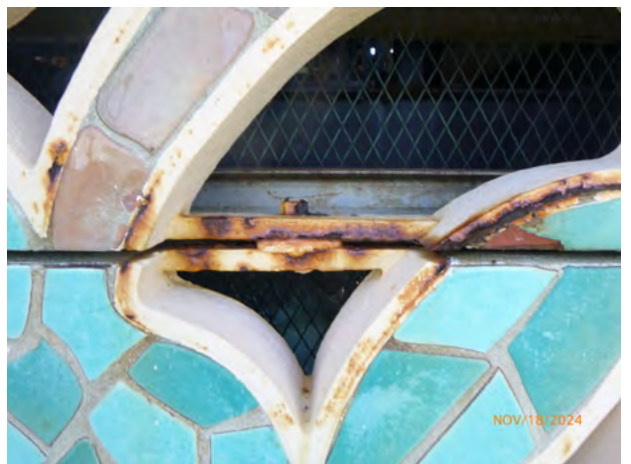
14-158 ArchMetal\_Corrosion Pitted 2024-2.jpg

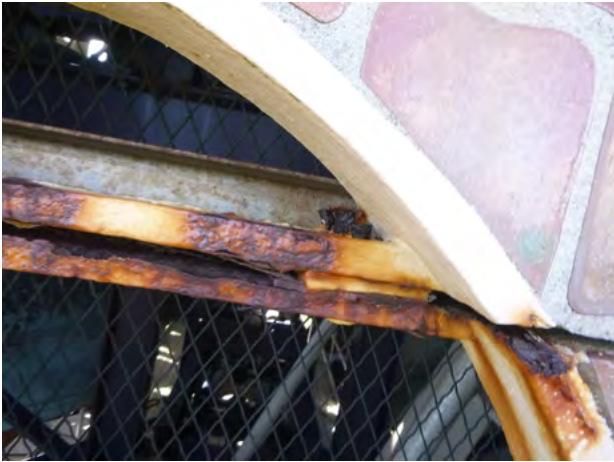
14-158 ArchMetal\_Corrosion Pitted 2024-3.jpg

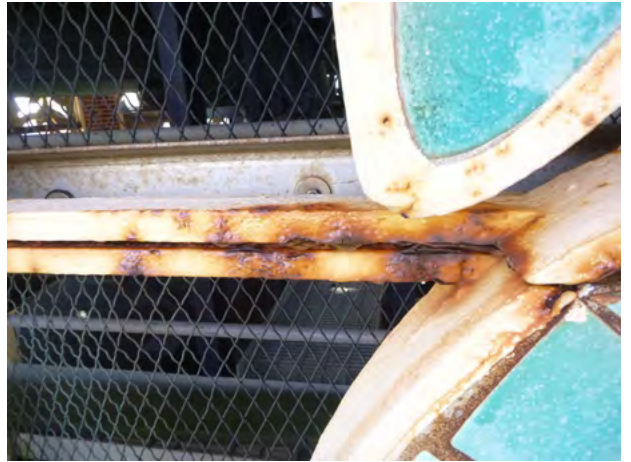
15-158 ArchMetal\_Corrosion Fastener rusted 2024-1.jpg

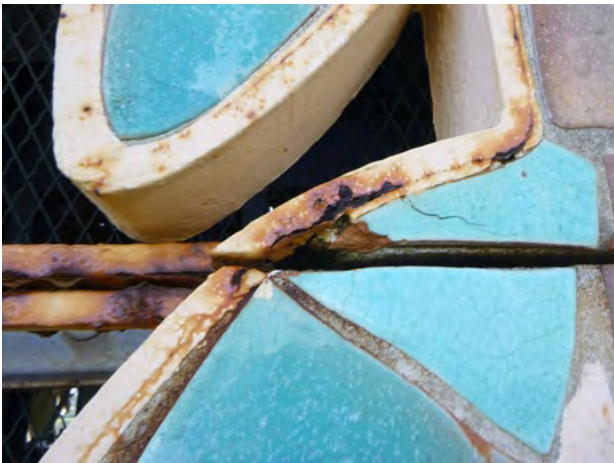
15-163 ArchMetal\_Corrosion Pitted 2024-1.jpg

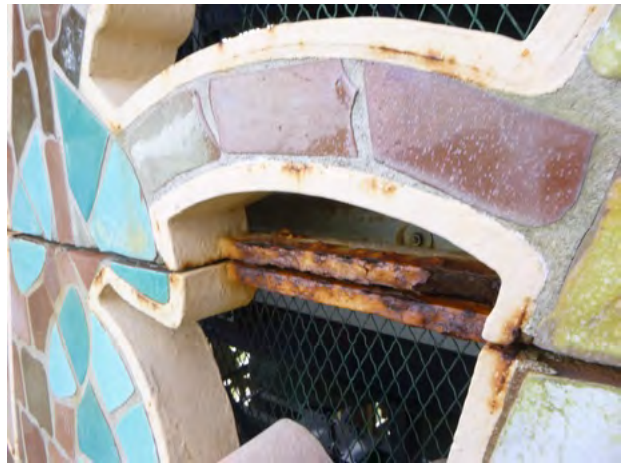
15-164 TerraCotta\_Spall Missing 2024-1.jpg

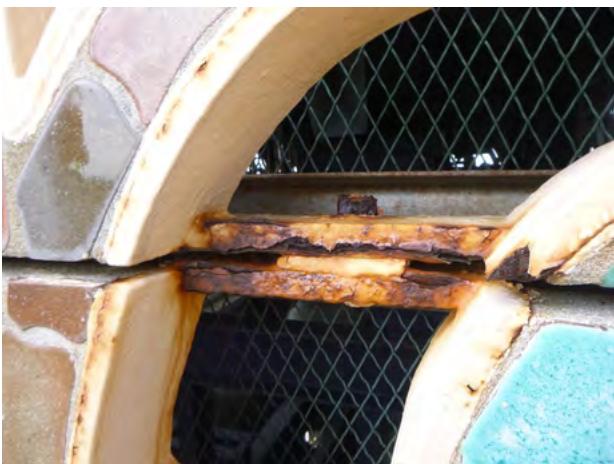
15-167 ArchMetal\_Corrosion Pitted 2024-1.jpg

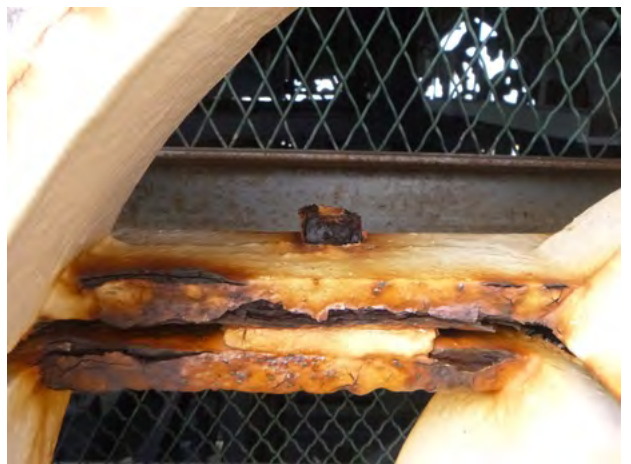
15-172 ArchMetal\_Corrosion Pitted 2024-1.jpg

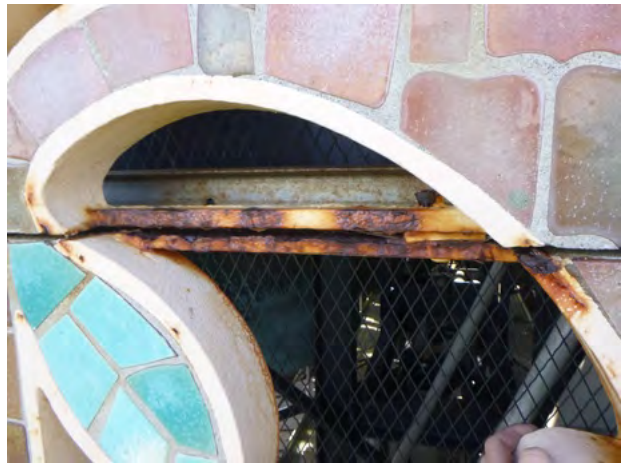
16-149 ArchMetal\_Corrosion Pitted 2024-1.jpg

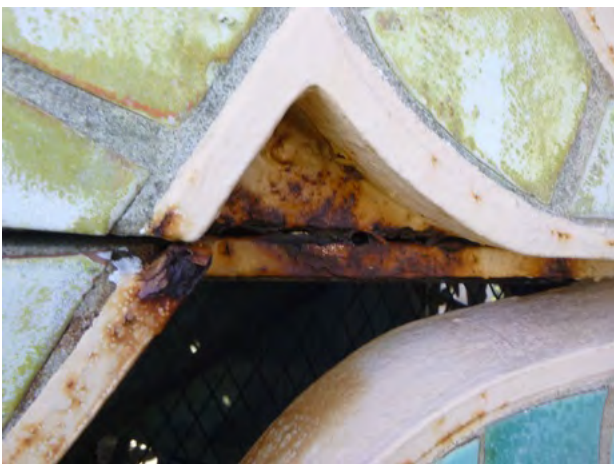
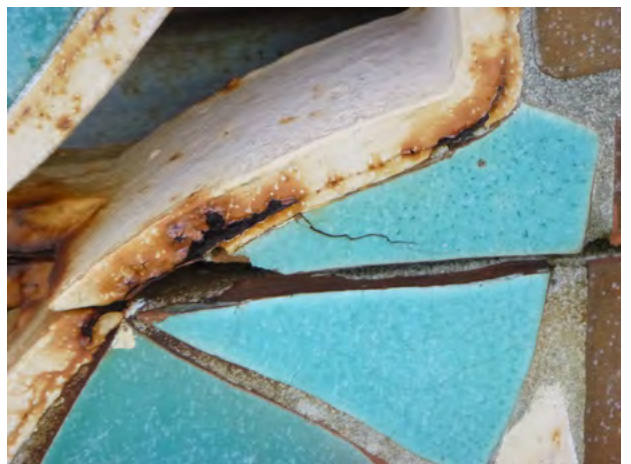
16-158 ArchMetal\_Corrosion Pitted 2024-1.jpg

16-158 ArchMetal\_Corrosion Pitted 2024-2.jpg

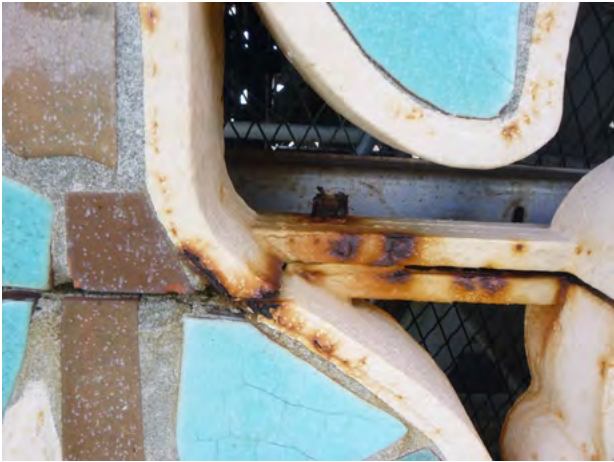
16-164 TerraCotta\_Crack Single unit 2024-1.jpg

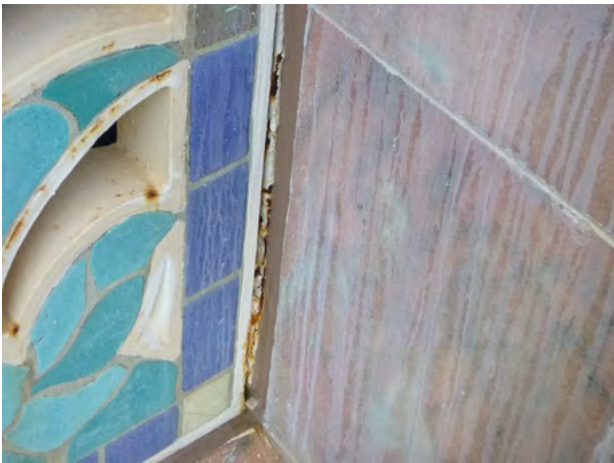
17-179 Stone\_SoilStain Leached Salts 2024-1.jpg

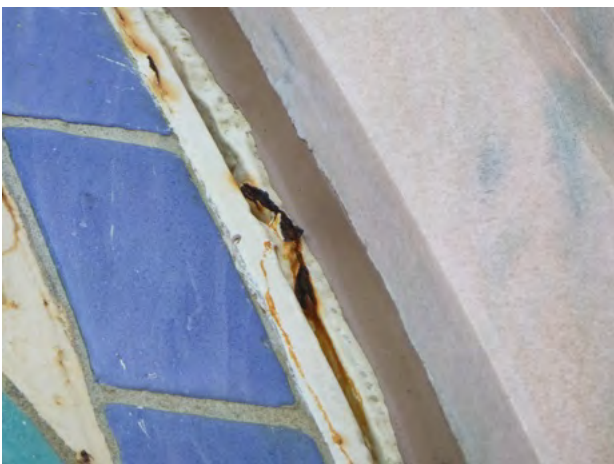
18-169 ArchMetal\_Corrosion Pitted 2024-1.jpg

18-169 ArchMetal\_Corrosion Pitted 2024-2.jpg

18-169 ArchMetal\_Corrosion Pitted 2024-3.jpg

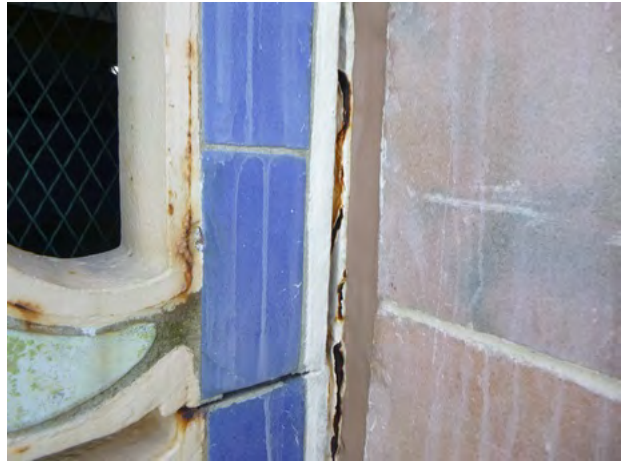
19-158 ArchMetal\_Note Photo-general 2024-7.jpg

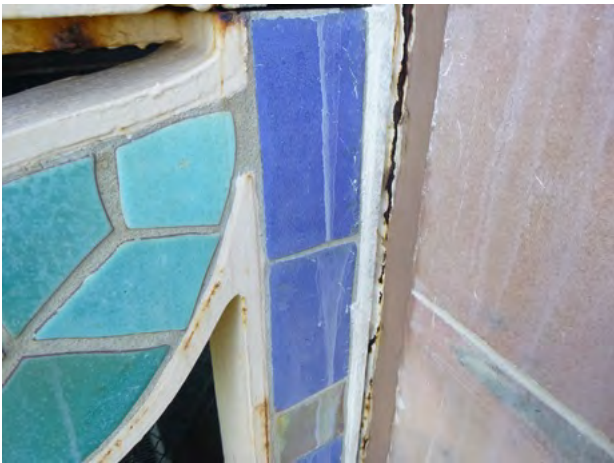
19-159 ArchMetal\_Corrosion Pitted 2024-1.jpg

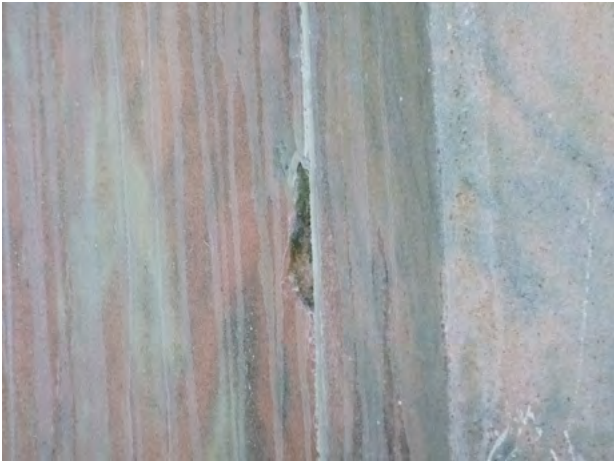
19-164 ArchMetal\_Note Photo-general 2024-3.jpg

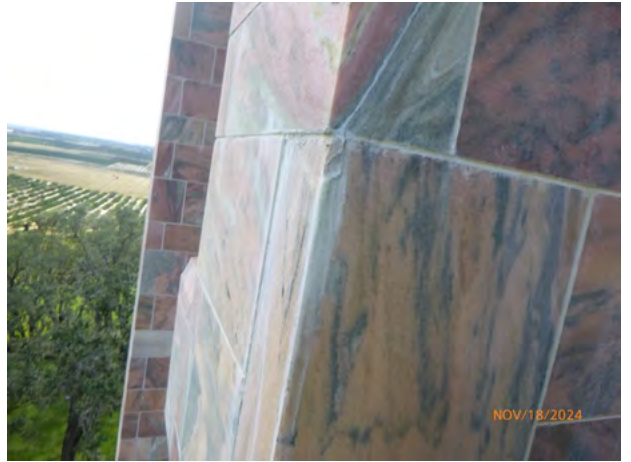
23-146 Stone\_Spall Removed 2024-1.jpg

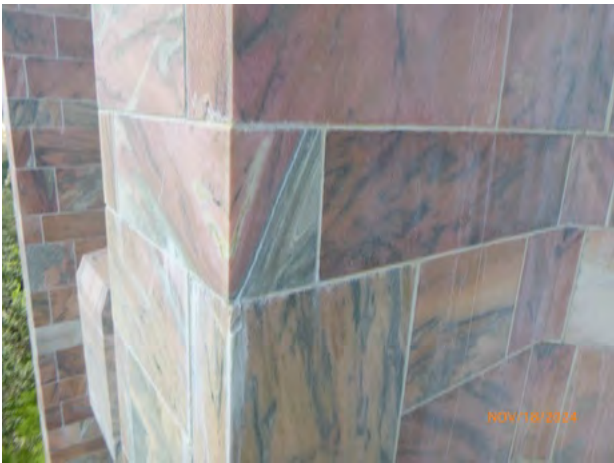
28-102 Stone\_SoilStain Leached Salts 2024-1.jpg

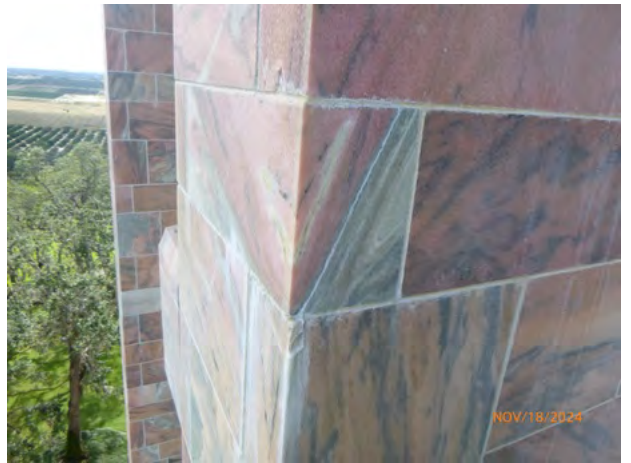
28-103 Stone\_Crack Single unit 2024-1.jpg

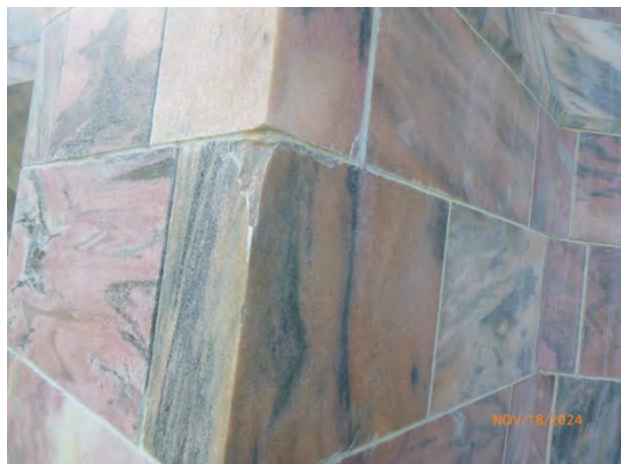
29-119 Stone\_SurfLoss Chipped 2024-1.jpg

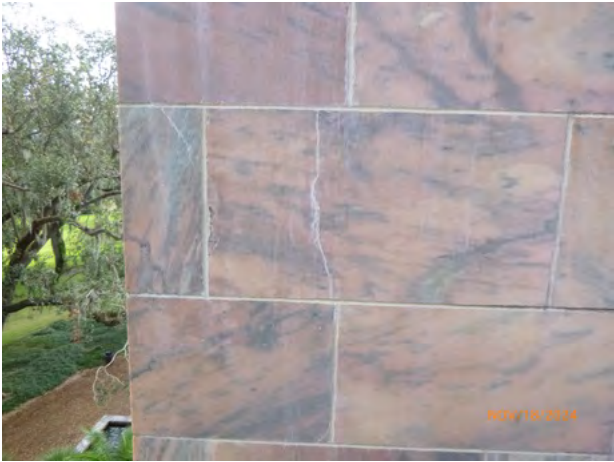
29-119 Stone\_SurfLoss Chipped 2024-2.jpg

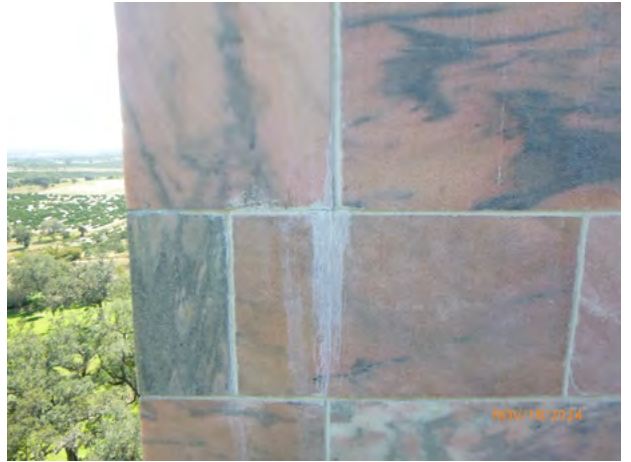
30-44 Stone\_Crack Single unit 2024-1.jpg

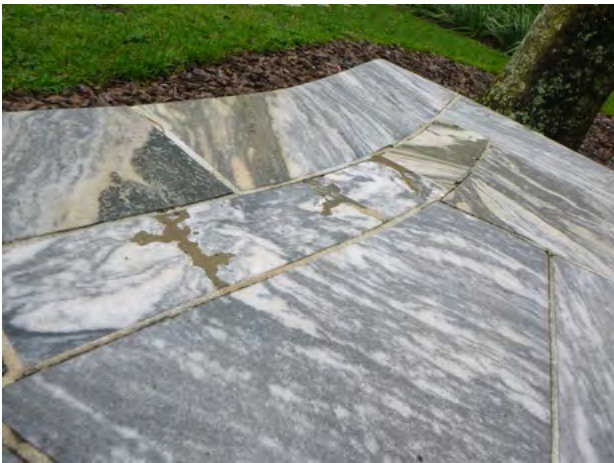
30-136 Stone\_SoilStain Leached Salts 2024-1.jpg

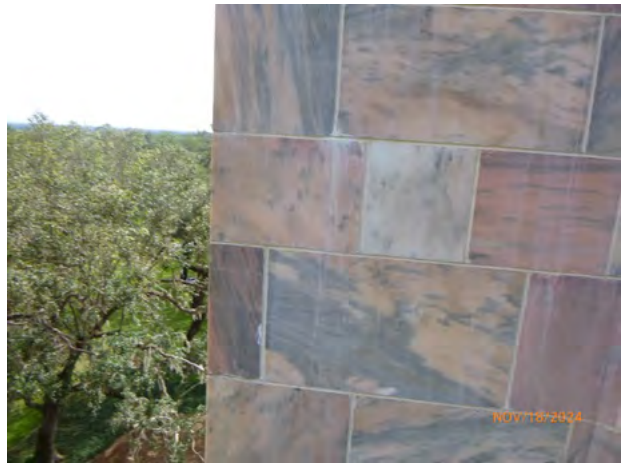
31-1 Stone\_Repair Patch Failed 2024-1.jpg

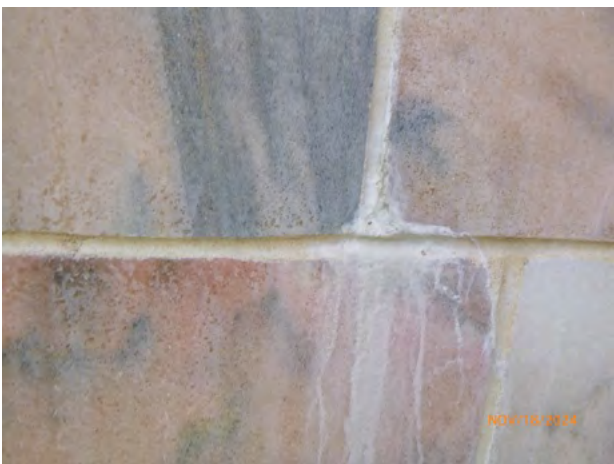
31-59 Stone\_SoilStain Leached Salts 2024-1.jpg

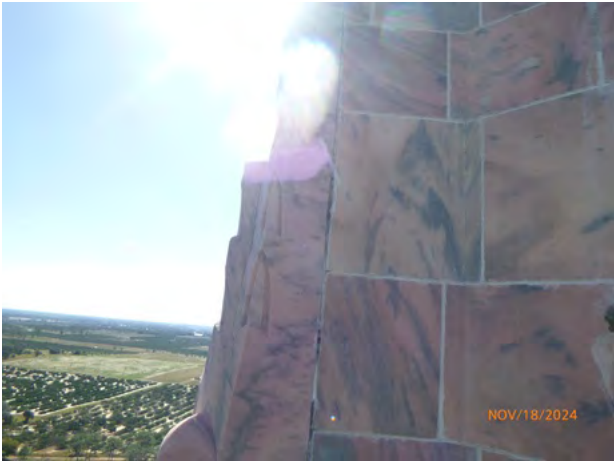
31-59 Stone\_SoilStain Leached Salts 2024-3.jpg

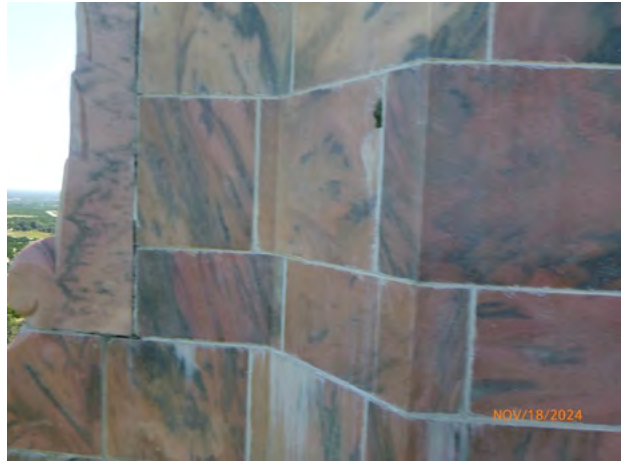
31-158 Stone\_Joints Mortar Failed 2024-1.jpg

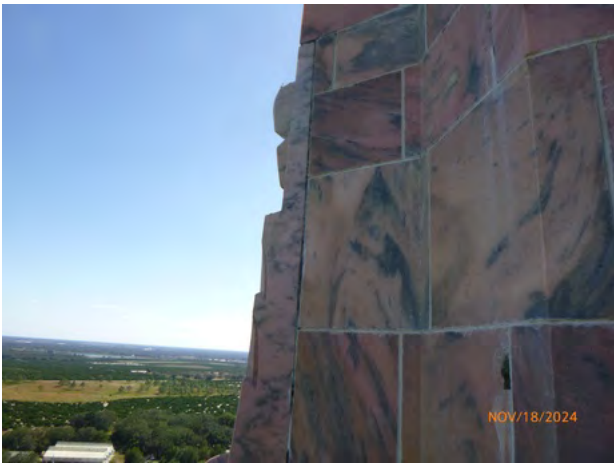
31-158 Stone\_Joints Mortar Failed 2024-2.jpg

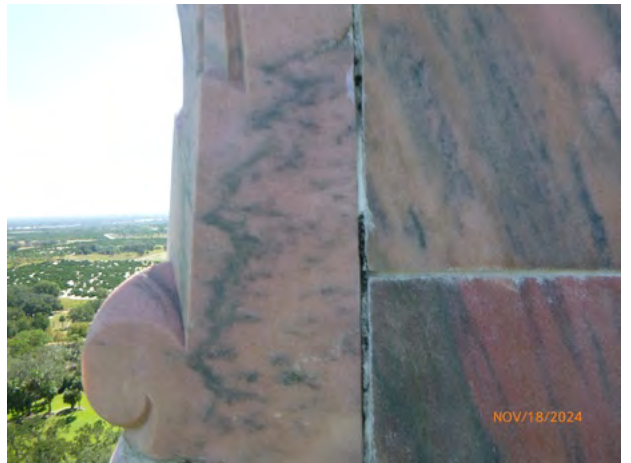
31-158 Stone\_Joints Mortar Failed 2024-3.jpg

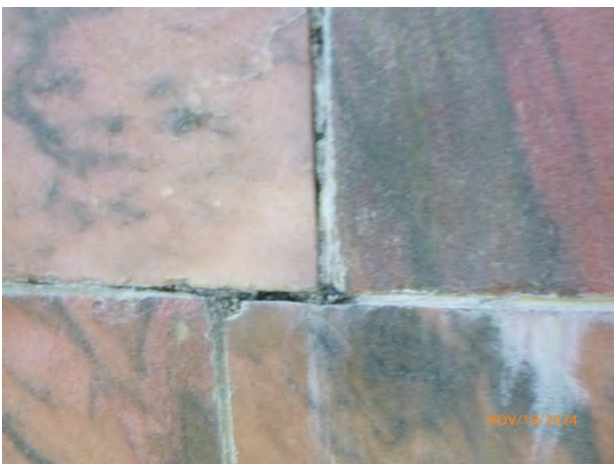
31-158 Stone\_Joints Mortar Failed 2024-4.jpg

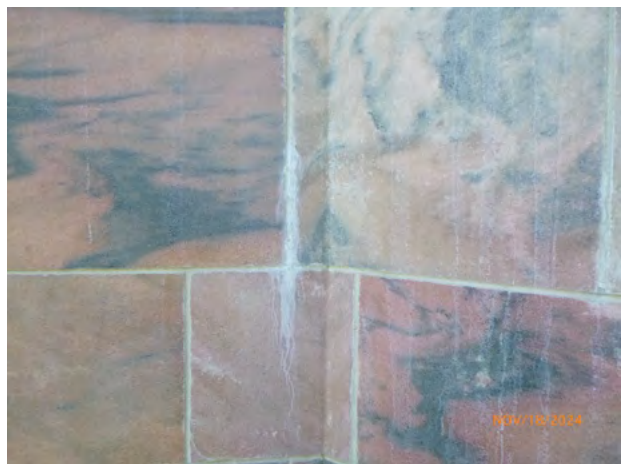
31-158 Stone\_Joints Mortar Failed 2024-5.jpg

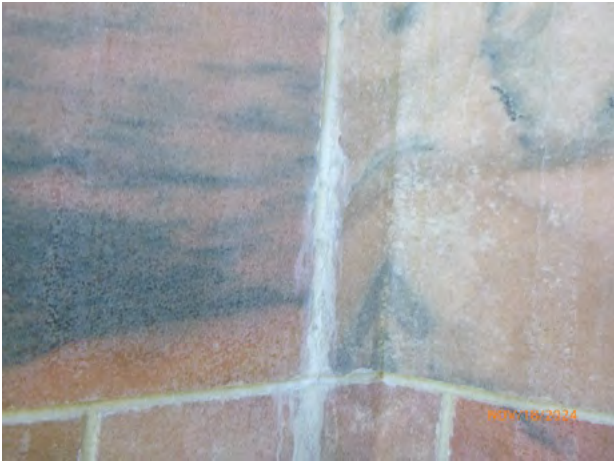
32-136 Stone\_SoilStain Leached Salts 2024-1.jpg
