### ***Bok Singing Tower Roof Restoration and Replacement***

# Bok Singing Tower Conditions Assessment

T.Y. Lin (formerly Silman) was contracted to perform a conditions assessment of the Bok Singing Tower at Bok Tower Gardens in Lake Wales, Florida. The Singing Tower stands 205 feet tall at the southwest corner of the gardens. A moat surrounds the base of the tower with two bridges to access the island. The tower houses a 60-bell carillon, associated carillonneur studio and library spaces, the Bok Tower Gardens Chao Research archive, and the Founder's Room. It is a steel frame construction clad in a masonry exterior of coquina and Georgia pink Etowah marble with brick masonry at the interior.

## **Bok Tower Focused Condition Assessment**

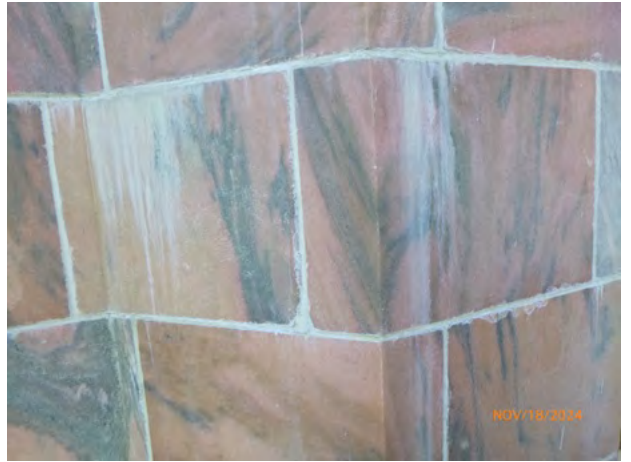
32-136 Stone\_SoilStain Leached Salts 2024-2.jpg

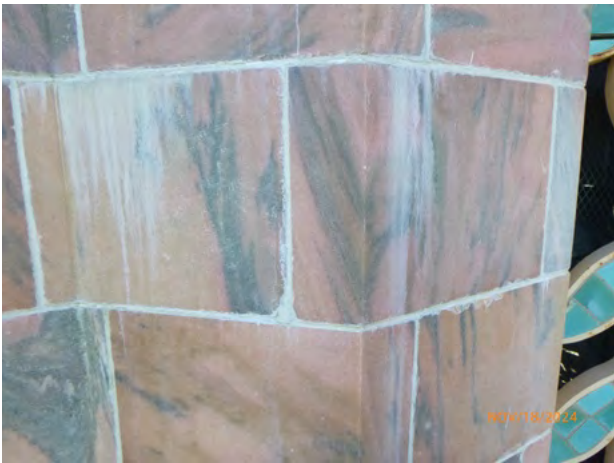
32-157 Stone\_SurfLoss Chipped 2024-1.jpg

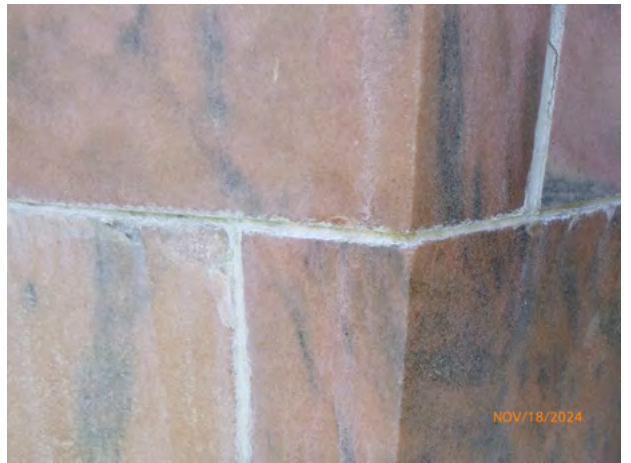
32-157 Stone\_SurfLoss Chipped 2024-2.jpg

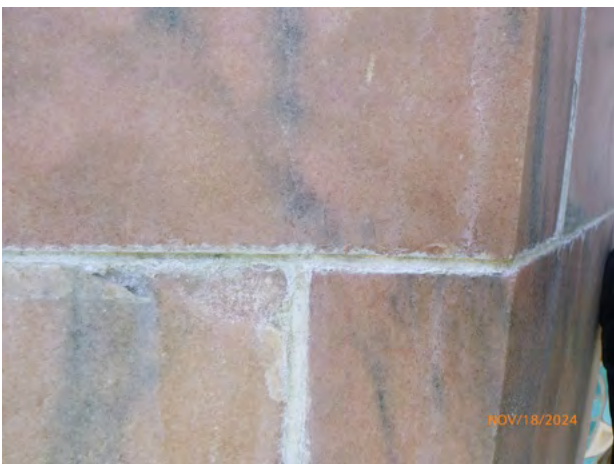
32-169 Stone\_SurfLoss Chipped 2024-1.jpg

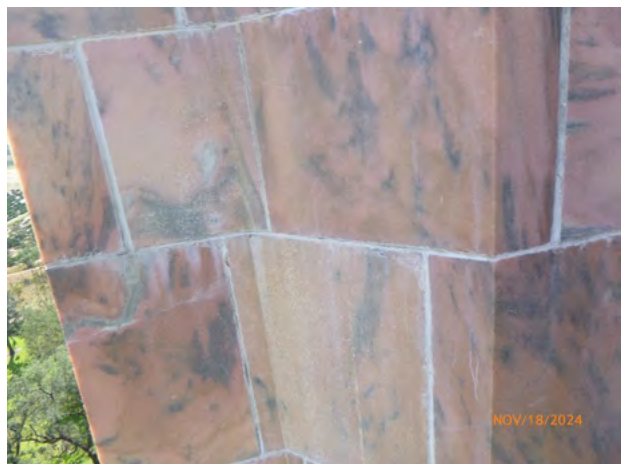
32-169 Stone\_SurfLoss Chipped 2024-2.jpg

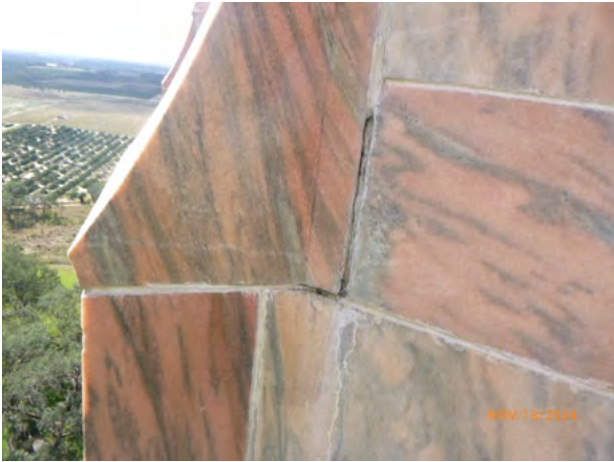
32-169 Stone\_SurfLoss Chipped 2024-3.jpg

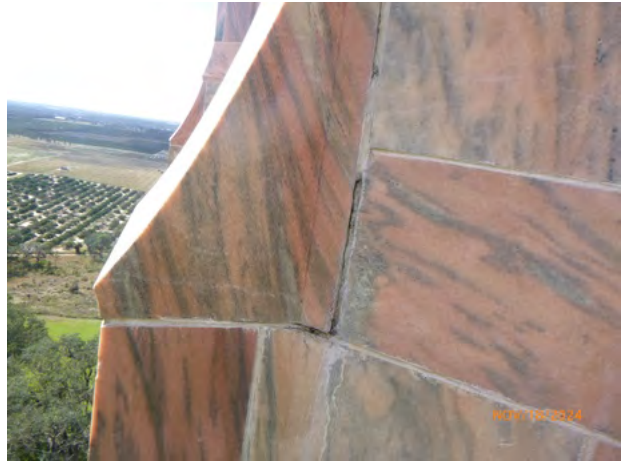
32-181 Stone\_Joints Mortar Failed 2024-1.jpg

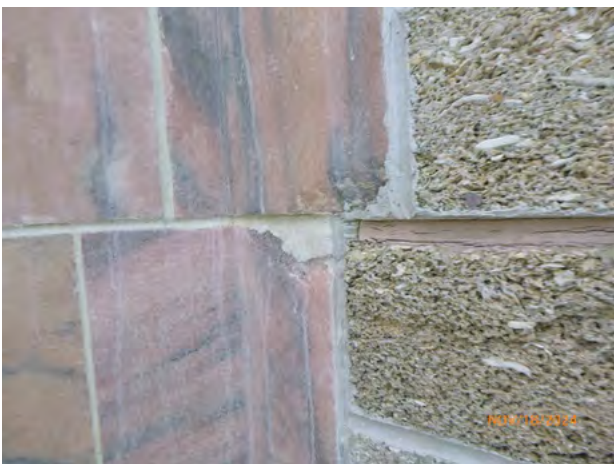
33-80 Stone\_SurfLoss Chipped 2024-1.jpg

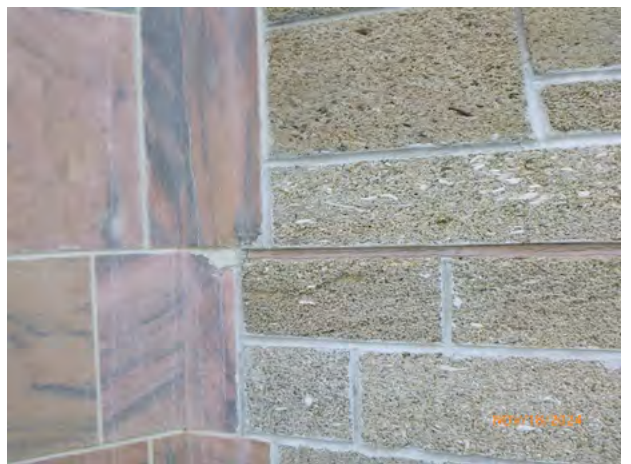
33-80 Stone\_SurfLoss Chipped 2024-2.jpg

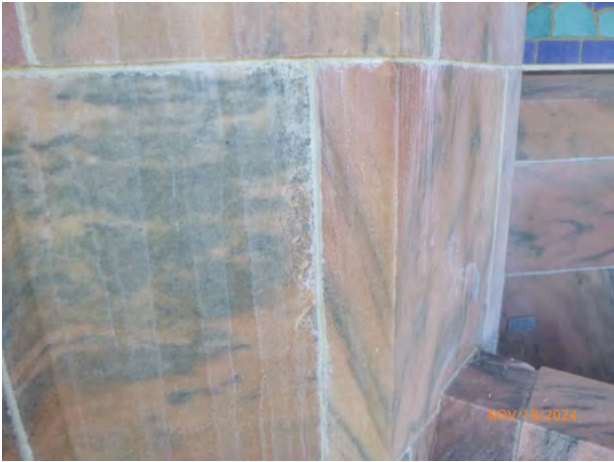
33-80 Stone\_SurfLoss Chipped 2024-3.jpg

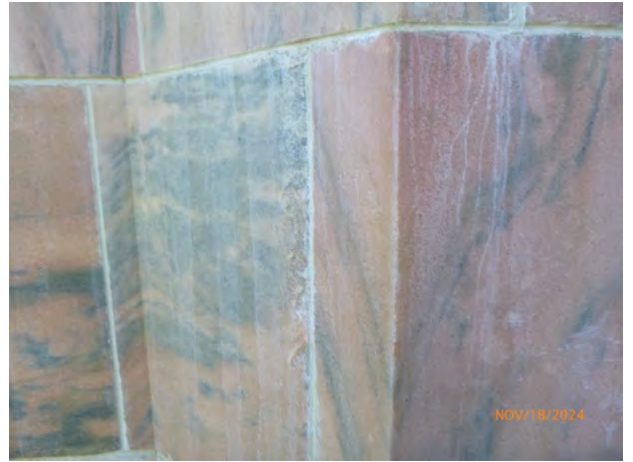
33-142 Stone\_SurfLoss Chipped 2024-1.jpg

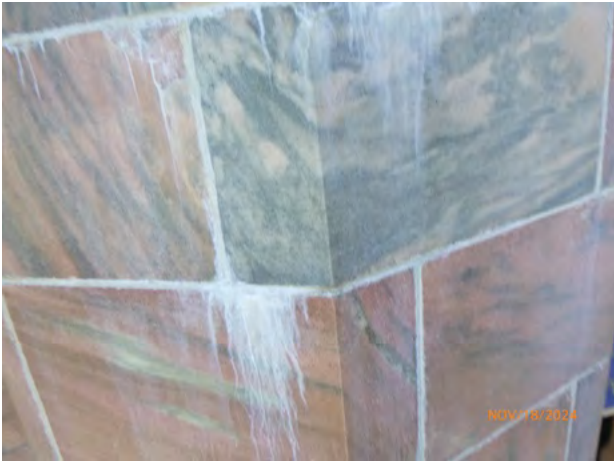
33-150 Stone\_SoilStain Leached Salts 2024-1.jpg

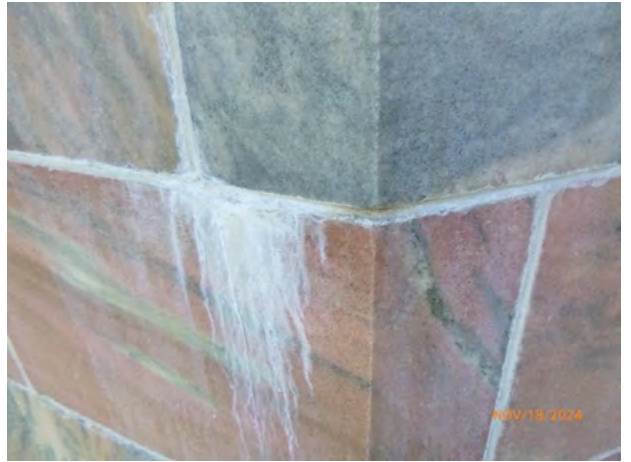
33-150 Stone\_SoilStain Leached Salts 2024-2.jpg

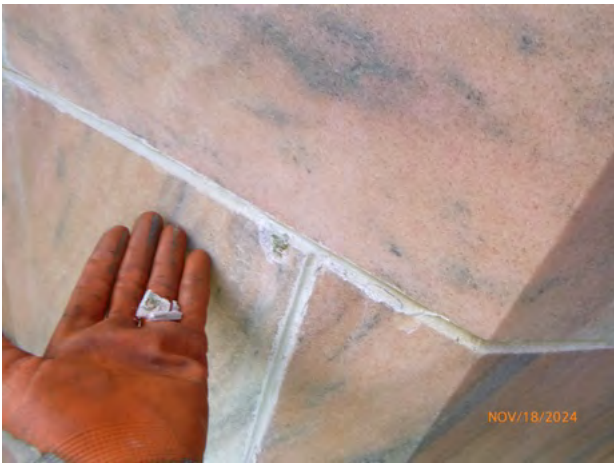
33-150 Stone\_SoilStain Leached Salts 2024-3.jpg

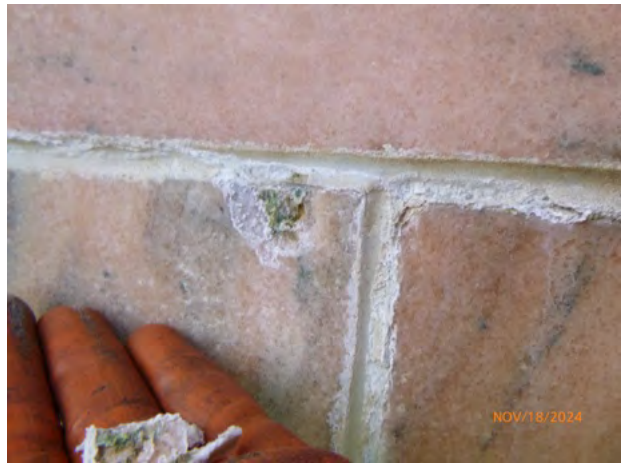
33-176 Stone\_SurfLoss Chipped 2024-1.jpg

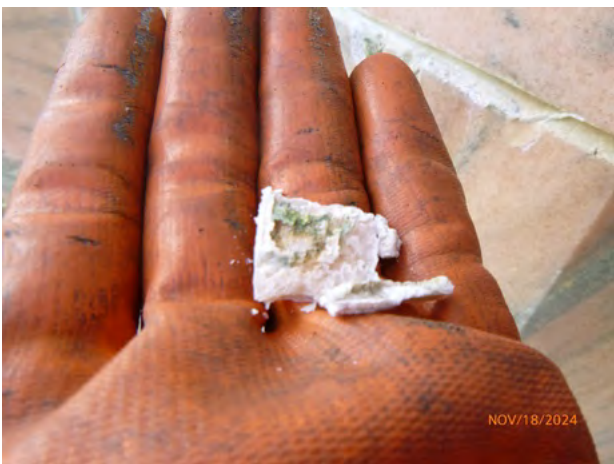
33-176 Stone\_SurfLoss Chipped 2024-2.jpg

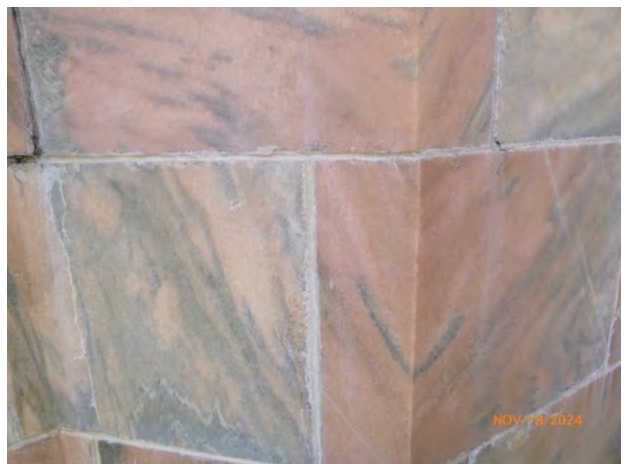
33-176 Stone\_SurfLoss Chipped 2024-3.jpg

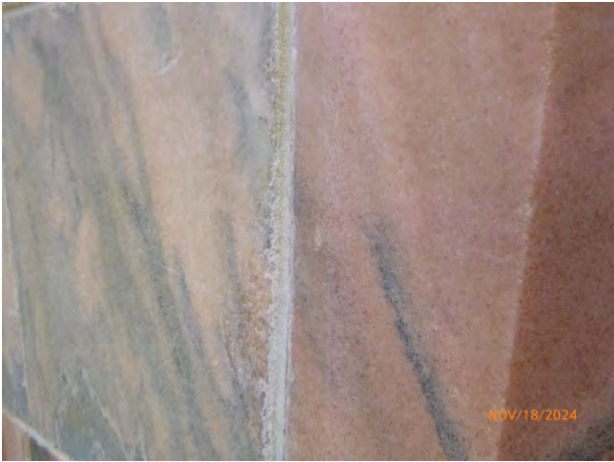
33-180 Stone\_SurfLoss Chipped 2024-1.jpg

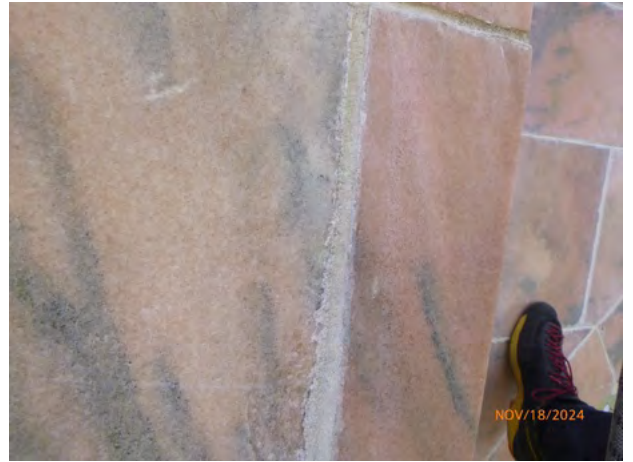
33-180 Stone\_SurfLoss Chipped 2024-2.jpg

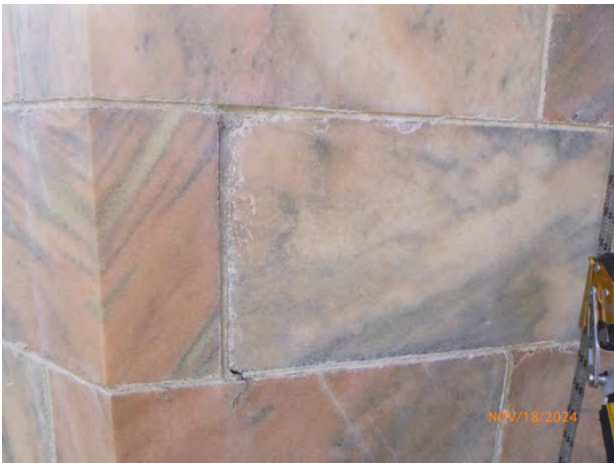
33-180 Stone\_SurfLoss Chipped 2024-3.jpg

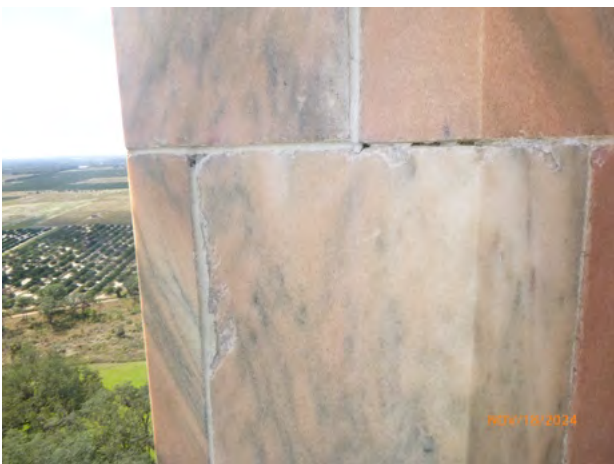
33-181 Stone\_SurfLoss Chipped 2024-2.jpg

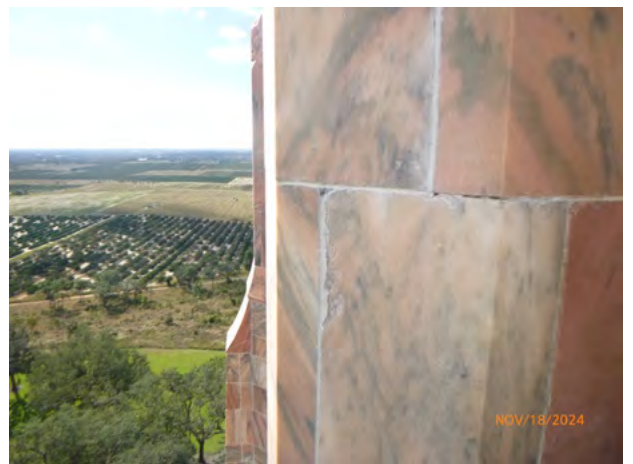
33-188 Stone\_Spall Missing 2024-1.jpg

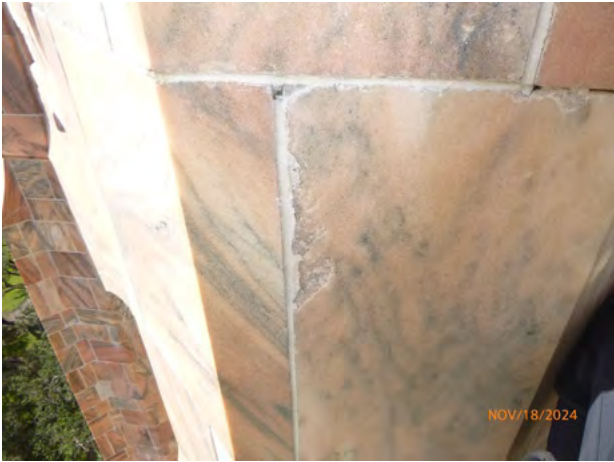
33-188 Stone\_Spall Missing 2024-2.jpg

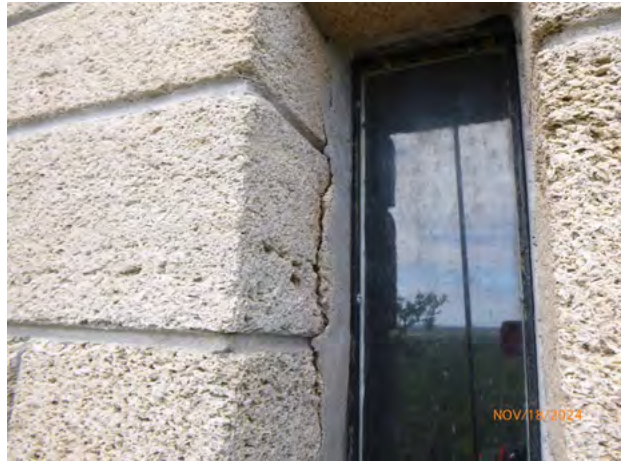
33-188 Stone\_Spall Missing 2024-3.jpg

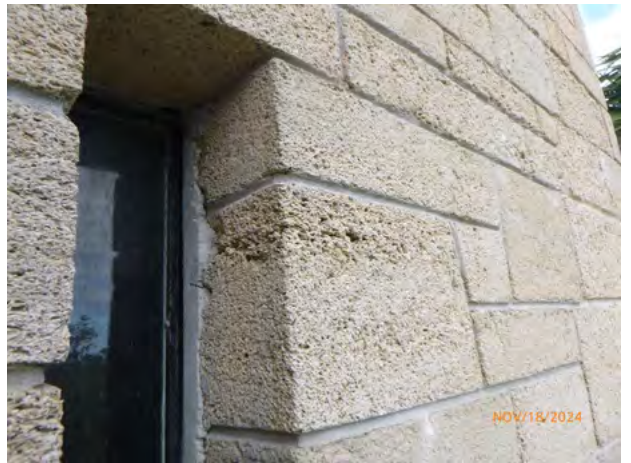
34-56 Stone\_Joints Mortar Failed 2024-2.jpg

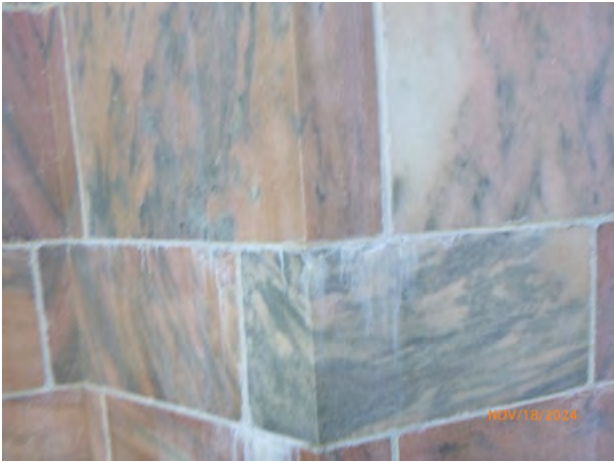
34-56 Stone\_Joints Mortar Failed 2024-5.jpg

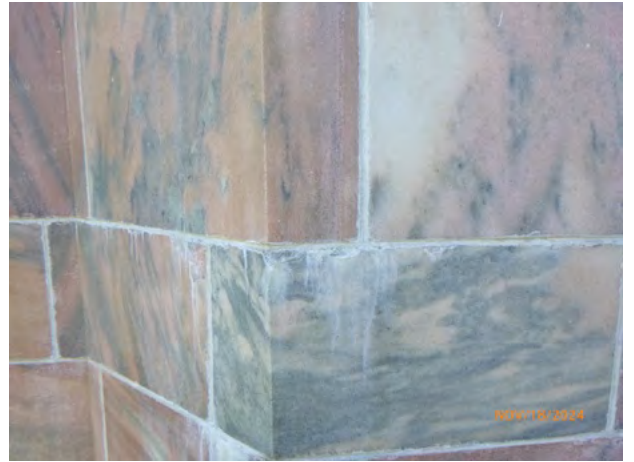
34-152 Stone\_SurfLoss Chipped 2024-1.jpg

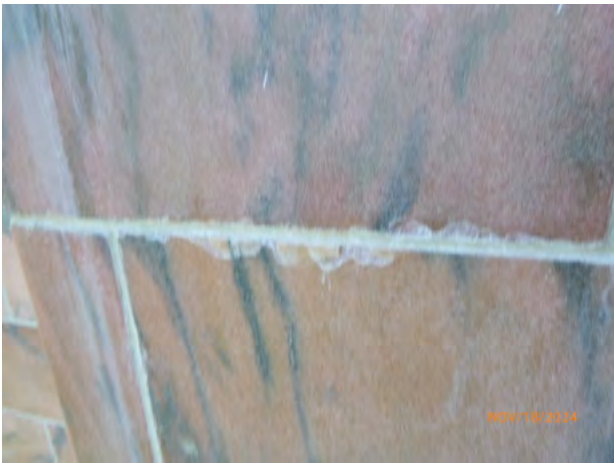
34-152 Stone\_SurfLoss Chipped 2024-2.jpg

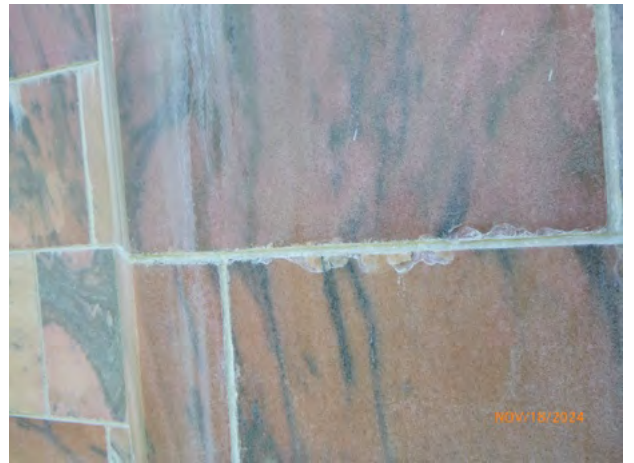
34-156 Stone\_SurfLoss Chipped 2024-1.jpg

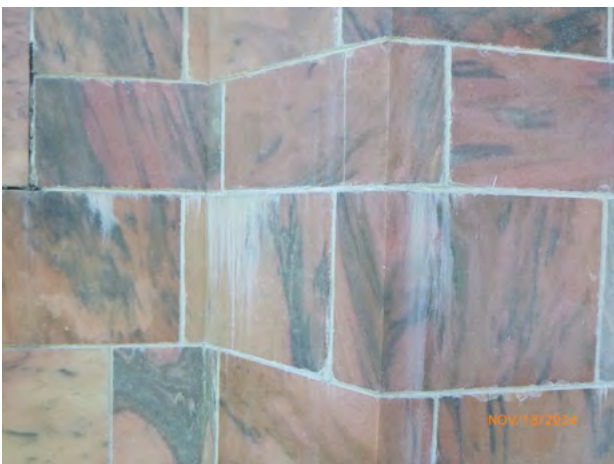
34-156 Stone\_SurfLoss Chipped 2024-2.jpg

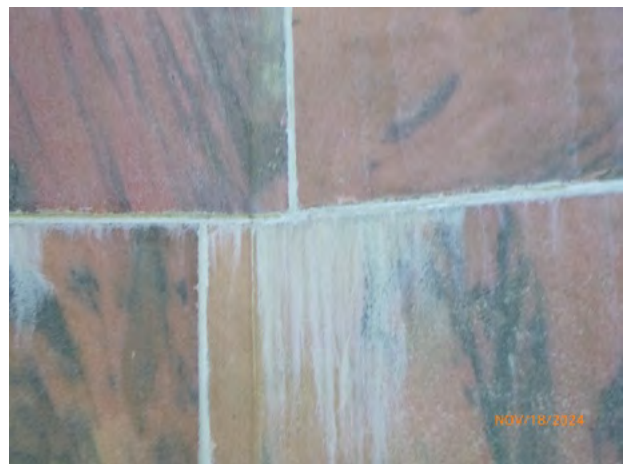
34-157 Stone\_SoilStain Leached Salts 2024-1.jpg

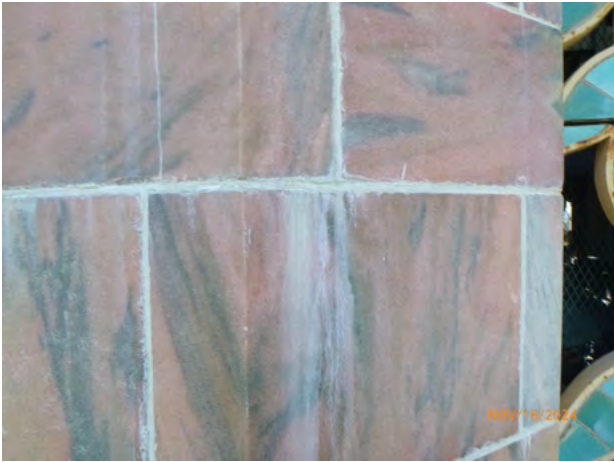
34-157 Stone\_SoilStain Leached Salts 2024-2.jpg

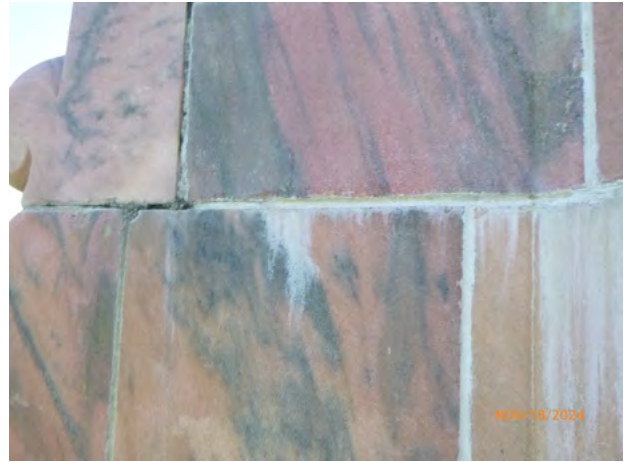
34-157 Stone\_SoilStain Leached Salts 2024-3.jpg

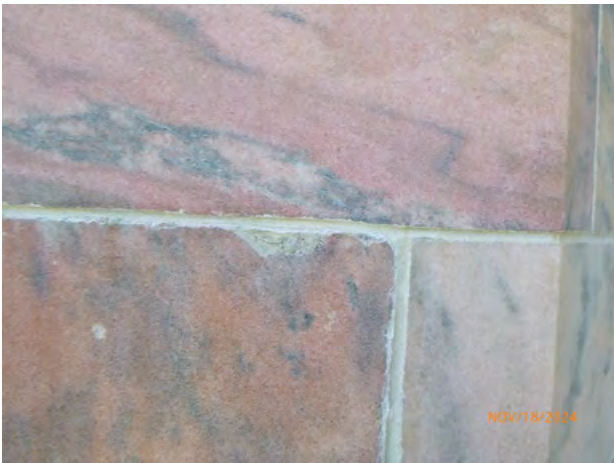
34-157 Stone\_SoilStain Leached Salts 2024-4.jpg

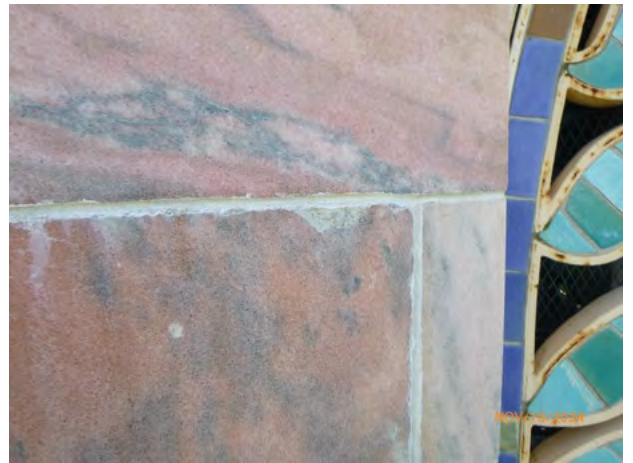
34-172 Stone\_Repair Patch Sound 2024-1.jpg

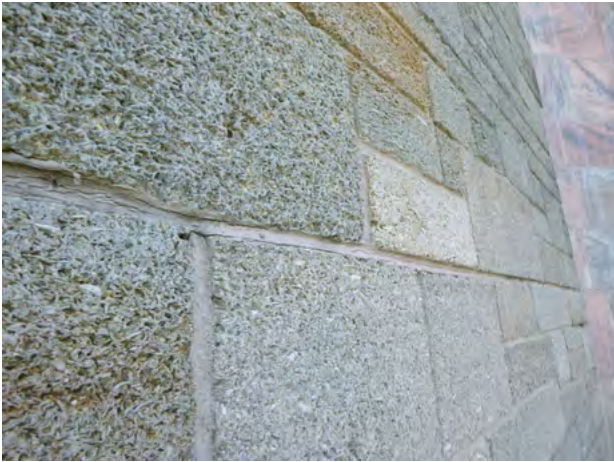
37-71 Stone\_Joints Sealant Failed 2024-1.jpg

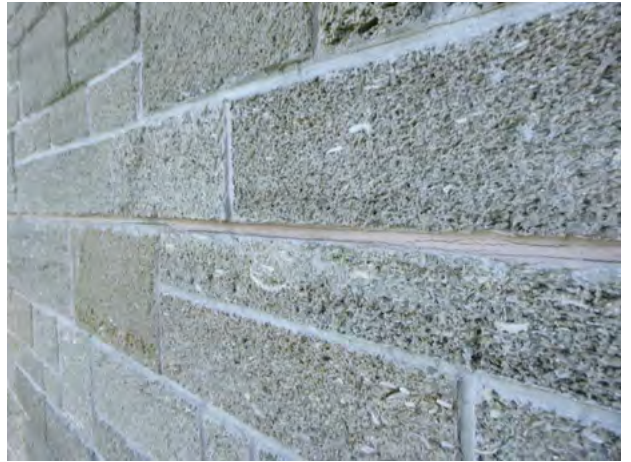
37-82 Stone\_Joints Sealant Failed 2024-1.jpg

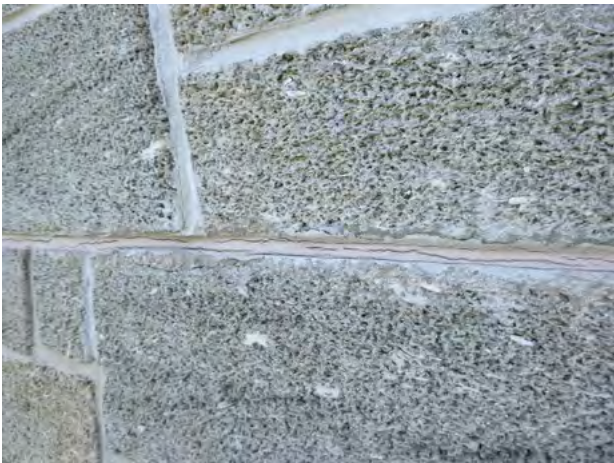
37-82 Stone\_Joints Sealant Failed 2024-2.jpg

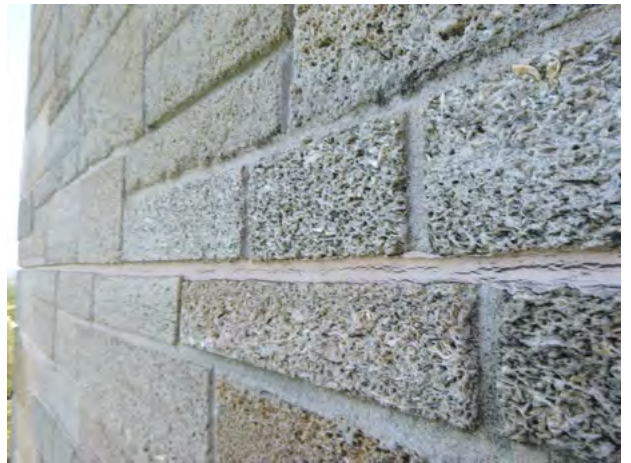
37-90 Stone\_Joints Sealant Failed 2024-1.jpg

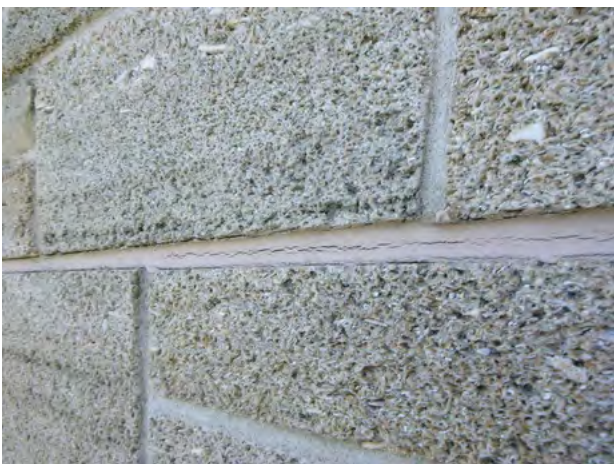
37-90 Stone\_Joints Sealant Failed 2024-2.jpg

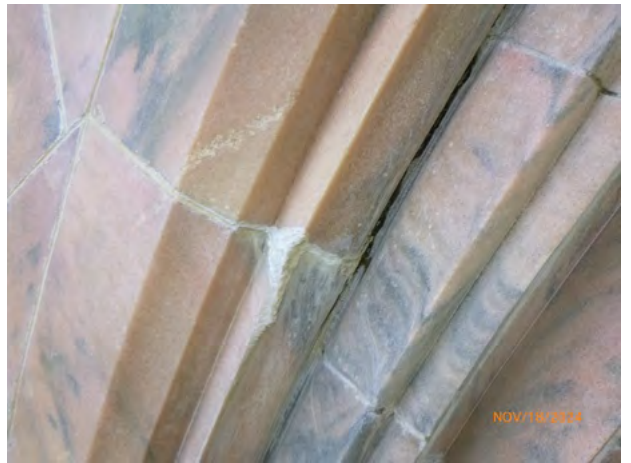
37-180 Stone\_SoilStain Leached Salts 2024-1.jpg

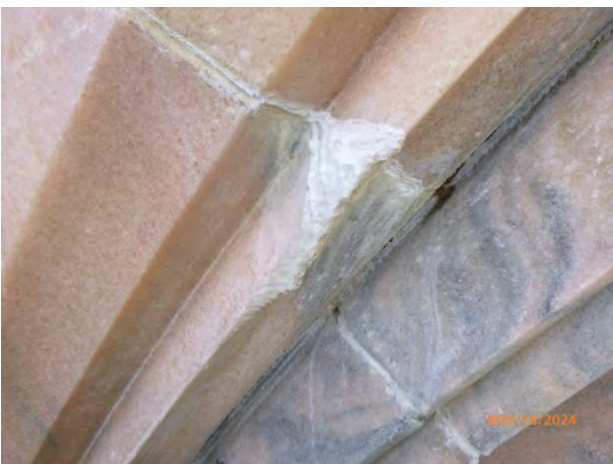
37-180 Stone\_SoilStain Leached Salts 2024-2.jpg

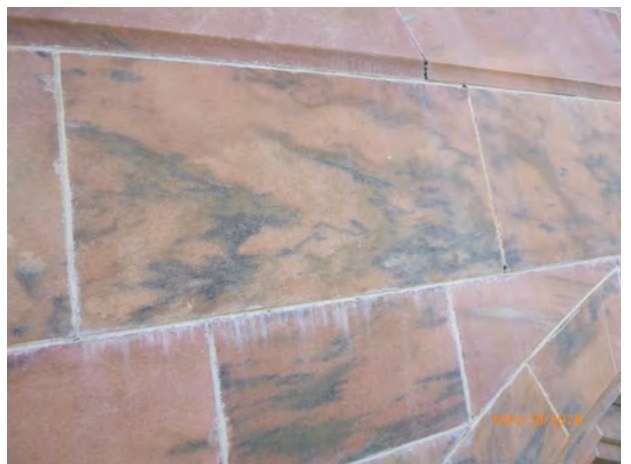
37-182 Stone\_SoilStain Leached Salts 2024-1.jpg

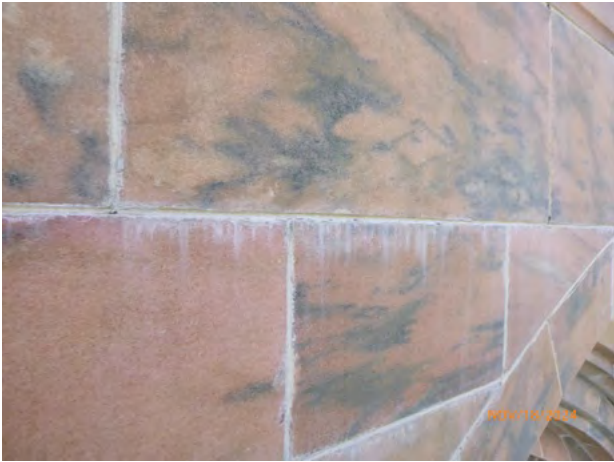
37-182 Stone\_SoilStain Leached Salts 2024-2.jpg

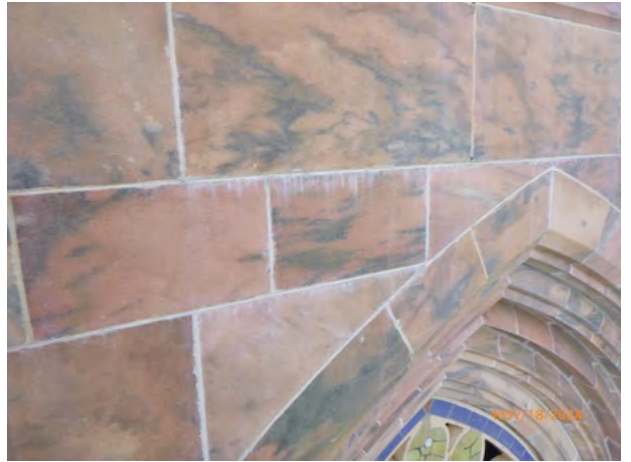
37-182 Stone\_SoilStain Leached Salts 2024-3.jpg

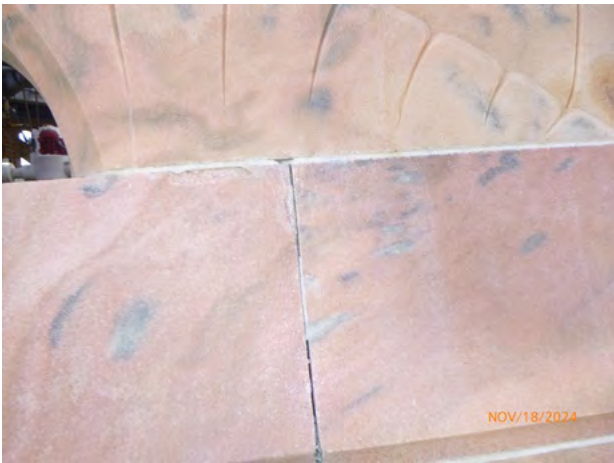
37-184 Stone\_Joints Mortar Failed 2024-1.jpg

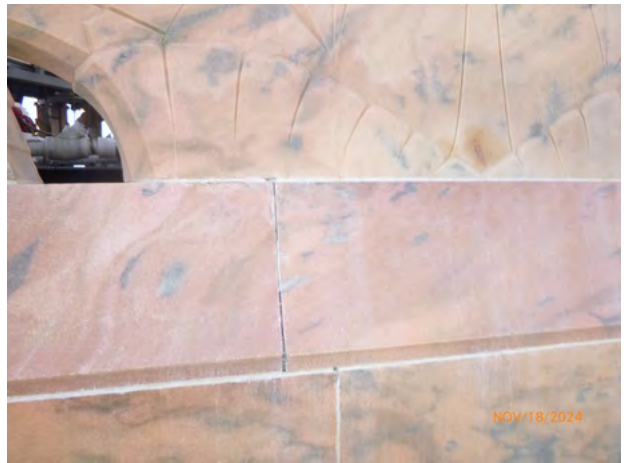
37-184 Stone\_Joints Mortar Failed 2024-2.jpg

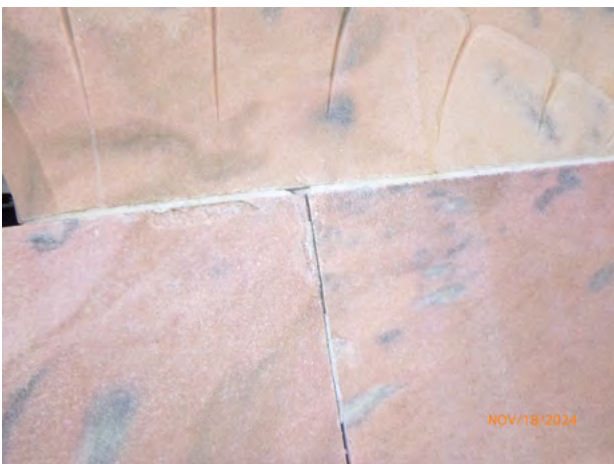
37-184 Stone\_SurfLoss Chipped 2024-1.jpg

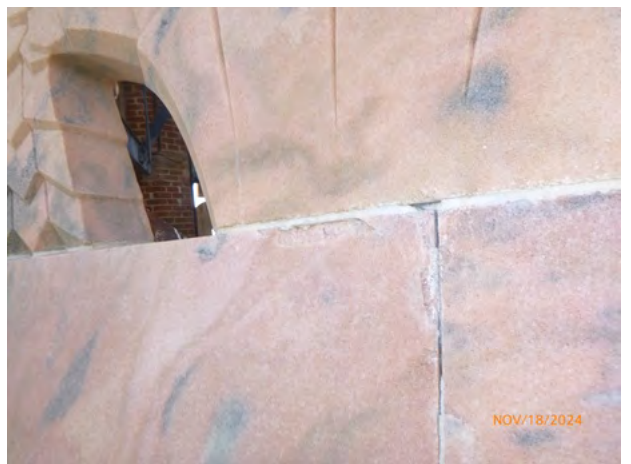
37-184 Stone\_SurfLoss Chipped 2024-2.jpg

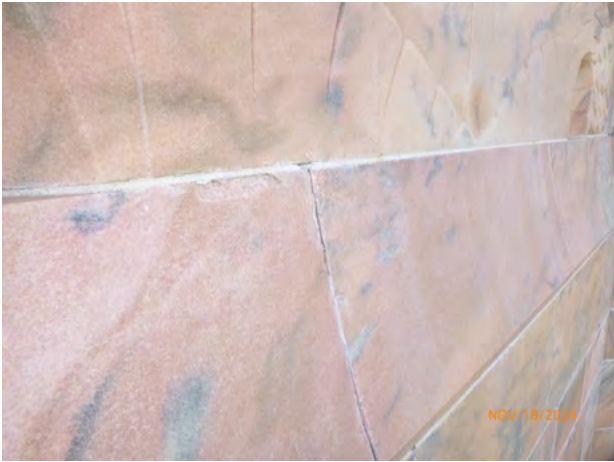
37-184 Stone\_SurfLoss Chipped 2024-3.jpg

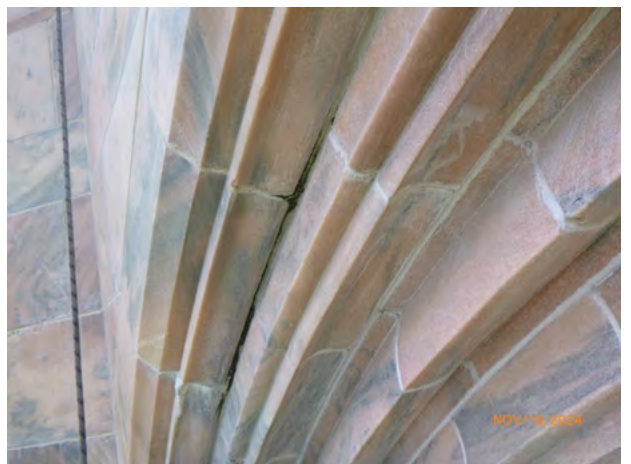
38-181 Stone\_Joints Mortar Failed 2024-3.jpg

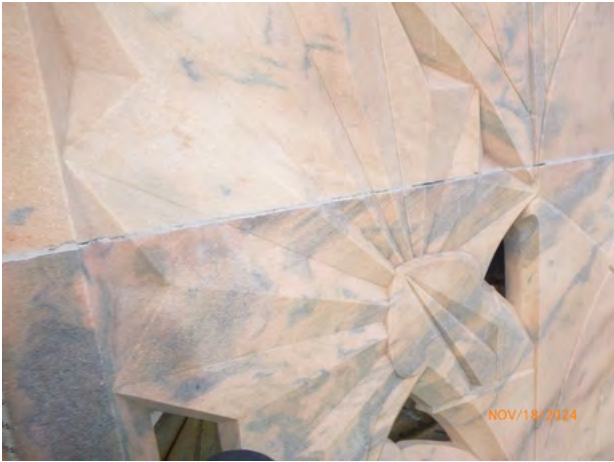
38-188 Stone\_Joints Mortar Failed 2024-1.jpg

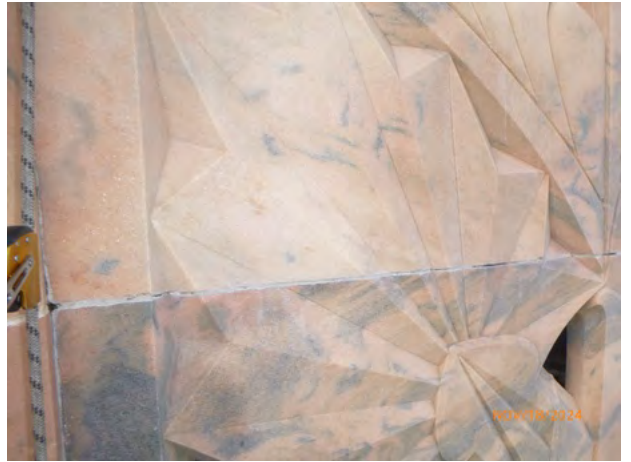
38-188 Stone\_Joints Mortar Failed 2024-2.jpg

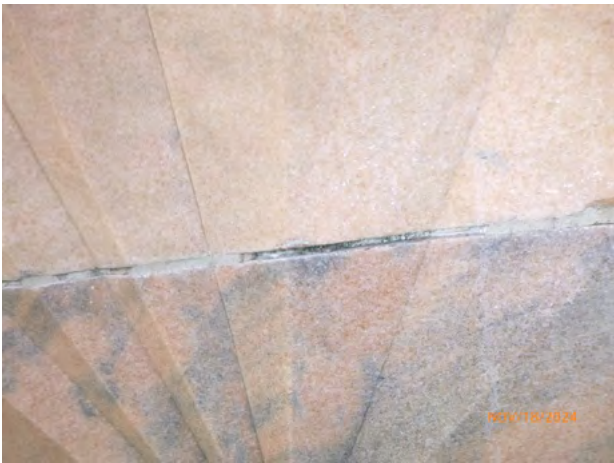
38-188 Stone\_Joints Mortar Failed 2024-3.jpg

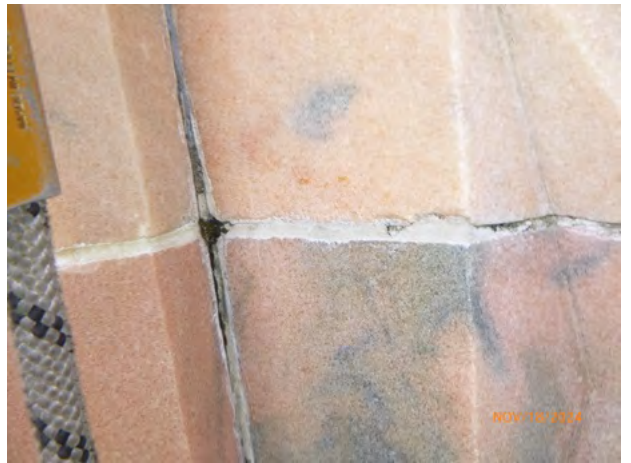
38-188 Stone\_Joints Mortar Failed 2024-4.jpg

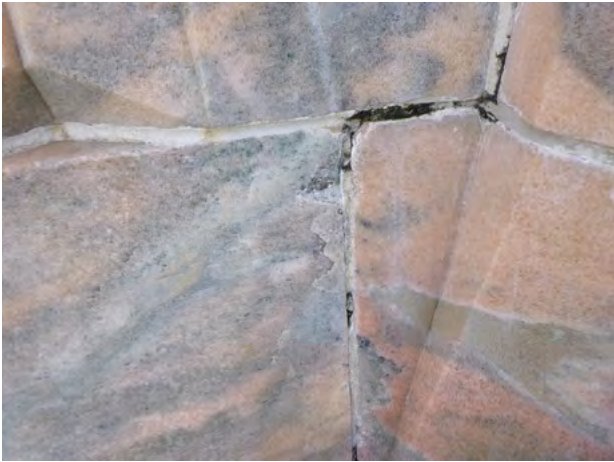
40-183 Stone\_SurfLoss Chipped 2024-1.jpg

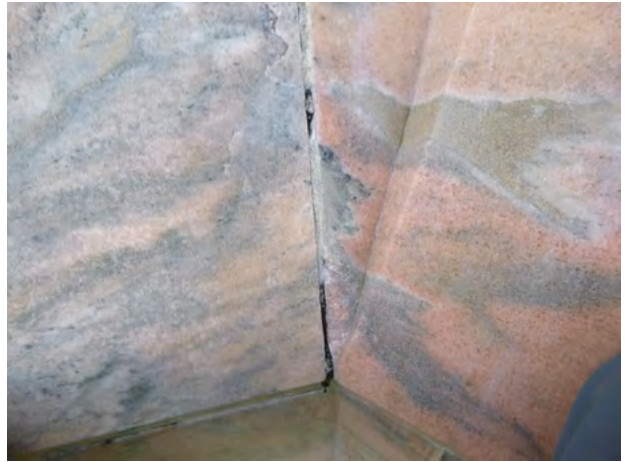
40-183 Stone\_SurfLoss Chipped 2024-2.jpg

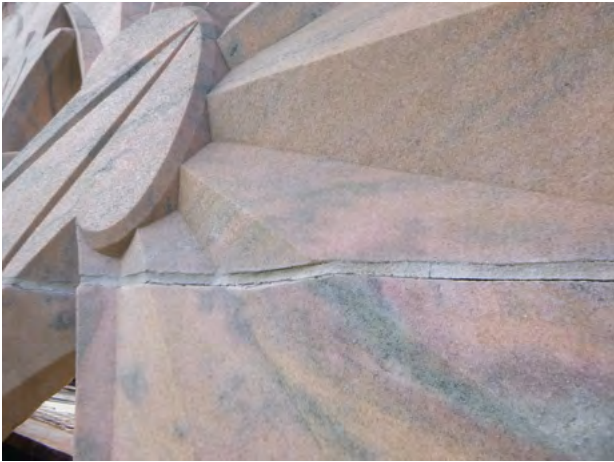
40-193 Stone\_Joints Mortar Failed 2024-1.jpg

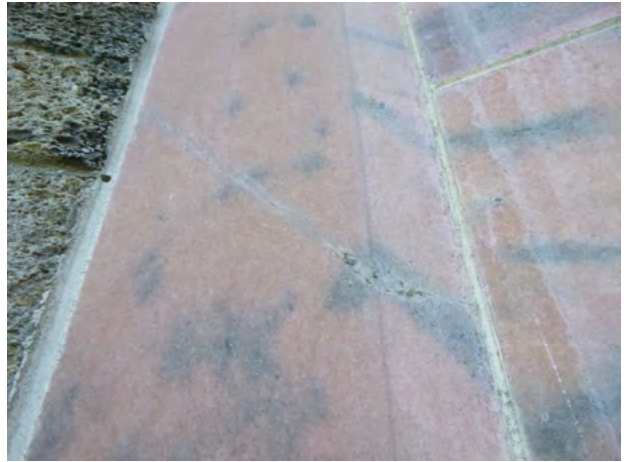
41-83 Stone\_Crack Single unit 2024-1.jpg

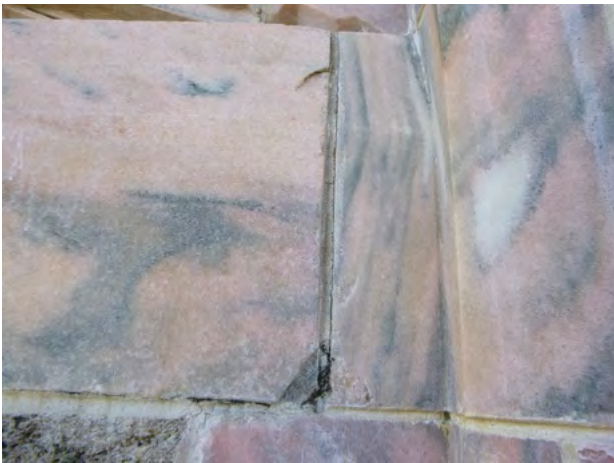
41-138 Stone\_SurfLoss Chipped 2024-1.jpg

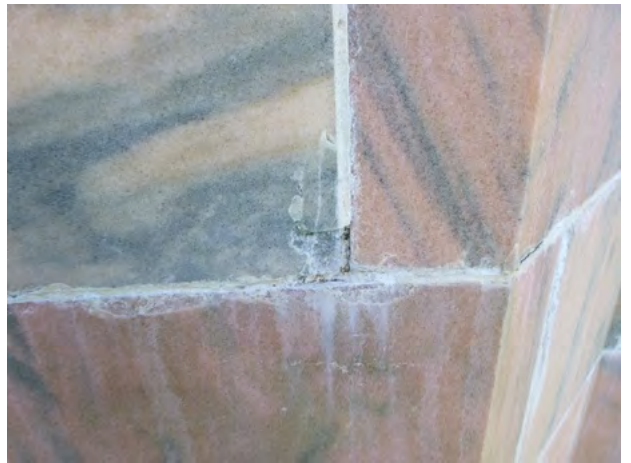
41-160 Stone\_SurfLoss Chipped 2024-1.jpg

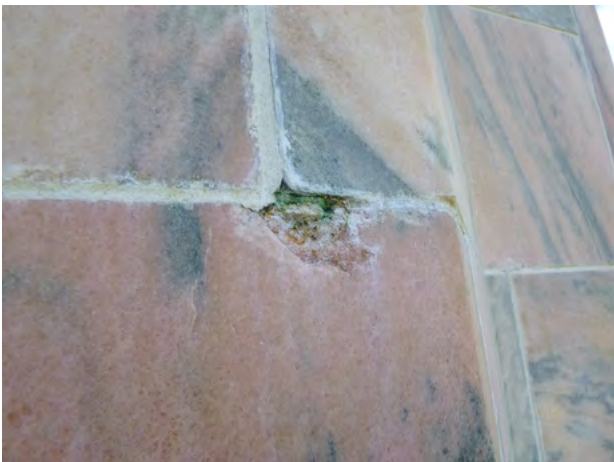
41-163 Stone\_Spall Missing 2024-1.jpg

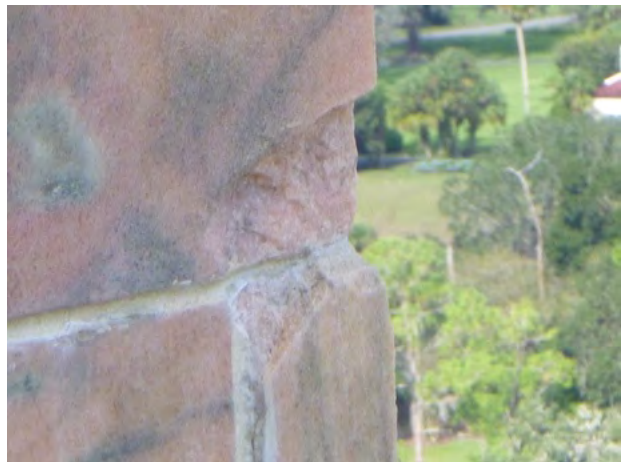
41-168 Stone\_Spall Missing 2024-1.jpg

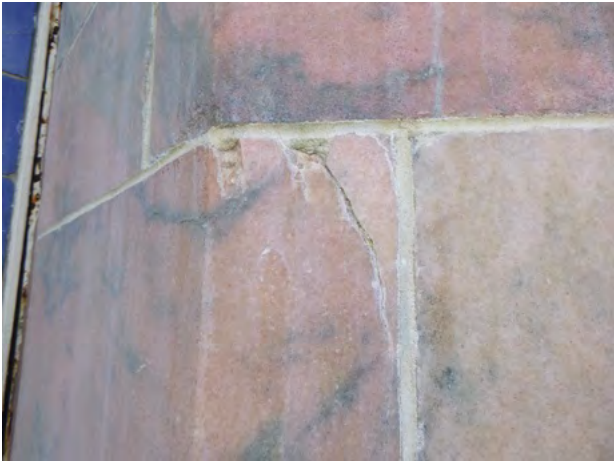
41-169 Stone\_Crack Single unit 2024-1.jpg

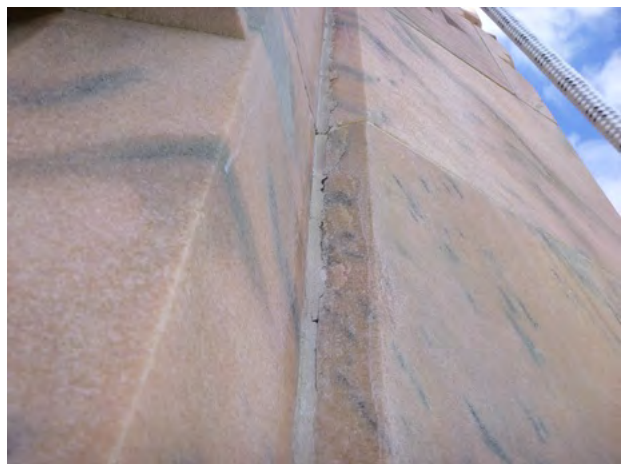
41-190 Stone\_SurfLoss Chipped 2024-1.jpg

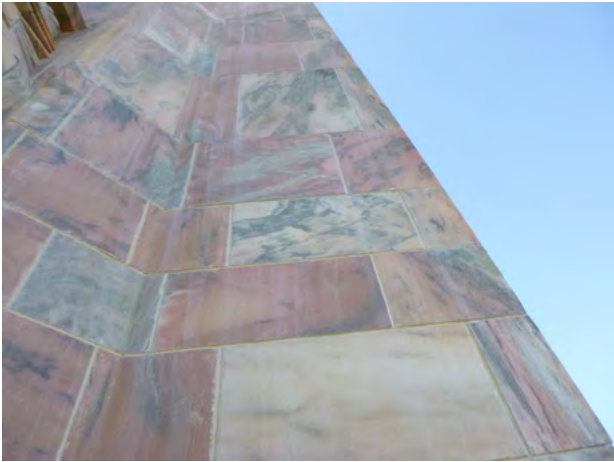
42-128 Stone\_SoilStain Efflorescence 2024-1.jpg

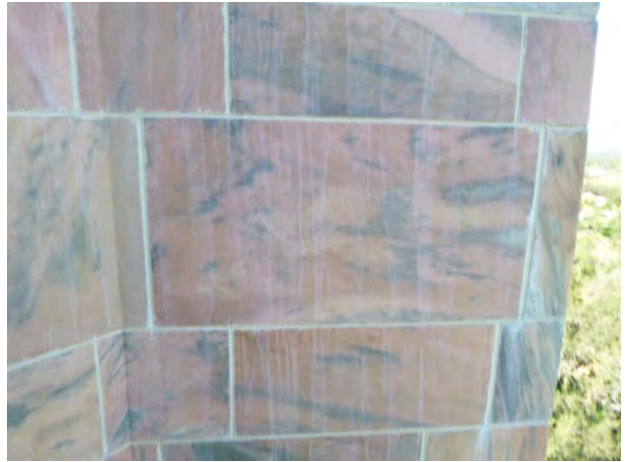
42-128 Stone\_SoilStain Efflorescence 2024-2.jpg

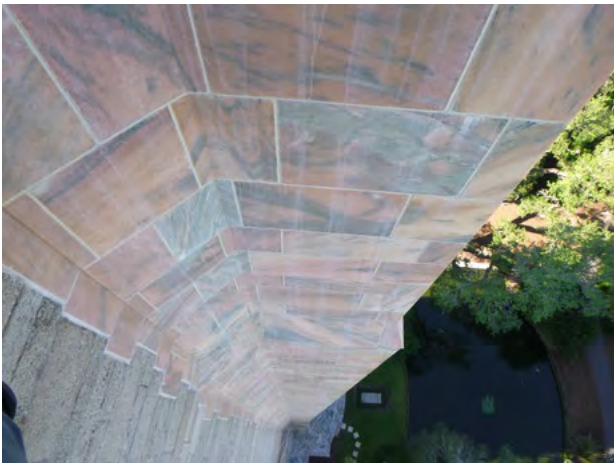
42-128 Stone\_SoilStain Efflorescence 2024-3.jpg

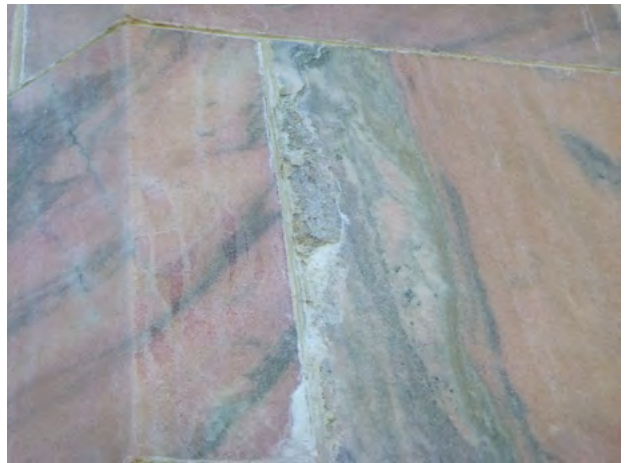
42-147 Stone\_SurfLoss Chipped 2024-1.jpg

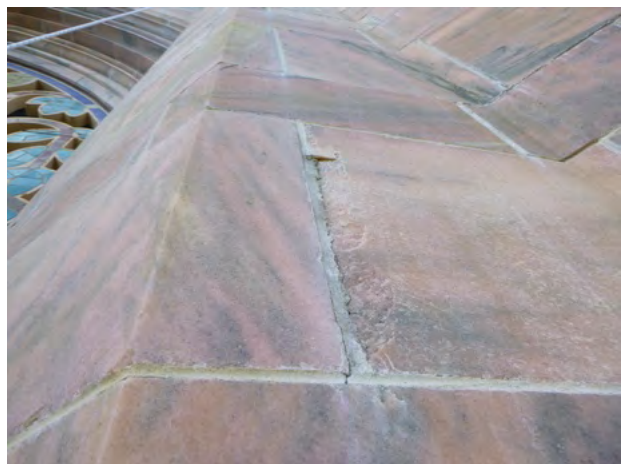
42-169 Stone\_SurfLoss Chipped 2024-1.jpg

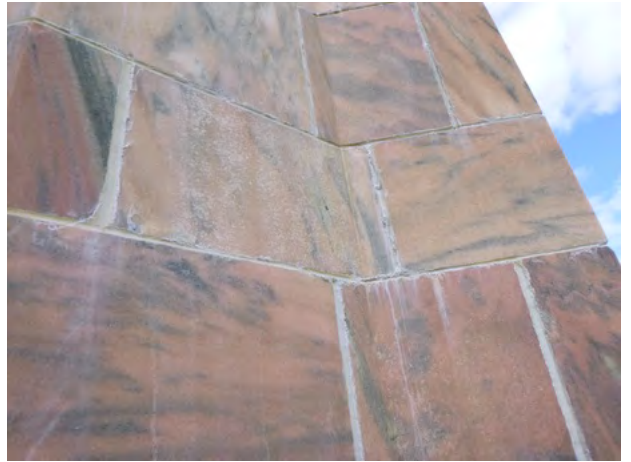
42-172 Stone\_SoilStain Leached Salts 2024-1.jpg

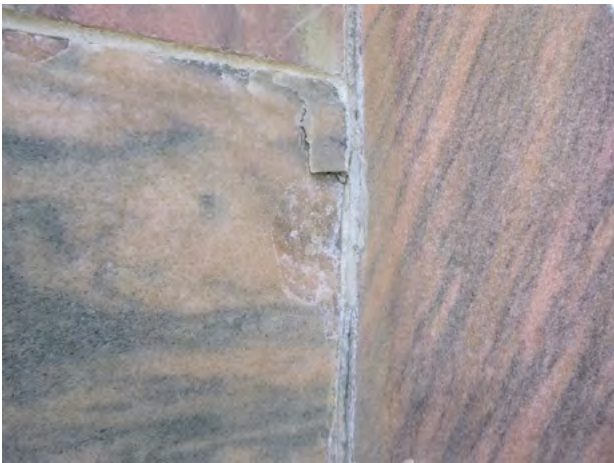
42-180 Stone\_Spall Missing 2024-1.jpg

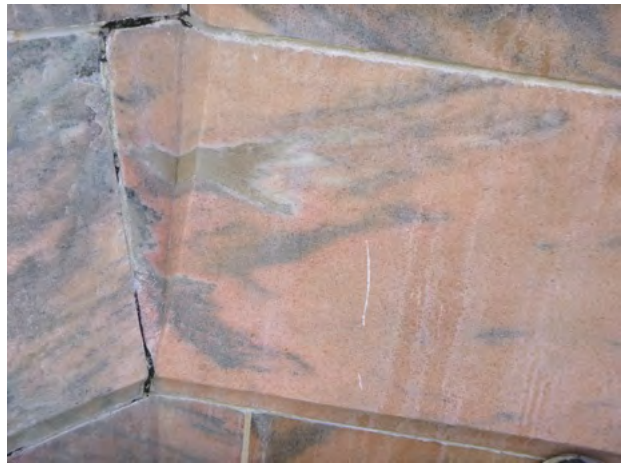
42-184 Stone\_SoilStain Efflorescence 2024-1.jpg

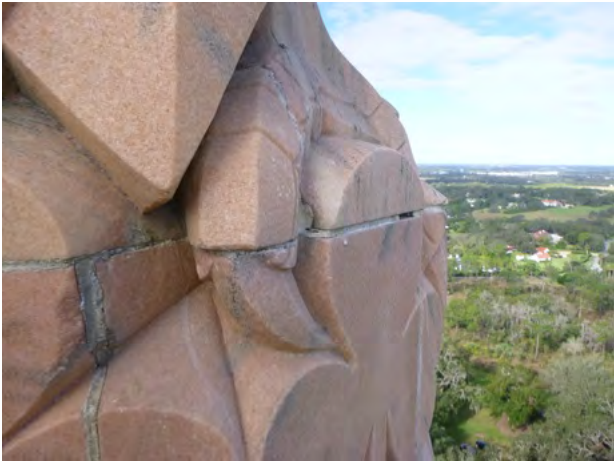
42-192 Stone\_Joints Mortar Failed 2024-2.jpg

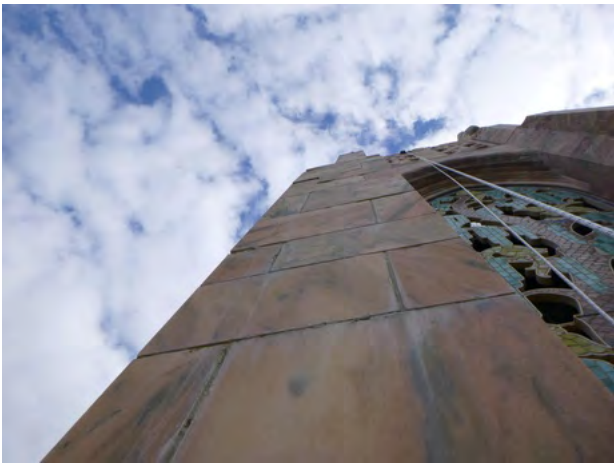
43-154 Stone\_Joints Mortar Failed 2024-1.jpg

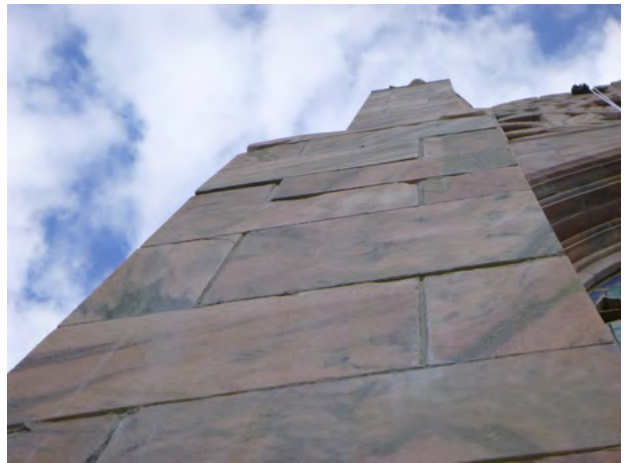
43-154 Stone\_Joints Mortar Failed 2024-2.jpg
