### ***Bok Singing Tower Roof Restoration and Replacement***

# Bok Singing Tower Conditions Assessment

T.Y. Lin (formerly Silman) was contracted to perform a conditions assessment of the Bok Singing Tower at Bok Tower Gardens in Lake Wales, Florida. The Singing Tower stands 205 feet tall at the southwest corner of the gardens. A moat surrounds the base of the tower with two bridges to access the island. The tower houses a 60-bell carillon, associated carillonneur studio and library spaces, the Bok Tower Gardens Chao Research archive, and the Founder's Room. It is a steel frame construction clad in a masonry exterior of coquina and Georgia pink Etowah marble with brick masonry at the interior.

## **Bok Tower Focused Condition Assessment**

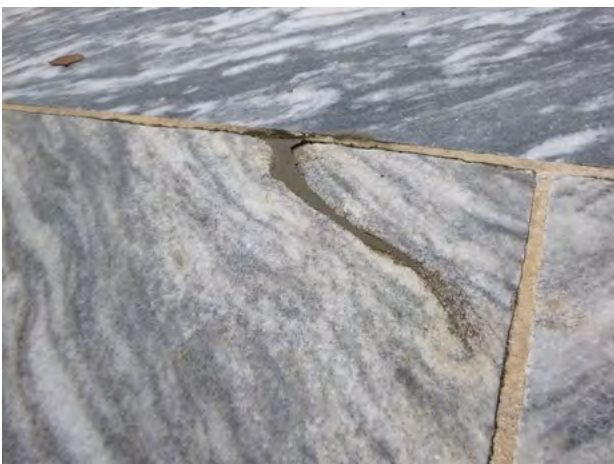
45-0 Stone\_Crack Repair failed 2024-1.jpg

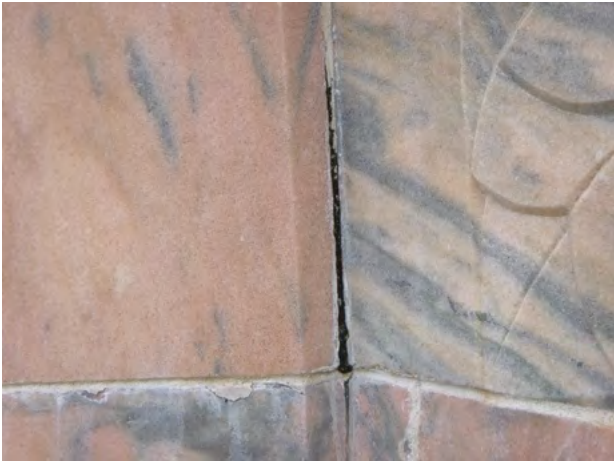
45-185 Stone\_Joints Mortar Failed 2024-1.jpg

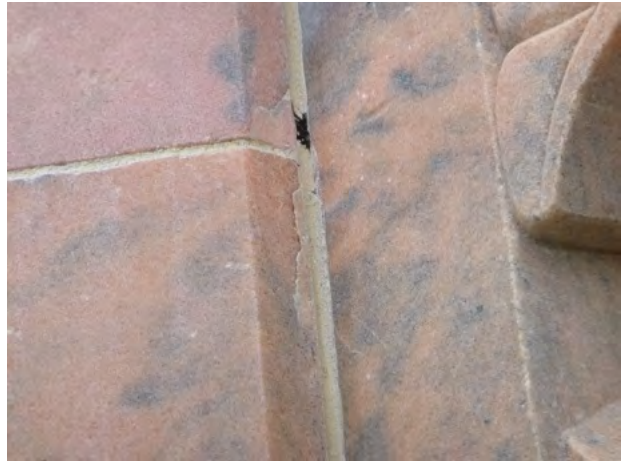
45-191 Stone\_SurfLoss Chipped 2024-1.jpg

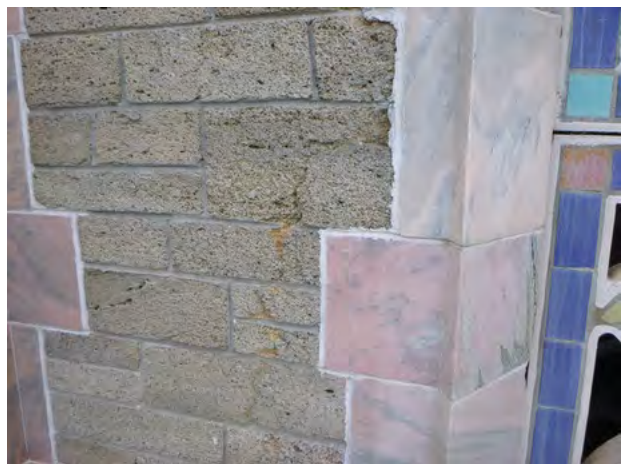
47-110 Stone\_Crack System units and joints 2024-3.jpg

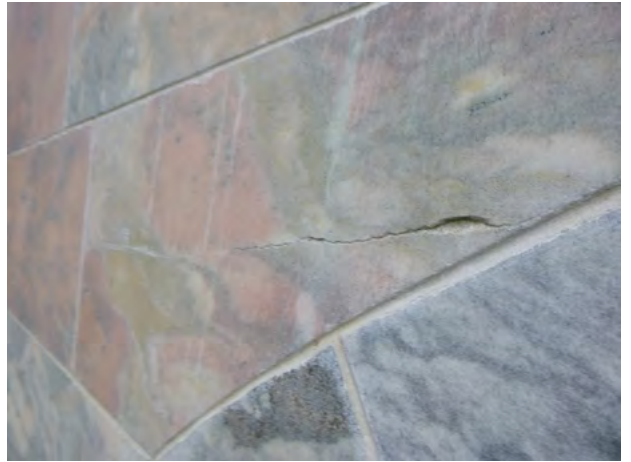
47-110 Stone\_Crack System units and joints 2024-4.jpg

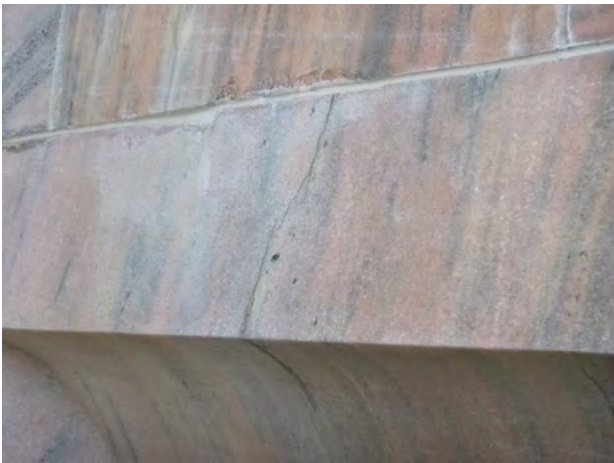
48-14 Stone\_Crack Single unit 2024-1.jpg

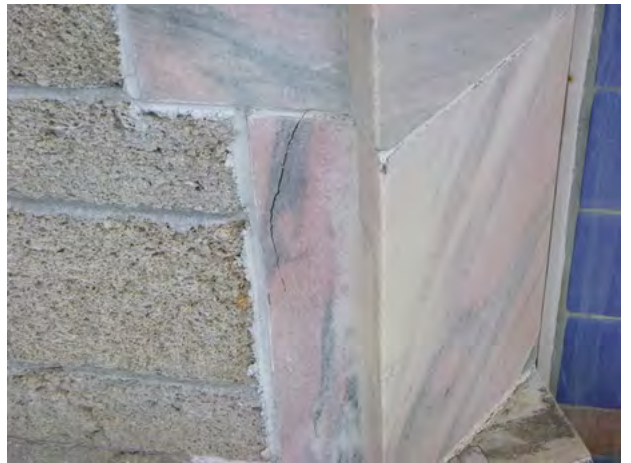
48-101 Stone\_Crack Single unit 2024-1.jpg

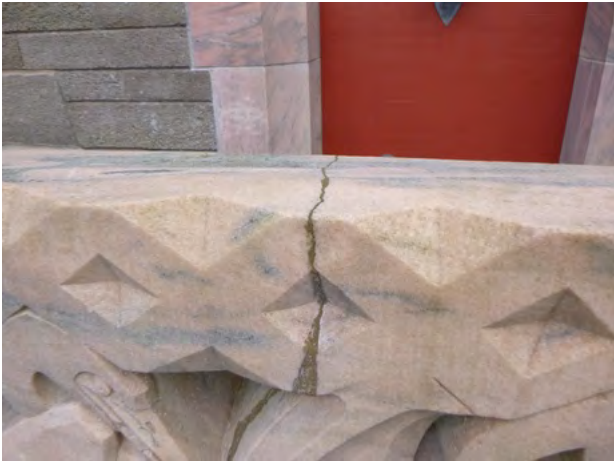
48-108 Stone\_Spall Missing 2024-1.jpg

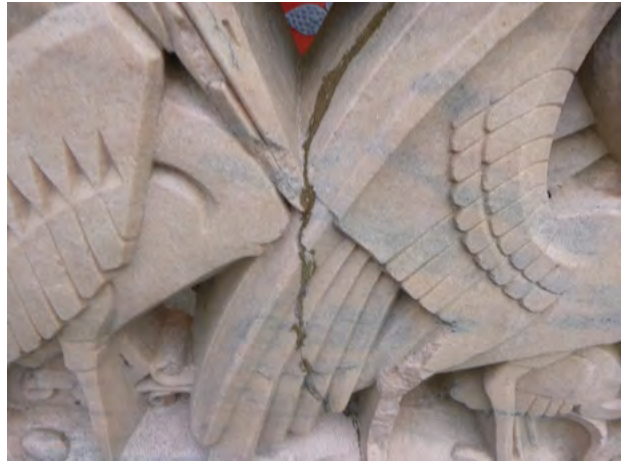
49-30 Stone\_Crack Repair failed 2024-1.jpg

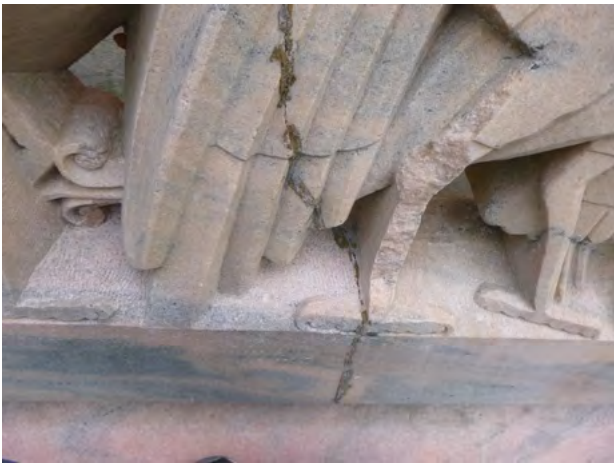
49-30 Stone\_Crack Repair failed 2024-2.jpg

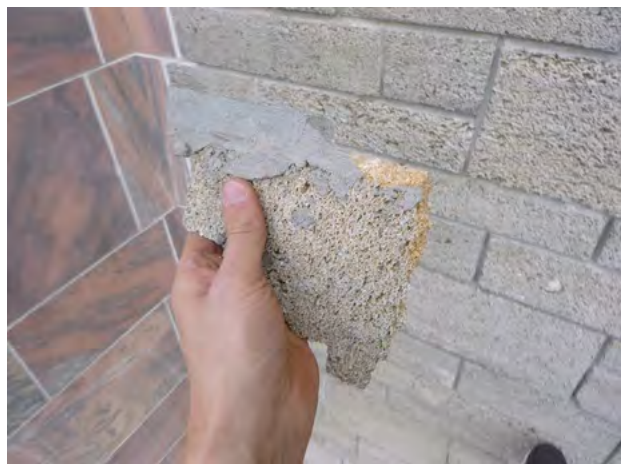
50-88 Stone\_Spall Removed 2024-1.jpg

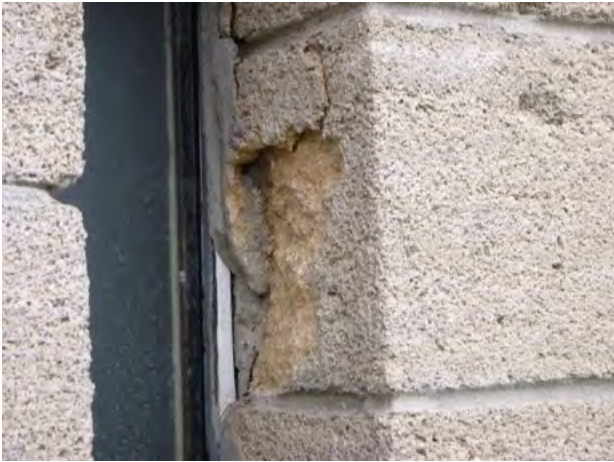
50-88 Stone\_Spall Removed 2024-2.jpg

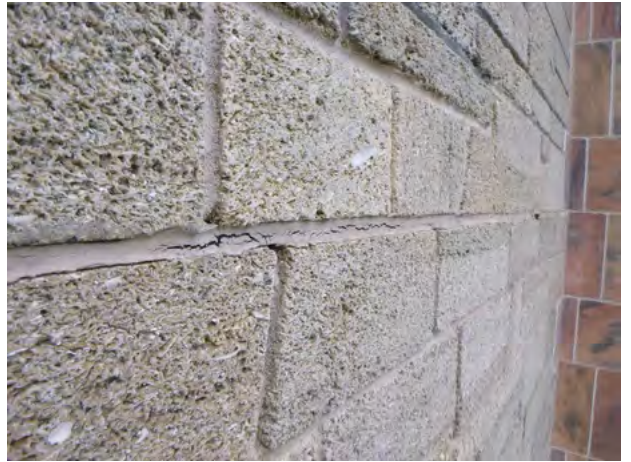
50-88 Stone\_Spall Removed 2024-3.jpg

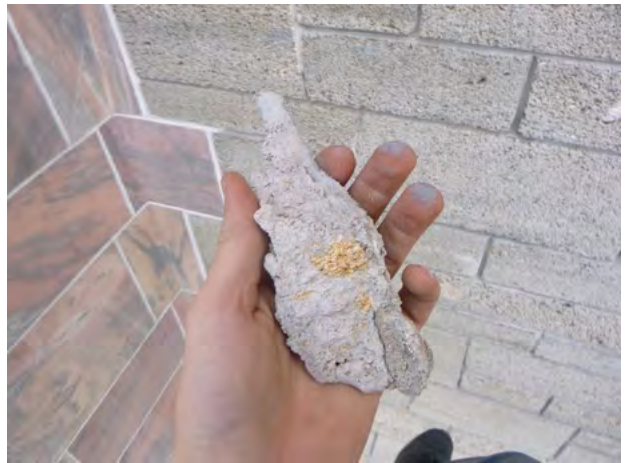
51-87 Stone\_Spall Removed + Steel 2024-1.jpg

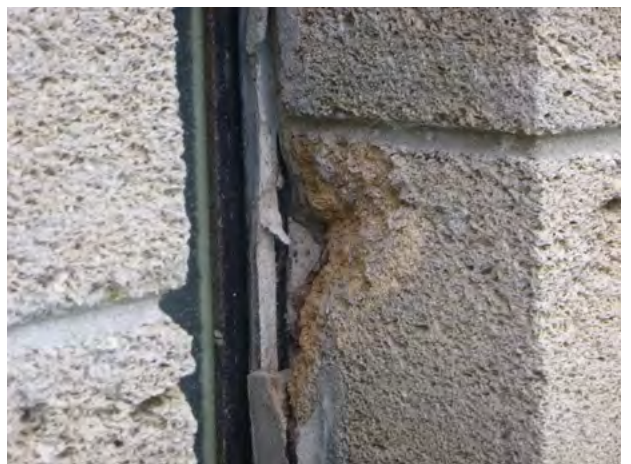
51-87 Stone\_Spall Removed + Steel 2024-3.jpg

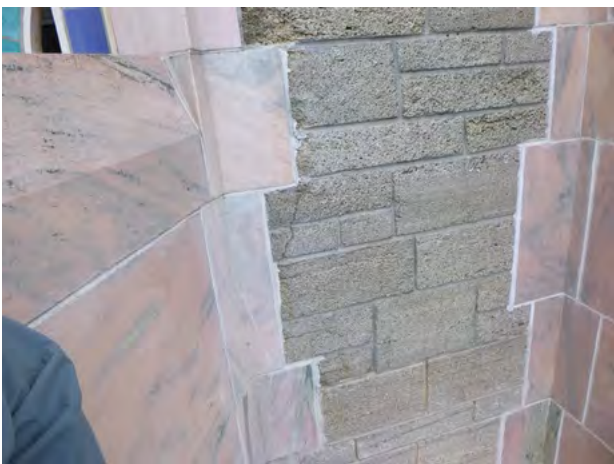
52-104 Stone\_SoilStain Biological 2024-1.jpg

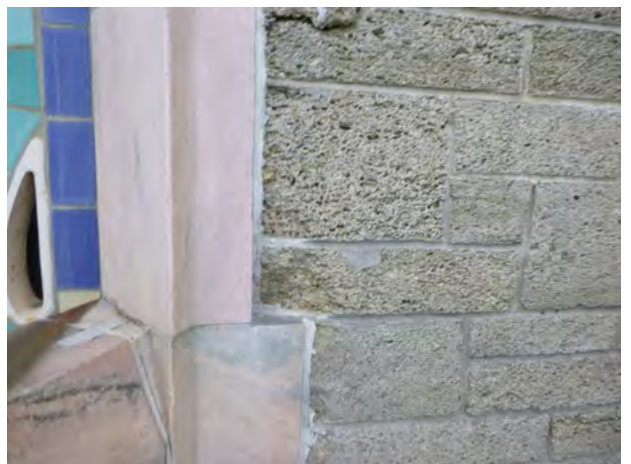
53-103 Stone\_Crack System units and joints 2024-1.jpg

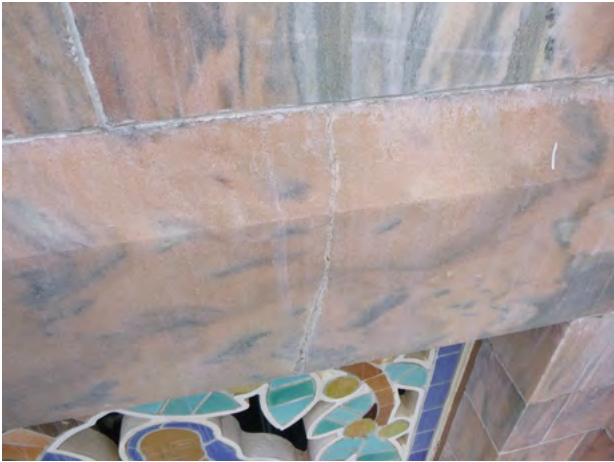
54-105 Stone\_Spall Missing 2024-1.jpg

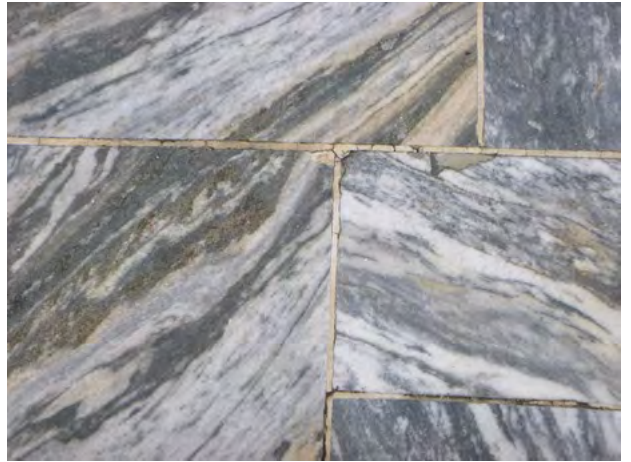
54-138 Stone\_Crack Single unit 2024-1.jpg

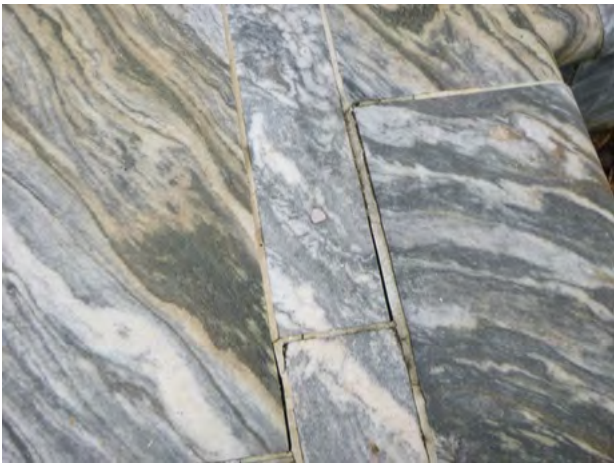
55-1 Stone\_Joints Mortar Failed 2024-1.jpg

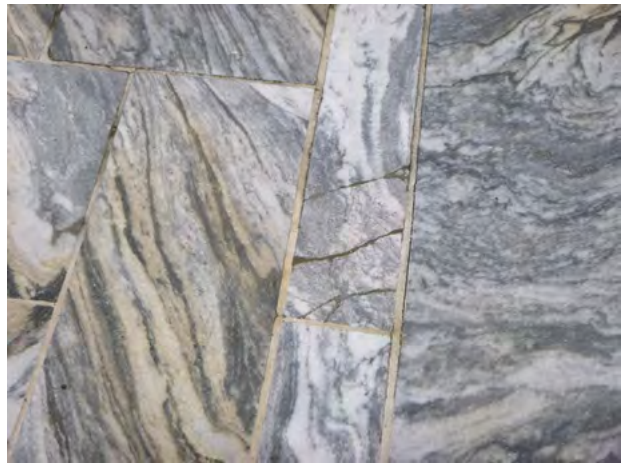
55-1 Stone\_Joints Mortar Failed 2024-2.jpg

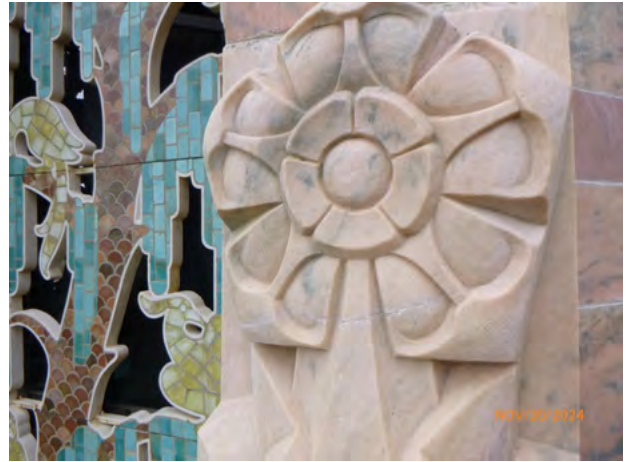
55-85 Stone\_Spall Bonded 2024-1.jpg

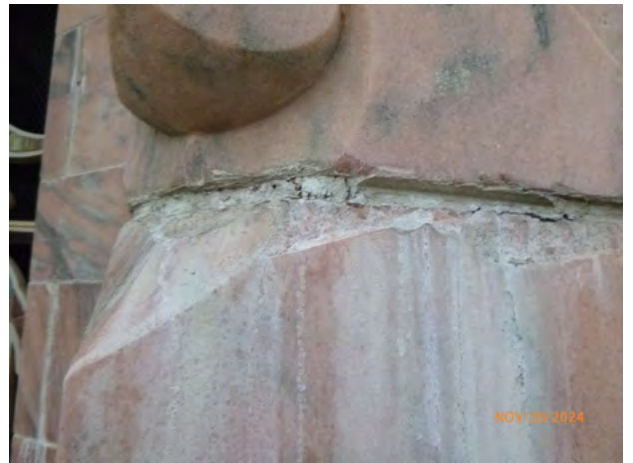
58-157 Stone\_Joints Mortar Failed 2024-1.jpg

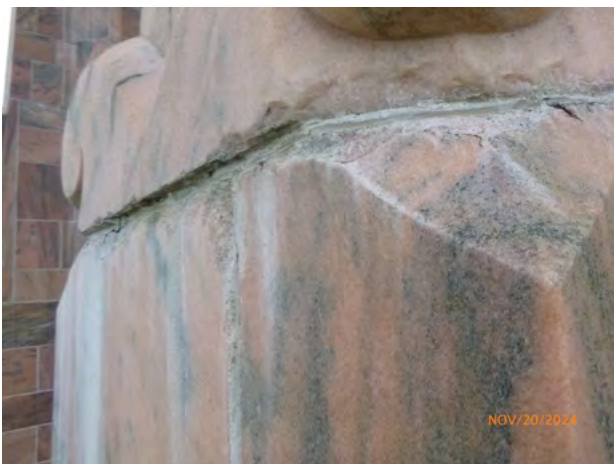
58-157 Stone\_Joints Mortar Failed 2024-2.jpg

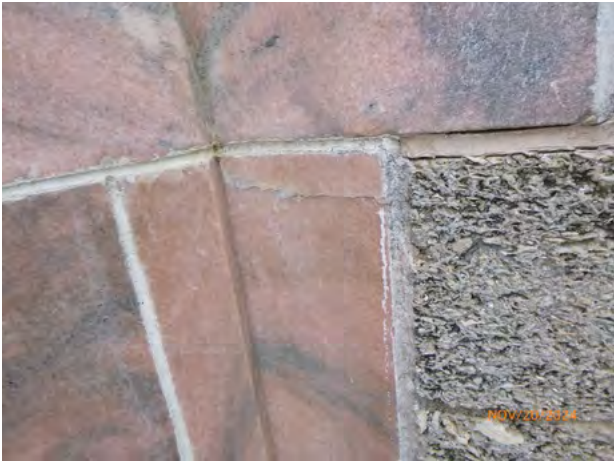
59-26 Stone\_SoilStain Biological 2024-1.jpg

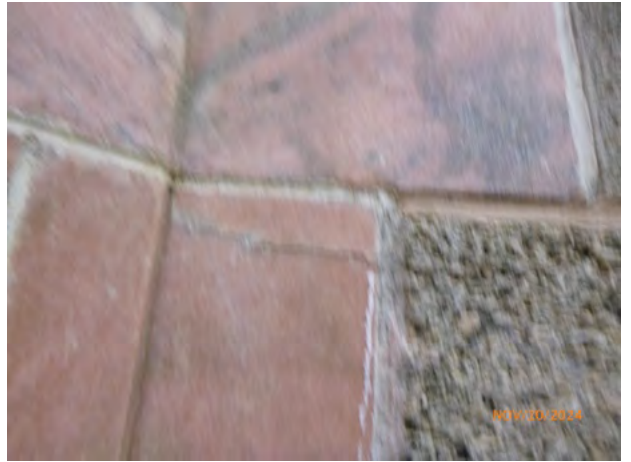
59-128 Stone\_Crack Single unit 2024-1.jpg

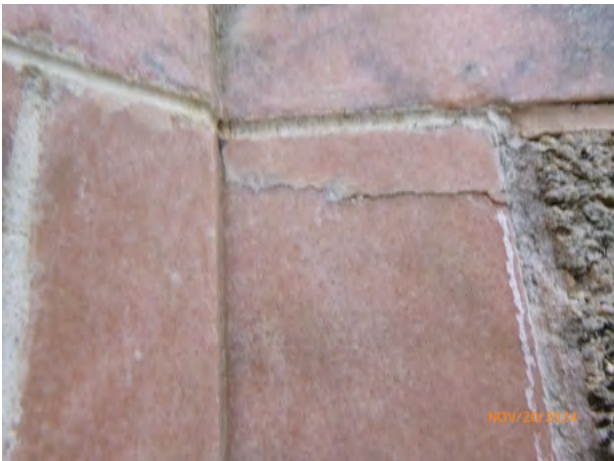
59-128 Stone\_Crack Single unit 2024-2.jpg

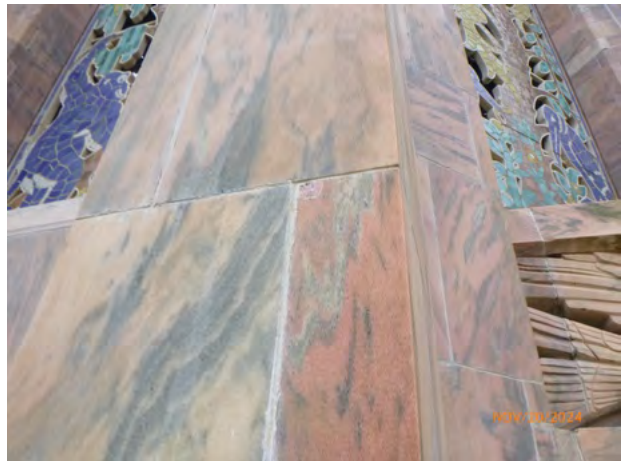
59-128 Stone\_Crack Single unit 2024-3.jpg

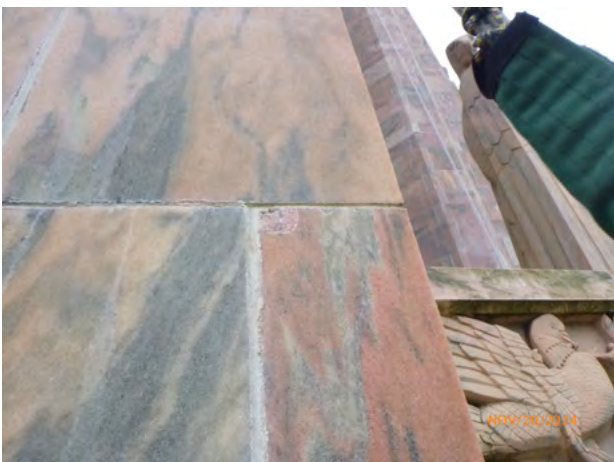
59-142 Stone\_SurfLoss Chipped 2024-1.jpg

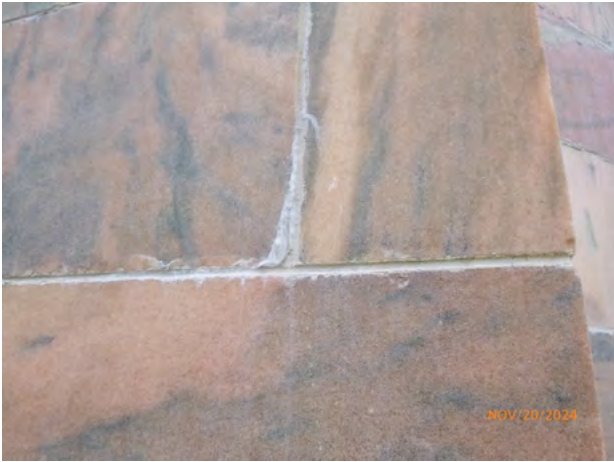
59-177 Stone\_SoilStain Leached Salts 2024-1.jpg

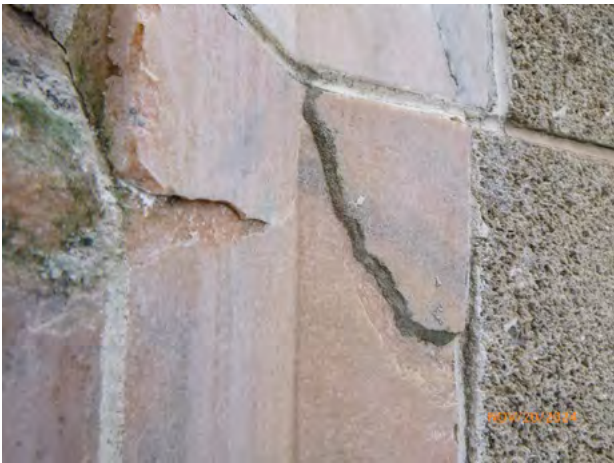
60-70 Stone\_Crack Single unit 2024-1.jpg

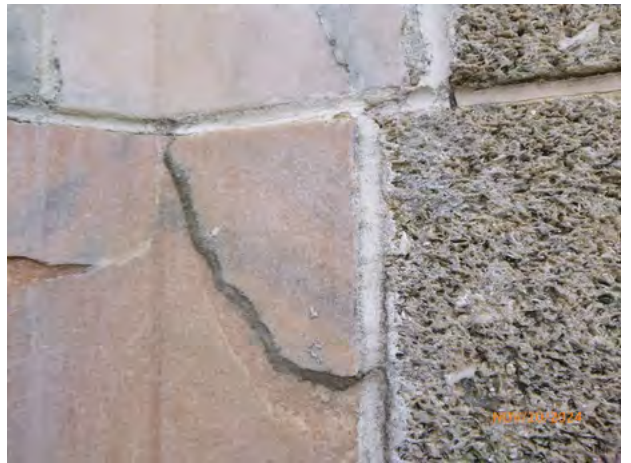
60-70 Stone\_Crack Single unit 2024-2.jpg

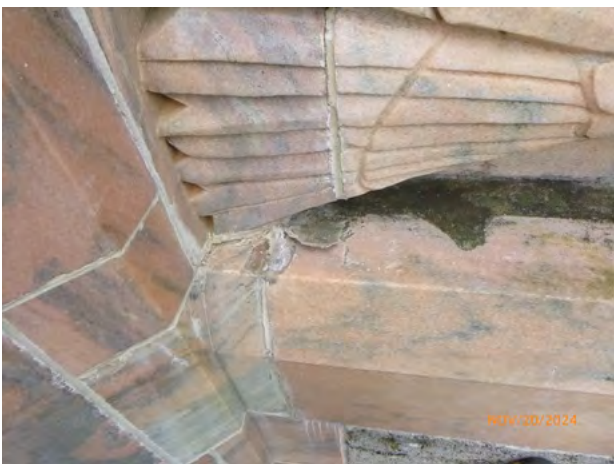
60-70 Stone\_Crack Single unit 2024-3.jpg

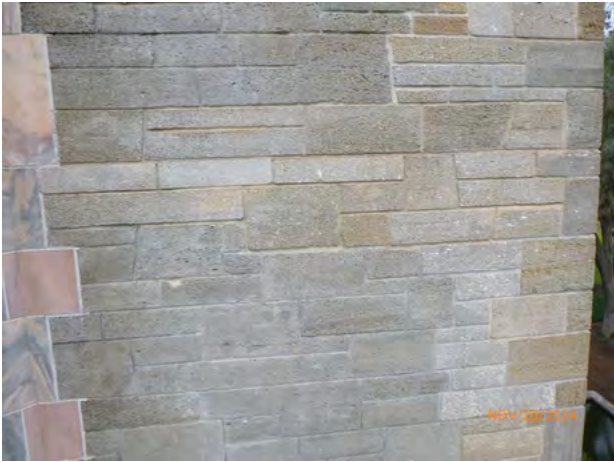
61-33 Stone\_SoilStain Biological 2024-2.jpg

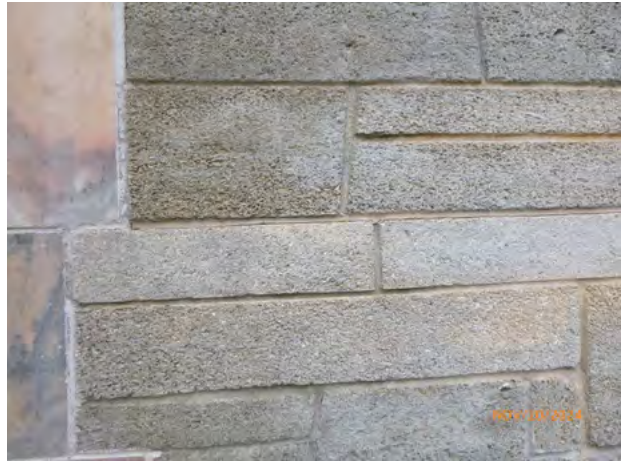
61-37 Stone\_Joints Sealant Failed 2024-1.jpg

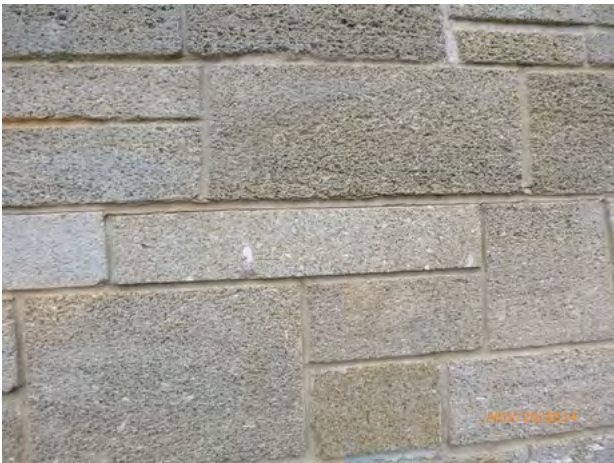
61-37 Stone\_Joints Sealant Failed 2024-2.jpg

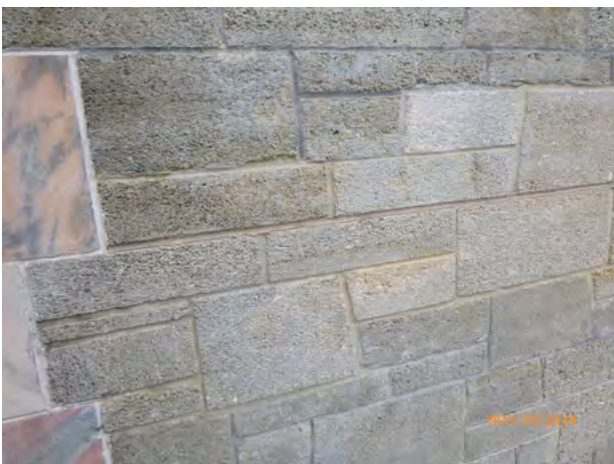
61-37 Stone\_Joints Sealant Failed 2024-4.jpg

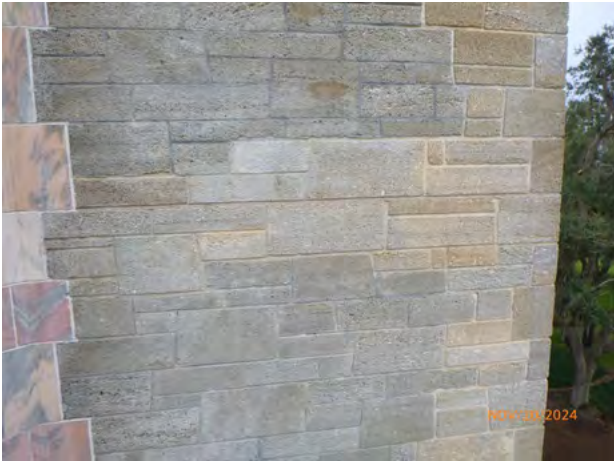
61-59 Stone\_Joints Sealant Failed 2024-2.jpg

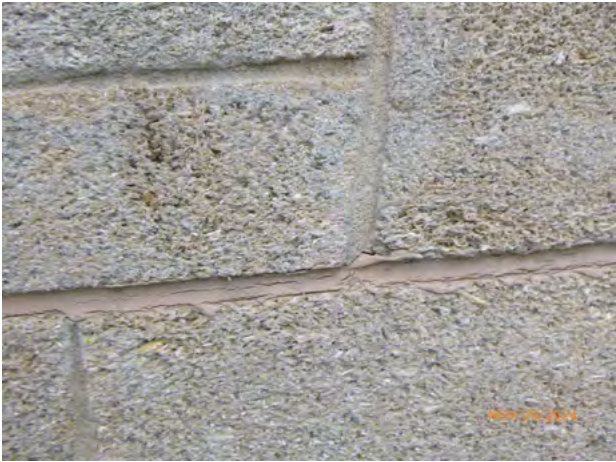
61-59 Stone\_Joints Sealant Failed 2024-3.jpg

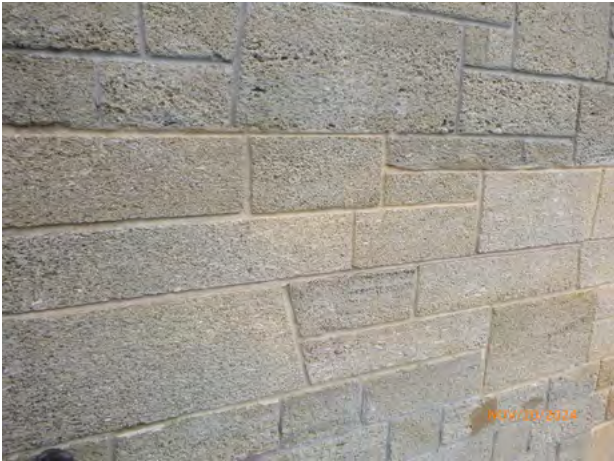
61-59 Stone\_Joints Sealant Failed 2024-4.jpg

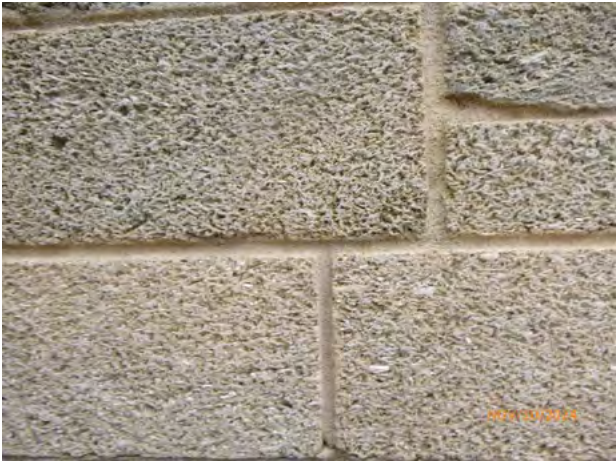
61-71 Stone\_Joints Sealant Failed 2024-1.jpg

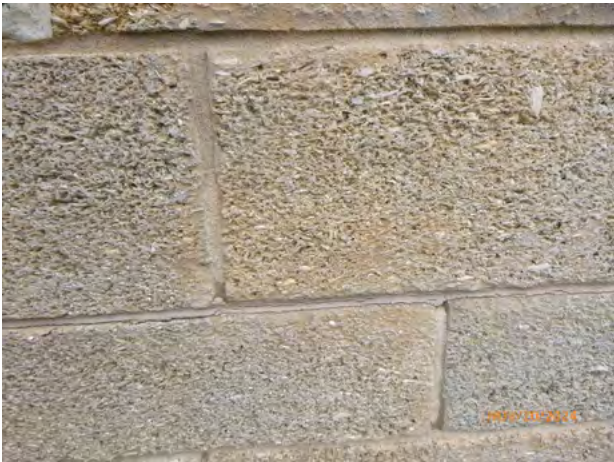
61-71 Stone\_Joints Sealant Failed 2024-2.jpg

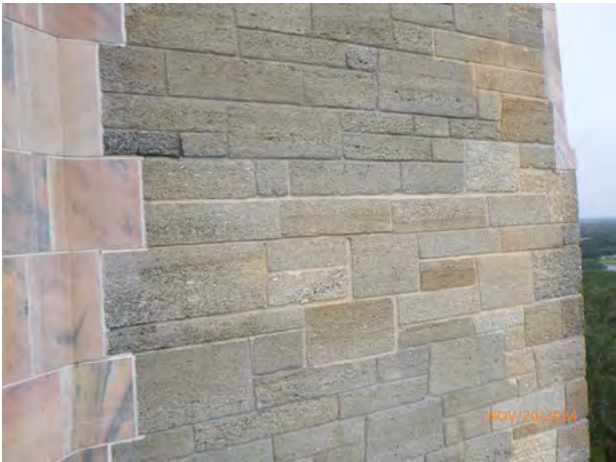
61-71 Stone\_Joints Sealant Failed 2024-3.jpg

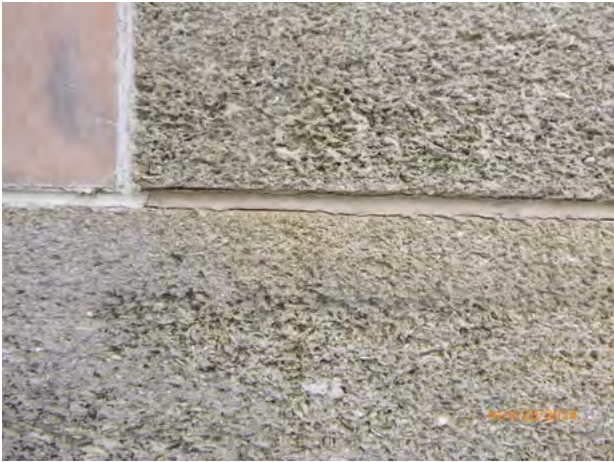
61-90 Stone\_Joints Sealant Failed 2024-1.jpg

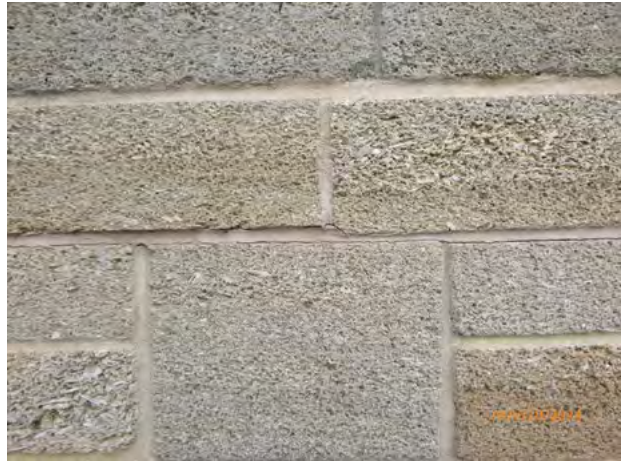
61-90 Stone\_Joints Sealant Failed 2024-2.jpg

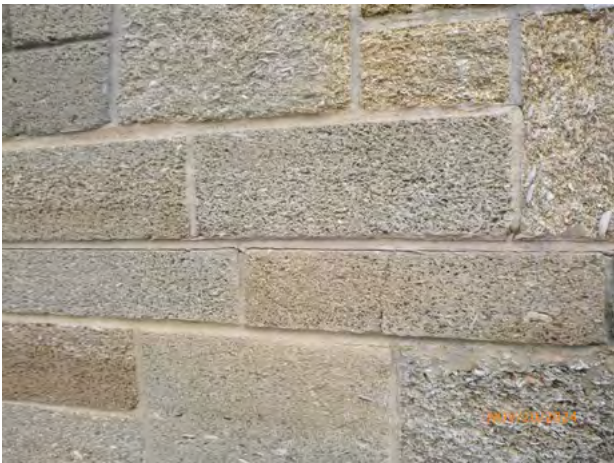
61-90 Stone\_Joints Sealant Failed 2024-3.jpg

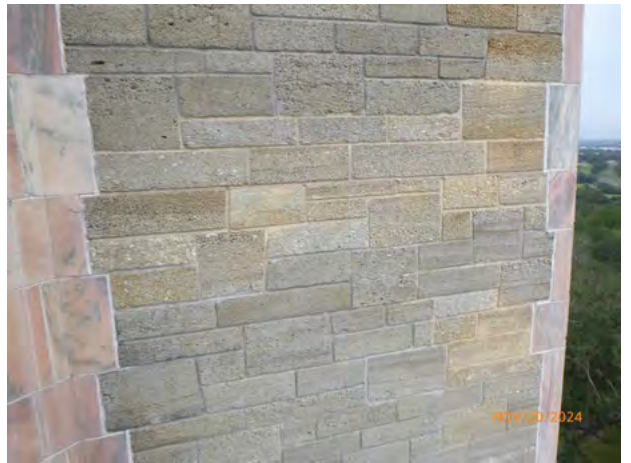
61-90 Stone\_Joints Sealant Failed 2024-4.jpg

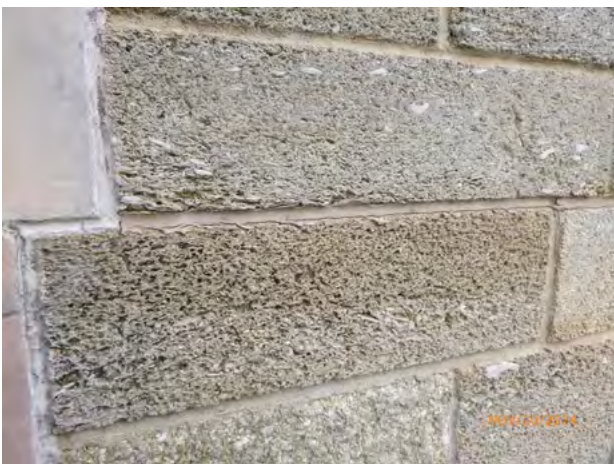
61-101 Stone\_Joints Sealant Failed 2024-1.jpg

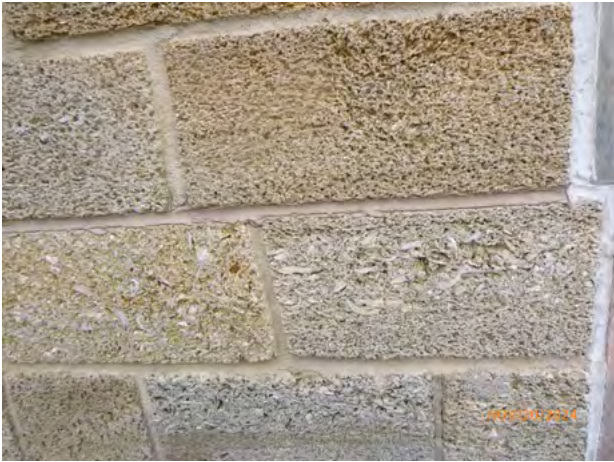
61-101 Stone\_Joints Sealant Failed 2024-3.jpg

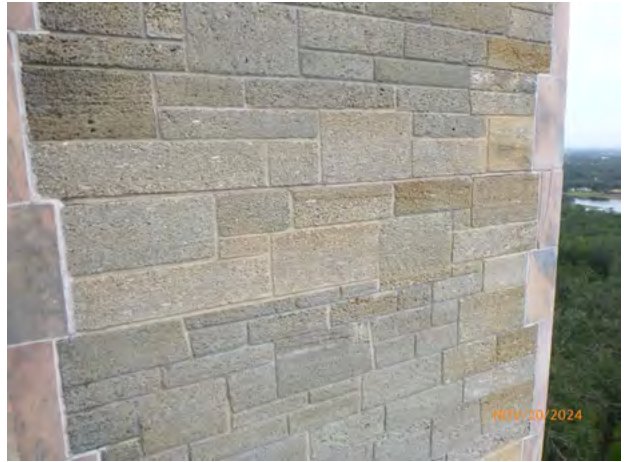
61-101 Stone\_Joints Sealant Failed 2024-4.jpg

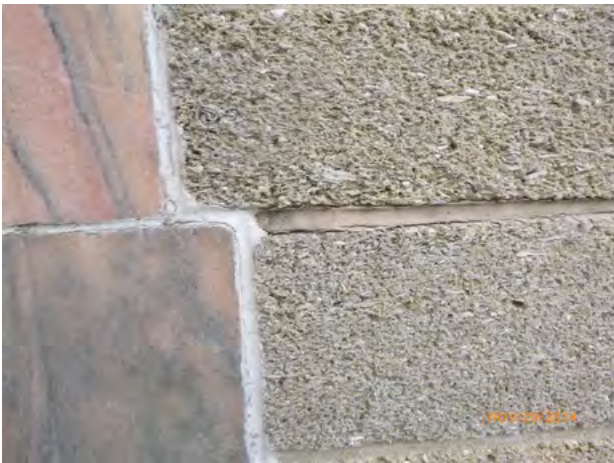
61-109 Stone\_Joints Sealant Failed 2024-1.jpg

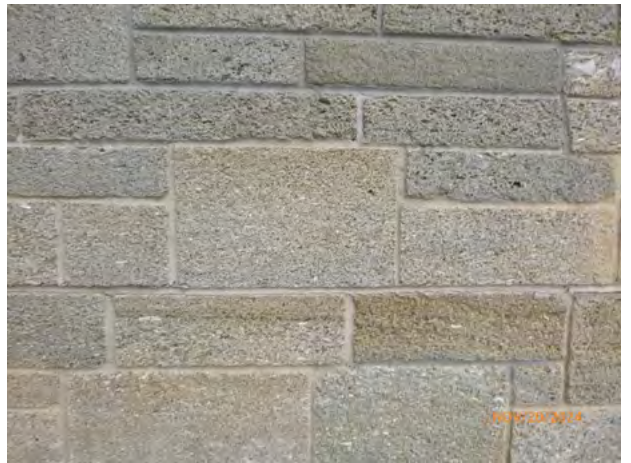
61-109 Stone\_Joints Sealant Failed 2024-2.jpg

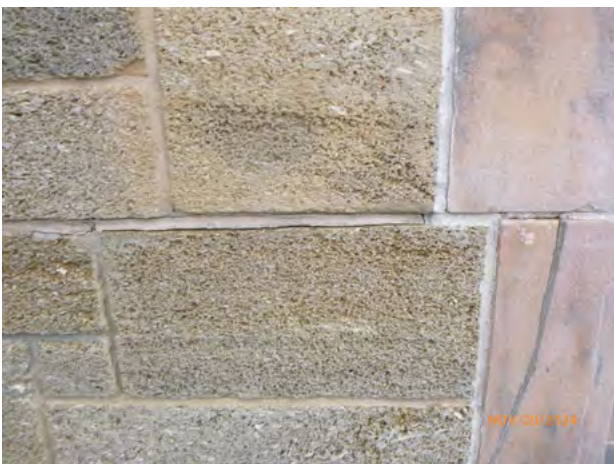
61-109 Stone\_Joints Sealant Failed 2024-3.jpg

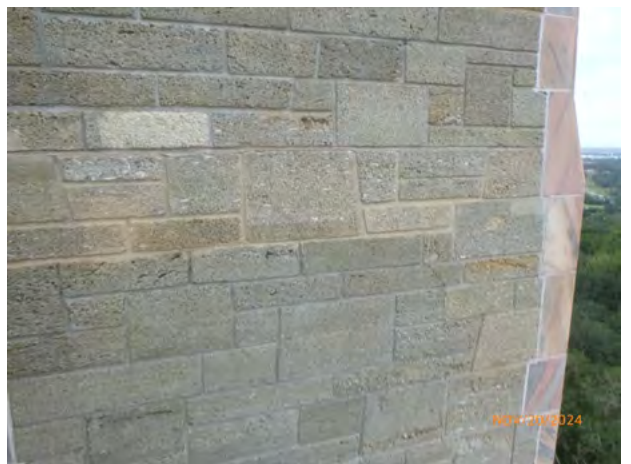
61-109 Stone\_Joints Sealant Failed 2024-4.jpg

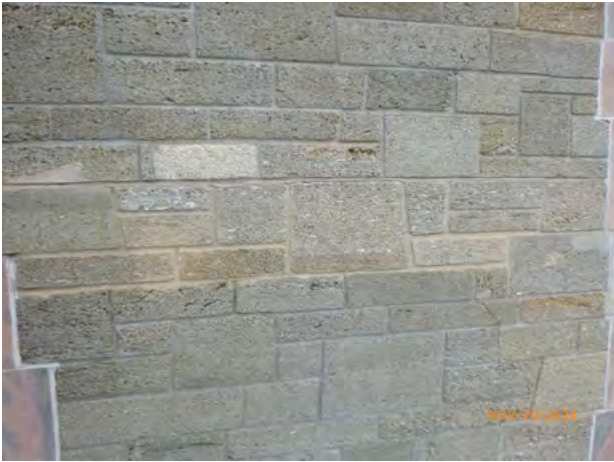
61-121 Stone\_Joints Sealant Failed 2024-1.jpg

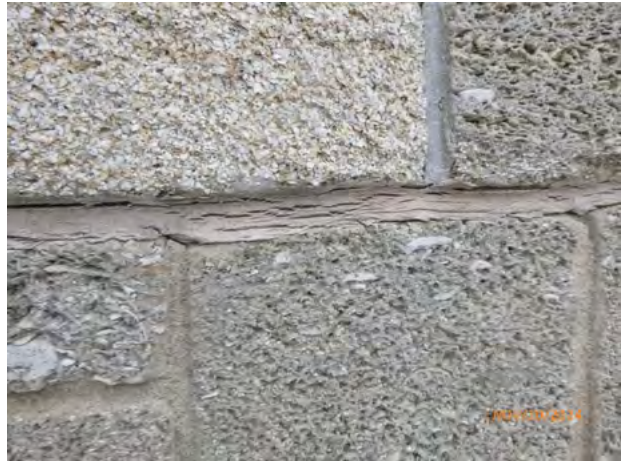
61-121 Stone\_Joints Sealant Failed 2024-2.jpg

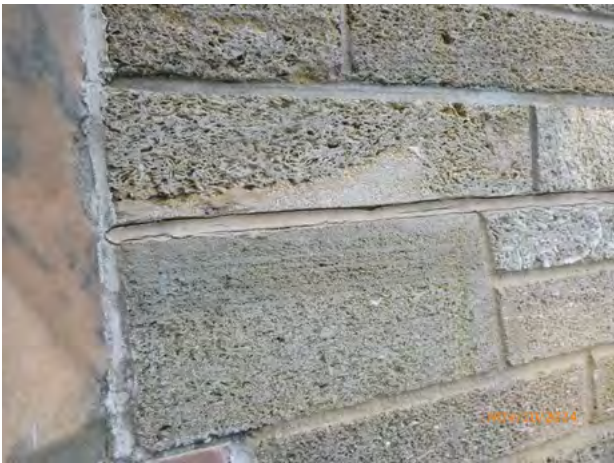
61-121 Stone\_Joints Sealant Failed 2024-3.jpg

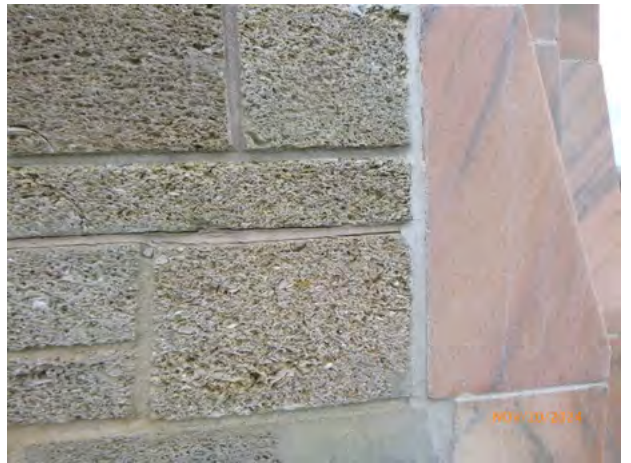
61-121 Stone\_Joints Sealant Failed 2024-4.jpg

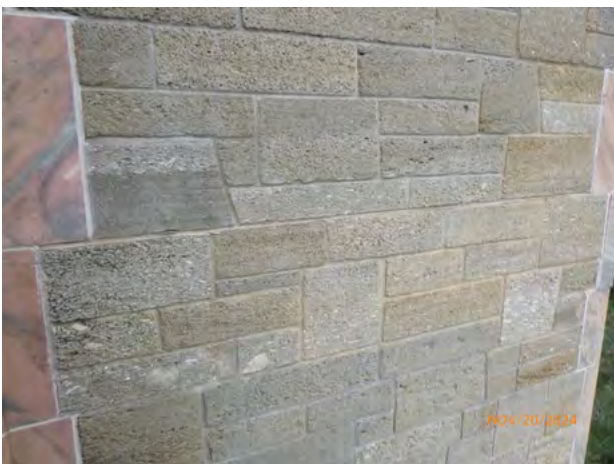
61-121 Stone\_Joints Sealant Failed 2024-5.jpg

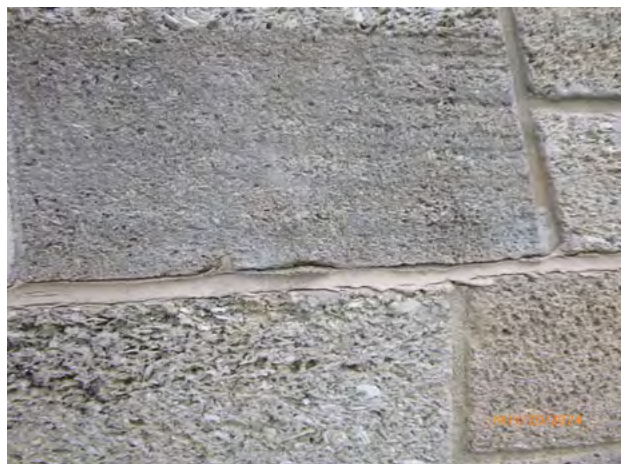
61-127 Stone\_Joints Sealant Failed 2024-1.jpg

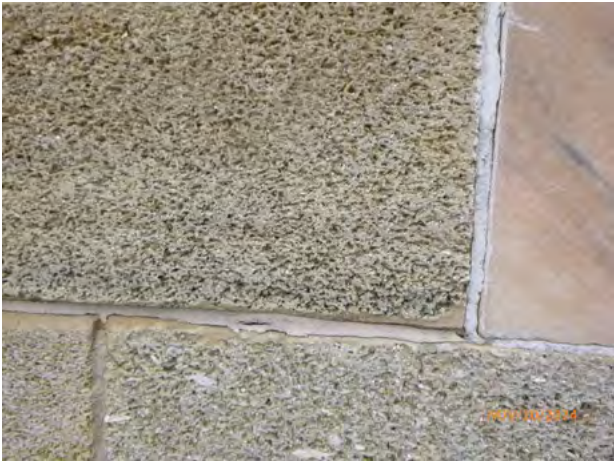
61-127 Stone\_Joints Sealant Failed 2024-2.jpg

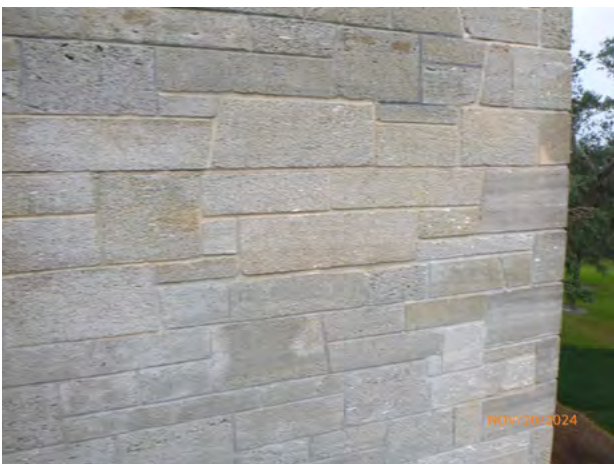
62-26 Stone\_SoilStain Biological 2024-3.jpg

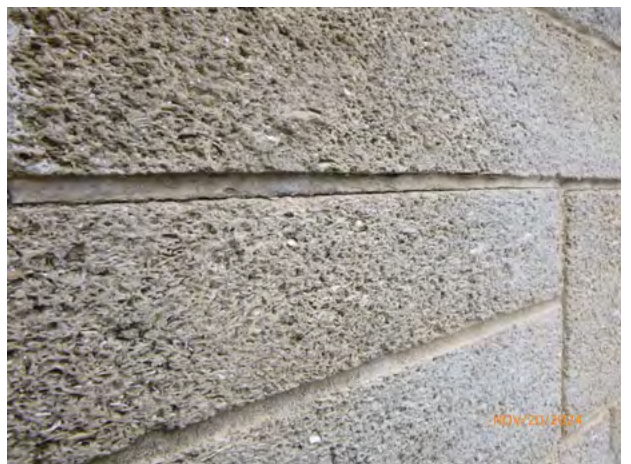
62-46 Stone\_Joints Sealant Failed 2024-1.jpg

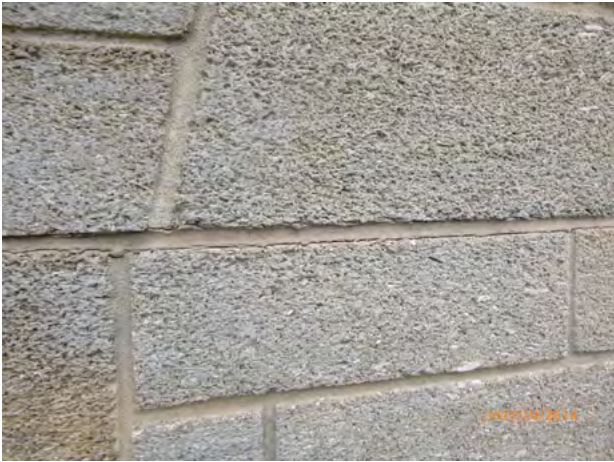
62-46 Stone\_Joints Sealant Failed 2024-2.jpg

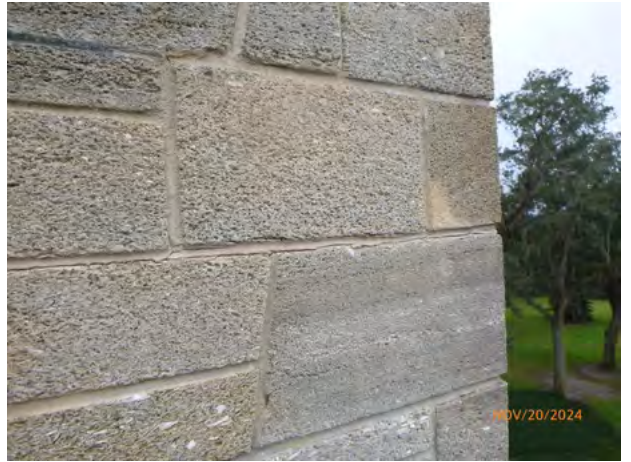
62-46 Stone\_Joints Sealant Failed 2024-3.jpg

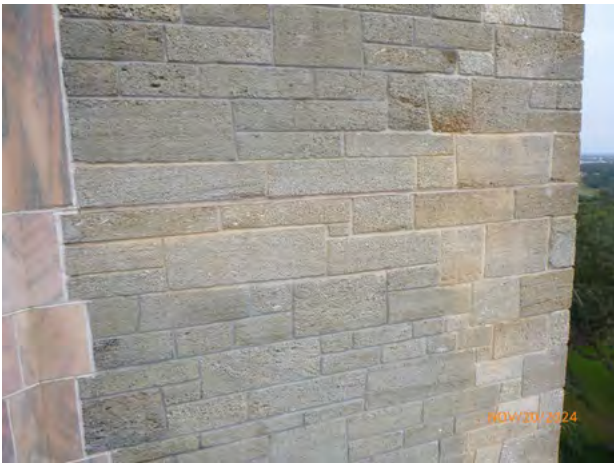
62-46 Stone\_Joints Sealant Failed 2024-4.jpg

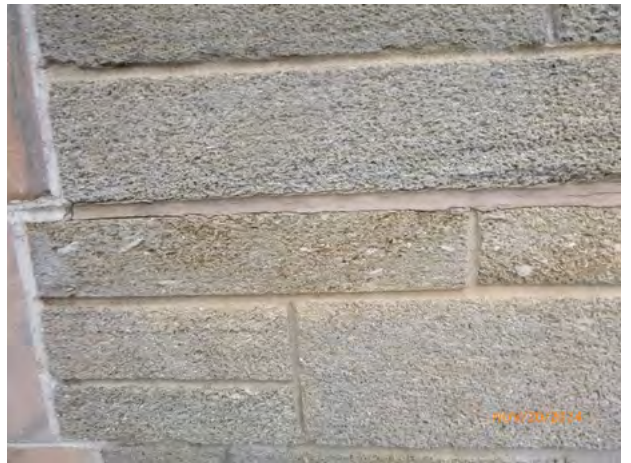
62-81 Stone\_Joints Sealant Failed 2024-1.jpg

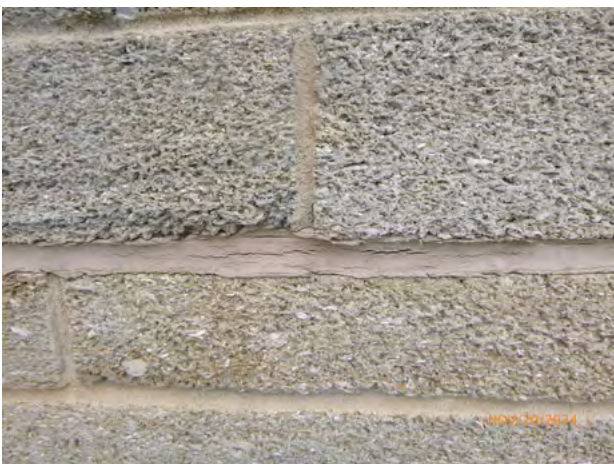
62-81 Stone\_Joints Sealant Failed 2024-2.jpg

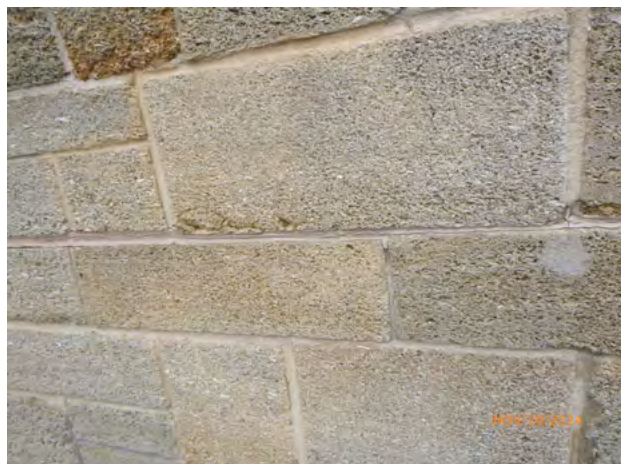
62-81 Stone\_Joints Sealant Failed 2024-3.jpg

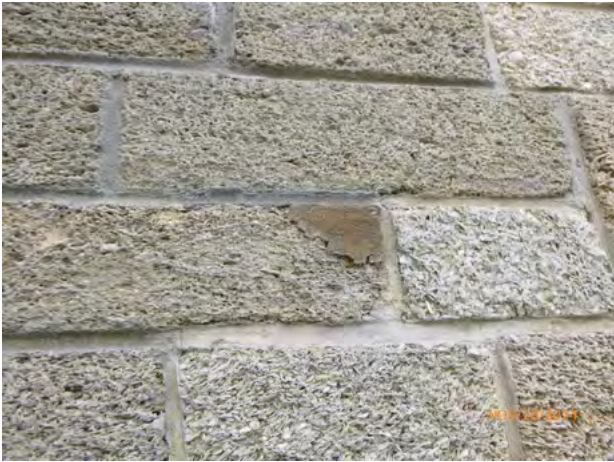
63-83 Stone\_Repair Patch Sound 2024-1.jpg

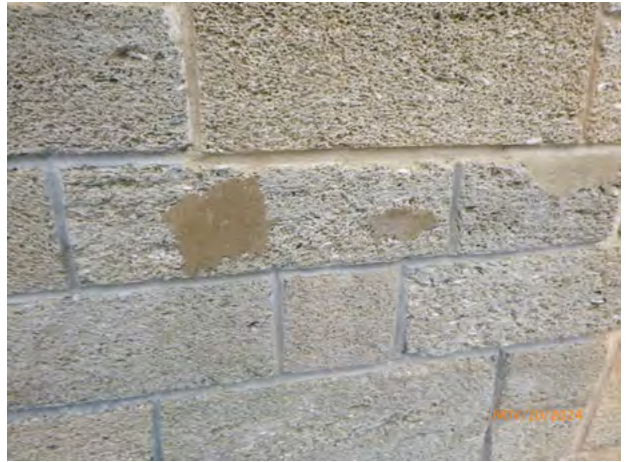
64-70 Stone\_Repair Patch Sound 2024-1.jpg

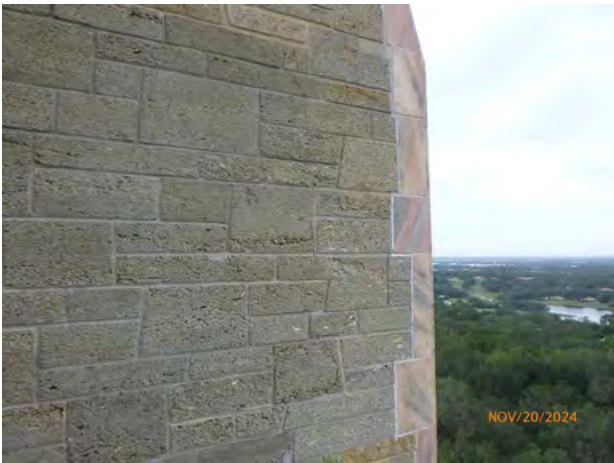
65-116 Stone\_Crack System units and joints 2024-1.jpg

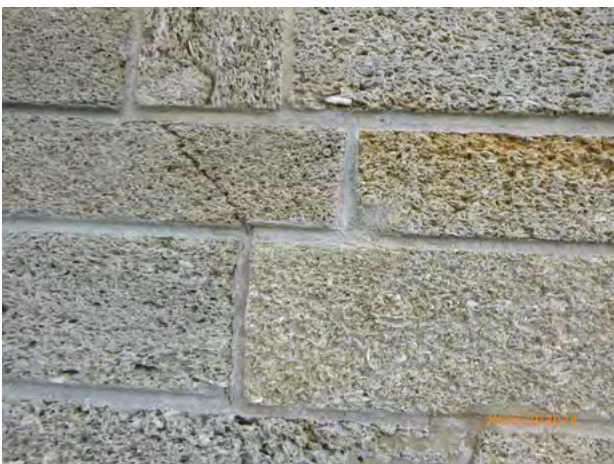
65-116 Stone\_Crack System units and joints 2024-3.jpg

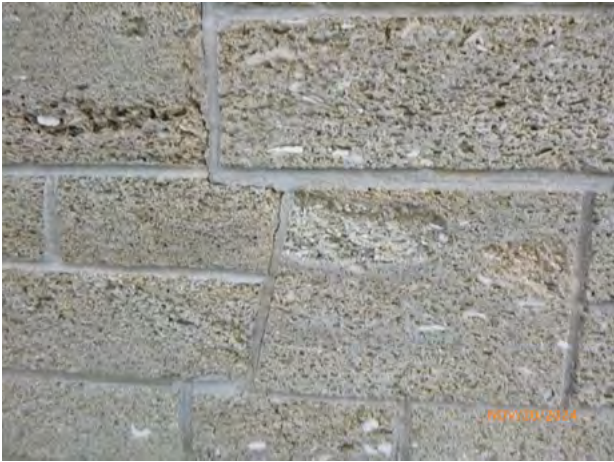
65-116 Stone\_Crack System units and joints 2024-5.jpg

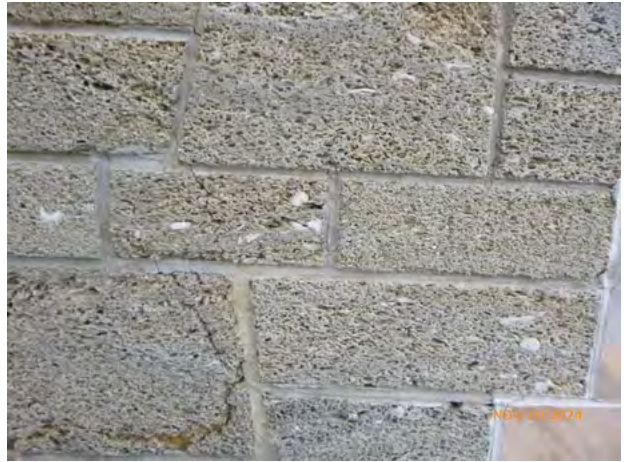
65-116 Stone\_Crack System units and joints 2024-6.jpg

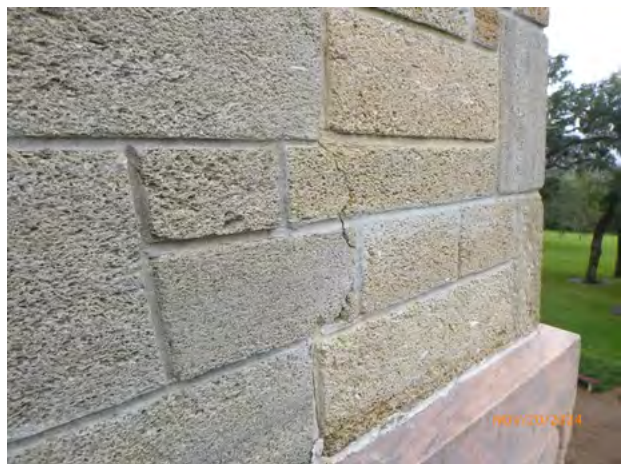
66-32 Stone\_Crack System units and joints 2024-1.jpg
