### ***Bok Singing Tower Roof Restoration and Replacement***

# Bok Singing Tower Conditions Assessment

T.Y. Lin (formerly Silman) was contracted to perform a conditions assessment of the Bok Singing Tower at Bok Tower Gardens in Lake Wales, Florida. The Singing Tower stands 205 feet tall at the southwest corner of the gardens. A moat surrounds the base of the tower with two bridges to access the island. The tower houses a 60-bell carillon, associated carillonneur studio and library spaces, the Bok Tower Gardens Chao Research archive, and the Founder's Room. It is a steel frame construction clad in a masonry exterior of coquina and Georgia pink Etowah marble with brick masonry at the interior.

## **Bok Tower Focused Condition Assessment**

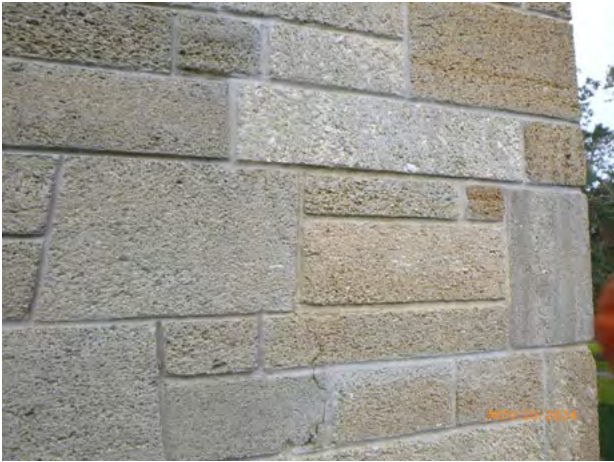
66-32 Stone\_Crack System units and joints 2024-2.jpg

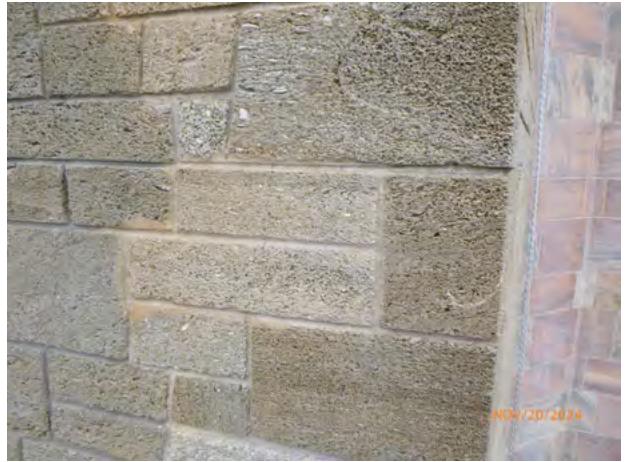
66-77 Stone\_Crack Single unit 2024-1.jpg

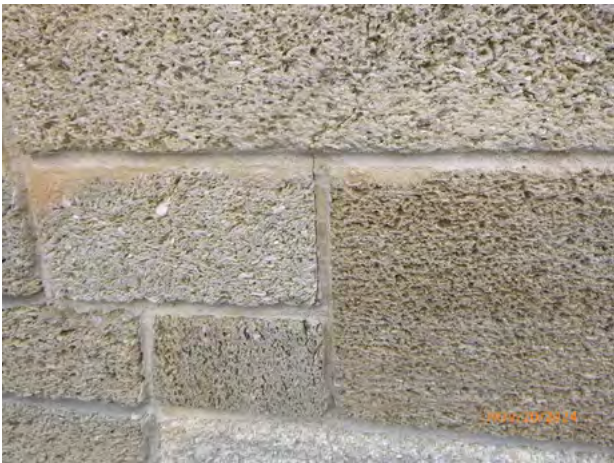
66-77 Stone\_Crack Single unit 2024-2.jpg

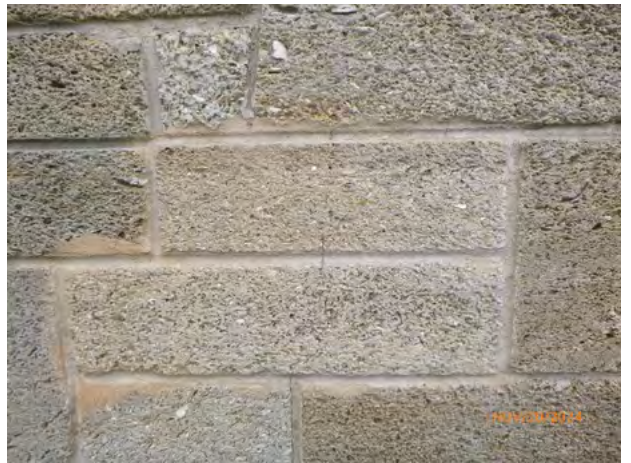
66-77 Stone\_Crack Single unit 2024-3.jpg

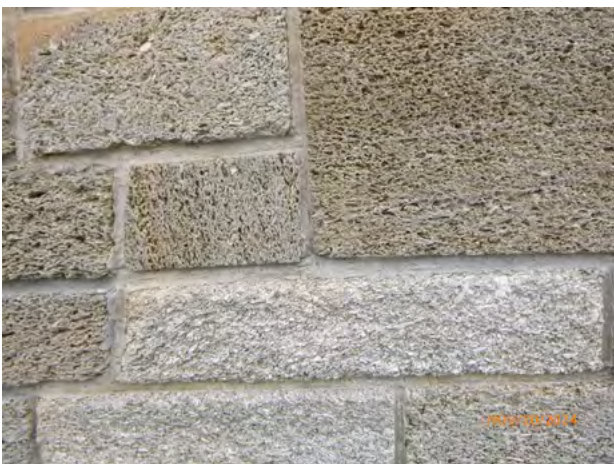
66-77 Stone\_Crack Single unit 2024-4.jpg

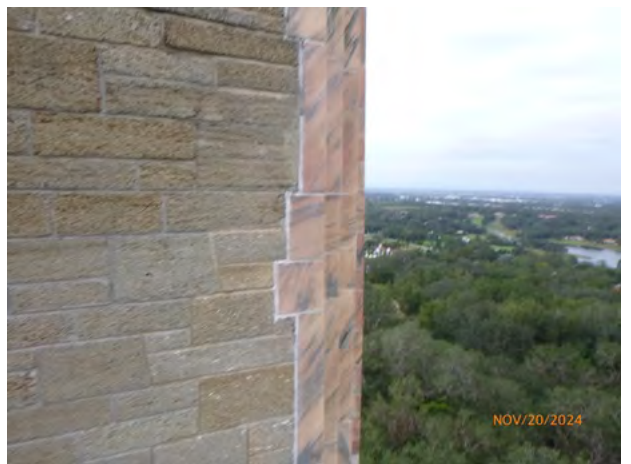
66-132 Stone\_Crack System units and joints 2024-1.jpg

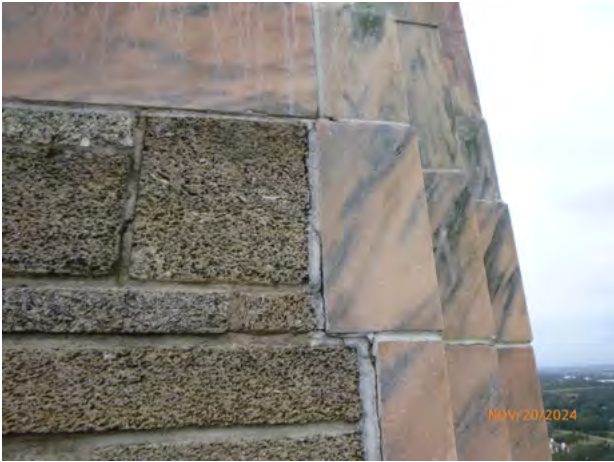
66-132 Stone\_Crack System units and joints 2024-2.jpg

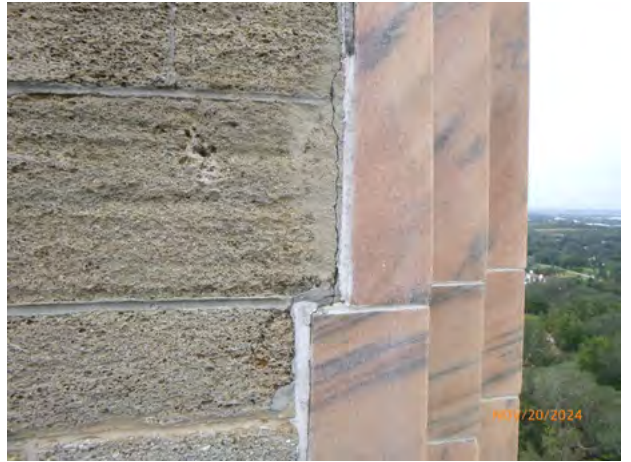
66-132 Stone\_Crack System units and joints 2024-3.jpg

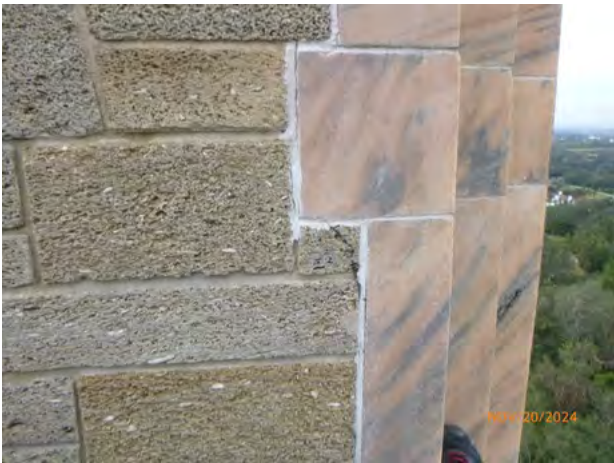
66-132 Stone\_Crack System units and joints 2024-4.jpg

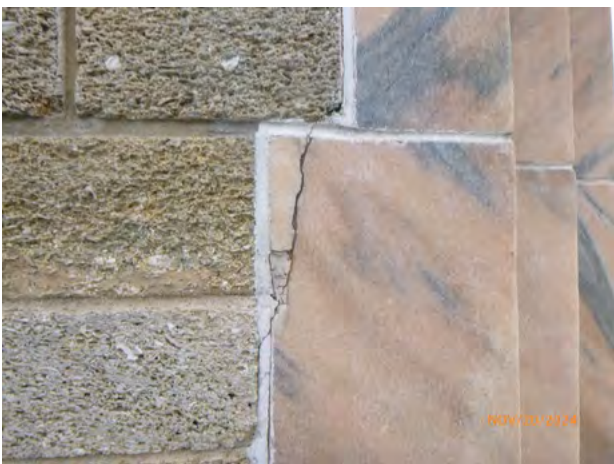
66-132 Stone\_Crack System units and joints 2024-6.jpg

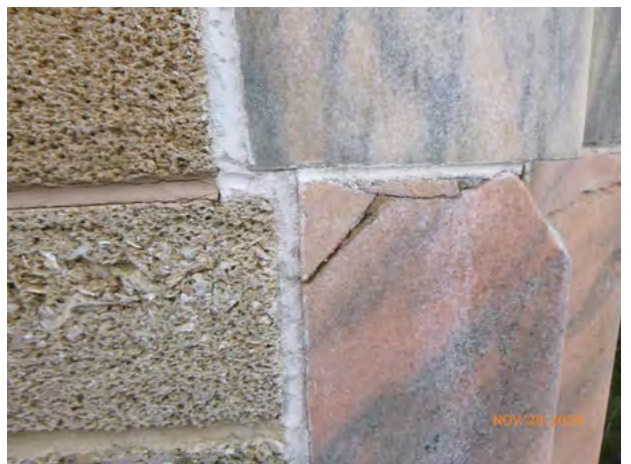
67-101 Stone\_Crack Repair failed 2024-1.jpg

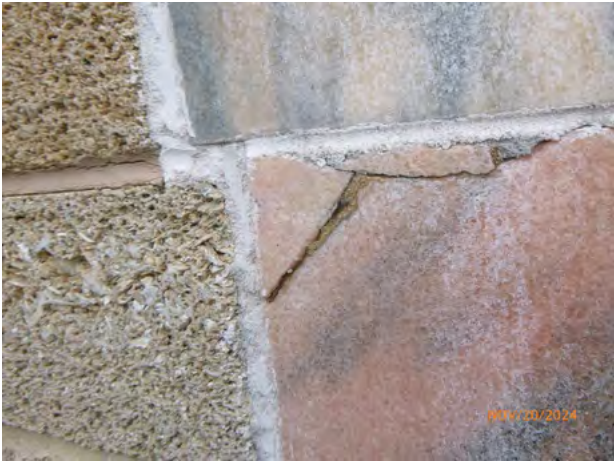
67-101 Stone\_Crack Repair failed 2024-2.jpg

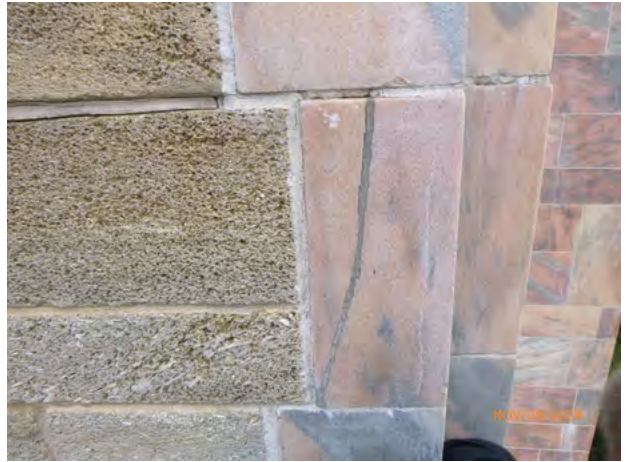
67-108 Stone\_Crack Repair failed 2024-1.jpg

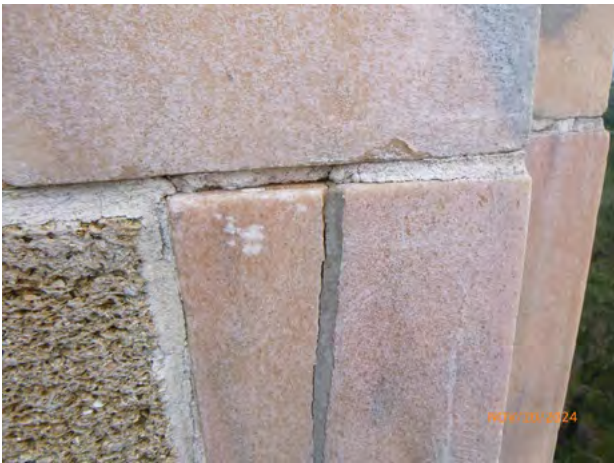
67-108 Stone\_Crack Repair failed 2024-2.jpg

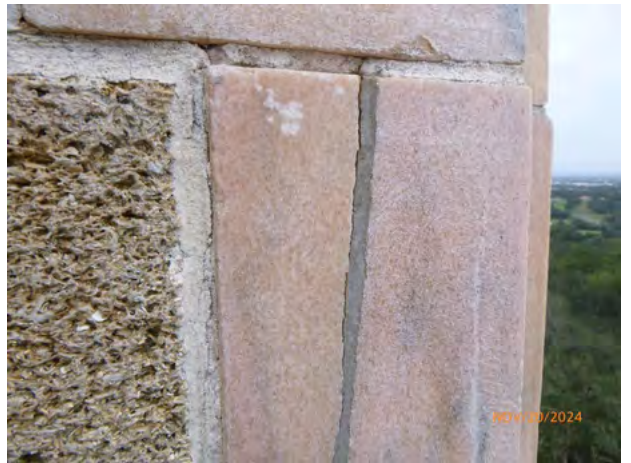
67-108 Stone\_Crack Repair failed 2024-3.jpg

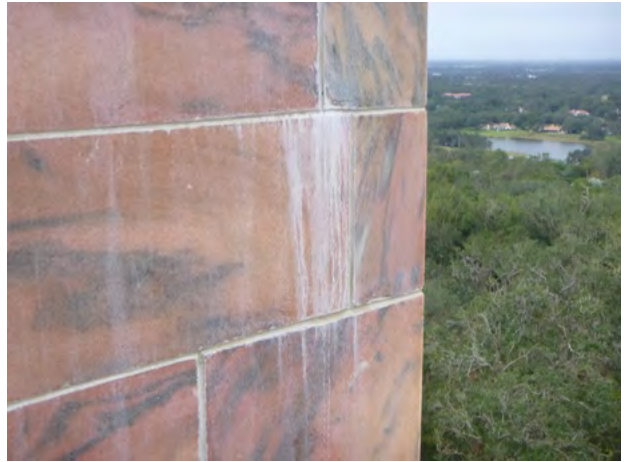
70-97 Stone\_SoilStain Leached Salts 2024-1.jpg

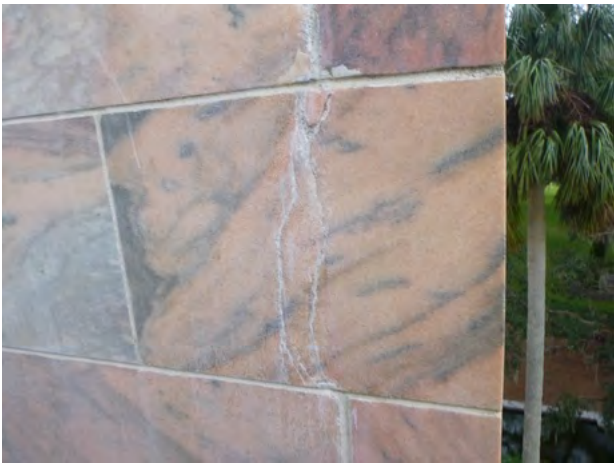
72-46 Stone\_Crack Single unit 2024-1.jpg

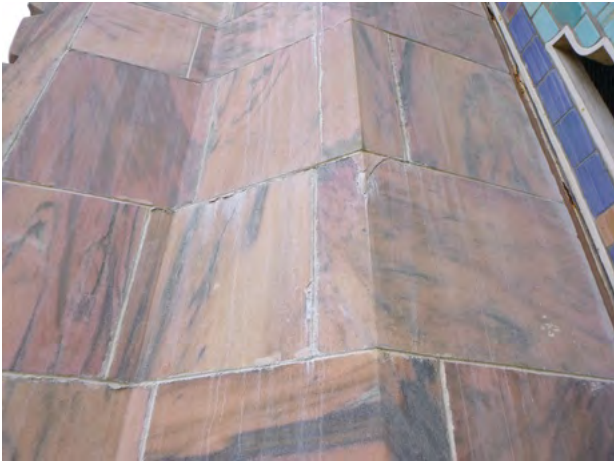
80-162 Stone\_SoilStain Leached Salts 2024-1.jpg

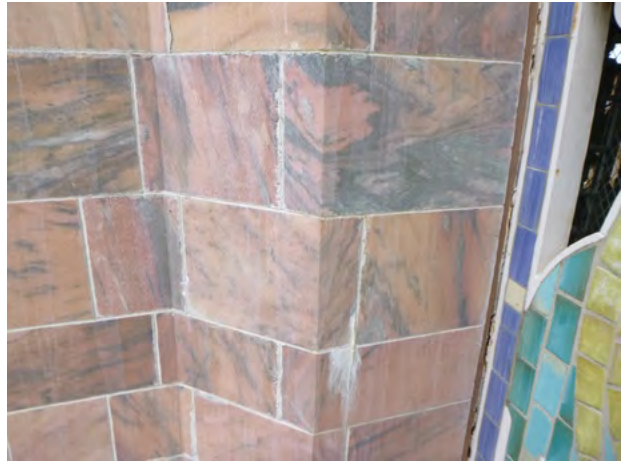
80-162 Stone\_SoilStain Leached Salts 2024-2.jpg

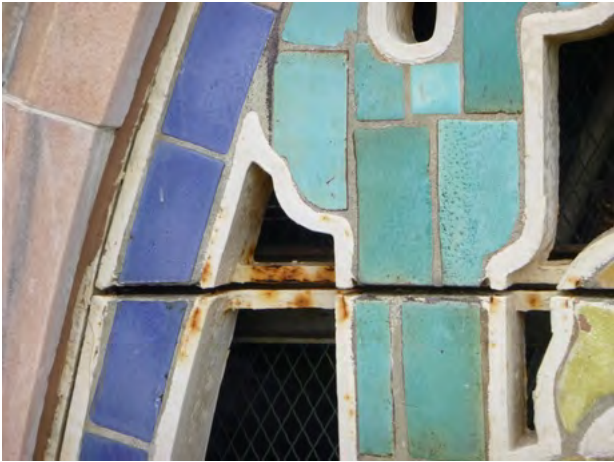
83-173 ArchMetal\_Corrosion Pitted 2024-1.jpg

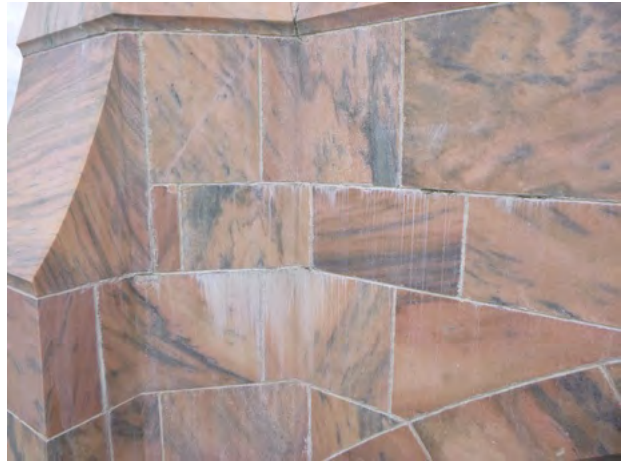
84-181 Stone\_SoilStain Leached Salts 2024-1.jpg

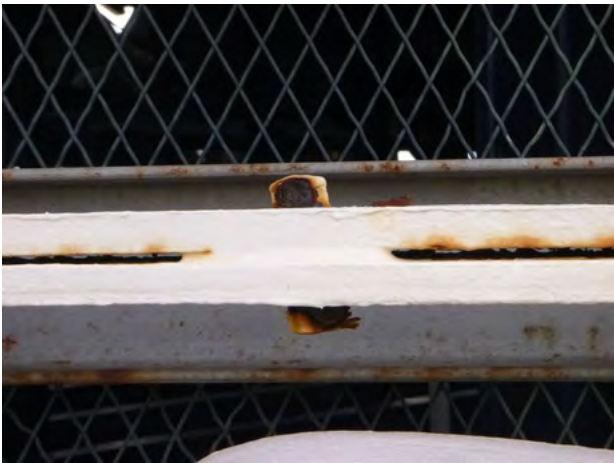
85-154 ArchMetal\_Corrosion Fastener rusted 2024-1.jpg

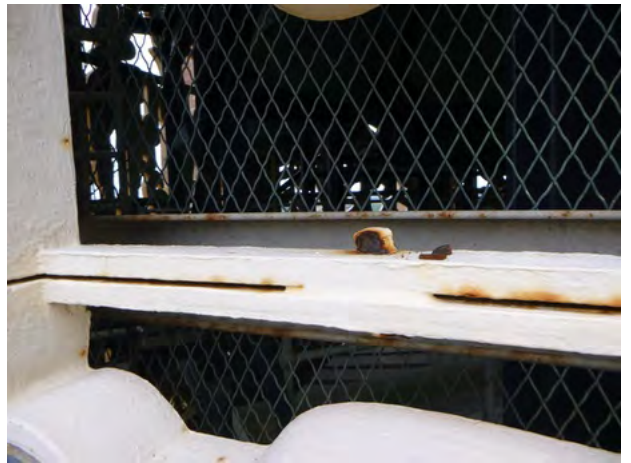
85-154 ArchMetal\_Corrosion Surface 2024-1.jpg

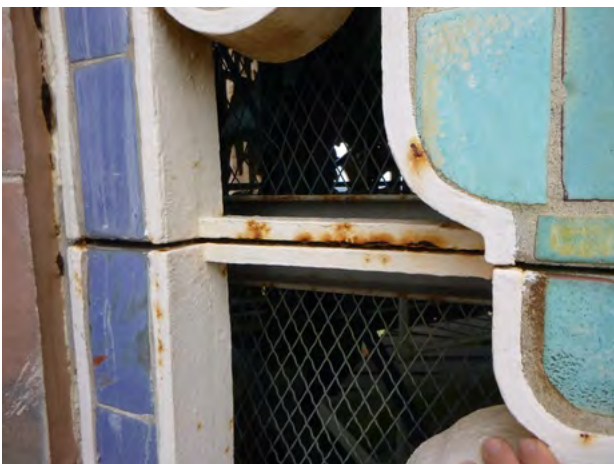
85-154 ArchMetal\_Corrosion Surface 2024-2.jpg

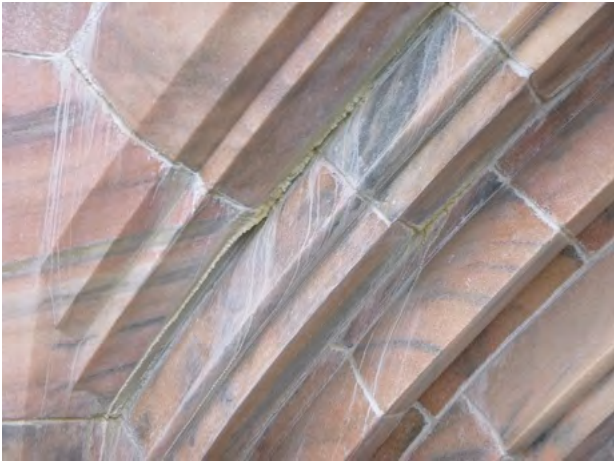
85-179 Stone\_SoilStain Leached Salts 2024-1.jpg

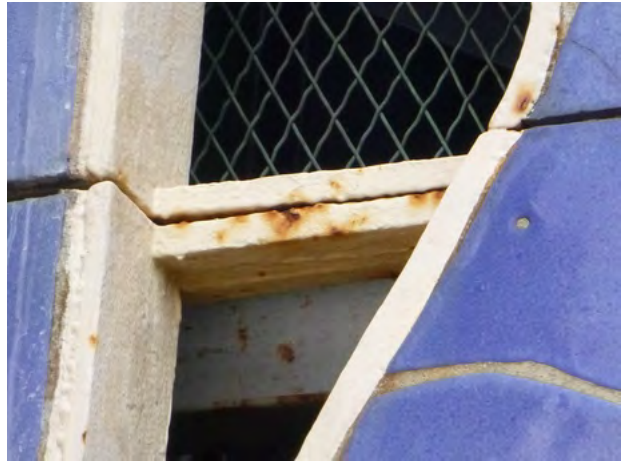
86-149 ArchMetal\_Corrosion Surface 2024-1.jpg

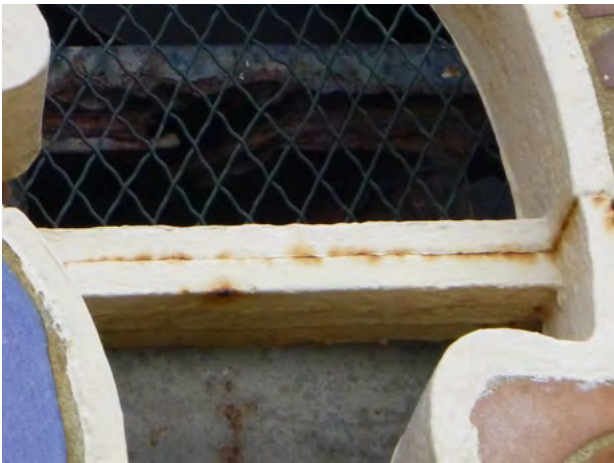
86-149 ArchMetal\_Corrosion Surface 2024-2.jpg

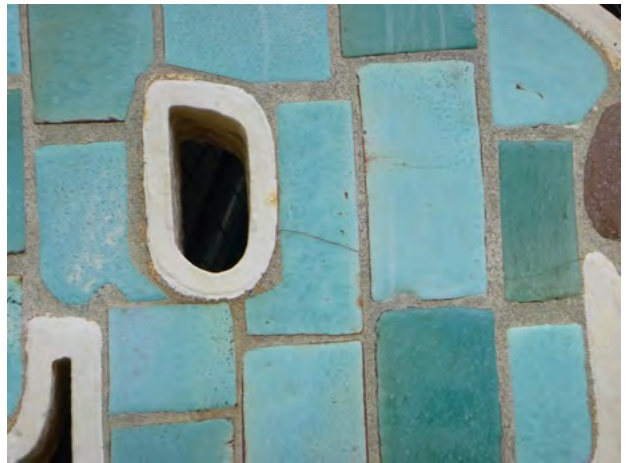
86-175 TerraCotta\_Crack Single unit 2024-1.jpg

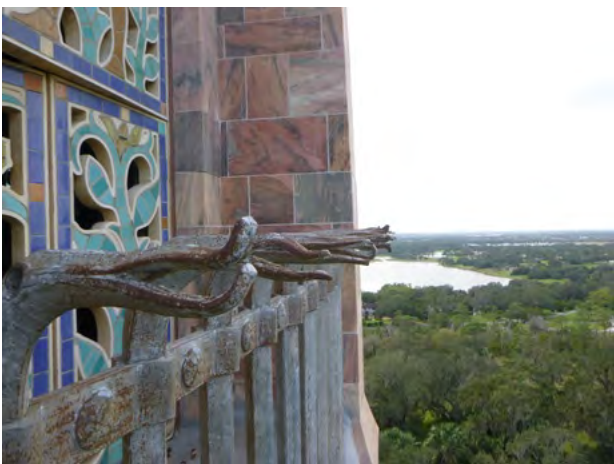
87-127 ArchMetal\_Corrosion Surface 2024-1.jpg

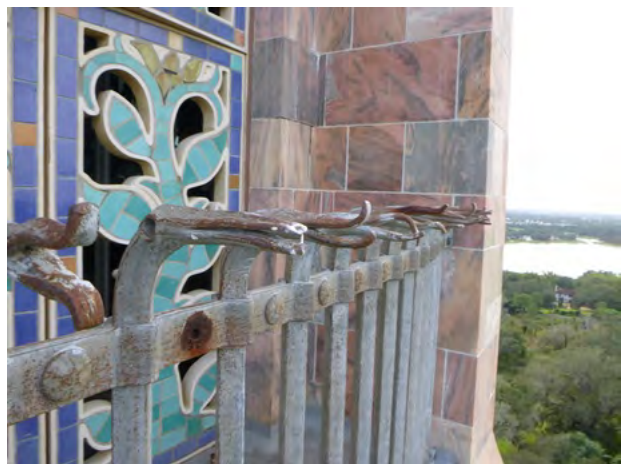
87-127 ArchMetal\_Corrosion Surface 2024-2.jpg

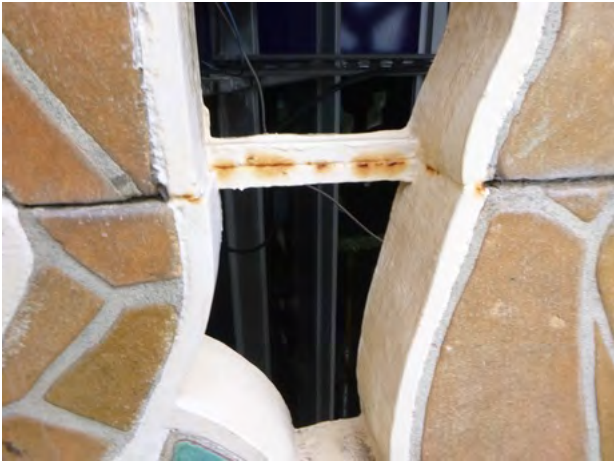
87-133 ArchMetal\_Corrosion Surface 2024-1.jpg

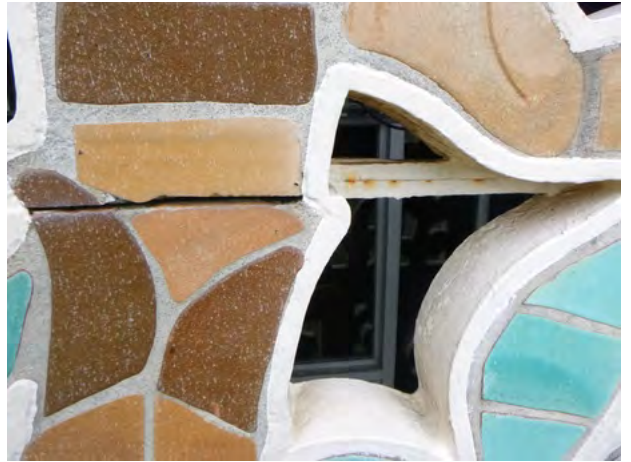
87-133 ArchMetal\_Corrosion Surface 2024-2.jpg

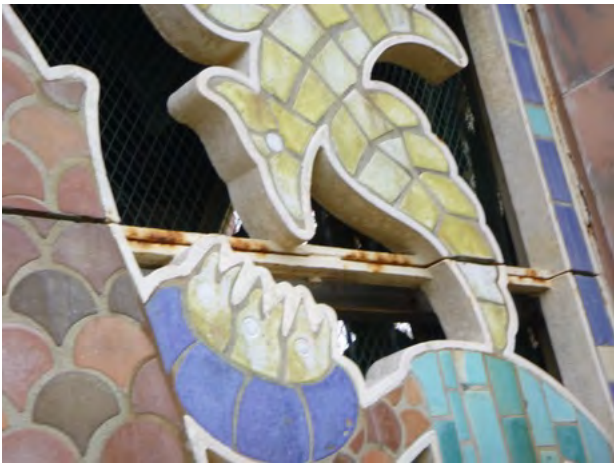
87-167 ArchMetal\_Coating Coating Failed 2024-1.jpg

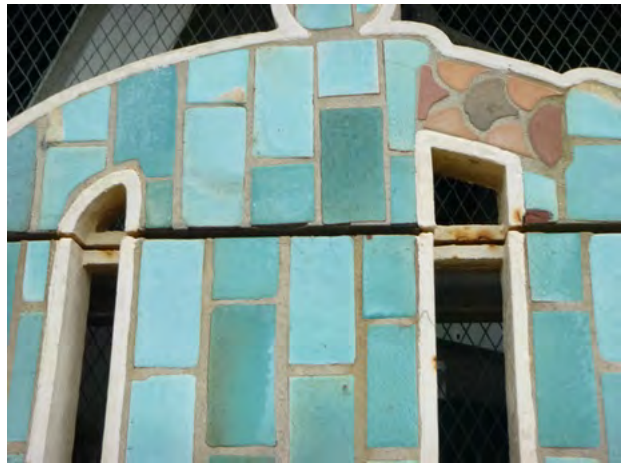
87-167 ArchMetal\_Coating Coating Failed 2024-2.jpg

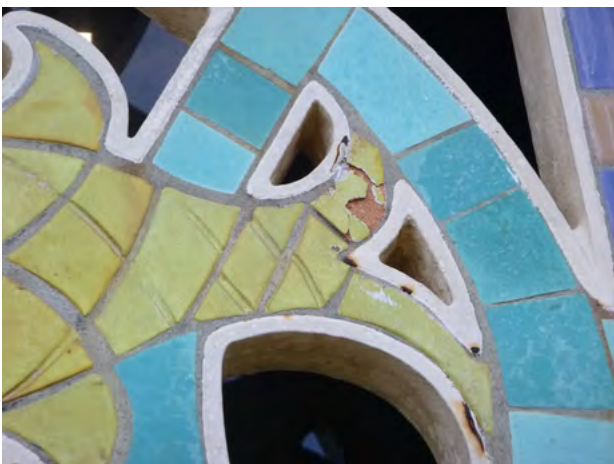
88-111 TerraCotta\_Spall Missing 2024-1.jpg

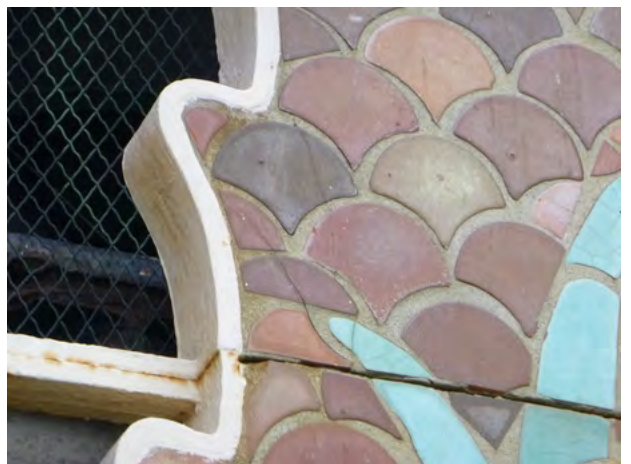
88-150 TerraCotta\_Crack Single unit 2024-1.jpg

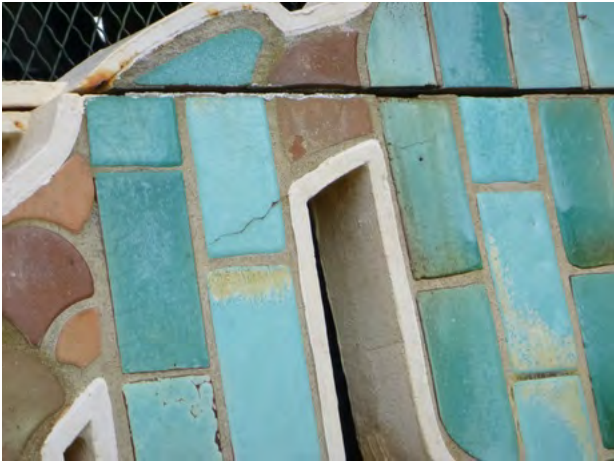
89-157 TerraCotta\_Crack Single unit 2024-1.jpg

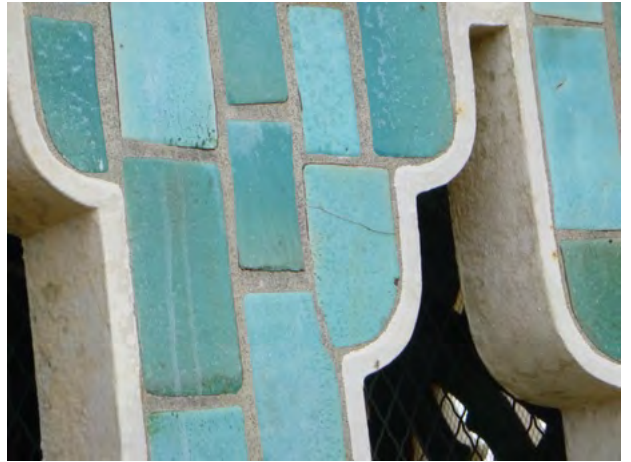
89-174 TerraCotta\_Crack Single unit 2024-1.jpg

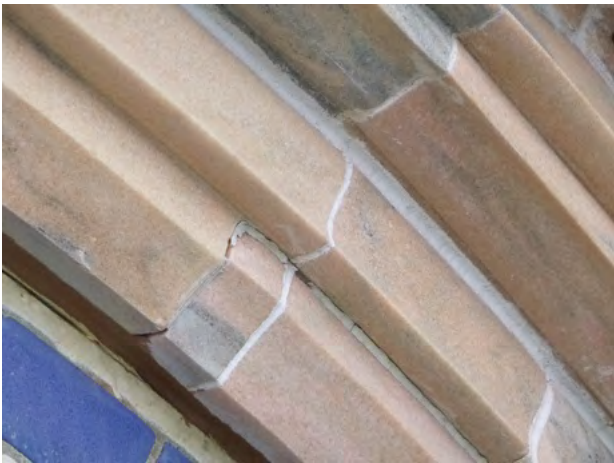
89-178 Stone\_Joints Mortar Failed 2024-1.jpg

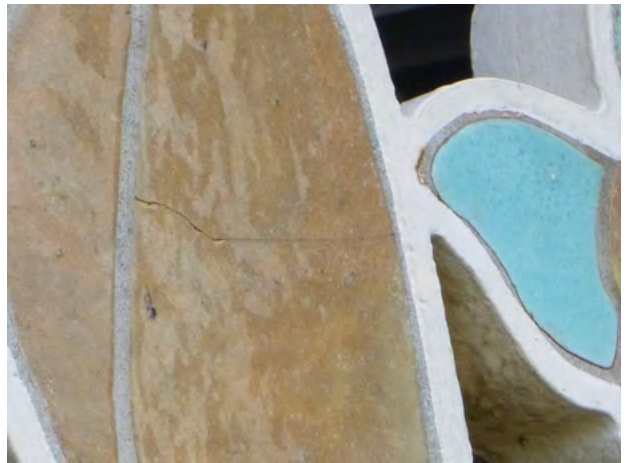
90-133 TerraCotta\_Crack Single unit 2024-1.jpg

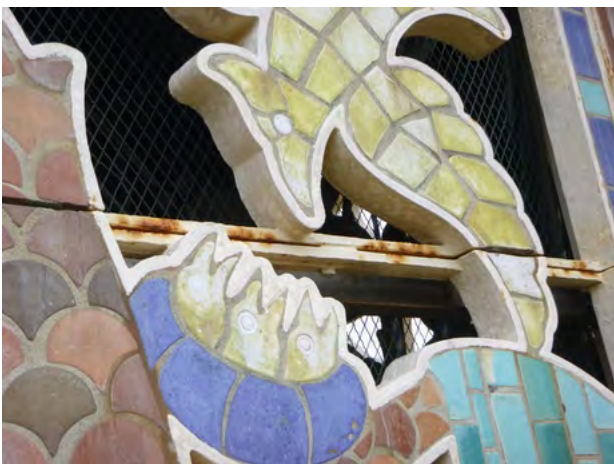
90-168 ArchMetal\_Corrosion Surface 2024-1.jpg

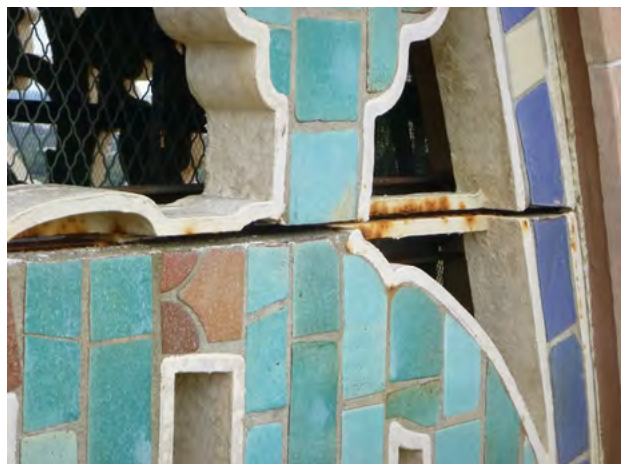
90-173 ArchMetal\_Corrosion Pitted 2024-1.jpg

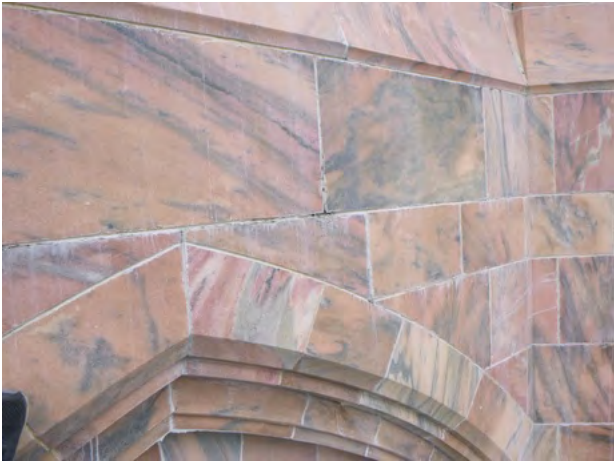
90-181 Stone\_SoilStain Leached Salts 2024-1.jpg

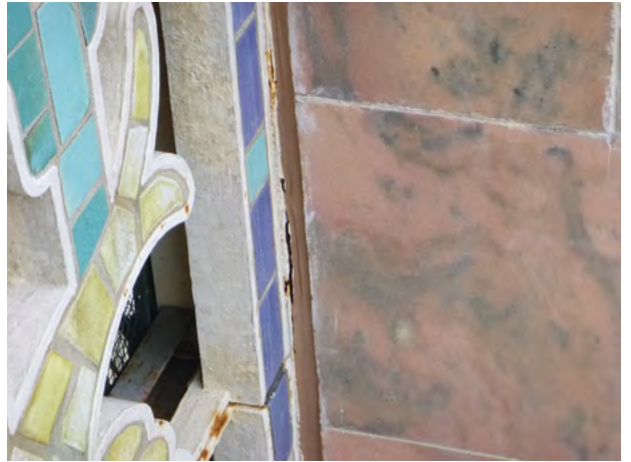
92-166 ArchMetal\_Corrosion Pitted 2024-1.jpg

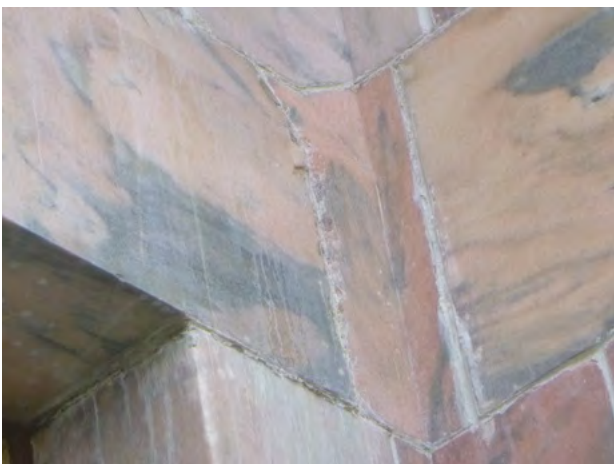
94-138 Stone\_SurfLoss Chipped 2024-1.jpg

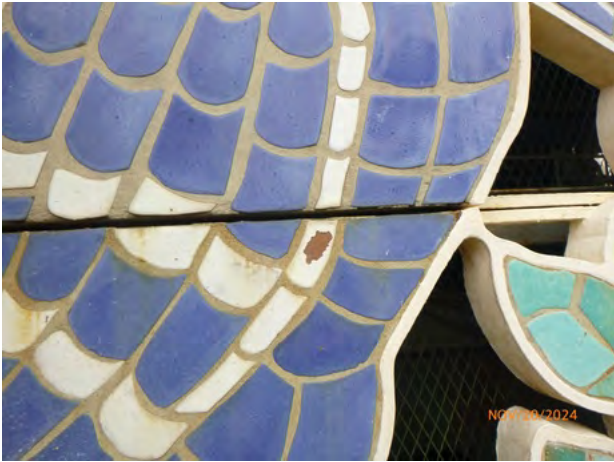
111-149 TerraCotta\_SurfLoss Glaze loss 2024-1.jpg

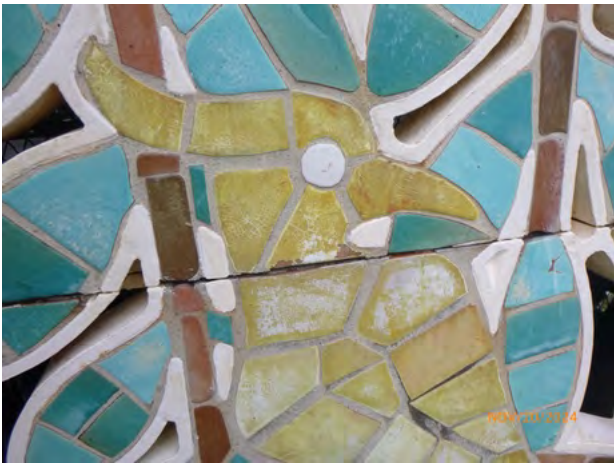
111-169 TerraCotta\_SurfLoss Glaze loss 2024-1.jpg

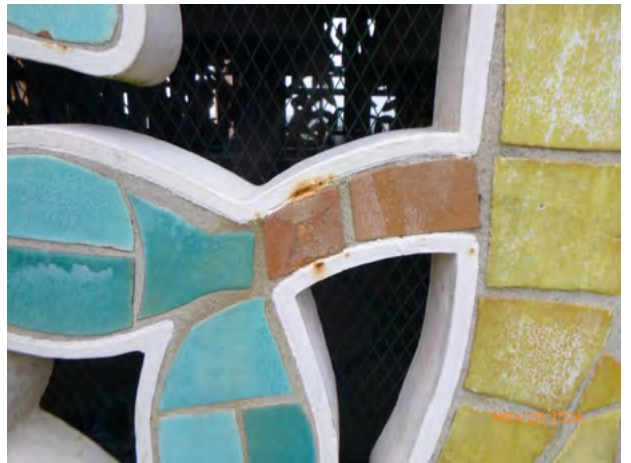
113-161 TerraCotta\_SurfLoss Glaze loss 2024-1.jpg

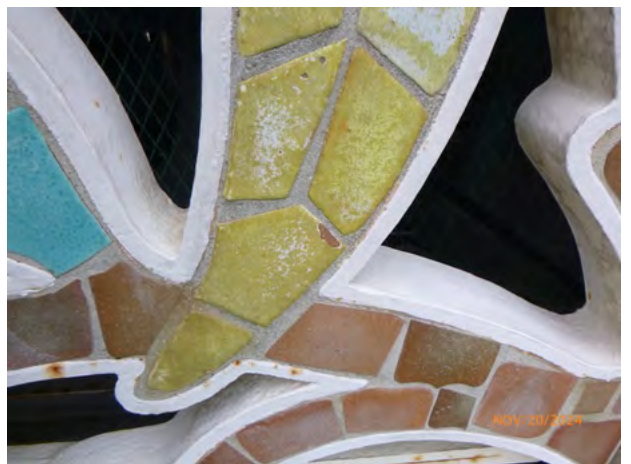
114-159 TerraCotta\_SurfLoss Glaze loss 2024-1.jpg

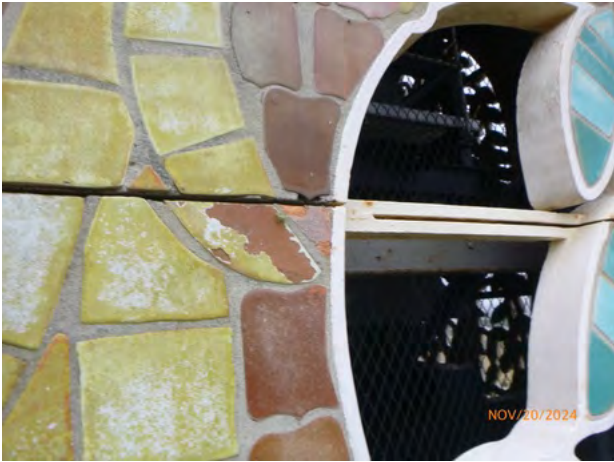
114-163 TerraCotta\_SurfLoss Glaze loss 2024-1.jpg

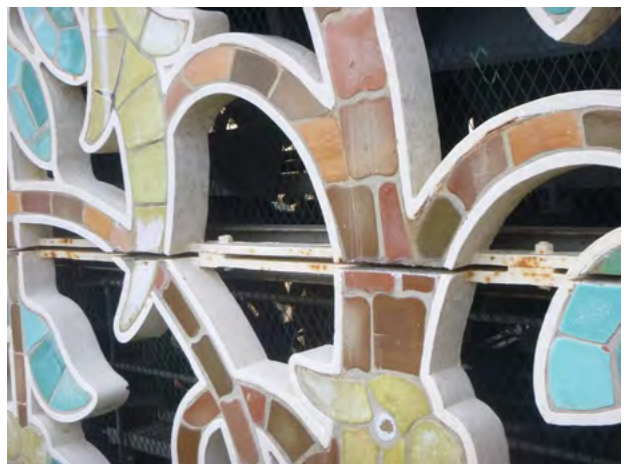
114-170 ArchMetal\_Note Photo-general 2024-4.jpg

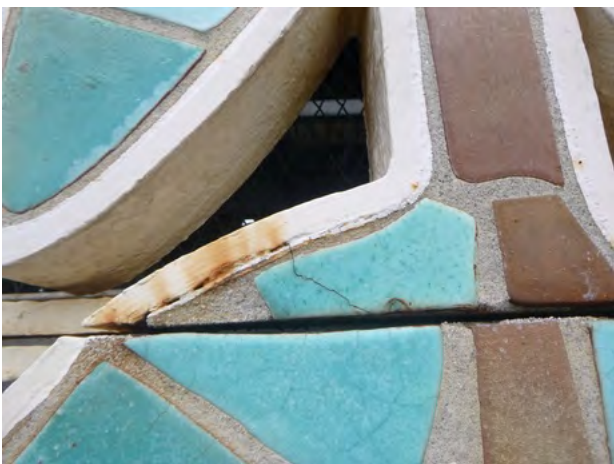
115-150 TerraCotta\_Note Photo-general 2024-4.jpg

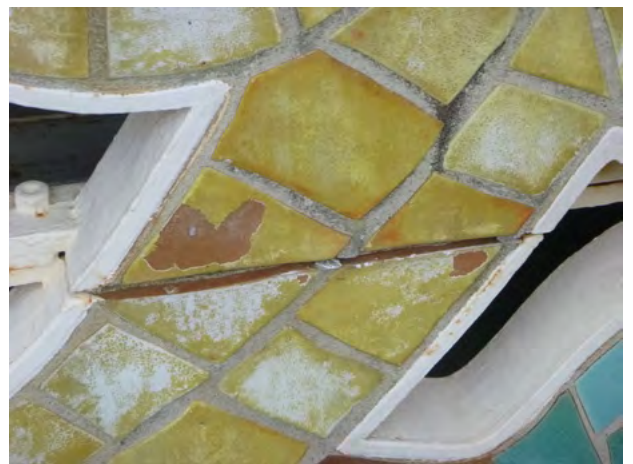
115-164 TerraCotta\_Crack Single unit 2024-1.jpg

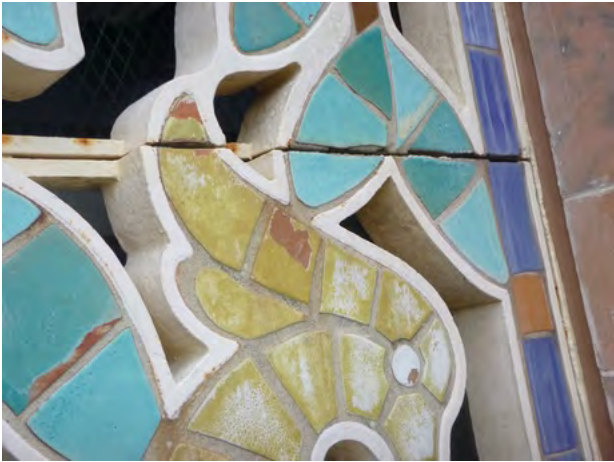
116-158 TerraCotta\_SurfLoss Glaze loss 2024-1.jpg

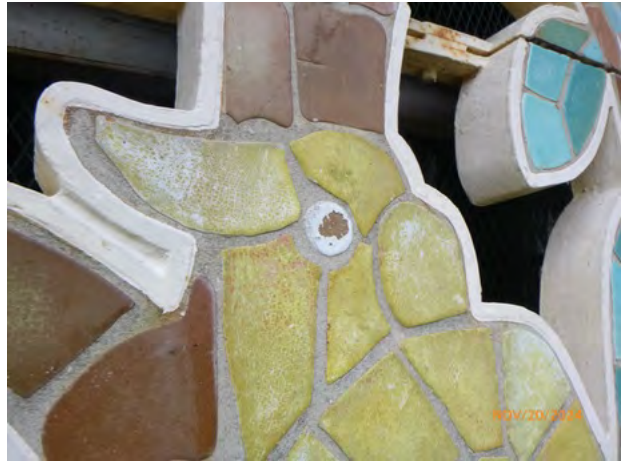
116-161 TerraCotta\_SurfLoss Glaze loss 2024-1.jpg

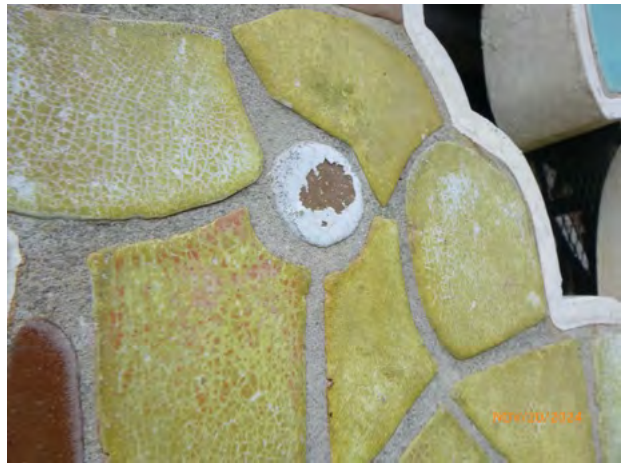
116-171 TerraCotta\_SurfLoss Glaze loss 2024-2.jpg

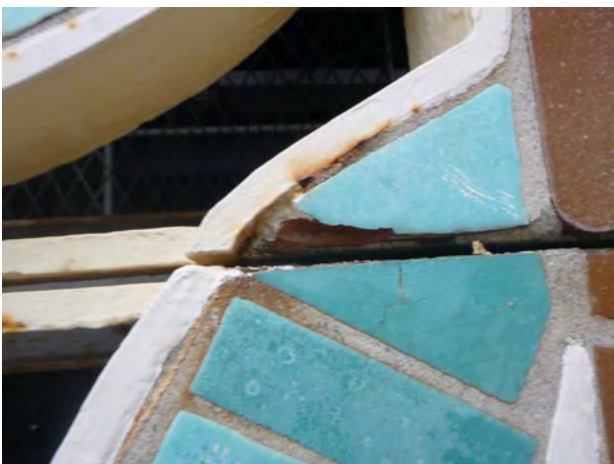
116-171 TerraCotta\_SurfLoss Glaze loss 2024-3.jpg

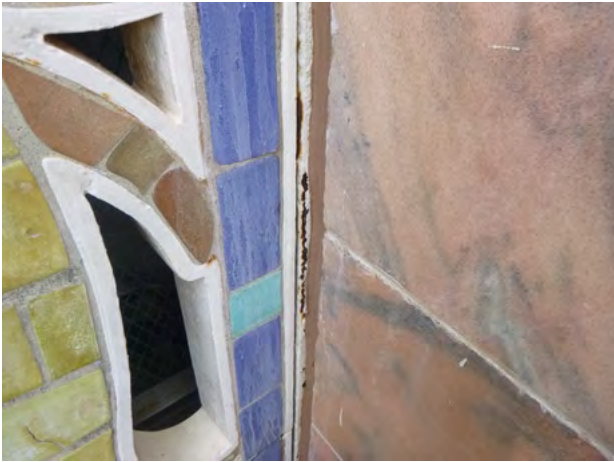
118-145 ArchMetal\_Corrosion Pitted 2024-1.jpg

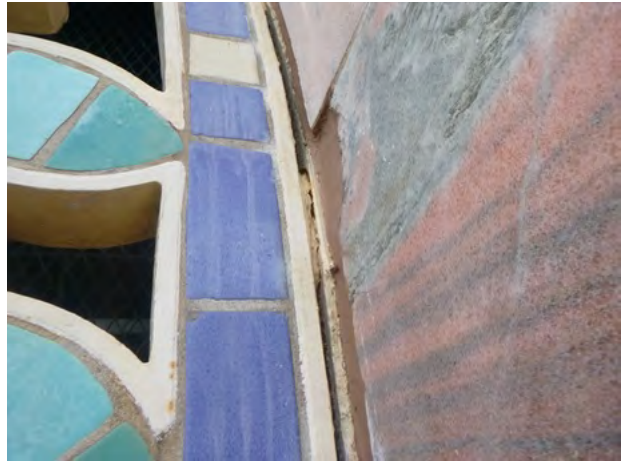
118-158 ArchMetal\_Corrosion Pitted 2024-1.jpg

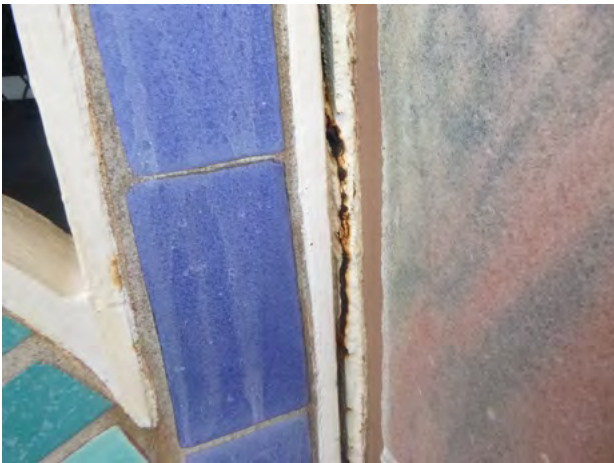
118-167 ArchMetal\_Corrosion Pitted 2024-1.jpg

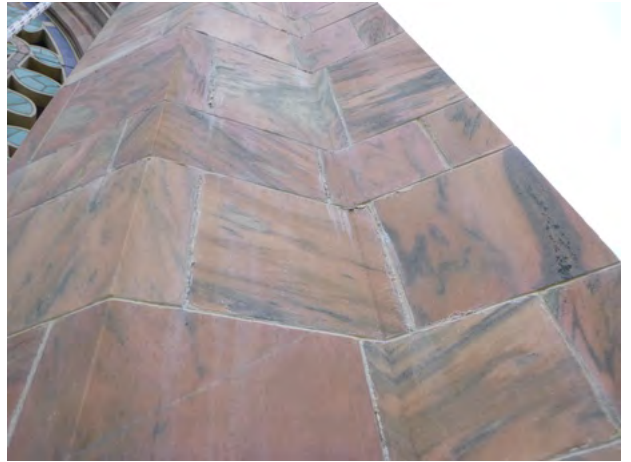
125-164 Stone\_SoilStain Leached Salts 2024-1.jpg

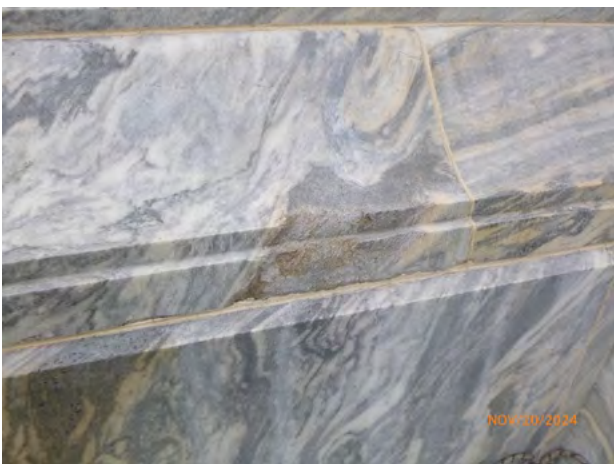
128-4 Stone\_Spall Missing 2024-1.jpg

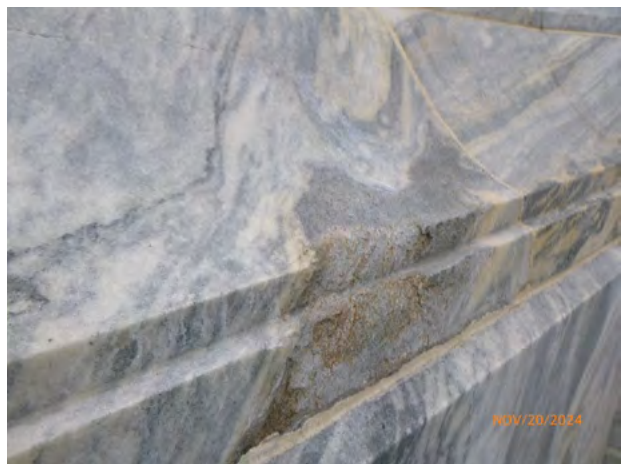
128-4 Stone\_Spall Missing 2024-2.jpg

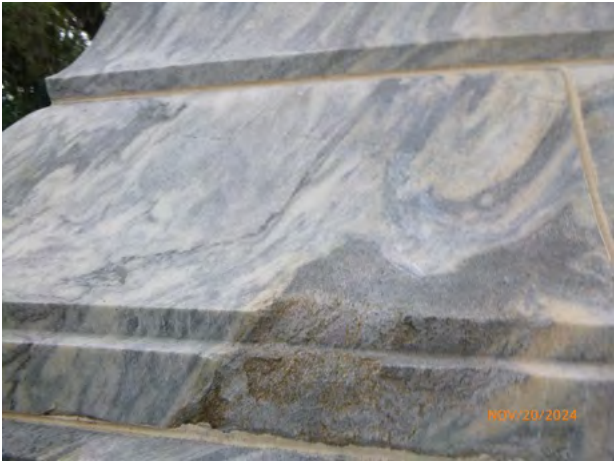
128-4 Stone\_Spall Missing 2024-3.jpg

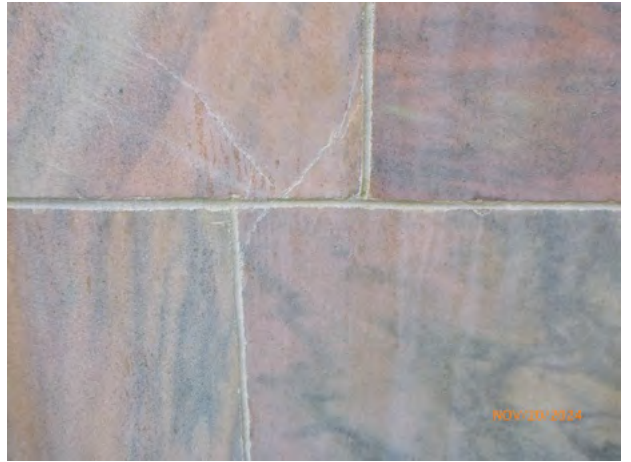
129-70 Stone\_Crack System units and joints 2024-1.jpg

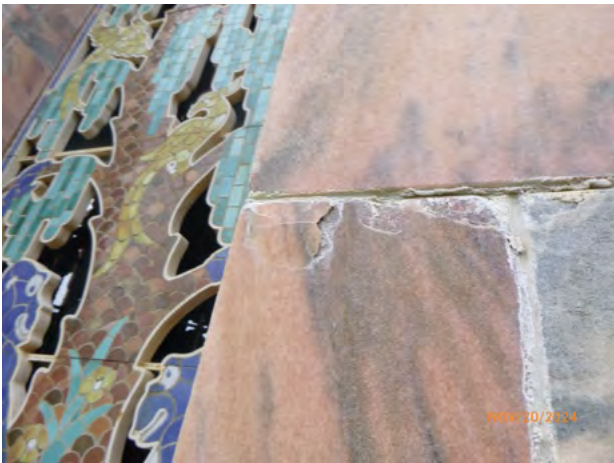
129-149 Stone\_Spall Removed 2024-1.jpg

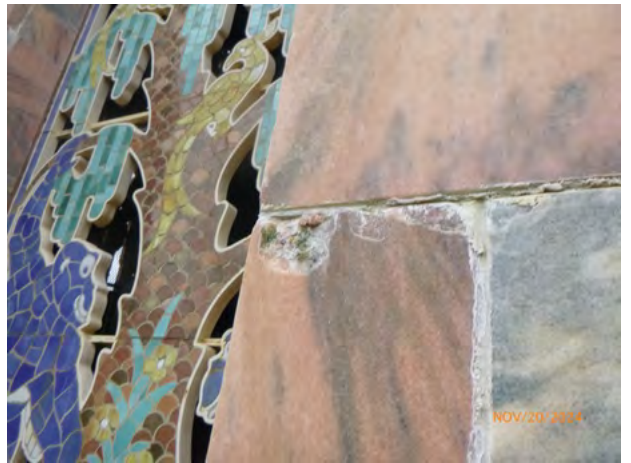
129-149 Stone\_Spall Removed 2024-2.jpg

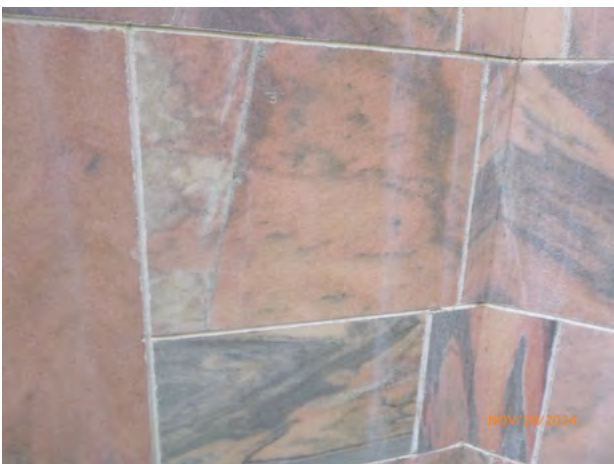
130-20 Stone\_Crack Single unit 2024-1.jpg

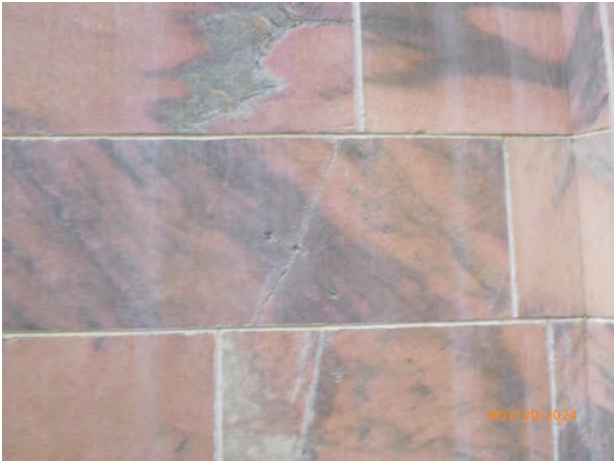
130-23 Stone\_Crack Single unit 2024-1.jpg

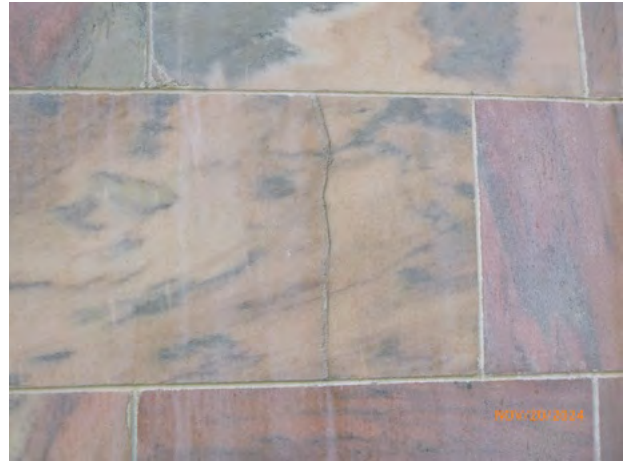
130-74 Stone\_Crack Repair sound 2024-1.jpg

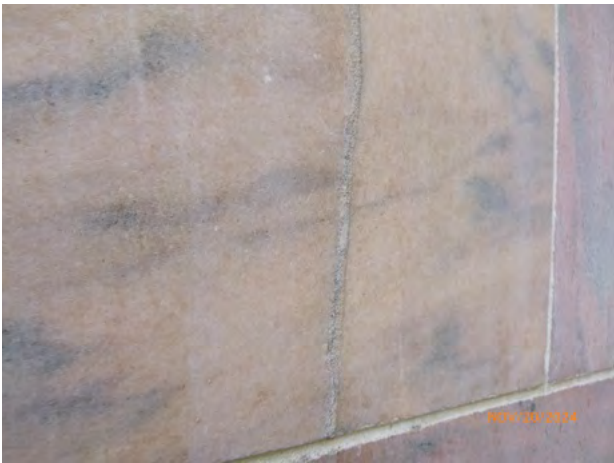
130-74 Stone\_Crack Repair sound 2024-2.jpg

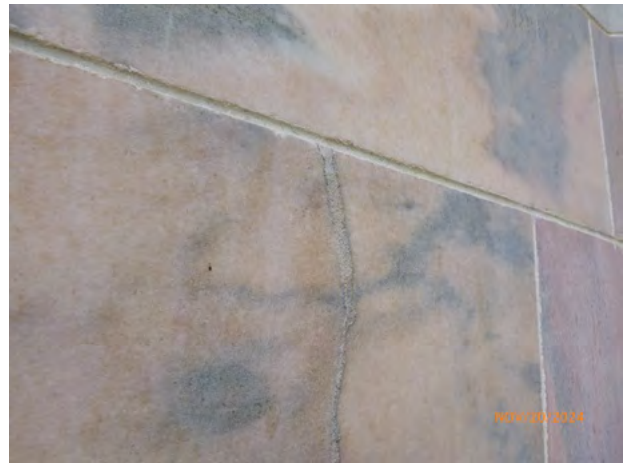
130-74 Stone\_Crack Repair sound 2024-3.jpg

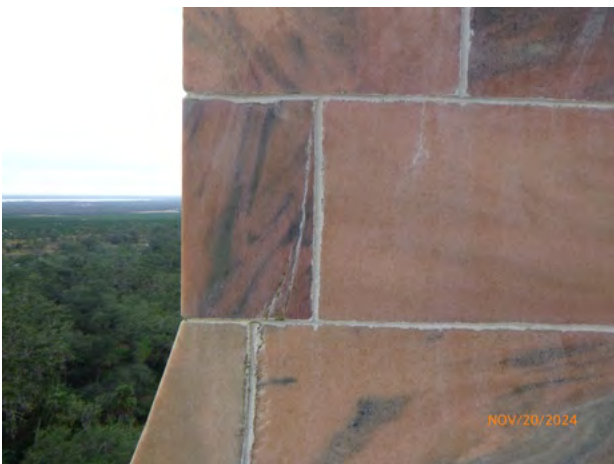
130-123 Stone\_Crack Repair sound 2024-1.jpg

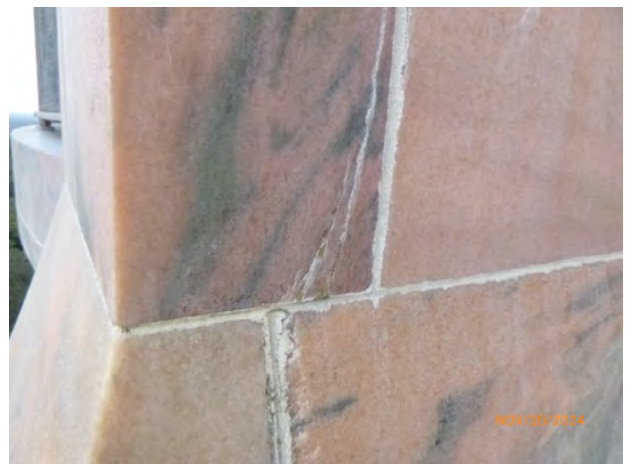
130-123 Stone\_Crack Repair sound 2024-2.jpg

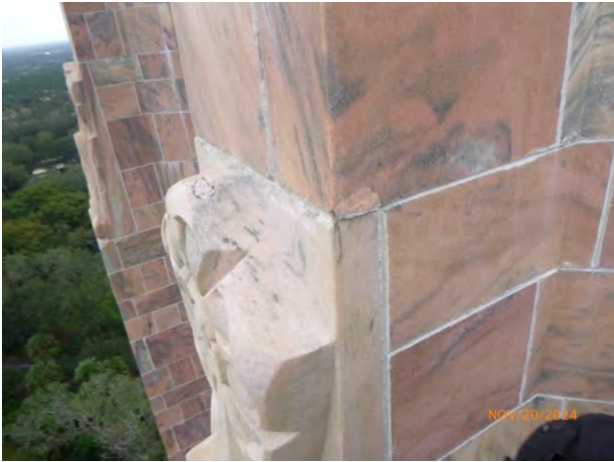
131-162 Stone\_SurfLoss Chipped 2024-1.jpg

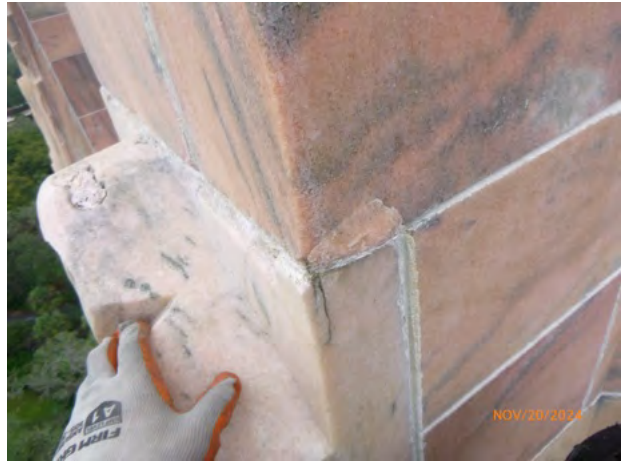
131-162 Stone\_SurfLoss Chipped 2024-2.jpg
