### ***Bok Singing Tower Roof Restoration and Replacement***

# Bok Singing Tower Conditions Assessment

T.Y. Lin (formerly Silman) was contracted to perform a conditions assessment of the Bok Singing Tower at Bok Tower Gardens in Lake Wales, Florida. The Singing Tower stands 205 feet tall at the southwest corner of the gardens. A moat surrounds the base of the tower with two bridges to access the island. The tower houses a 60-bell carillon, associated carillonneur studio and library spaces, the Bok Tower Gardens Chao Research archive, and the Founder's Room. It is a steel frame construction clad in a masonry exterior of coquina and Georgia pink Etowah marble with brick masonry at the interior.

## **Bok Tower Focused Condition Assessment**

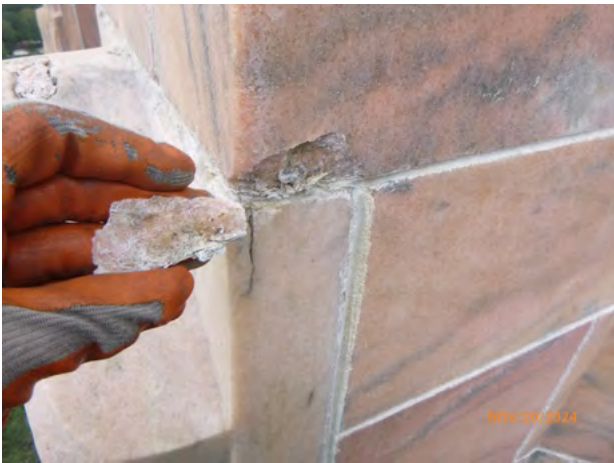
131-162 Stone\_SurfLoss Chipped 2024-3.jpg

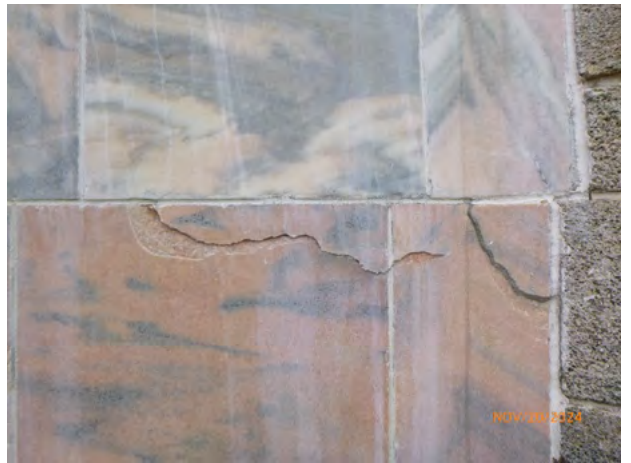
132-71 Stone\_Spall Removed + Steel 2024-1.jpg

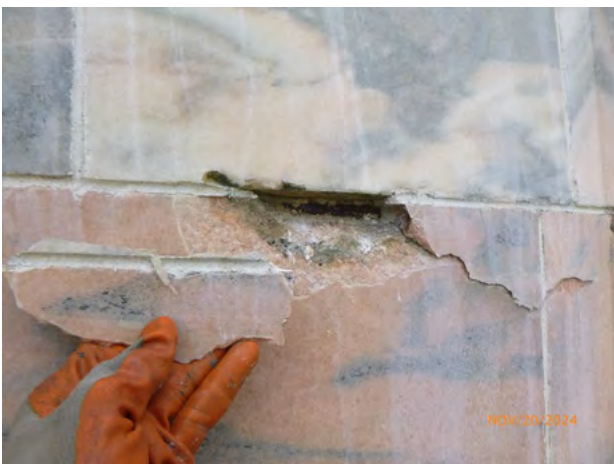
132-71 Stone\_Spall Removed + Steel 2024-2.jpg

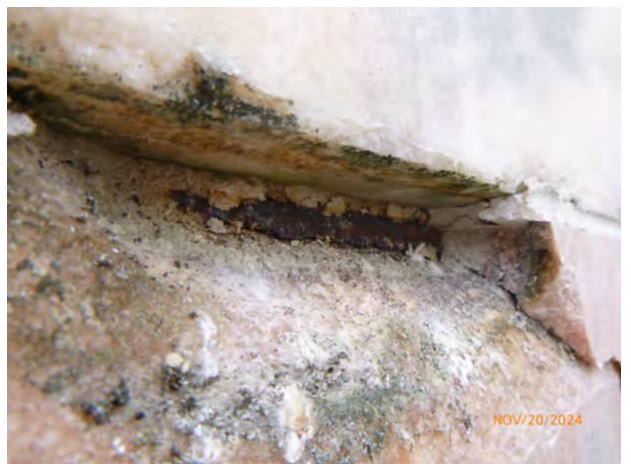
132-71 Stone\_Spall Removed + Steel 2024-3.jpg

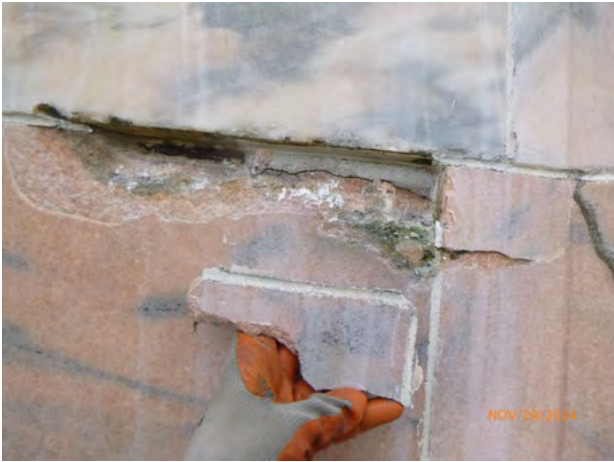
132-71 Stone\_Spall Removed + Steel 2024-4.jpg

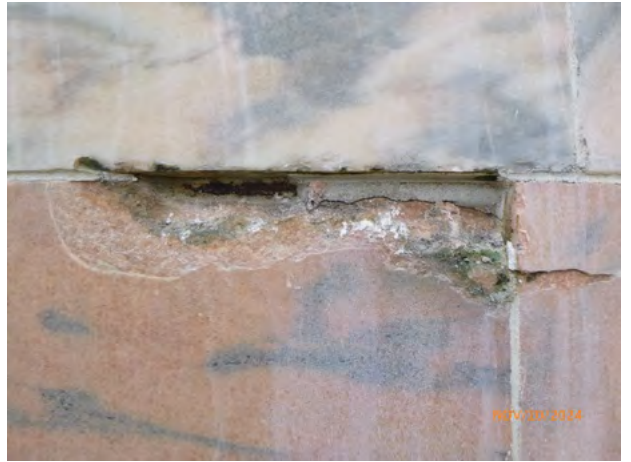
132-71 Stone\_Spall Removed + Steel 2024-5.jpg

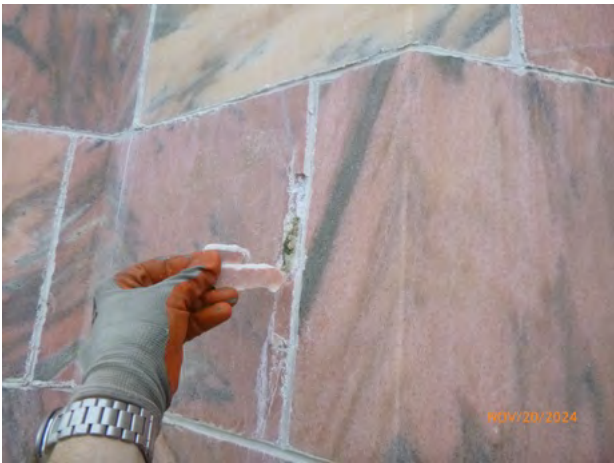
132-161 Stone\_Spall Removed 2024-1.jpg

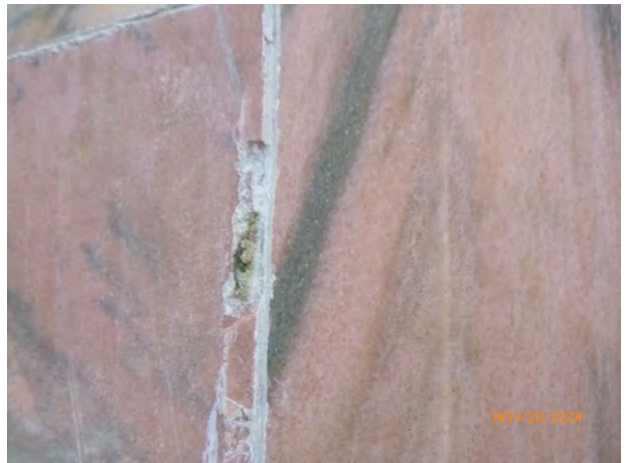
132-161 Stone\_Spall Removed 2024-2.jpg

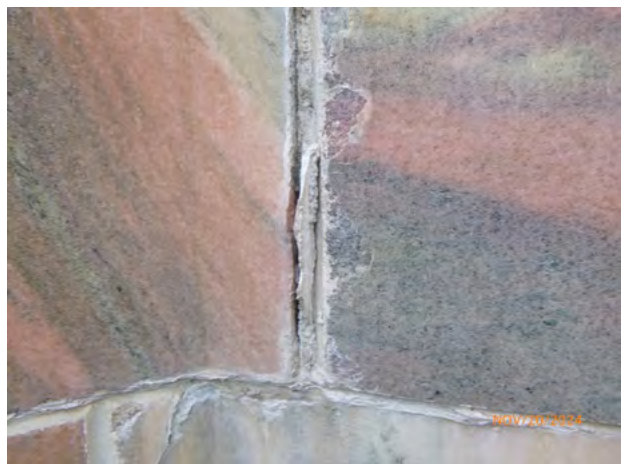
132-181 Stone\_Joints Mortar Removed 2024-1.jpg

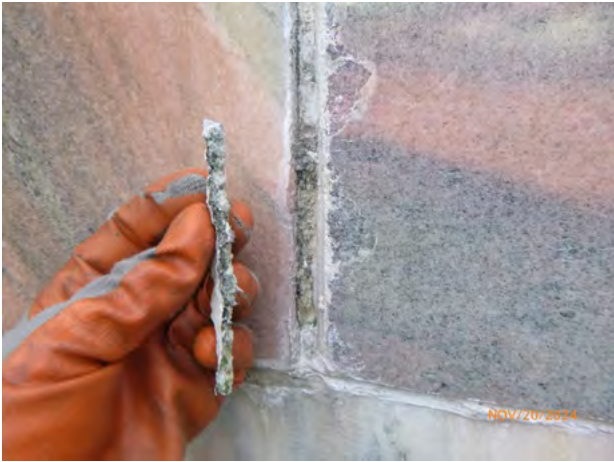
132-181 Stone\_Joints Mortar Removed 2024-2.jpg

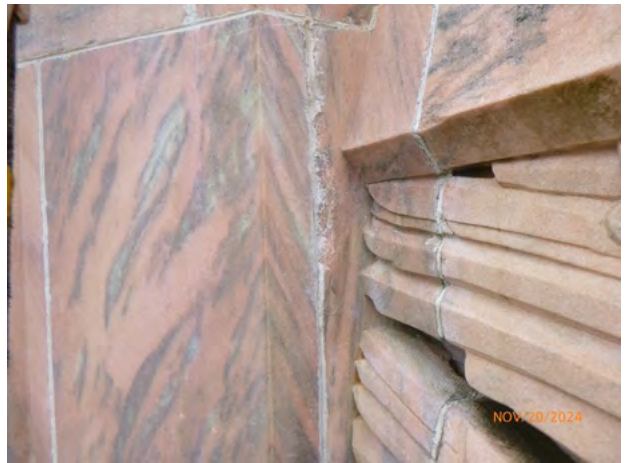
133-46 Stone\_Spall Bonded 2024-2.jpg

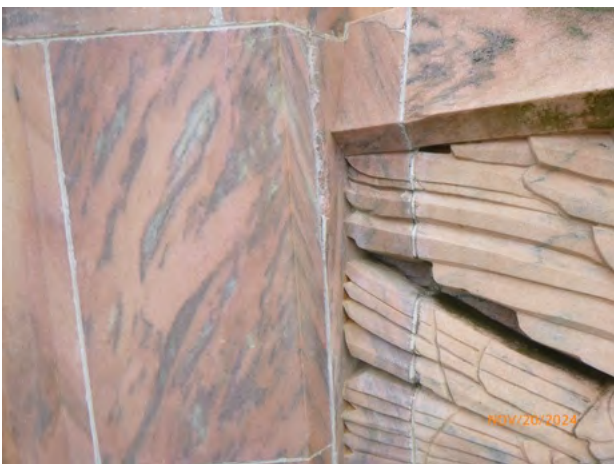
133-139 Stone\_SurfLoss Chipped 2024-1.jpg

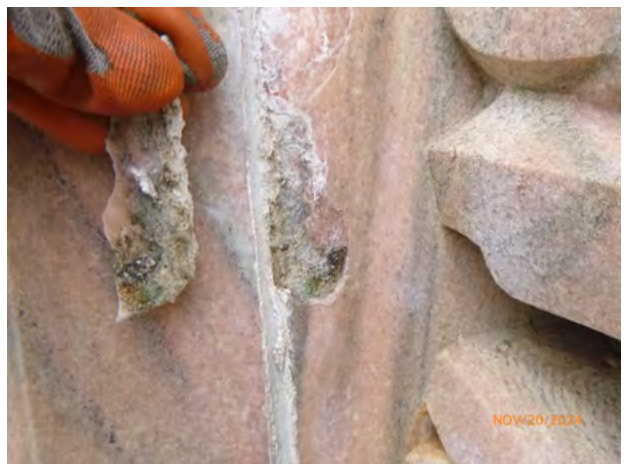
133-139 Stone\_SurfLoss Chipped 2024-2.jpg

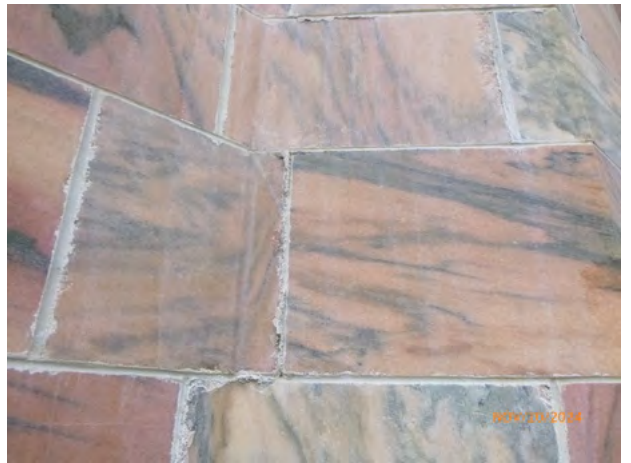
133-141 Stone\_Spall Bonded 2024-3.jpg

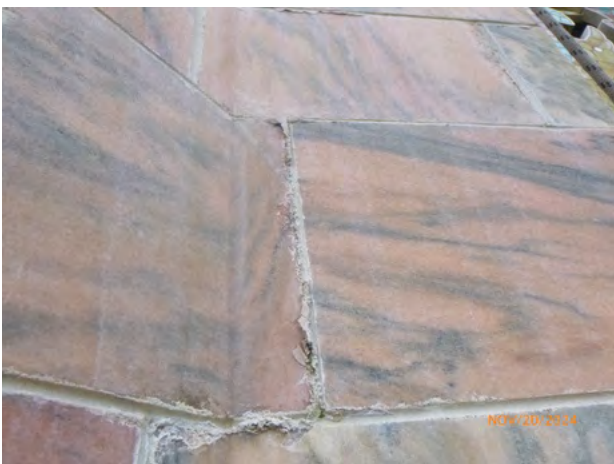
133-148 Stone\_SurfLoss Chipped 2024-1.jpg

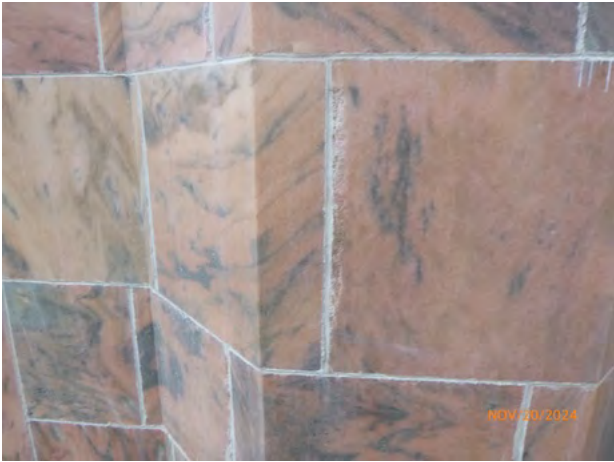
133-148 Stone\_SurfLoss Chipped 2024-3.jpg

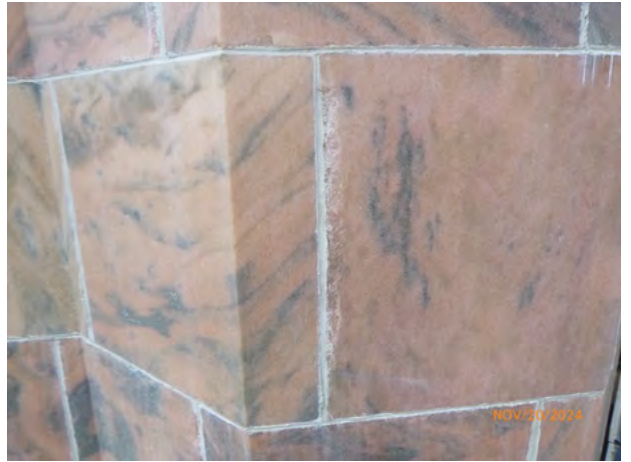
133-159 Stone\_SurfLoss Chipped 2024-1.jpg

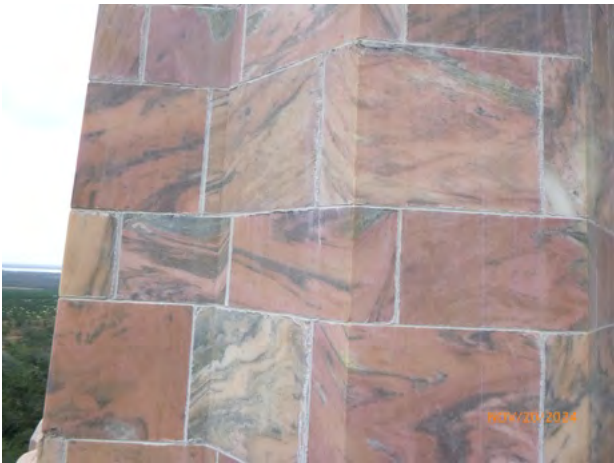
133-159 Stone\_SurfLoss Chipped 2024-2.jpg

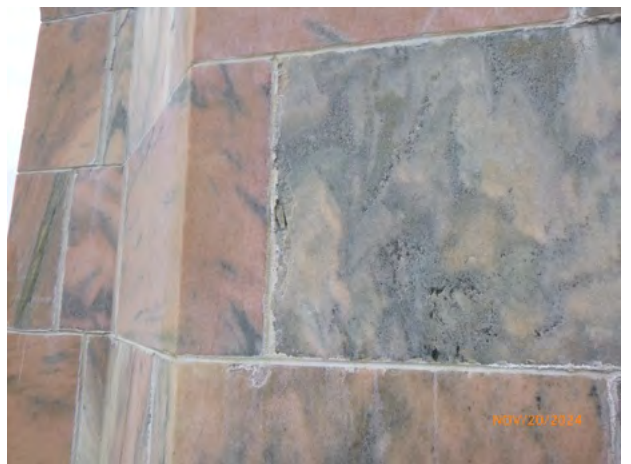
133-161 Stone\_SurfLoss Chipped 2024-3.jpg

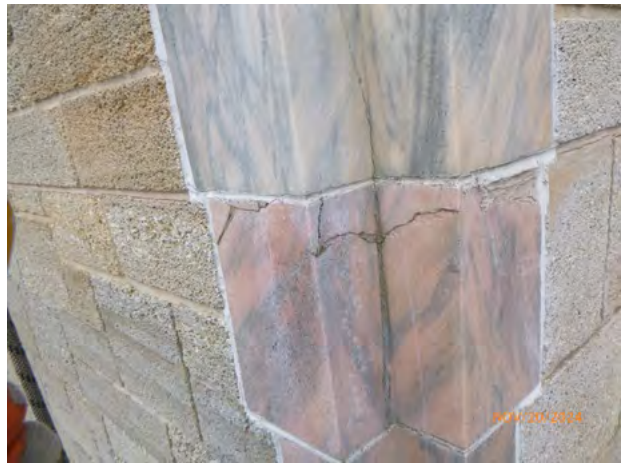
134-30 Stone\_Displacement Horizontal 2024-3.jpg

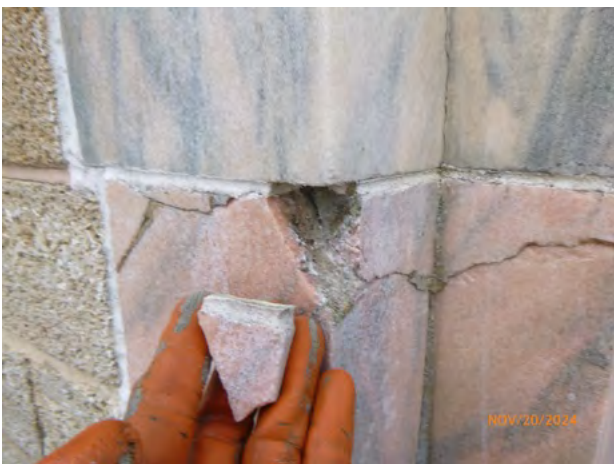
134-102 Stone\_Spall Removed 2024-1.jpg

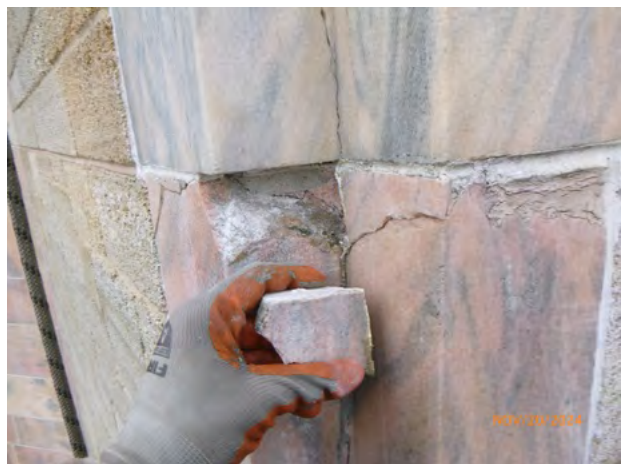
134-102 Stone\_Spall Removed 2024-2.jpg

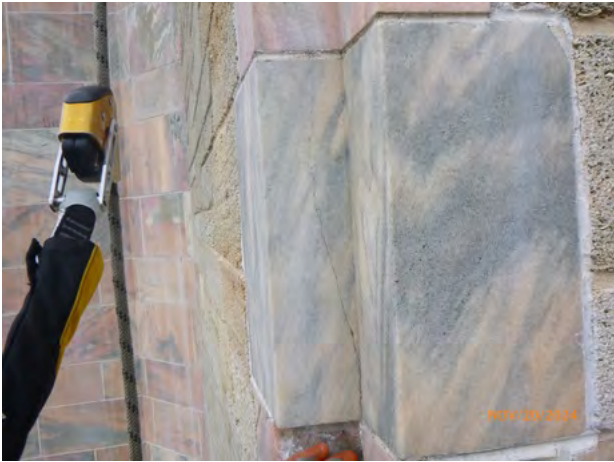
134-102 Stone\_Spall Removed 2024-3.jpg

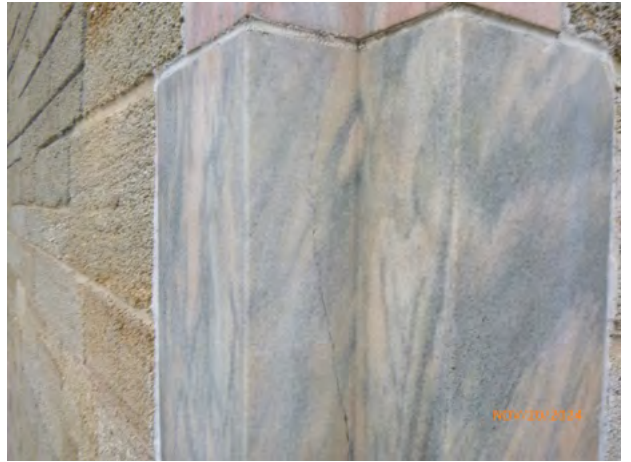
134-105 Stone\_Crack Single unit 2024-1.jpg

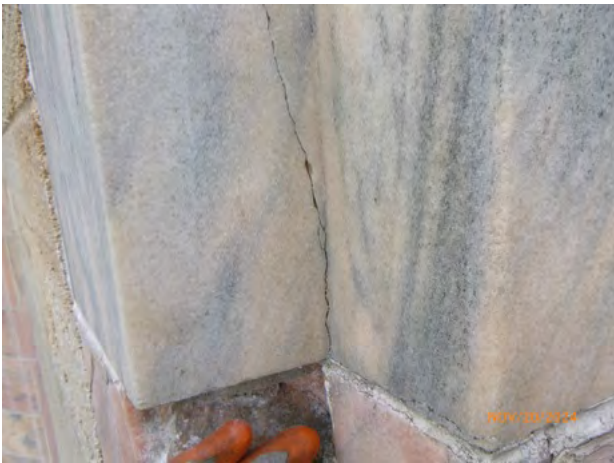
134-105 Stone\_Crack Single unit 2024-2.jpg

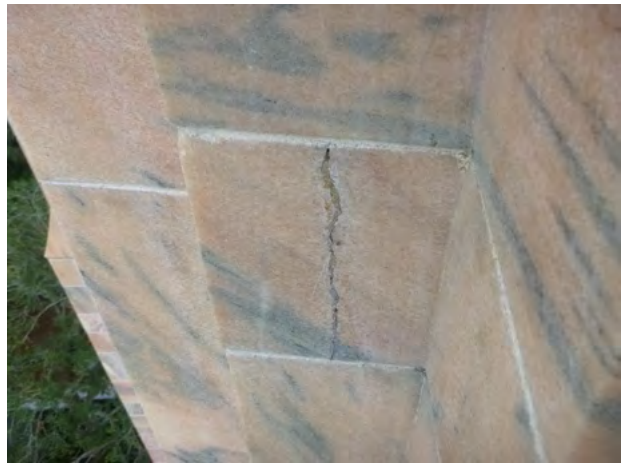
134-105 Stone\_Crack Single unit 2024-3.jpg

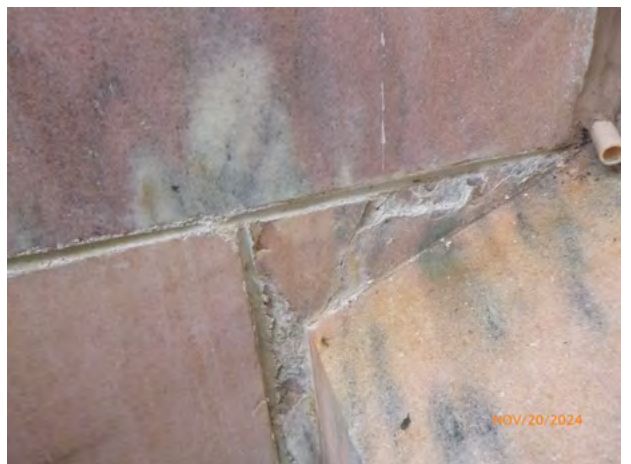
134-142 Stone\_Spall Missing 2024-1.jpg

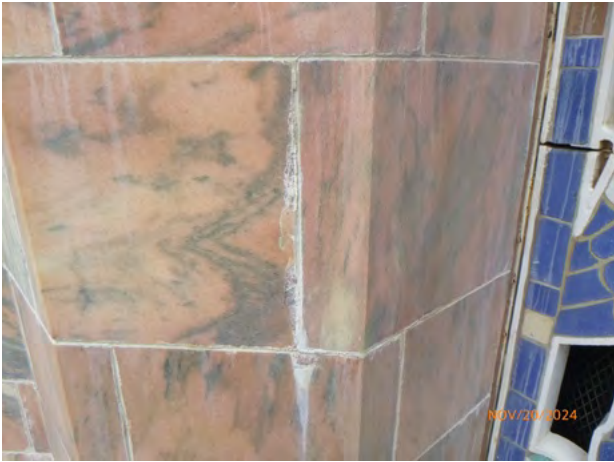
134-142 Stone\_Spall Missing 2024-2.jpg

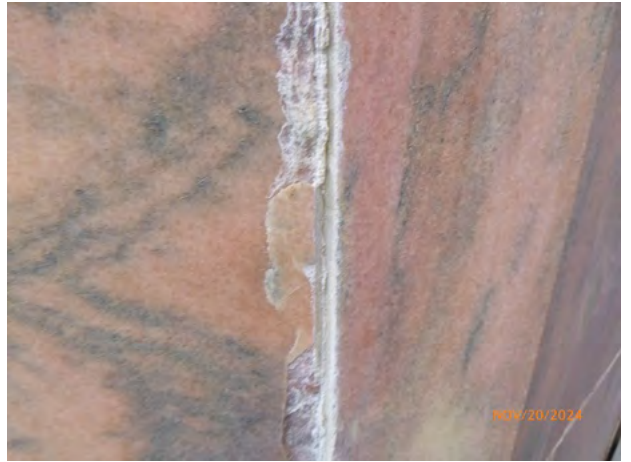
134-146 Stone\_SurfLoss Chipped 2024-1.jpg

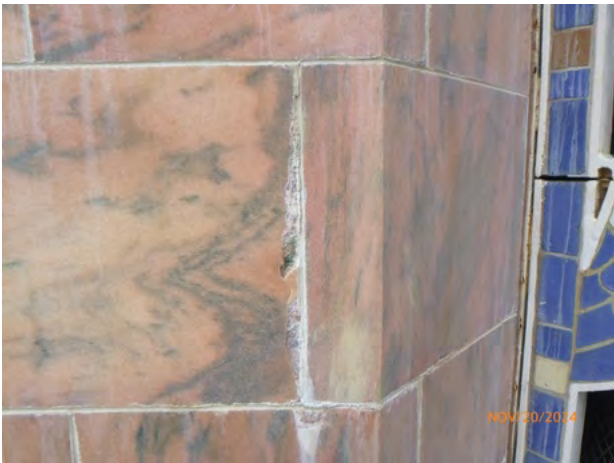
134-146 Stone\_SurfLoss Chipped 2024-2.jpg

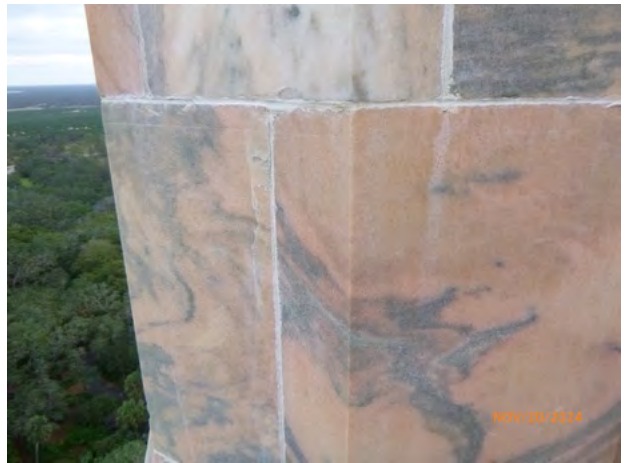
134-146 Stone\_SurfLoss Chipped 2024-3.jpg

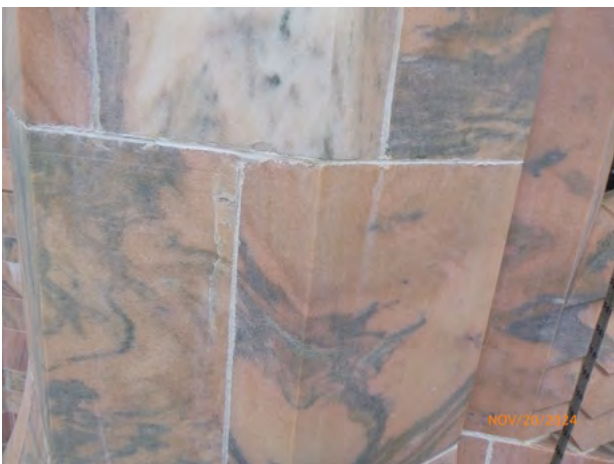
134-187 Stone\_SurfLoss Chipped 2024-1.jpg

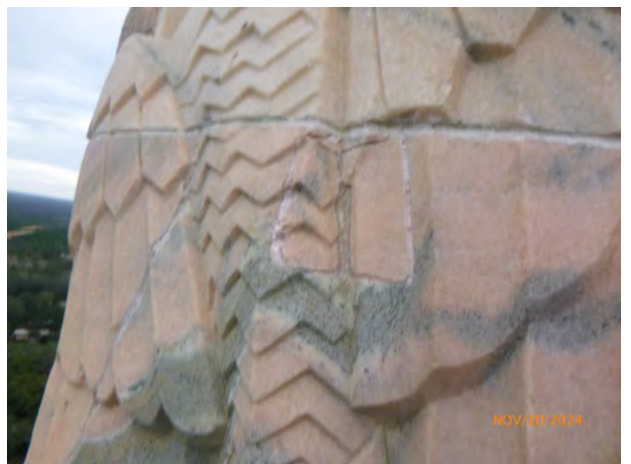
134-187 Stone\_SurfLoss Chipped 2024-2.jpg

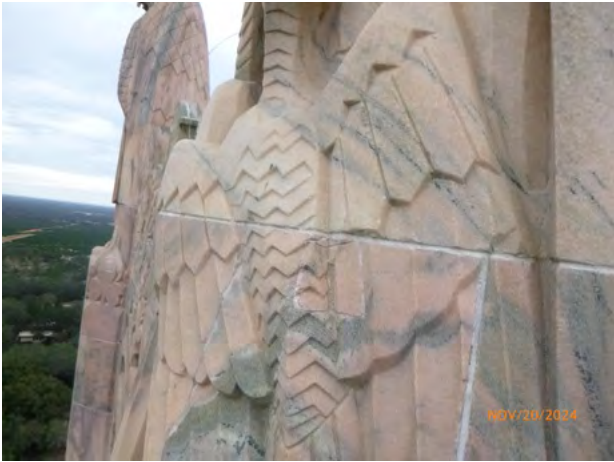
134-196 Stone\_Repair Dutchman Failed 2024-1.jpg

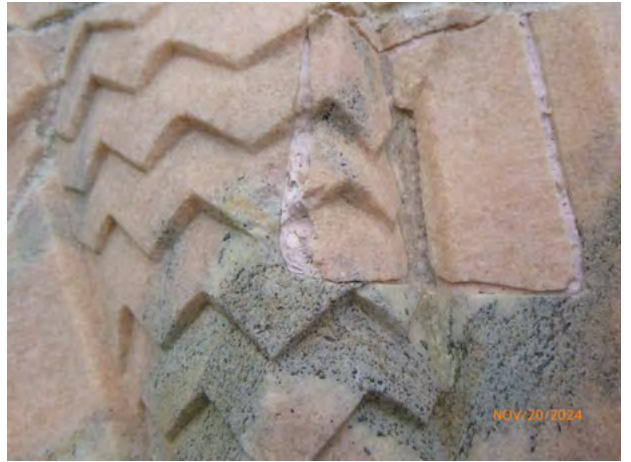
134-196 Stone\_Repair Dutchman Failed 2024-2.jpg

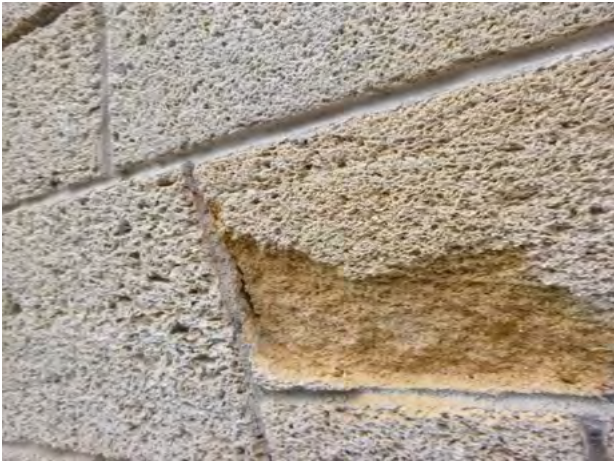
137-17 Stone\_Spall Removed 2024-1.jpg

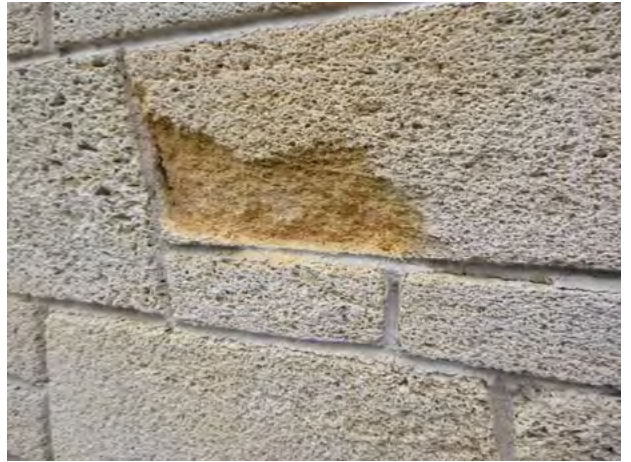
137-17 Stone\_Spall Removed 2024-2.jpg

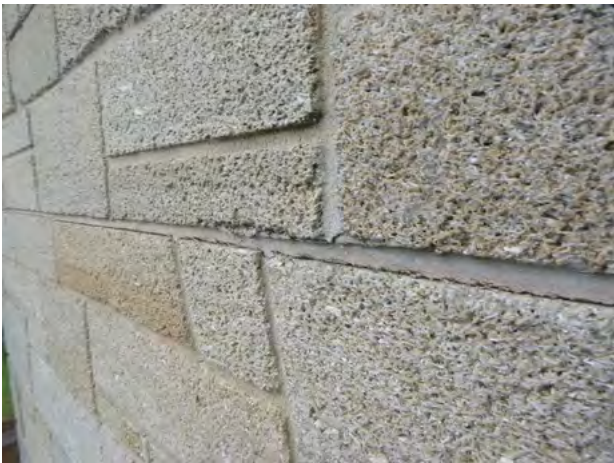
137-17 Stone\_Spall Removed 2024-3.jpg

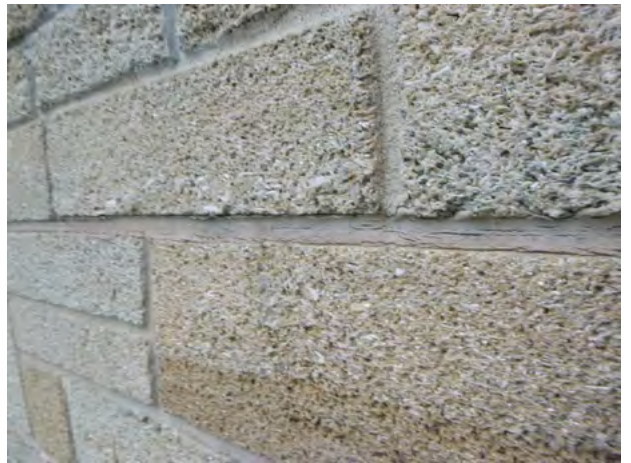
137-42 Stone\_Joints Sealant Failed 2024-1.jpg

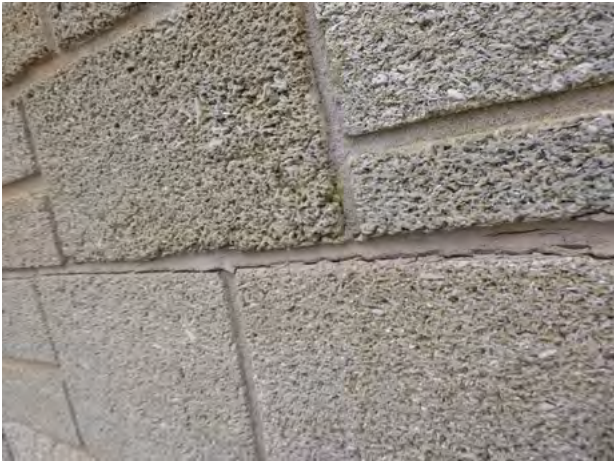
137-68 Stone\_Joints Sealant Failed 2024-1.jpg

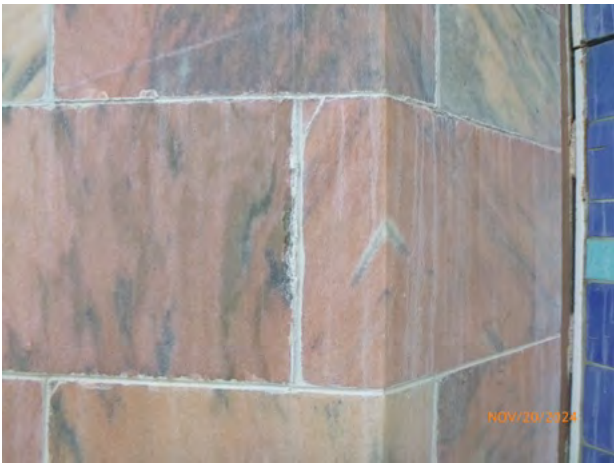
137-113 Stone\_Crack System units 2024-1.jpg

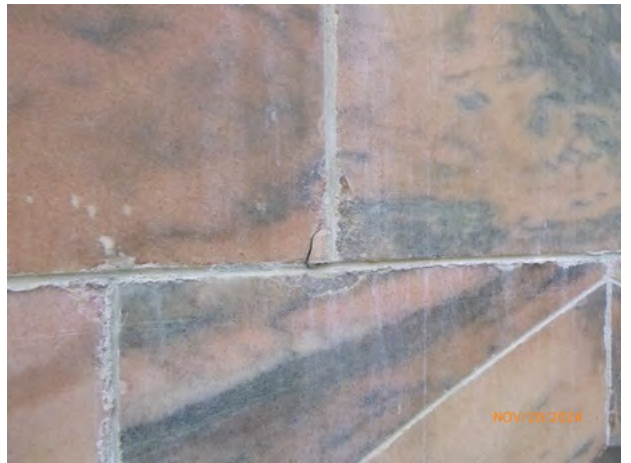
137-157 Stone\_SurfLoss Chipped 2024-1.jpg

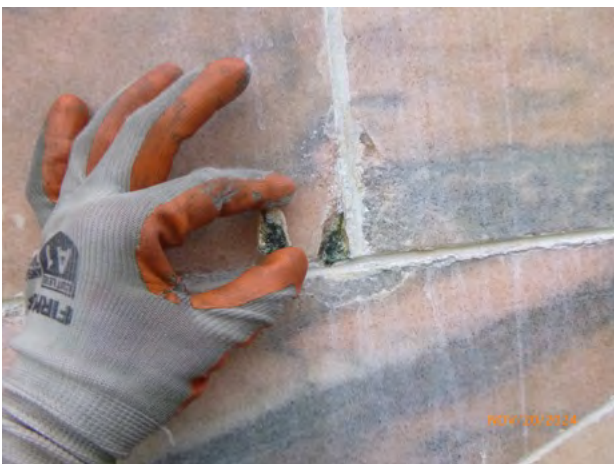
137-182 Stone\_Spall Removed 2024-1.jpg

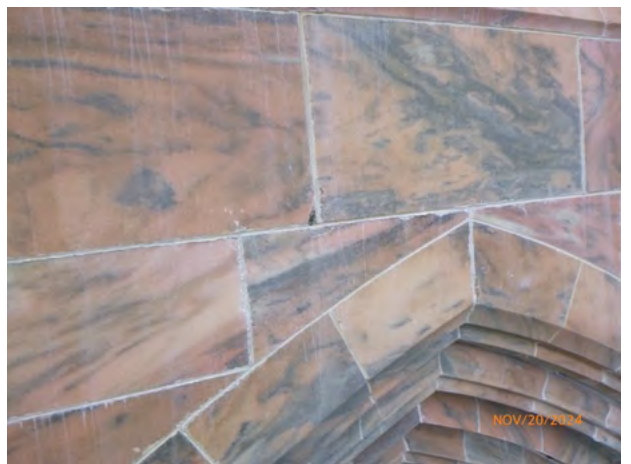
137-182 Stone\_Spall Removed 2024-2.jpg

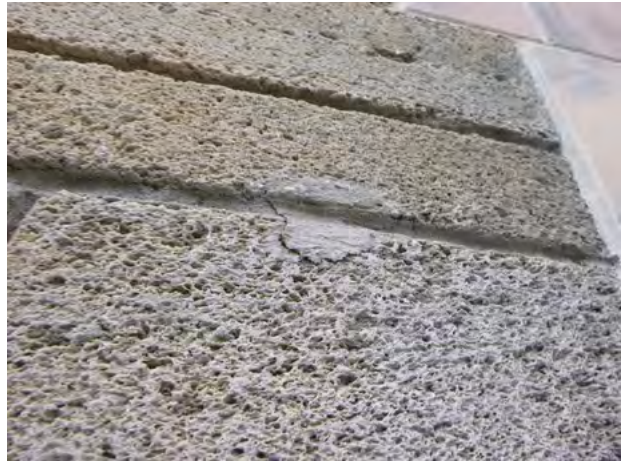
138-16 Stone\_Spall Bonded 2024-1.jpg

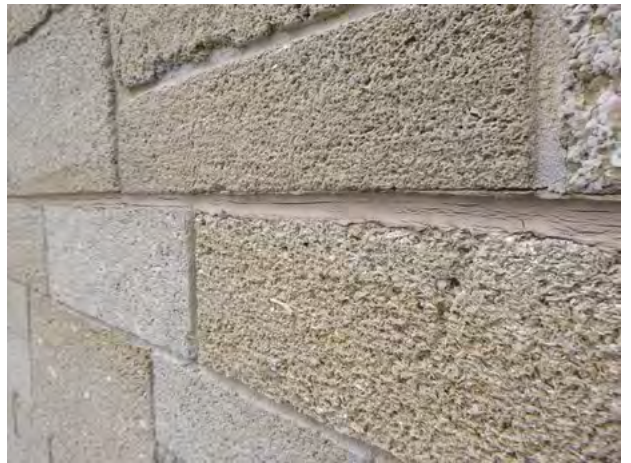
138-80 Stone\_Joints Sealant Failed 2024-1.jpg

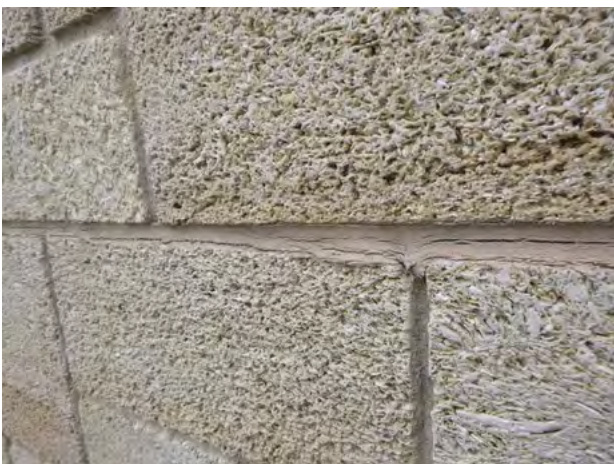
138-106 Stone\_Joints Sealant Failed 2024-1.jpg

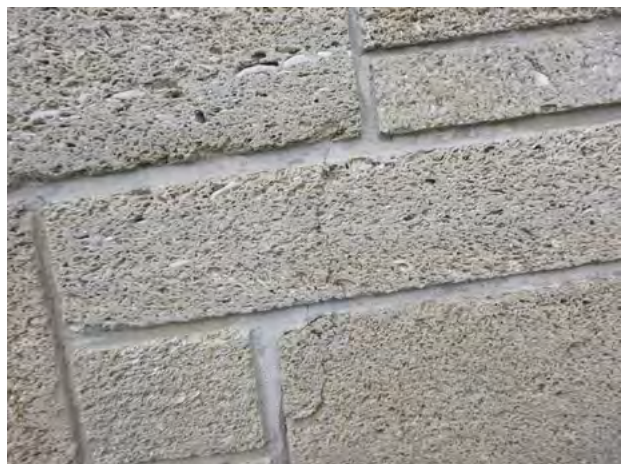
138-106 Stone\_Joints Sealant Failed 2024-2.jpg

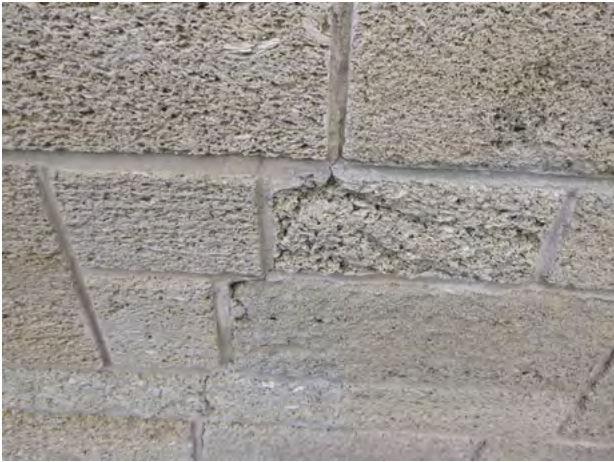
138-118 Stone\_Crack System units and joints 2024-1.jpg

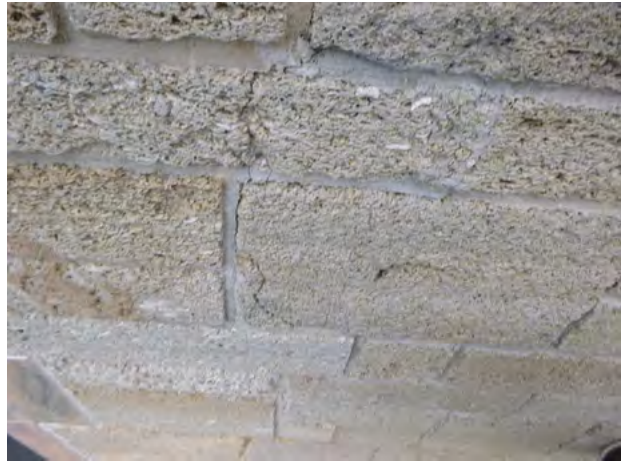
138-118 Stone\_Crack System units and joints 2024-2.jpg

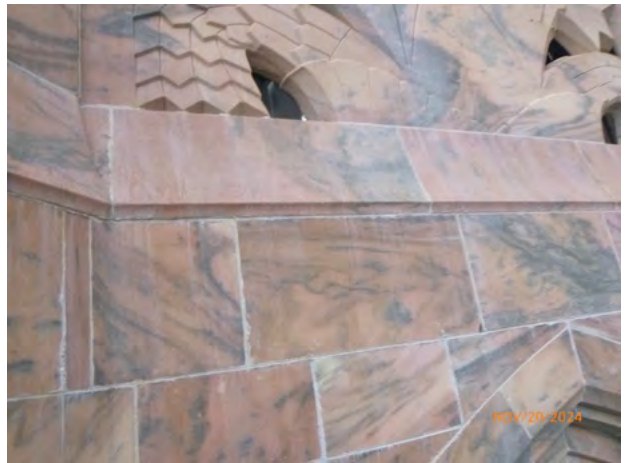
138-140 Test\_Area Water test 2024-1.jpg

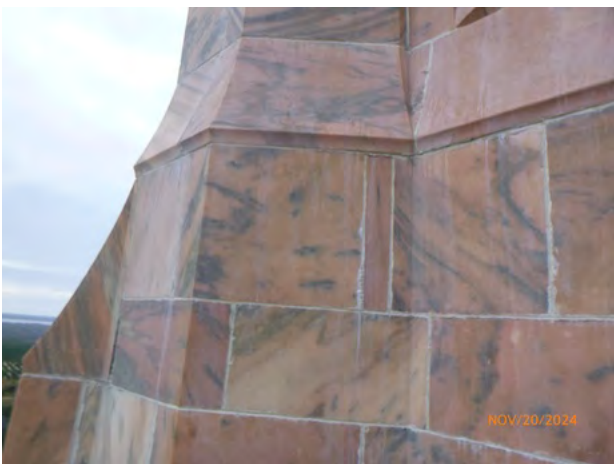
138-179 Stone\_SoilStain Leached Salts 2024-1.jpg

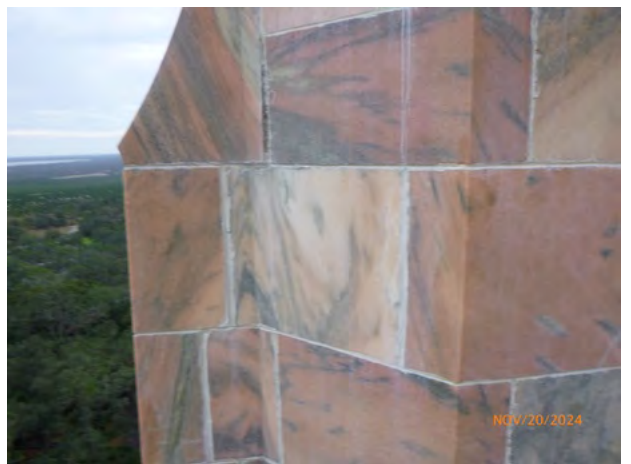
138-179 Stone\_SoilStain Leached Salts 2024-2.jpg

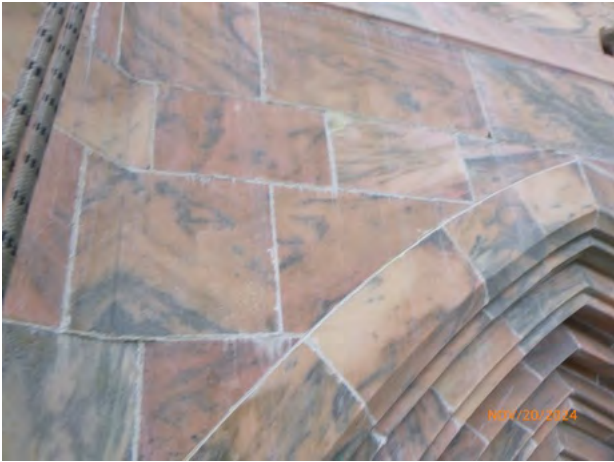
138-179 Stone\_SoilStain Leached Salts 2024-3.jpg

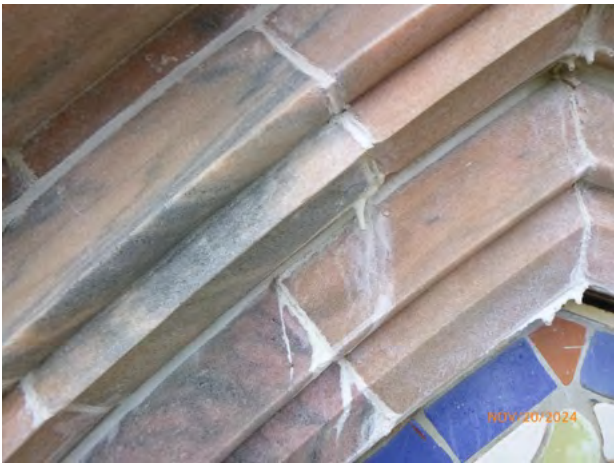
138-179 Stone\_SoilStain Leached Salts 2024-5.jpg

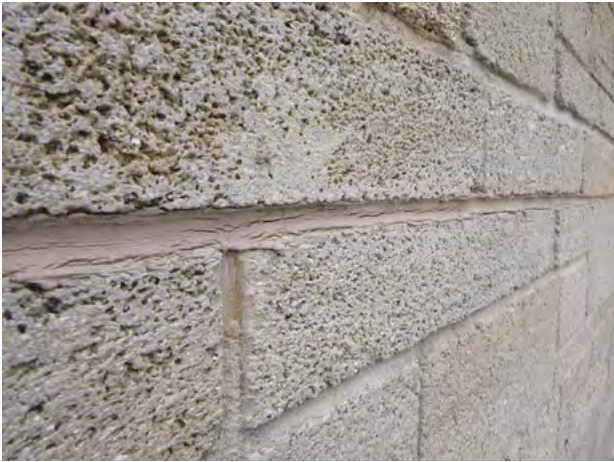
139-89 Stone\_Joints Sealant Failed 2024-1.jpg

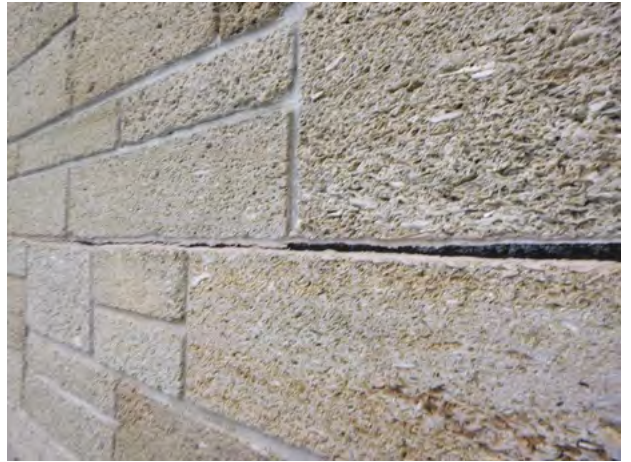
139-89 Stone\_Joints Sealant Failed 2024-2.jpg

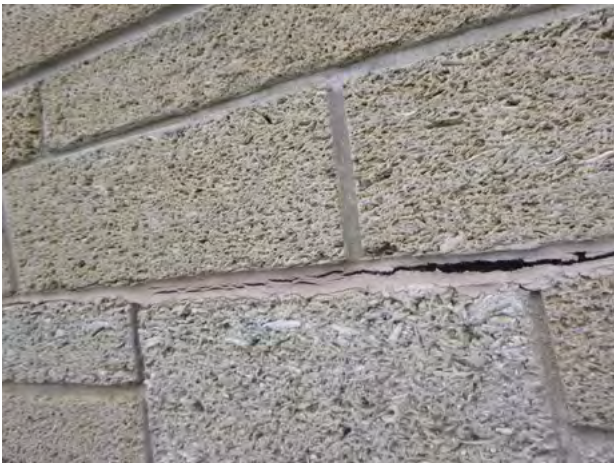
139-121 Stone\_Joints Sealant Failed 2024-1.jpg

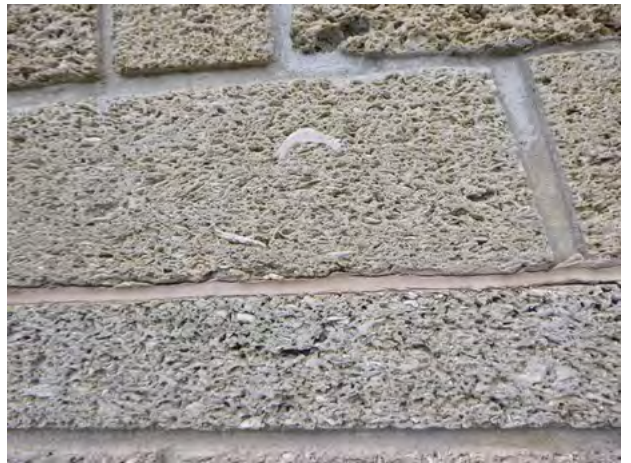
139-121 Stone\_Joints Sealant Failed 2024-2.jpg

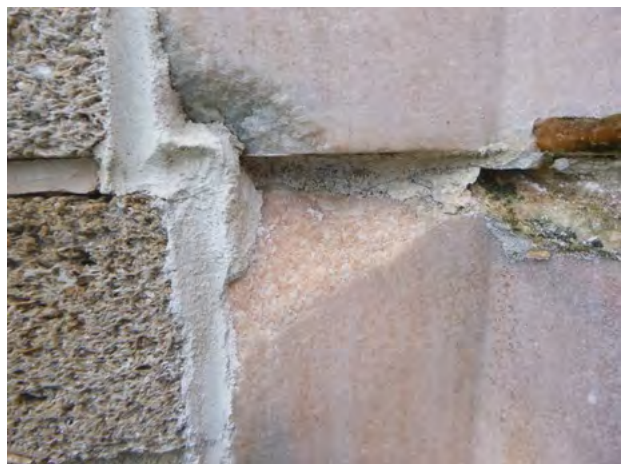
139-195 Stone\_Spall Missing 2024-1.jpg

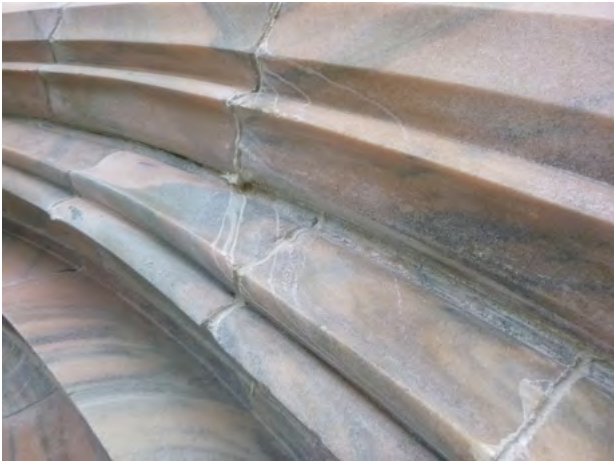
140-69 Stone\_Spall Missing 2024-1.jpg

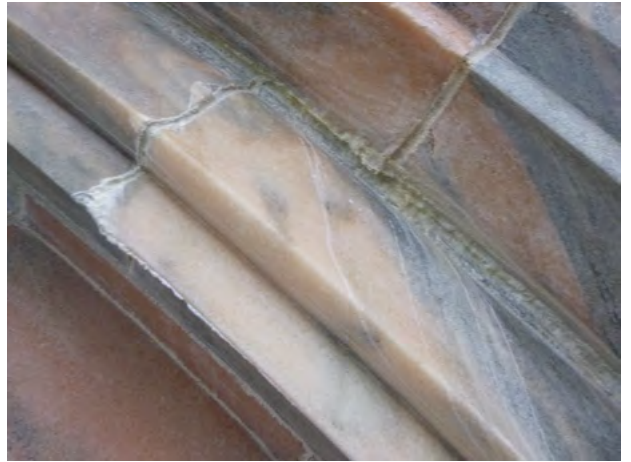
140-178 Stone\_SoilStain Leached Salts 2024-1.jpg

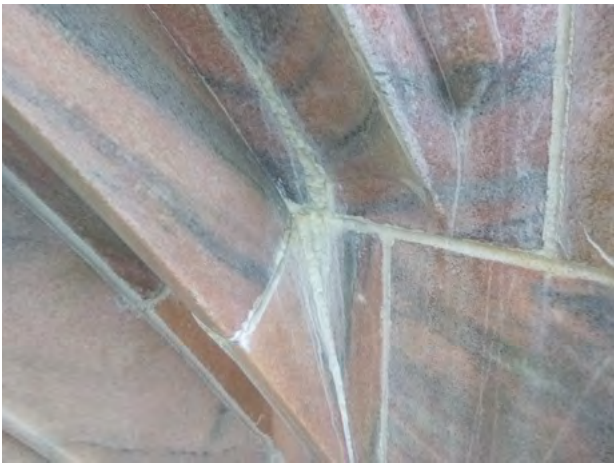
140-178 Stone\_SoilStain Leached Salts 2024-2.jpg

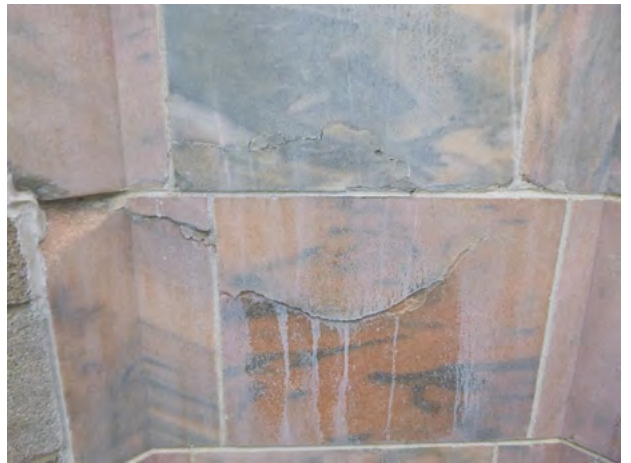
140-178 Stone\_SoilStain Leached Salts 2024-3.jpg

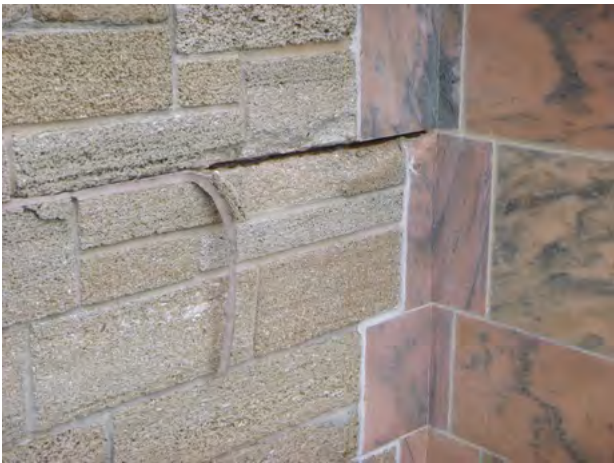
150-90 Stone\_Joints Sealant Failed 2024-2.jpg

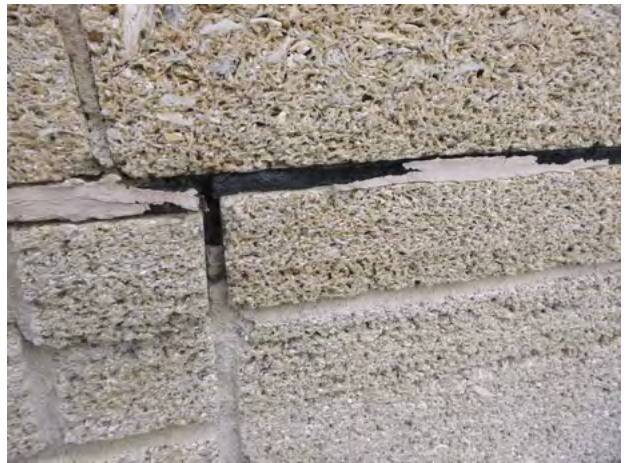
150-90 Stone\_Joints Sealant Failed 2024-3.jpg

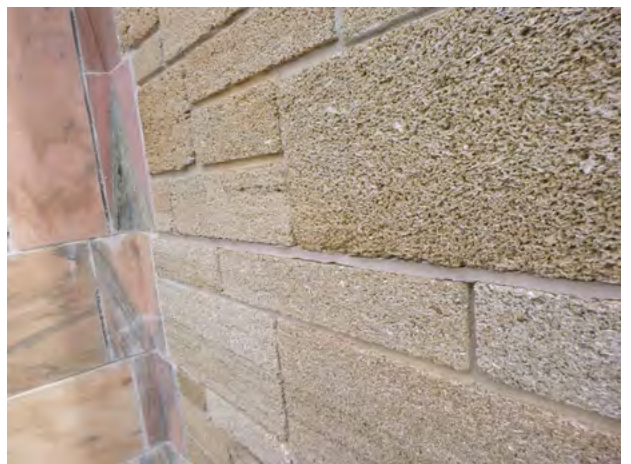
151-67 Stone\_Joints Sealant Failed 2024-1.jpg

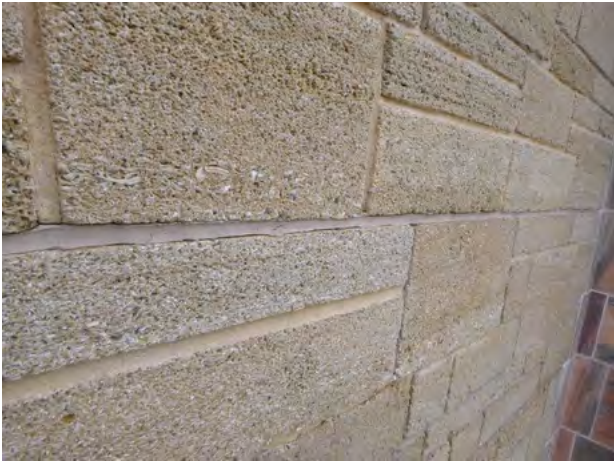
151-79 Stone\_Joints Sealant Failed 2024-1.jpg

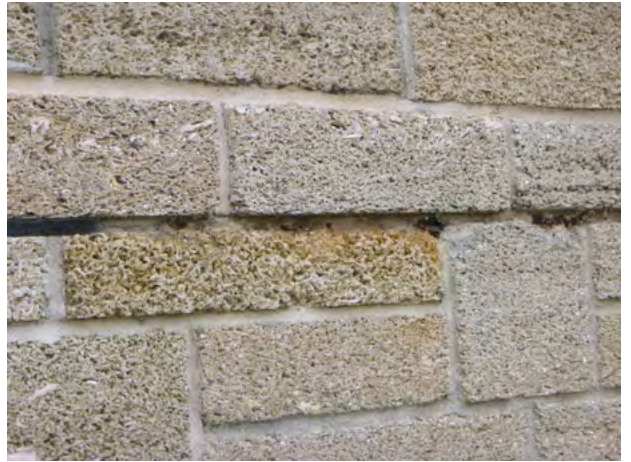
151-79 Stone\_Joints Sealant Failed 2024-2.jpg

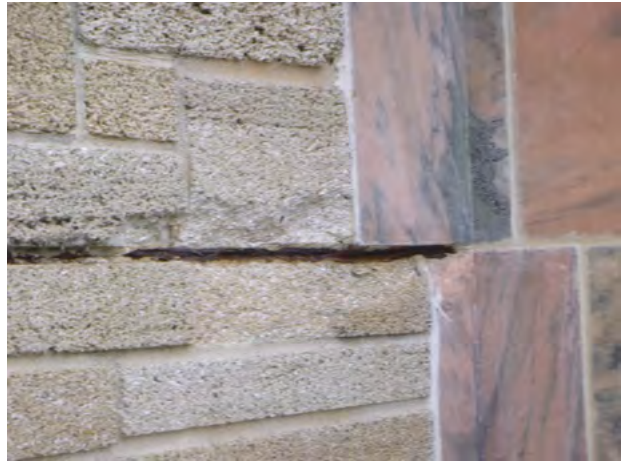
152-76 Stone\_Embedment Other Embedment 2024-1.jpg

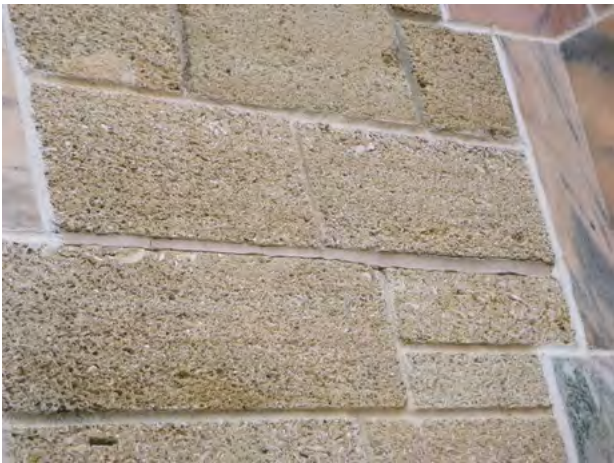
154-91 Stone\_Spall Missing + Steel 2024-1.jpg

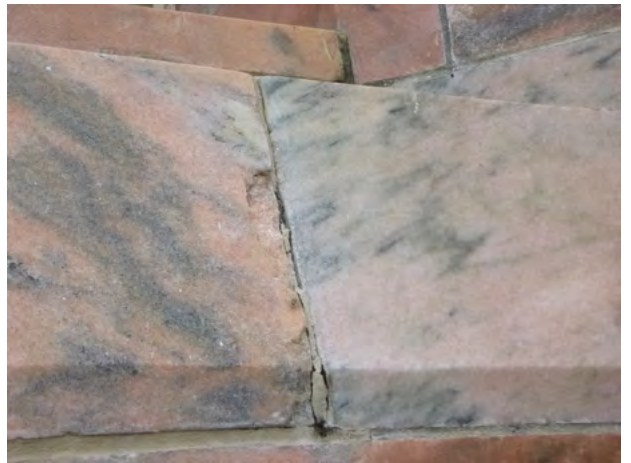
154-101 Stone\_Joints Sealant Failed 2024-1.jpg

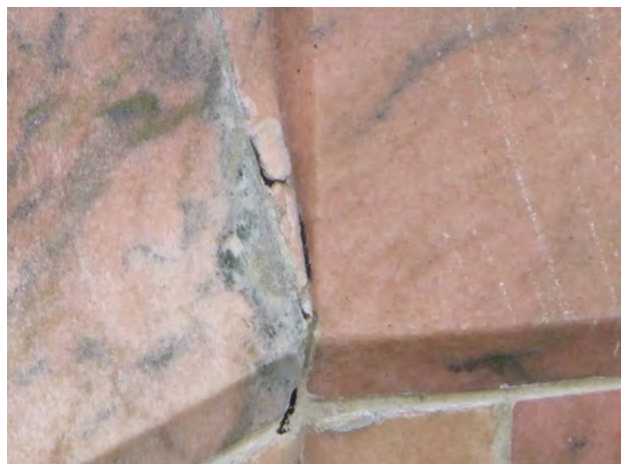
155-100 Stone\_Crack Single unit 2024-1.jpg

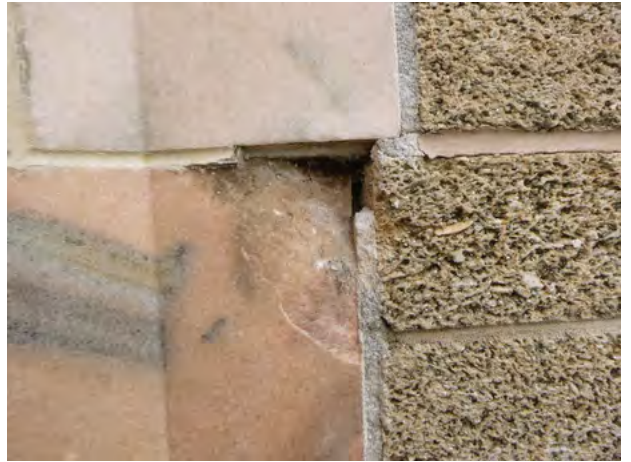
160-66 Stone\_Spall Removed + Steel 2024-1.jpg

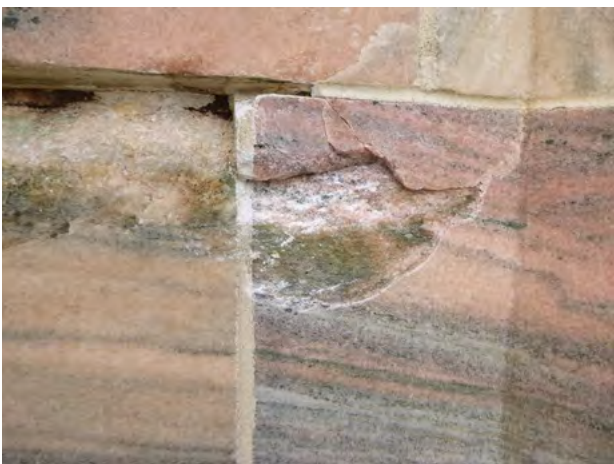
161-46 Stone\_Spall Removed 2024-1.jpg

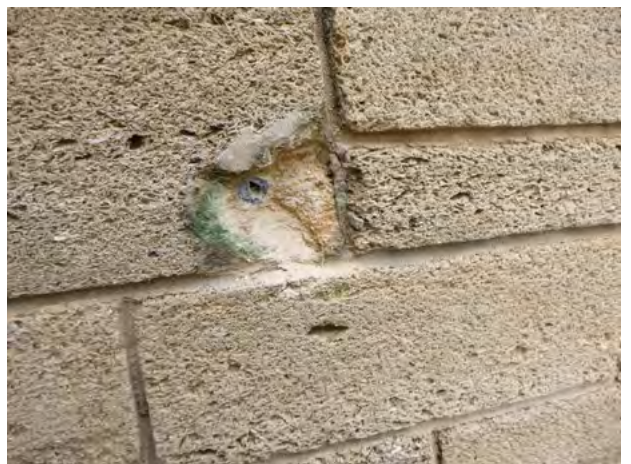
161-46 Stone\_Spall Removed 2024-2.jpg
