### ***Bok Singing Tower Roof Restoration and Replacement***

# Bok Singing Tower Conditions Assessment

T.Y. Lin (formerly Silman) was contracted to perform a conditions assessment of the Bok Singing Tower at Bok Tower Gardens in Lake Wales, Florida. The Singing Tower stands 205 feet tall at the southwest corner of the gardens. A moat surrounds the base of the tower with two bridges to access the island. The tower houses a 60-bell carillon, associated carillonneur studio and library spaces, the Bok Tower Gardens Chao Research archive, and the Founder's Room. It is a steel frame construction clad in a masonry exterior of coquina and Georgia pink Etowah marble with brick masonry at the interior.

## **Bok Tower Focused Condition Assessment**

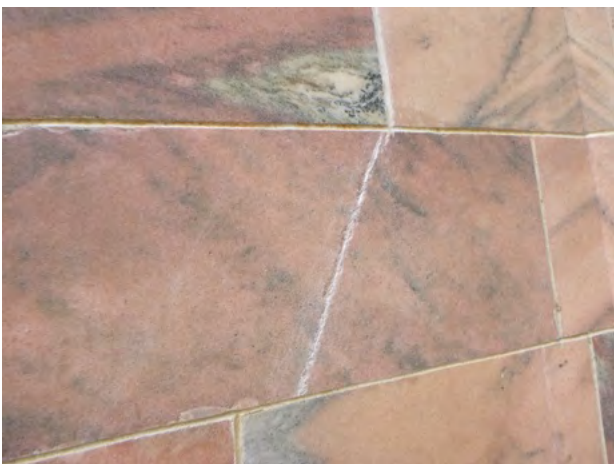
230-16 Stone\_Note Photo-general 2024-4.jpg

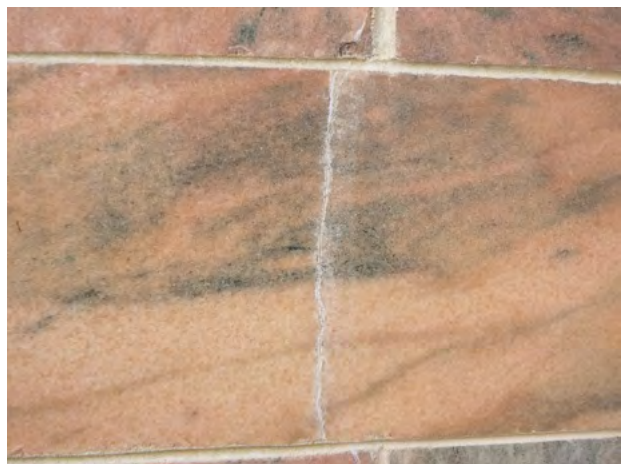
230-23 Stone\_Crack Single unit 2024-1.jpg

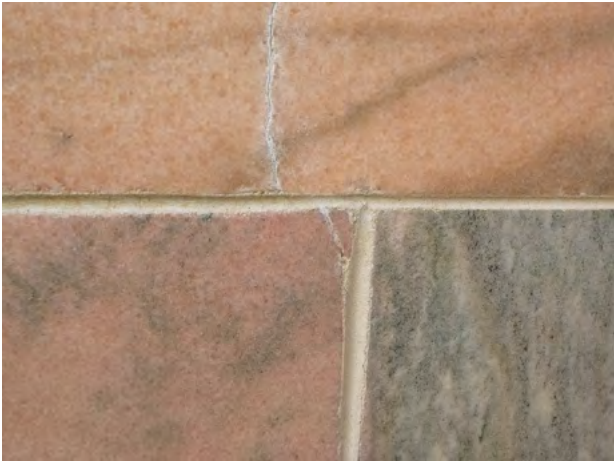
230-51 Stone\_Crack System units and joints 2024-1.jpg

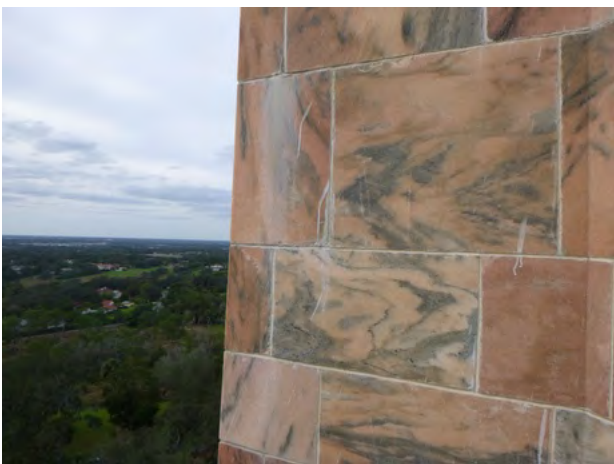
230-71 Stone\_Note Photo-general 2024-3.jpg

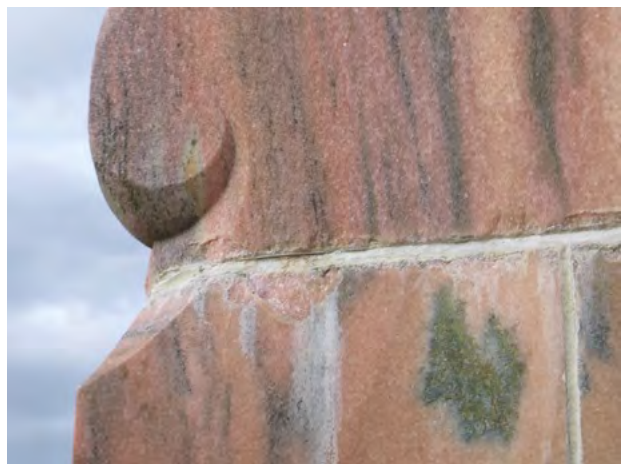
230-138 Stone\_SoilStain Leached Salts 2024-1.jpg

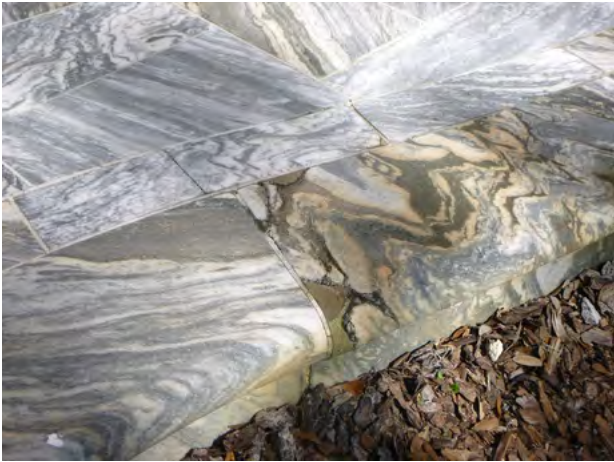
230-158 Stone\_SurfLoss Chipped 2024-1.jpg

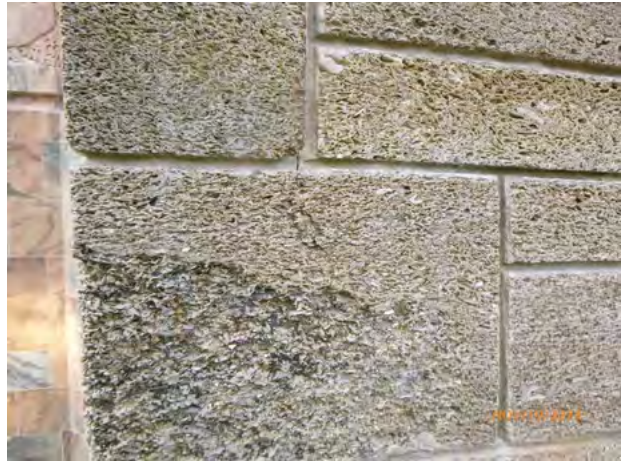
234-0 Stone\_Joints Mortar Failed 2024-1.jpg

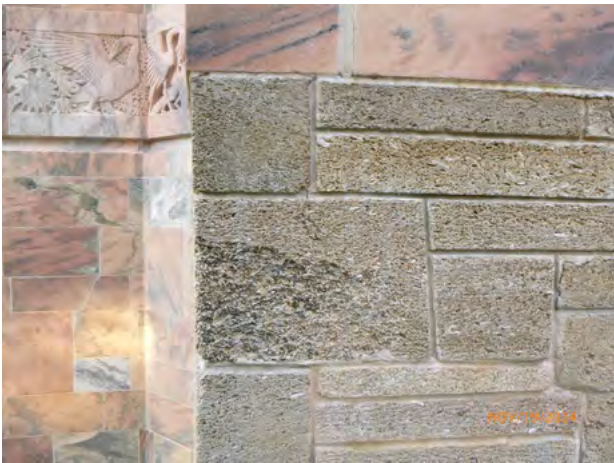
234-26 Stone\_Crack System units and joints 2024-1.jpg

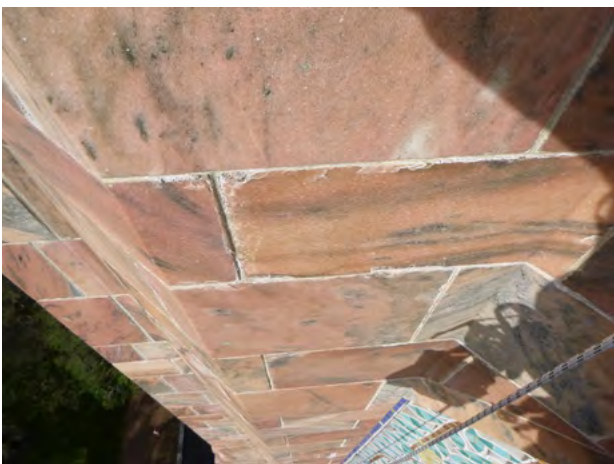
234-80 Stone\_Spall Bonded 2024-1.jpg

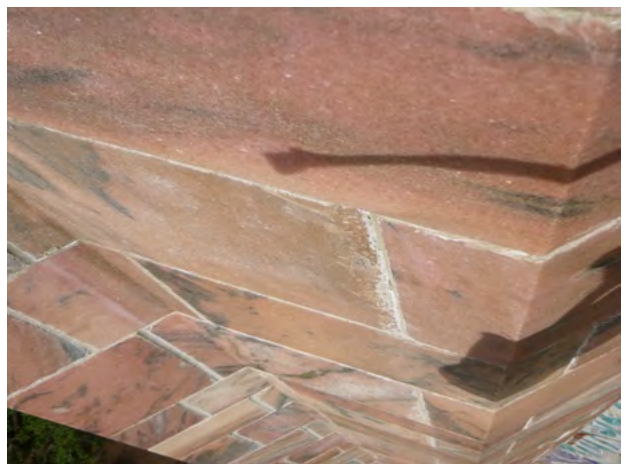
234-180 Stone\_SurfLoss Chipped 2024-1.jpg

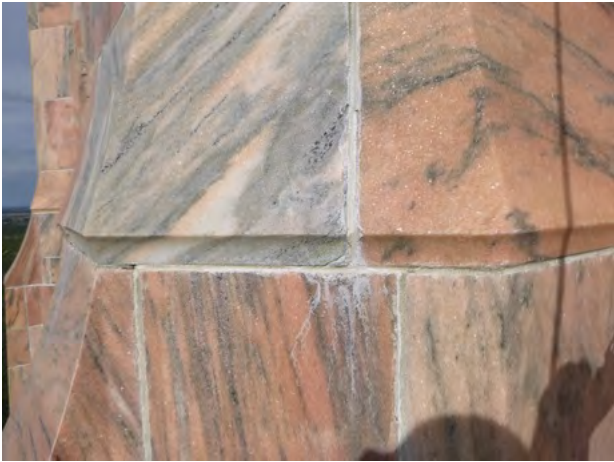
234-180 Stone\_SurfLoss Chipped 2024-2.jpg

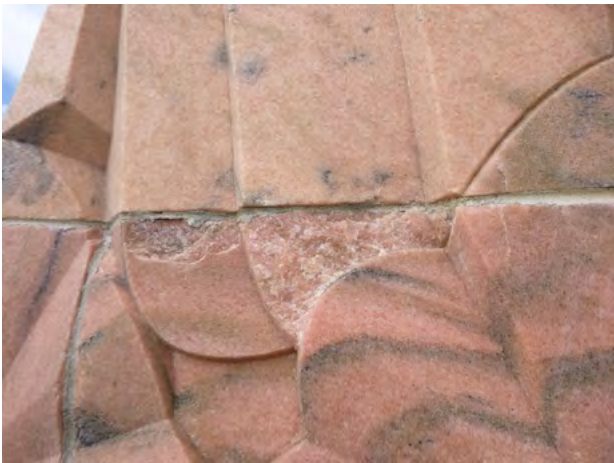
234-187 Stone\_Spall Bonded 2024-1.jpg

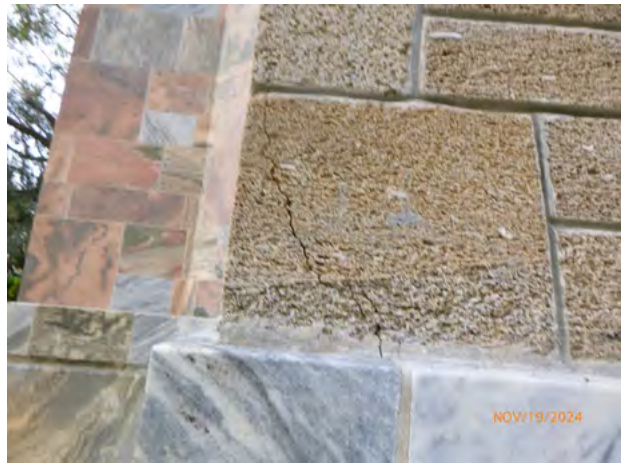
234-192 Stone\_SurfLoss Chipped 2024-1.jpg

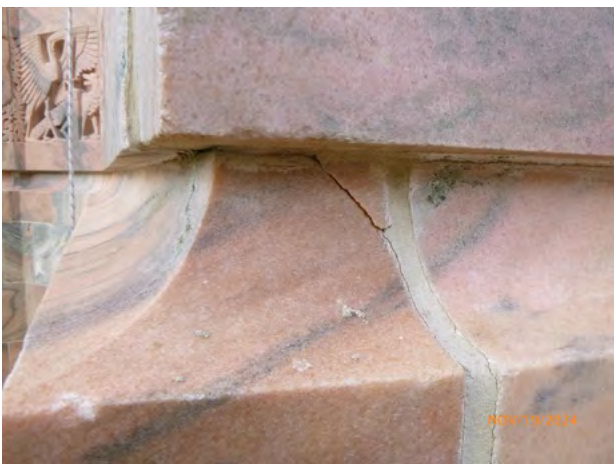
235-11 Stone\_Crack Single unit 2024-1.jpg

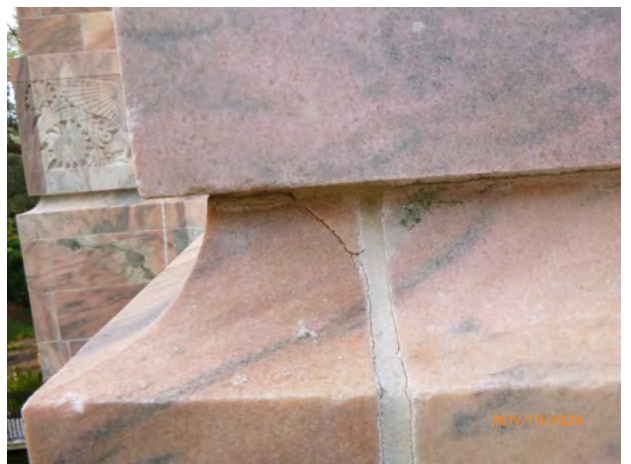
235-28 Stone\_Crack Single unit 2024-1.jpg

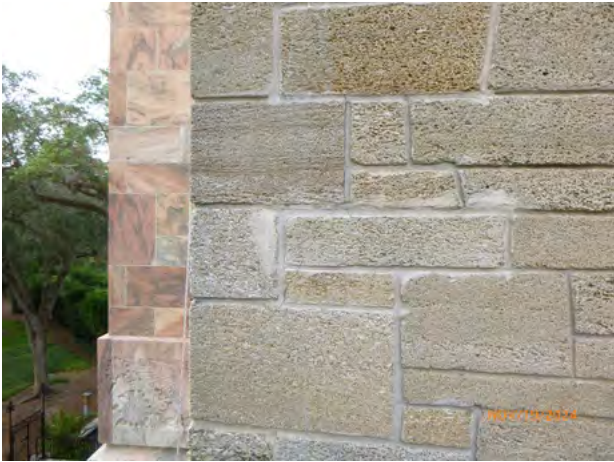
235-28 Stone\_Crack Single unit 2024-2.jpg

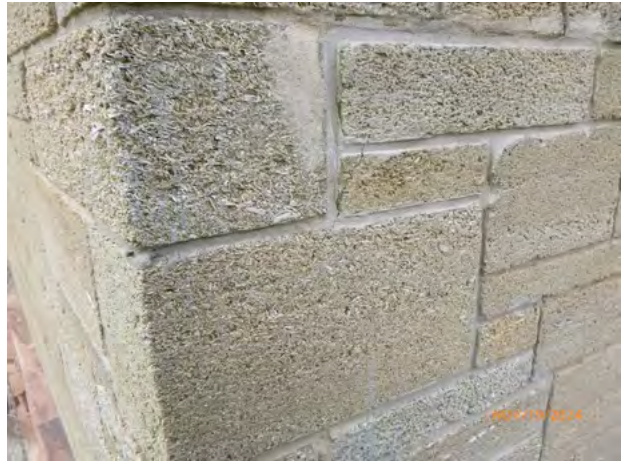
235-33 Stone\_Crack System units and joints 2024-1.jpg

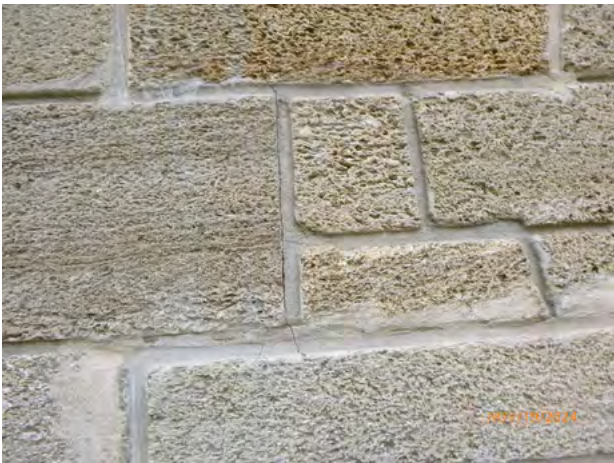
235-33 Stone\_Crack System units and joints 2024-2.jpg

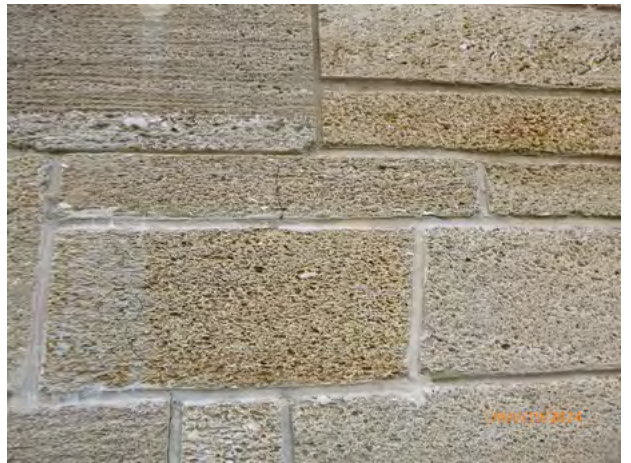
235-33 Stone\_Crack System units and joints 2024-3.jpg

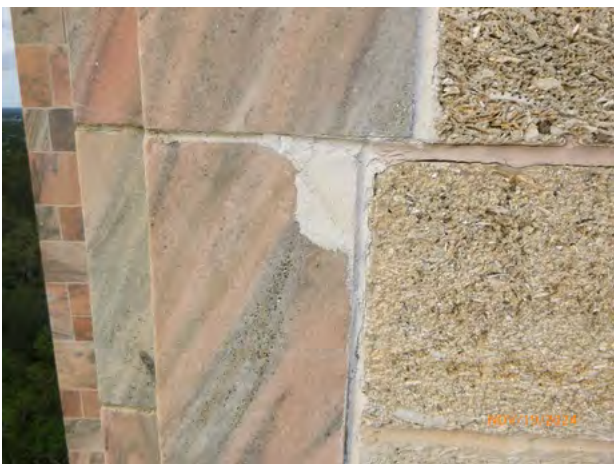
235-33 Stone\_Crack System units and joints 2024-4.jpg

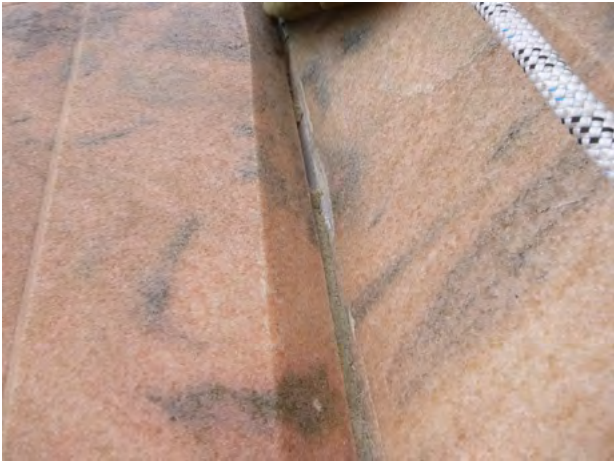
235-181 Stone\_SoilStain Leached Salts 2024-1.jpg

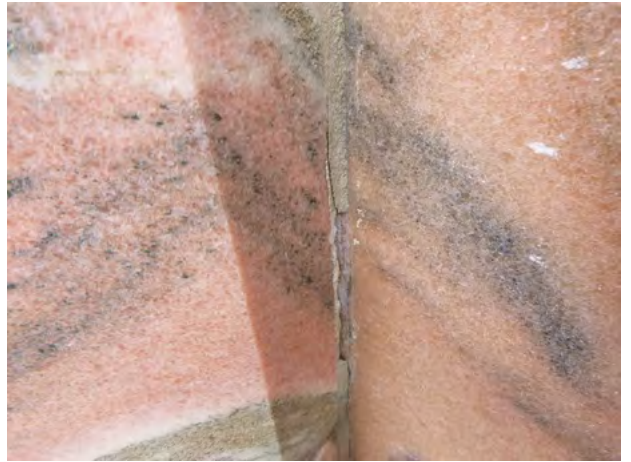
235-194 Stone\_Joints Mortar Failed 2024-1.jpg

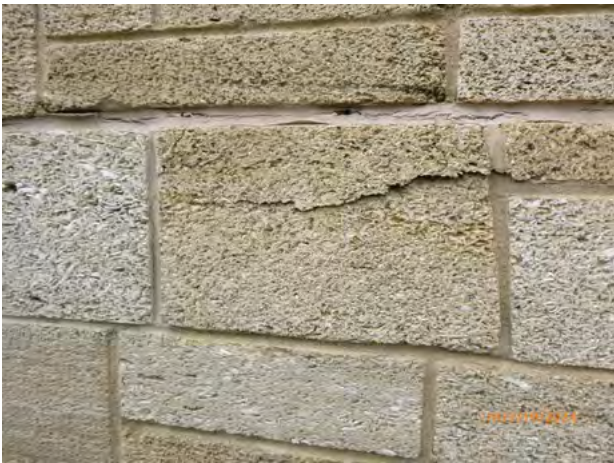
235-194 Stone\_Joints Mortar Failed 2024-2.jpg

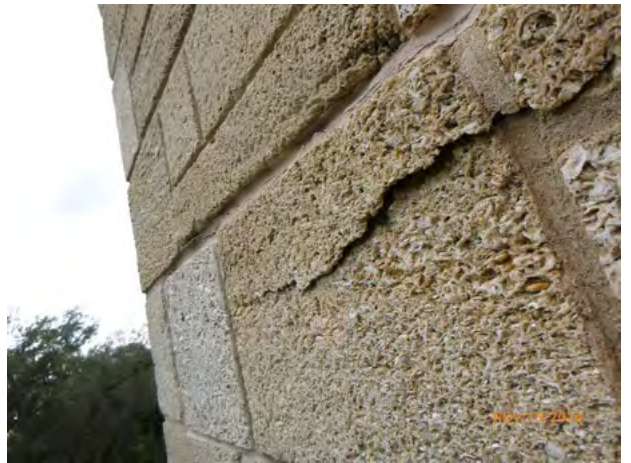
236-42 Stone\_Crack Single unit 2024-1.jpg

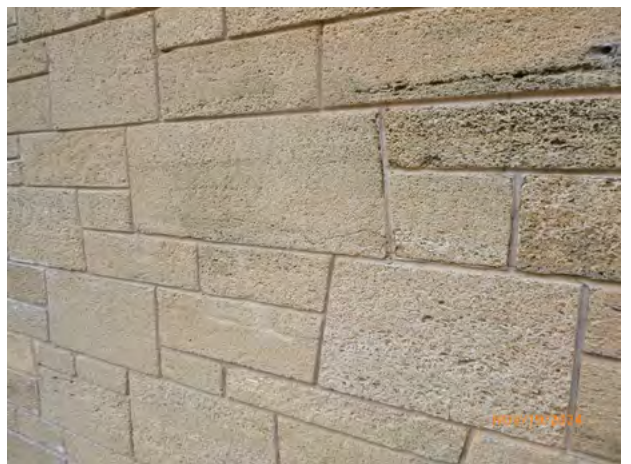
236-91 Stone\_Repair Patch Sound 2024-1.jpg

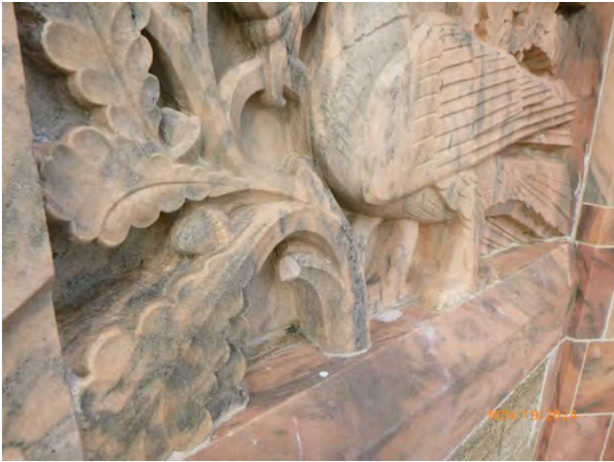
237-15 Stone\_Crack Single unit 2024-1.jpg

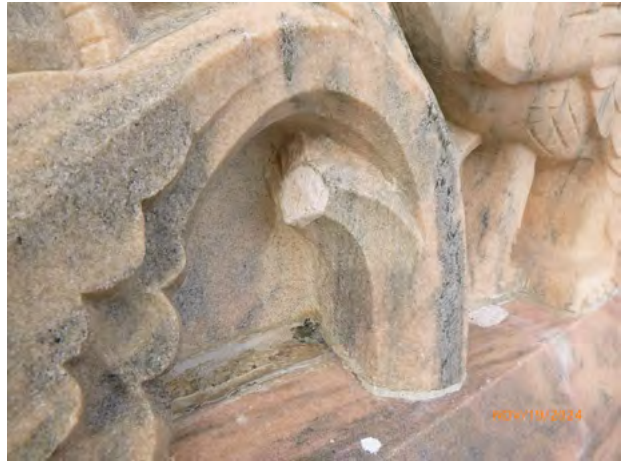
237-139 Stone\_Spall Missing 2024-1.jpg

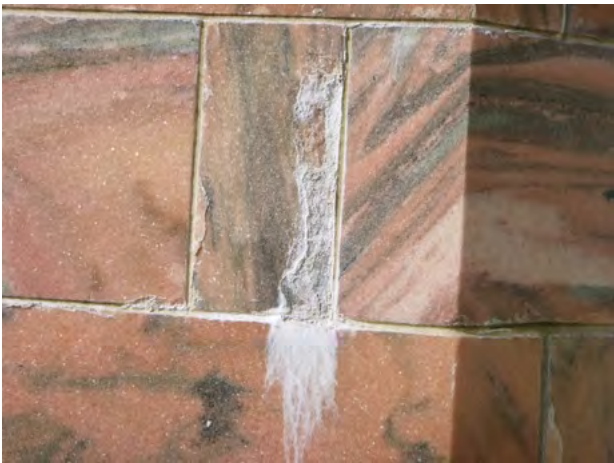
237-139 Stone\_Spall Missing 2024-2.jpg

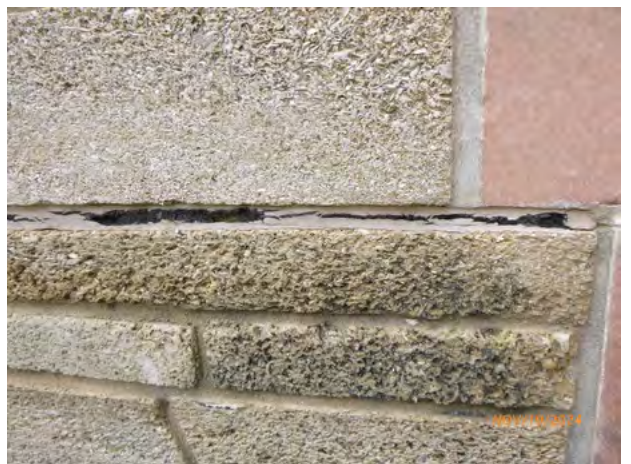
241-37 Stone\_Joints Sealant Failed 2024-1.jpg

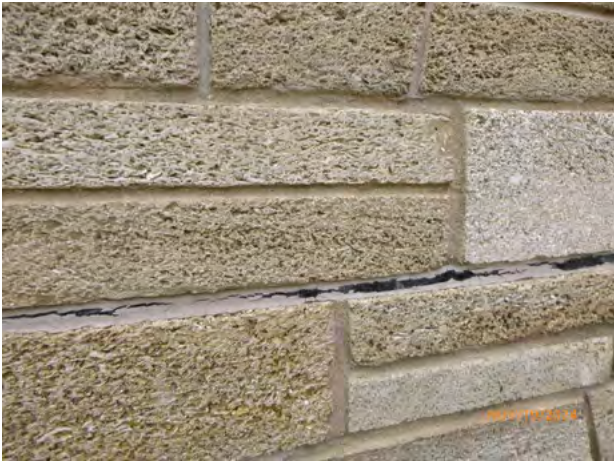
241-37 Stone\_Joints Sealant Failed 2024-2.jpg

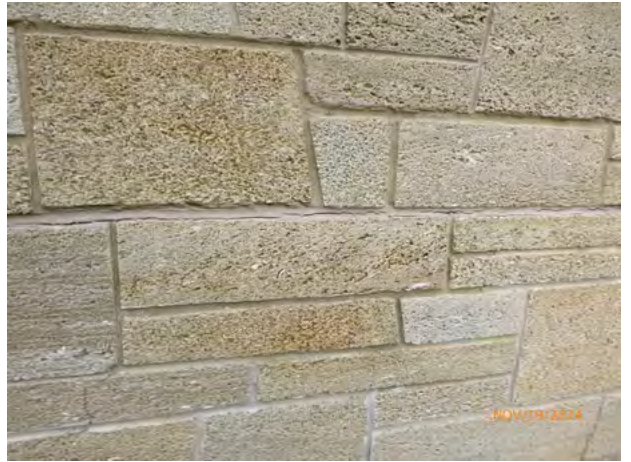
241-37 Stone\_Joints Sealant Failed 2024-3.jpg

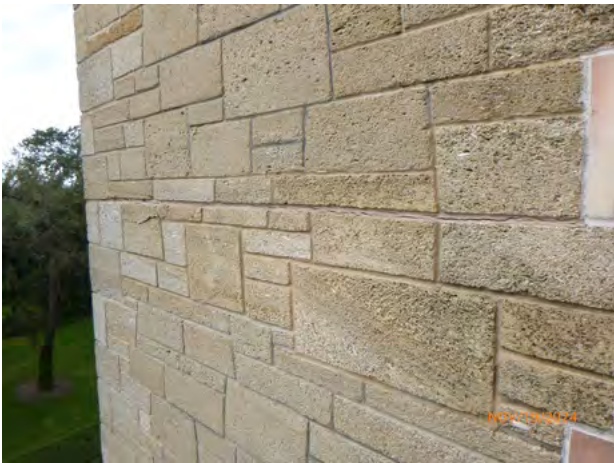
241-37 Stone\_Joints Sealant Failed 2024-4.jpg

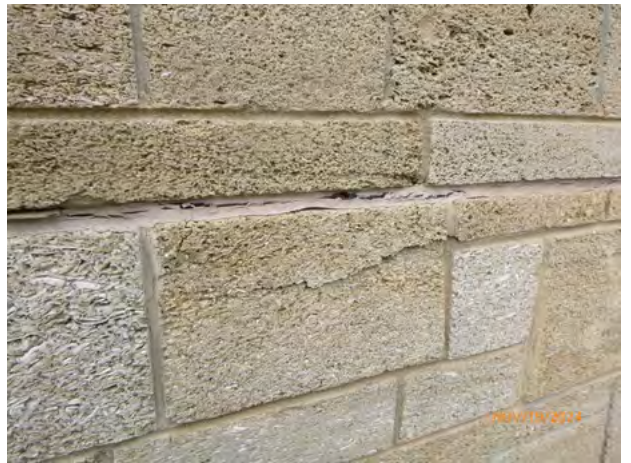
241-44 Stone\_Joints Sealant Failed 2024-1.jpg

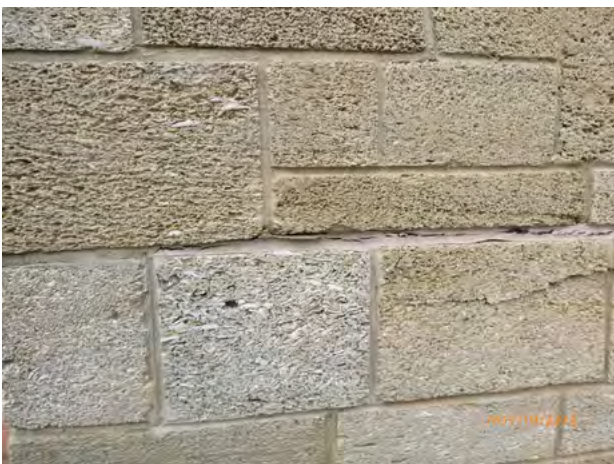
241-44 Stone\_Joints Sealant Failed 2024-2.jpg

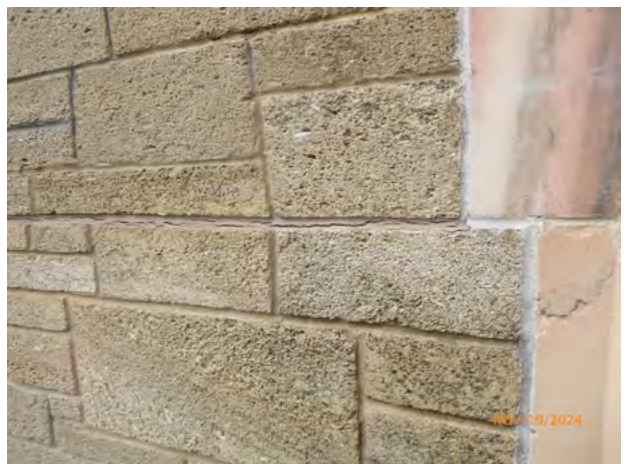
241-44 Stone\_Joints Sealant Failed 2024-3.jpg

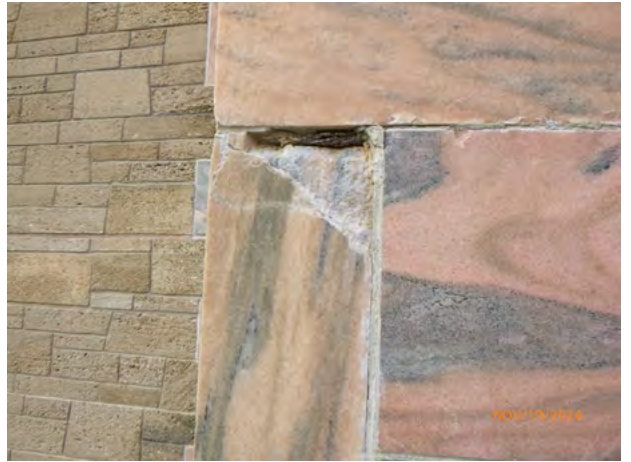
241-57 Stone\_Spall Removed + Steel 2024-1.jpg

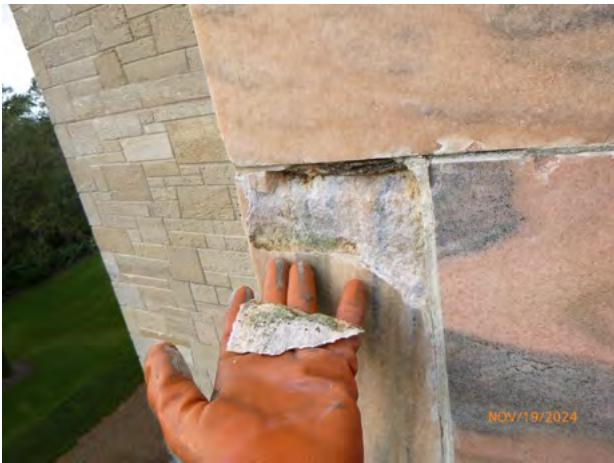
241-57 Stone\_Spall Removed + Steel 2024-2.jpg

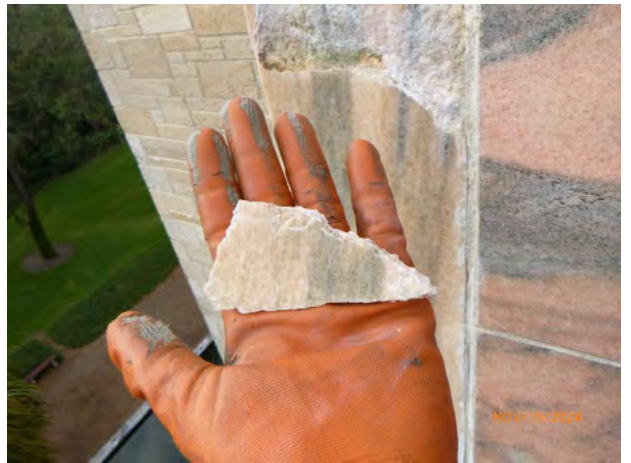
241-57 Stone\_Spall Removed + Steel 2024-3.jpg

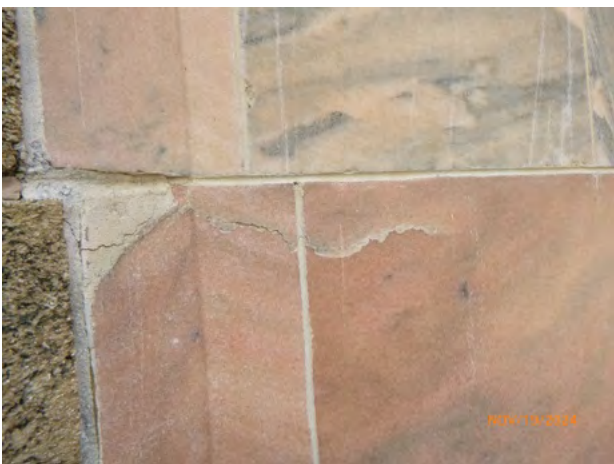
241-57 Stone\_Spall Removed + Steel 2024-4.jpg

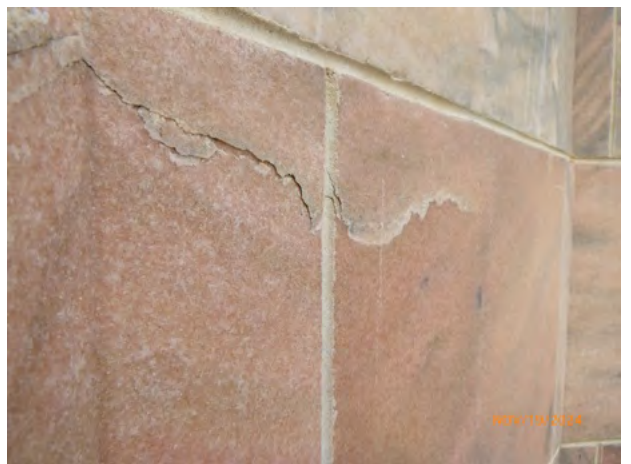
241-70 Stone\_Crack System units and joints 2024-1.jpg

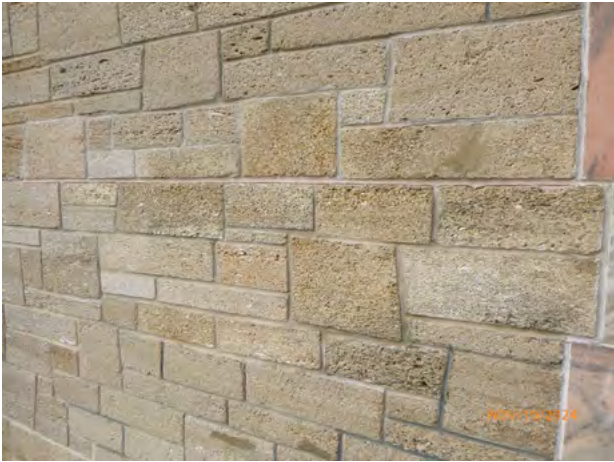
241-70 Stone\_Crack System units and joints 2024-2.jpg

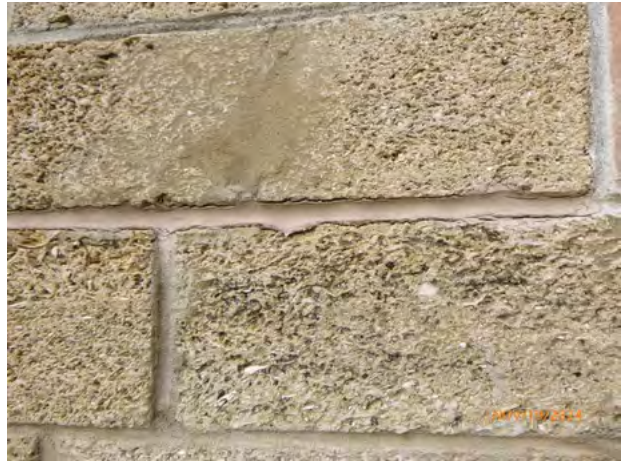
241-80 Stone\_Joints Sealant Failed 2024-1.jpg

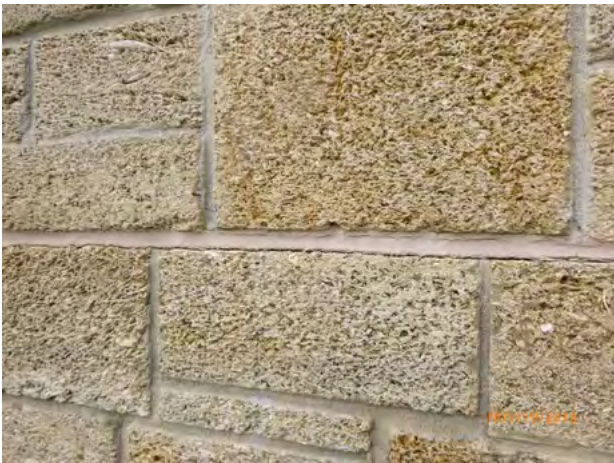
241-80 Stone\_Joints Sealant Failed 2024-2.jpg

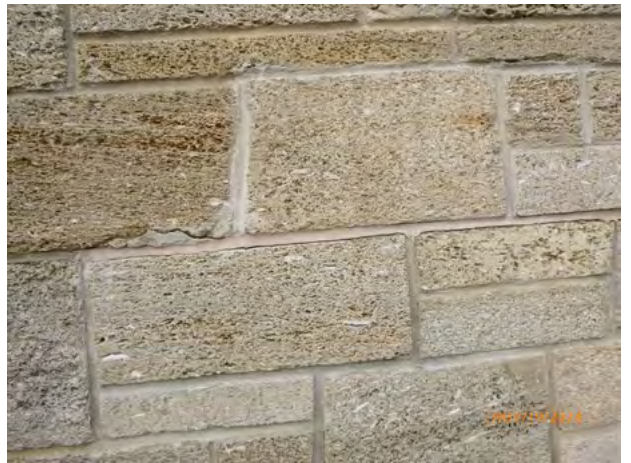
241-80 Stone\_Joints Sealant Failed 2024-3.jpg

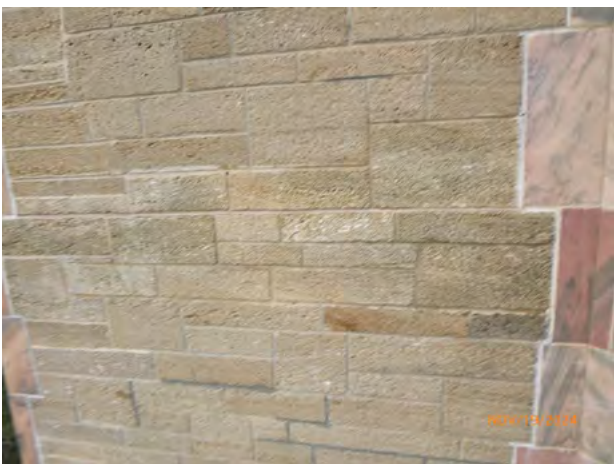
241-80 Stone\_Joints Sealant Failed 2024-4.jpg

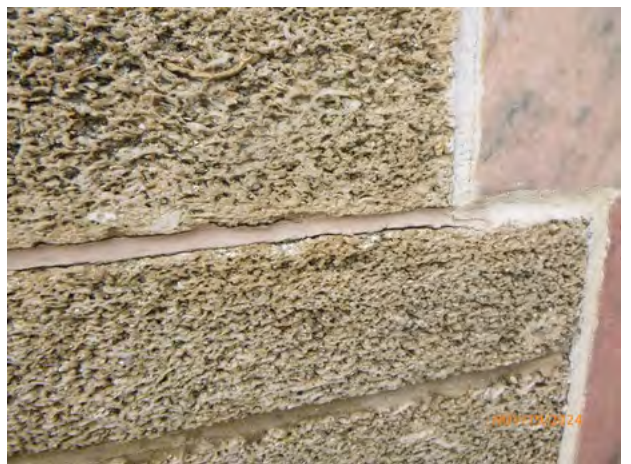
241-130 Stone\_Joints Sealant Failed 2024-1.jpg

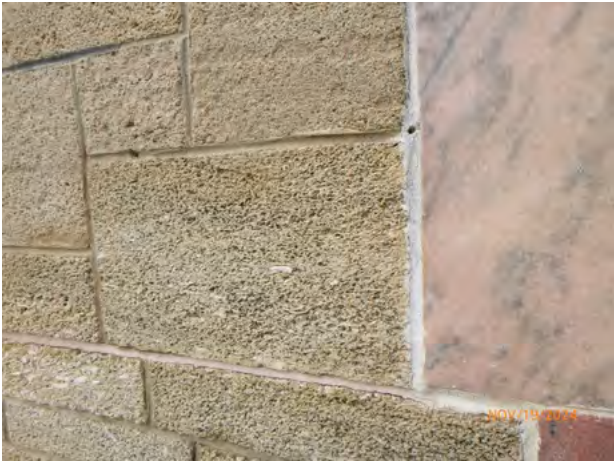
241-130 Stone\_Joints Sealant Failed 2024-2.jpg

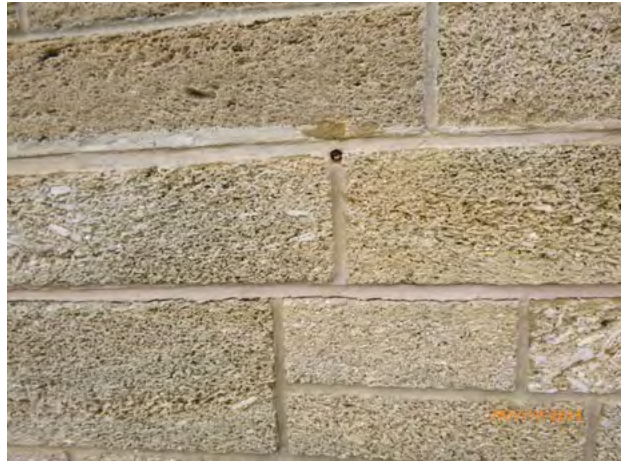
241-130 Stone\_Joints Sealant Failed 2024-3.jpg

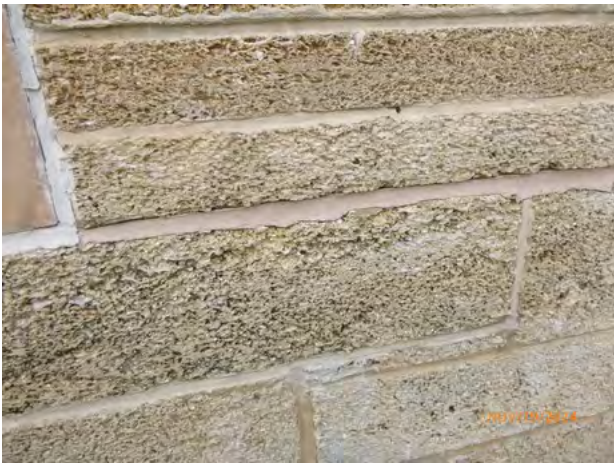
241-130 Stone\_Joints Sealant Failed 2024-4.jpg

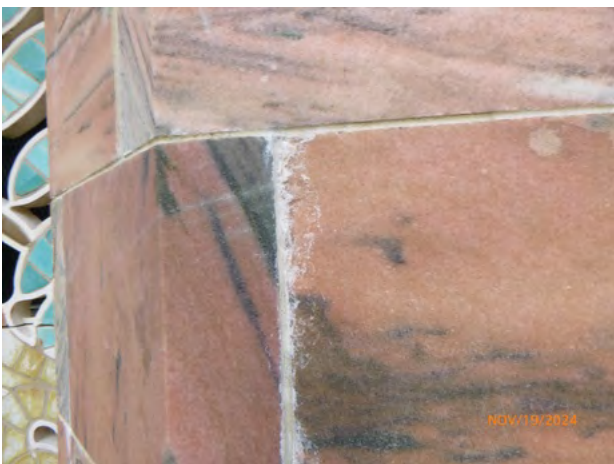
241-164 Stone\_SurfLoss Chipped 2024-1.jpg

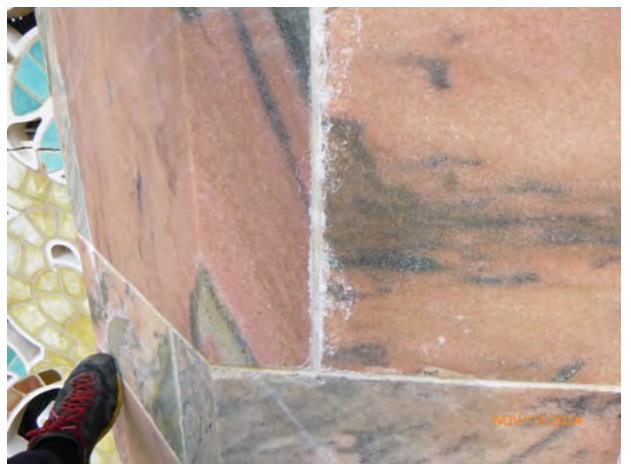
241-164 Stone\_SurfLoss Chipped 2024-2.jpg

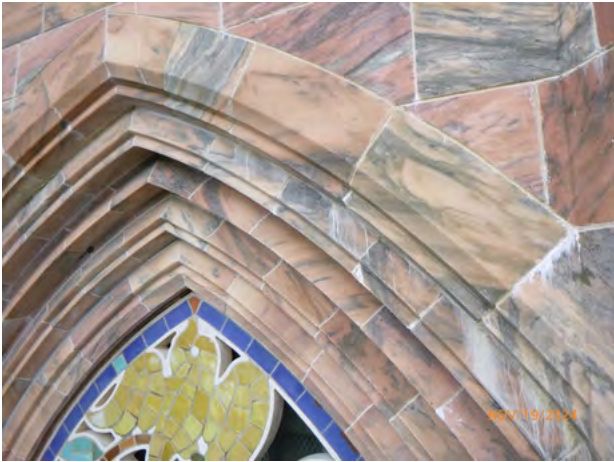
241-164 Stone\_SurfLoss Chipped 2024-3.jpg

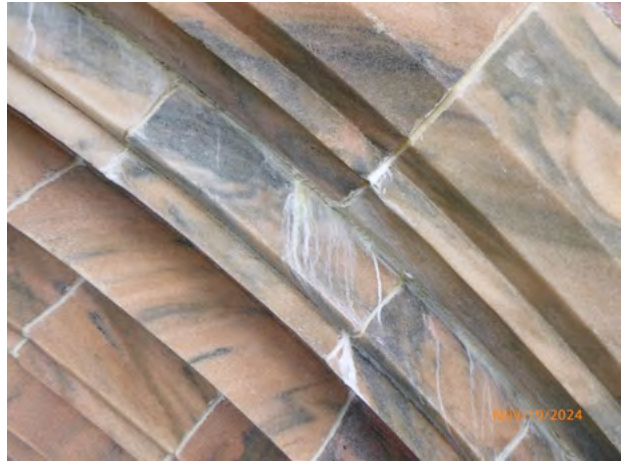
241-178 Stone\_SoilStain Leached Salts 2024-1.jpg

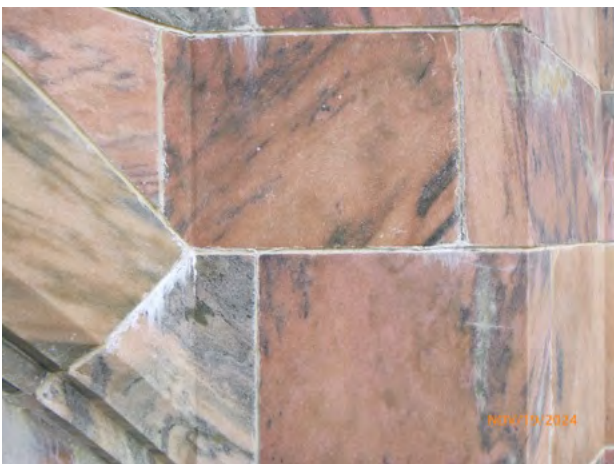
241-178 Stone\_SoilStain Leached Salts 2024-4.jpg

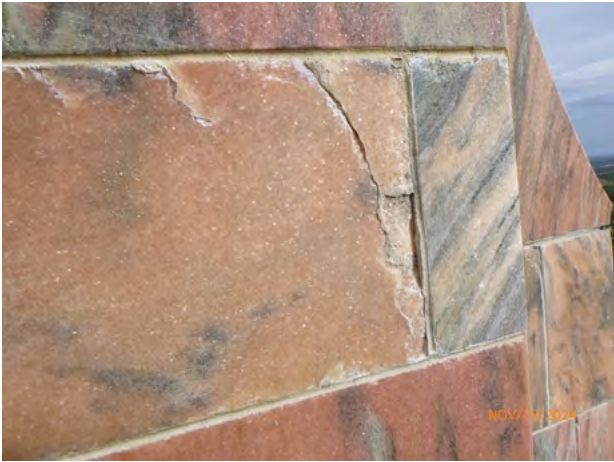
241-178 Stone\_SoilStain Leached Salts 2024-6.jpg

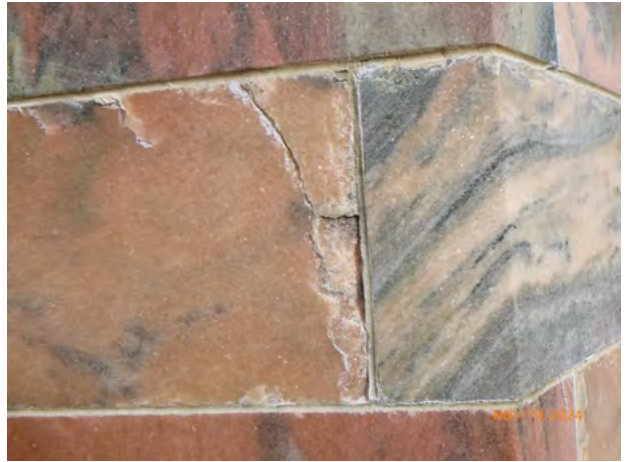
241-181 Stone\_Crack Single unit 2024-1.jpg

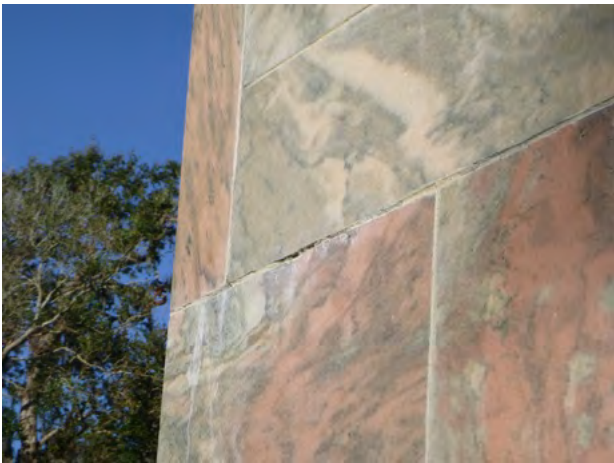
241-181 Stone\_Crack Single unit 2024-2.jpg

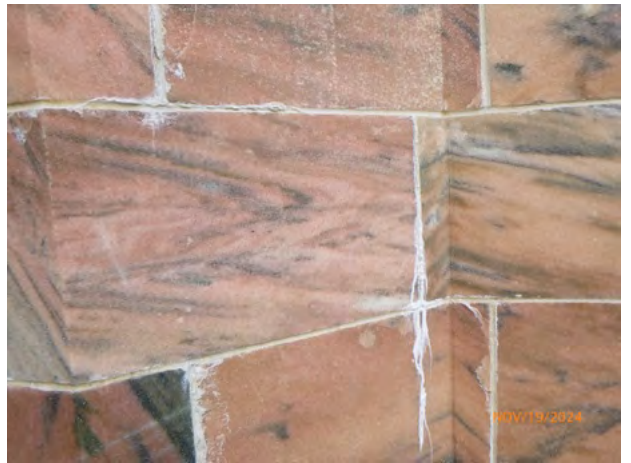
242-10 Stone\_Joints Mortar Failed 2024-1.jpg

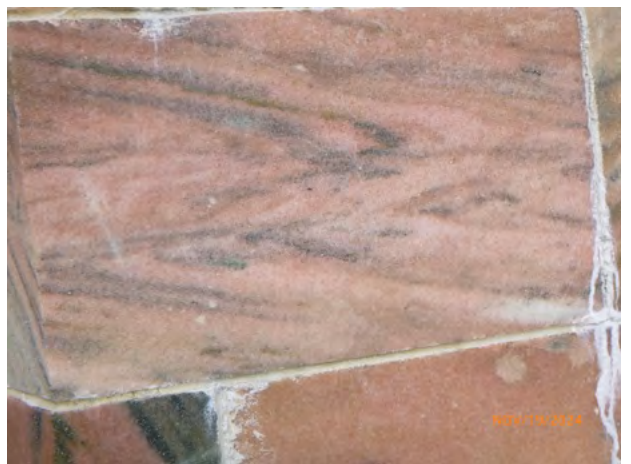
242-164 Stone\_SoilStain Leached Salts 2024-2.jpg

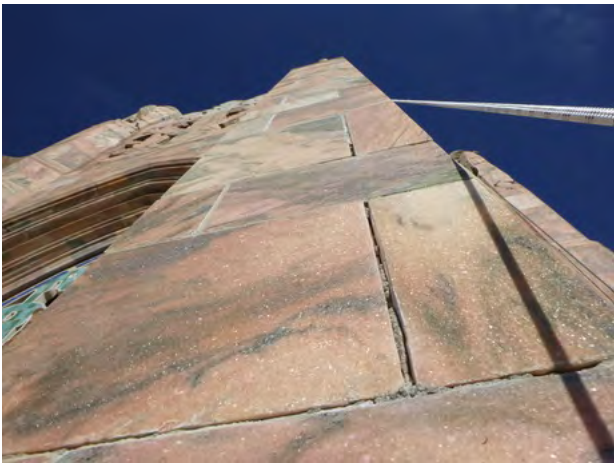
257-28 Stone\_Spall Bonded 2024-1.jpg

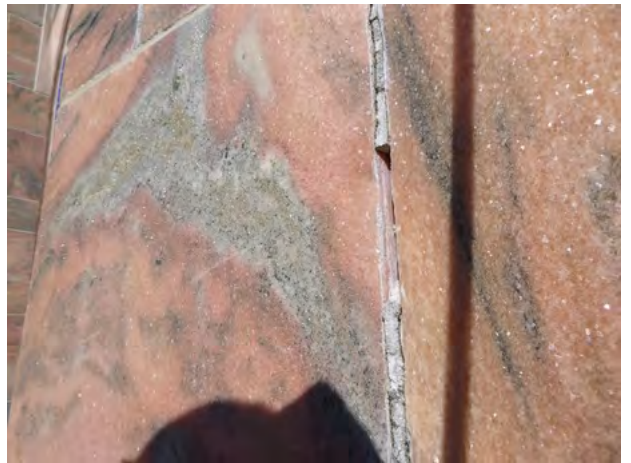
257-166 Stone\_Joints Mortar Failed 2024-1.jpg

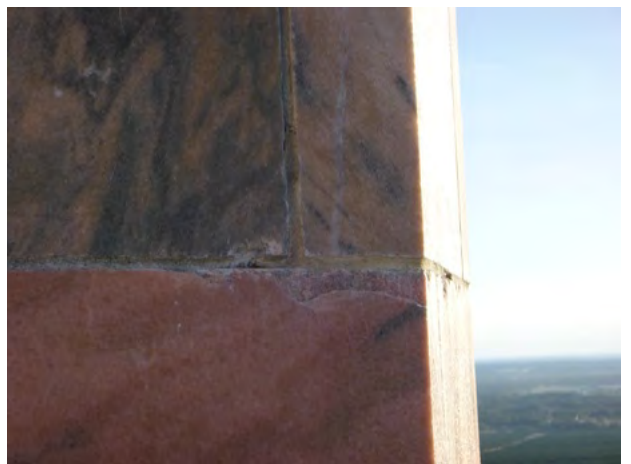
257-183 Stone\_Joints Mortar Failed 2024-1.jpg

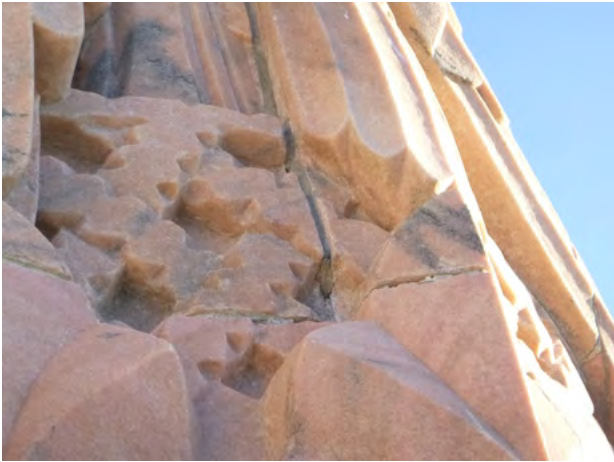
257-189 Stone\_SurfLoss Chipped 2024-1.jpg

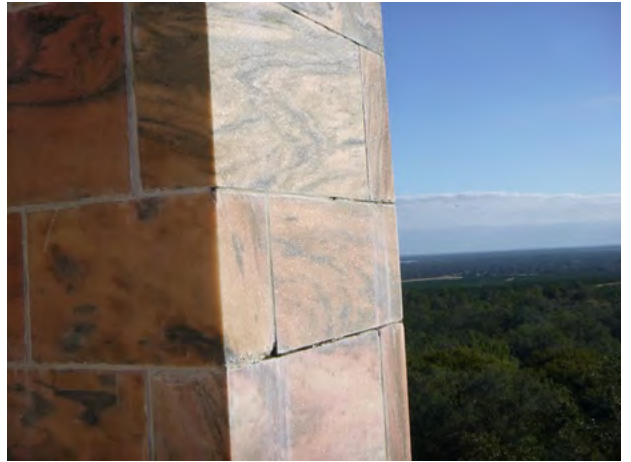
257-192 Stone\_Joints Mortar Failed 2024-1.jpg

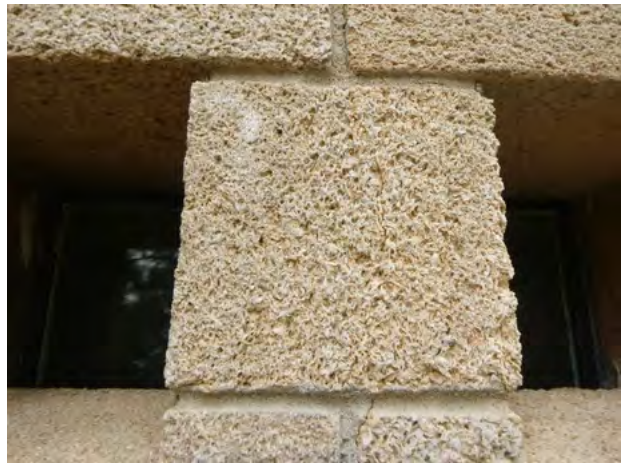
259-5 Stone\_Crack Single unit 2024-1.jpg

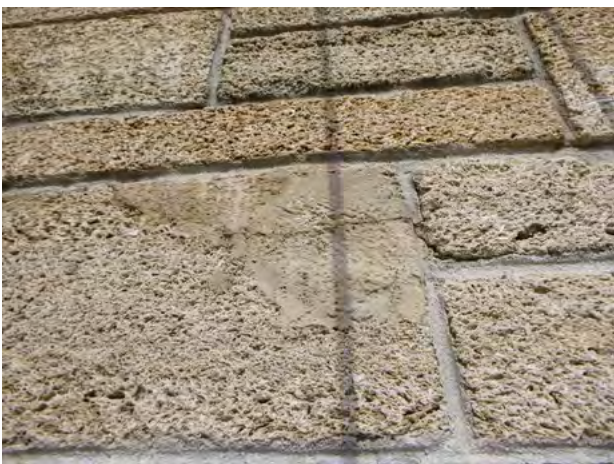
262-11 Stone\_Crack Single unit 2024-1.jpg

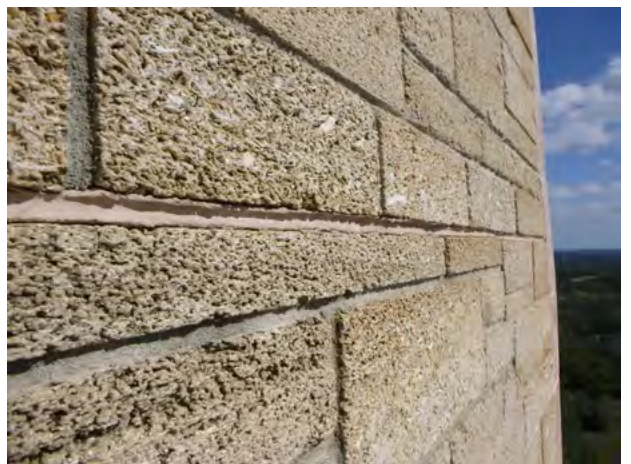
262-120 Stone\_Repair Patch Failed 2024-1.jpg

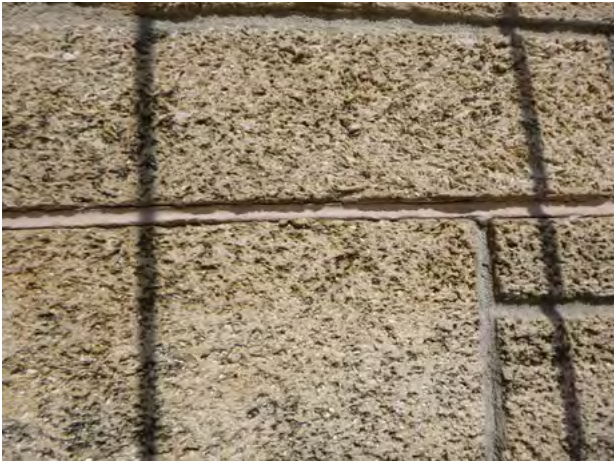
262-121 Stone\_Joints Sealant Failed 2024-1.jpg

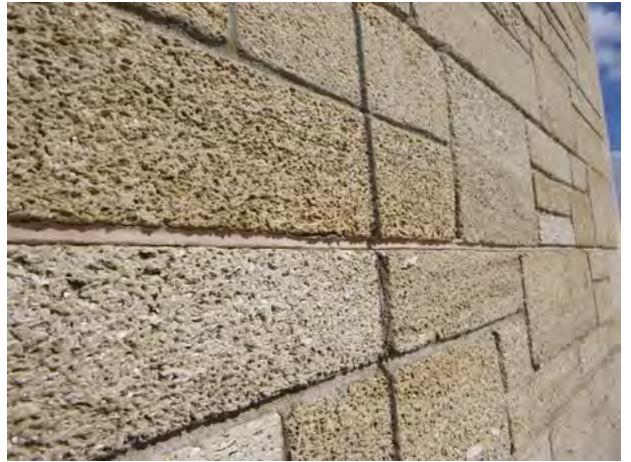
262-121 Stone\_Joints Sealant Failed 2024-2.jpg

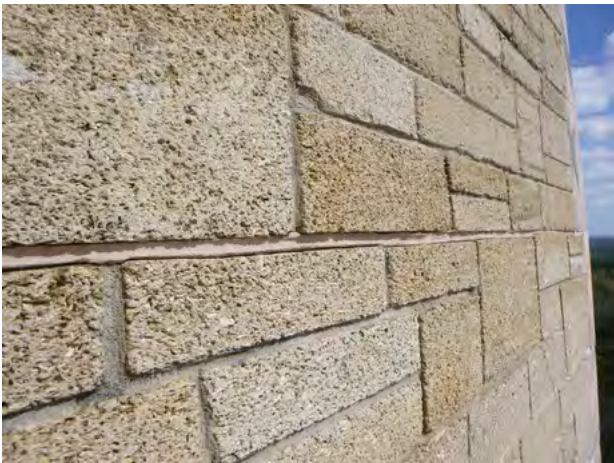
263-100 Stone\_Joints Sealant Failed 2024-1.jpg

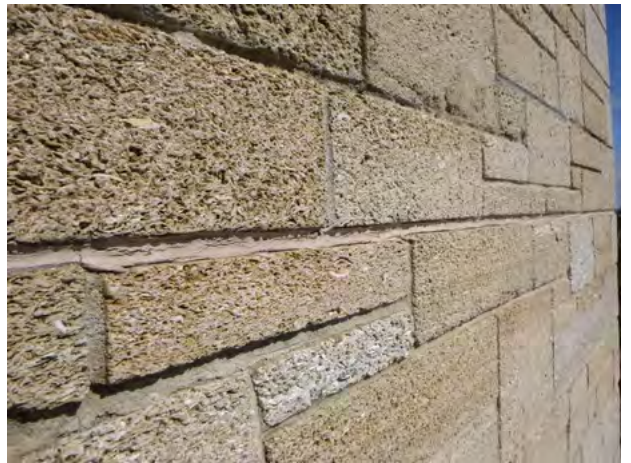
263-125 Stone\_Joints Sealant Failed 2024-1.jpg

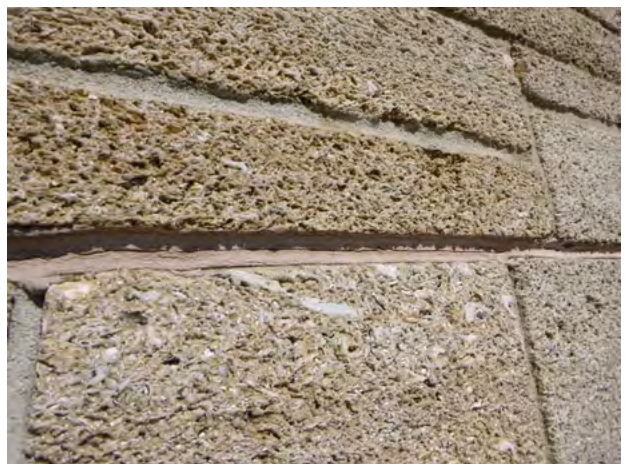
264-82 Stone\_Joints Sealant Failed 2024-1.jpg

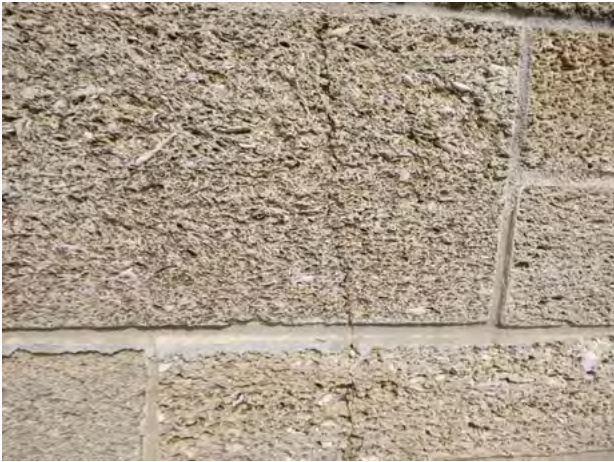
264-82 Stone\_Joints Sealant Failed 2024-2.jpg

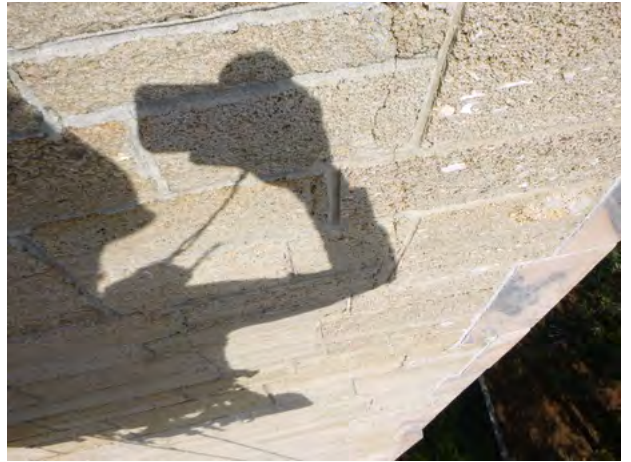
264-132 Stone\_Crack System units and joints 2024-1.jpg

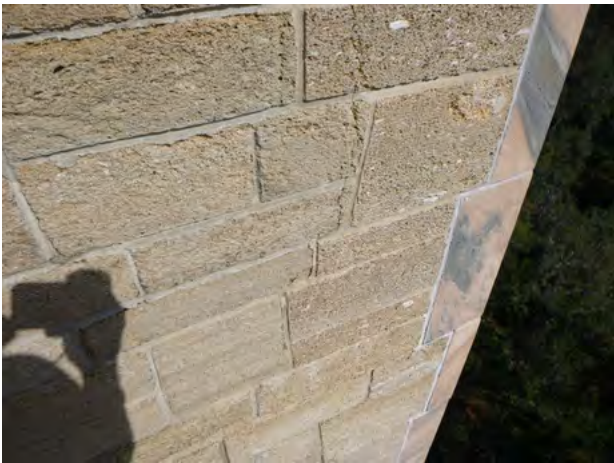
264-132 Stone\_Crack System units and joints 2024-2.jpg

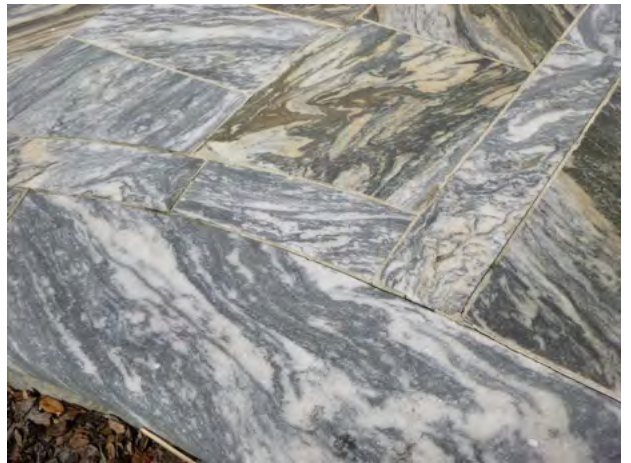
264-132 Stone\_Crack System units and joints 2024-3.jpg
