### ***Bok Singing Tower Roof Restoration and Replacement***

# Bok Singing Tower Conditions Assessment

T.Y. Lin (formerly Silman) was contracted to perform a conditions assessment of the Bok Singing Tower at Bok Tower Gardens in Lake Wales, Florida. The Singing Tower stands 205 feet tall at the southwest corner of the gardens. A moat surrounds the base of the tower with two bridges to access the island. The tower houses a 60-bell carillon, associated carillonneur studio and library spaces, the Bok Tower Gardens Chao Research archive, and the Founder's Room. It is a steel frame construction clad in a masonry exterior of coquina and Georgia pink Etowah marble with brick masonry at the interior.

## **Bok Tower Focused Condition Assessment**

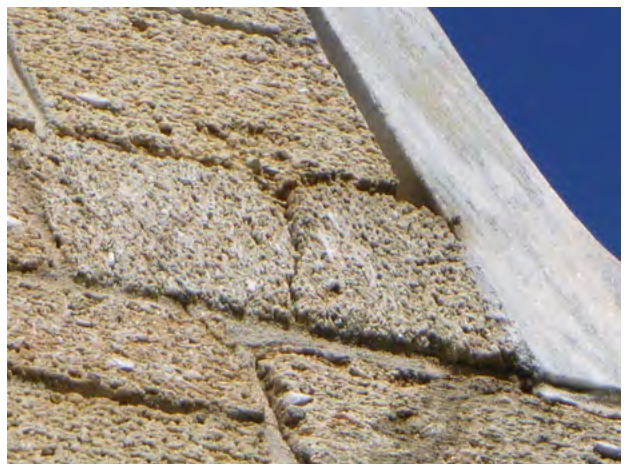
266-90 Stone\_Crack System units and joints 2024-1.jpg

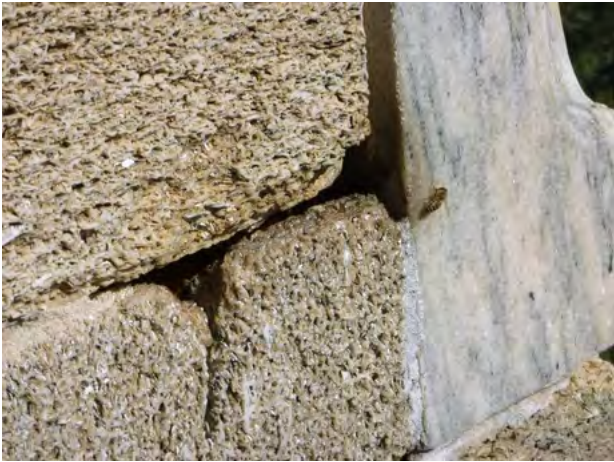
266-90 Stone\_Crack System units and joints 2024-2.jpg

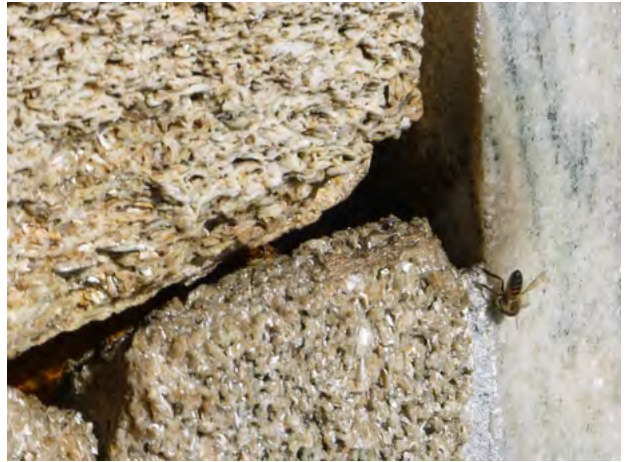
266-92 Stone\_Joints Mortar Missing 2024-1.jpg

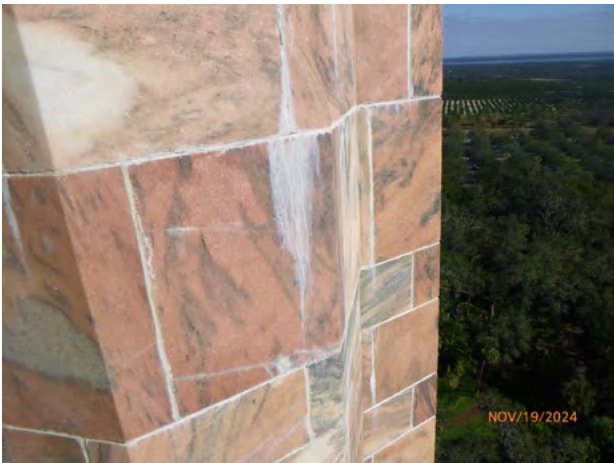
266-92 Stone\_Joints Mortar Missing 2024-2.jpg

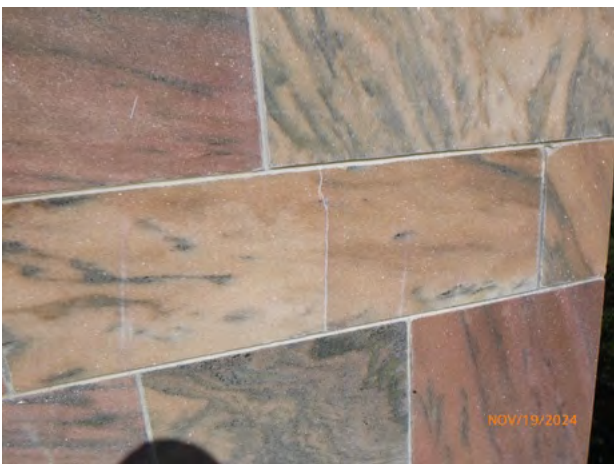
269-169 Stone\_SoilStain Leached Salts 2024-2.jpg

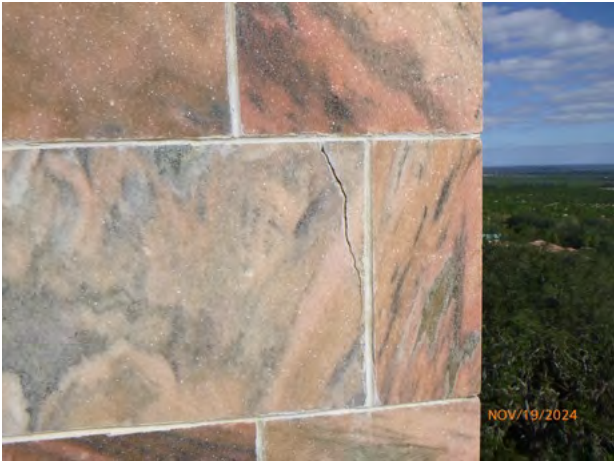
271-75 Stone\_Crack Single unit 2024-2.jpg

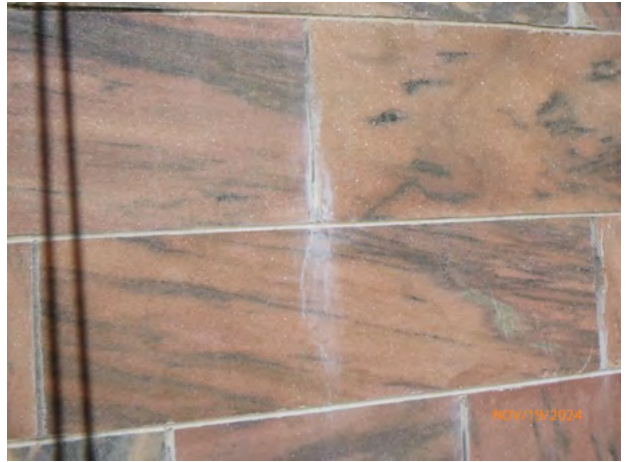
271-147 Stone\_Crack Single unit 2024-1.jpg

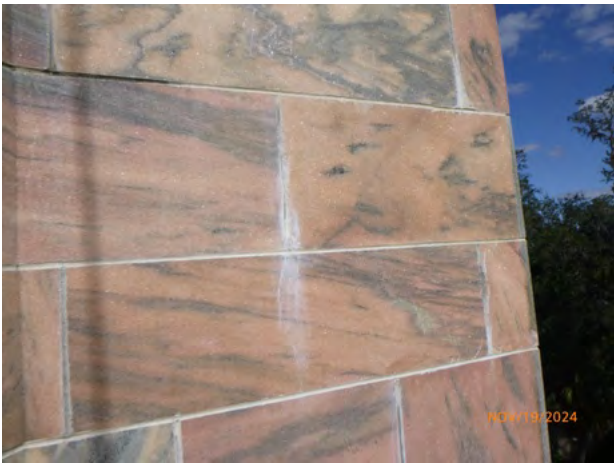
272-35 Stone\_SoilStain Leached Salts 2024-1.jpg

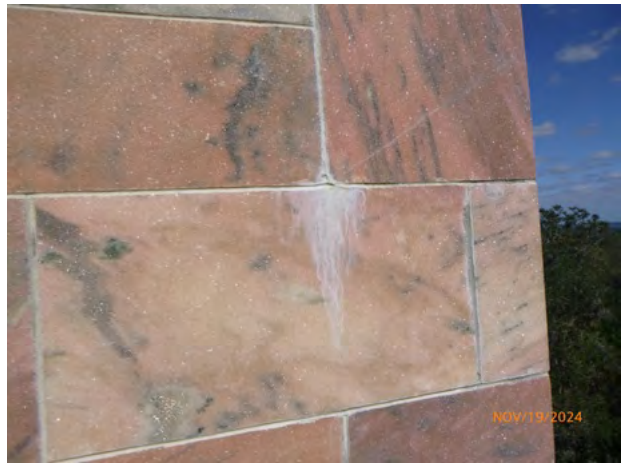
272-35 Stone\_SoilStain Leached Salts 2024-2.jpg

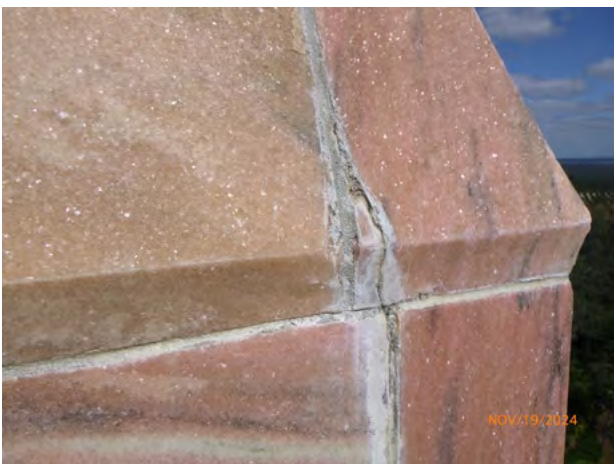
272-71 Stone\_SoilStain Leached Salts 2024-1.jpg

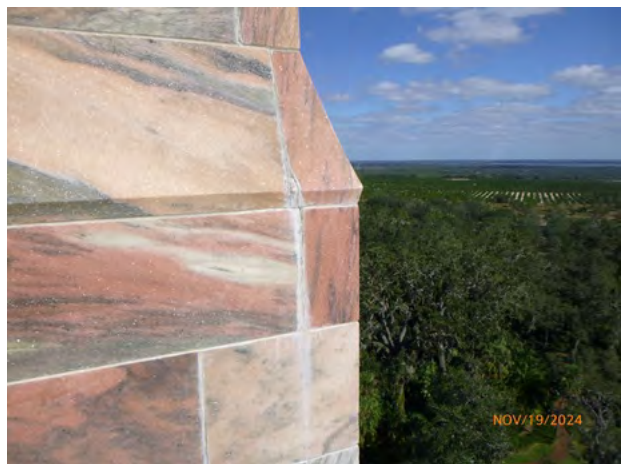
272-121 Stone\_Crack Single unit 2024-1.jpg

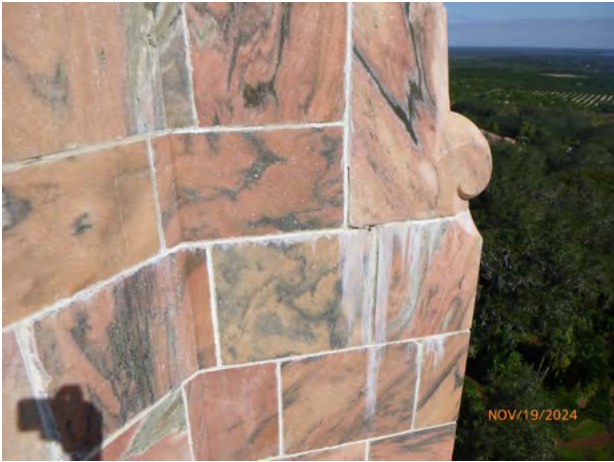
272-121 Stone\_Crack Single unit 2024-2.jpg

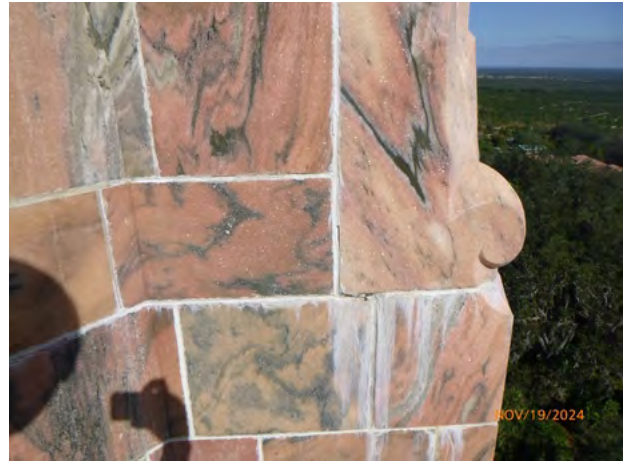
272-156 Stone\_SoilStain Leached Salts 2024-1.jpg

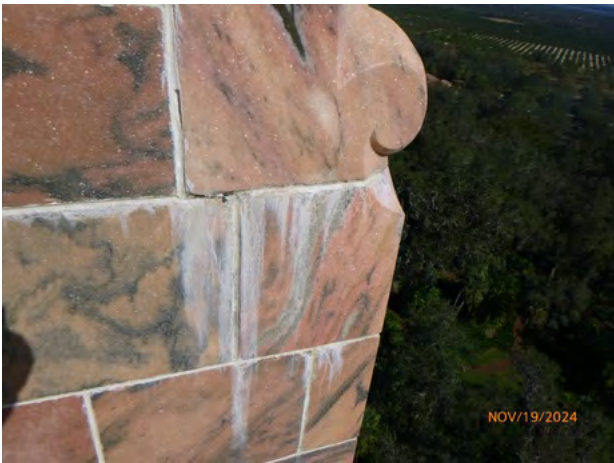
272-156 Stone\_SoilStain Leached Salts 2024-2.jpg

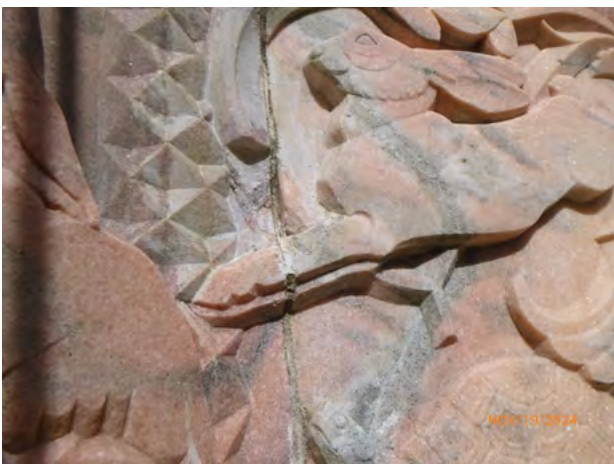
273-11 Stone\_Crack System units 2024-1.jpg

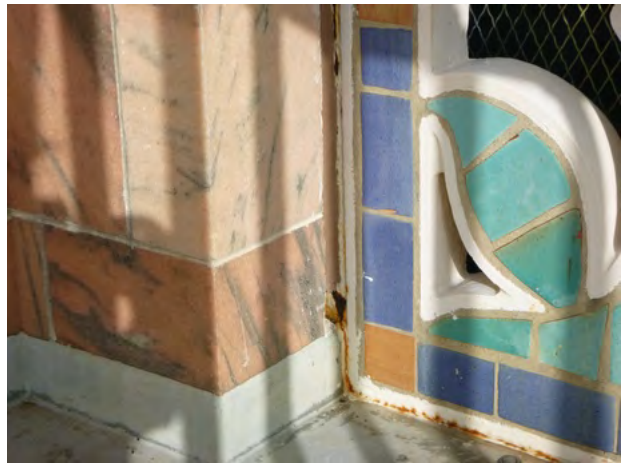
282-134 Stone\_Spall Bonded 2024-1.jpg

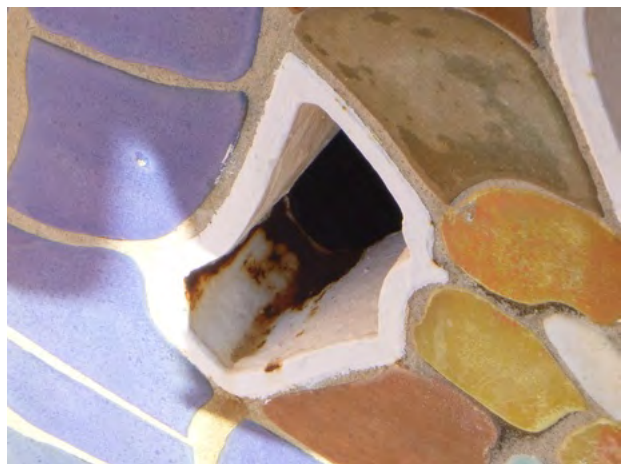
284-159 ArchMetal\_Corrosion Surface 2024-1.jpg

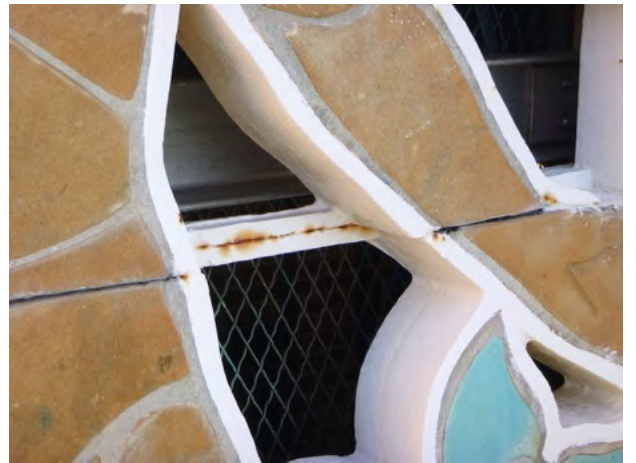
287-133 ArchMetal\_Corrosion Surface 2024-1.jpg

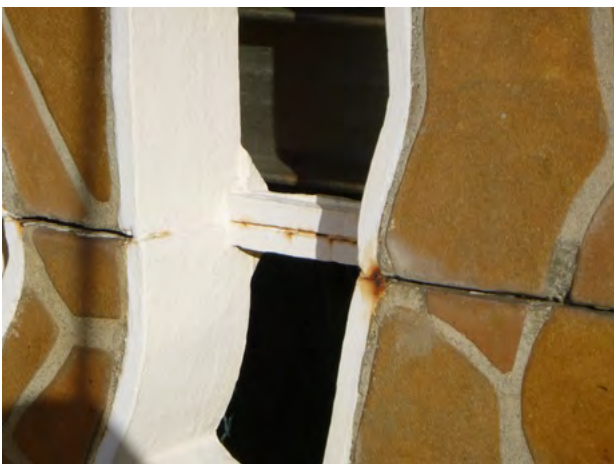
287-133 ArchMetal\_Corrosion Surface 2024-2.jpg

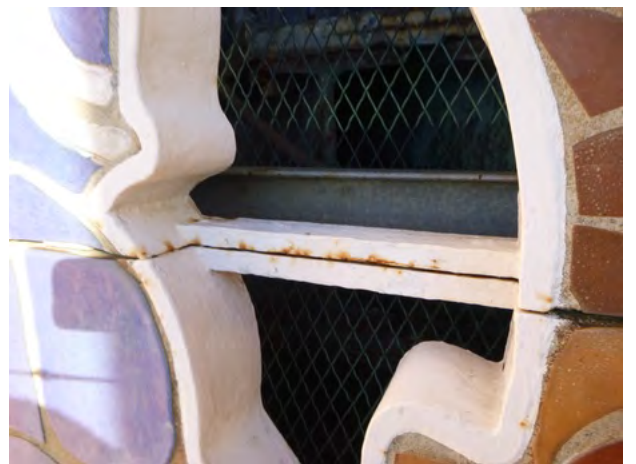
287-133 ArchMetal\_Corrosion Surface 2024-3.jpg

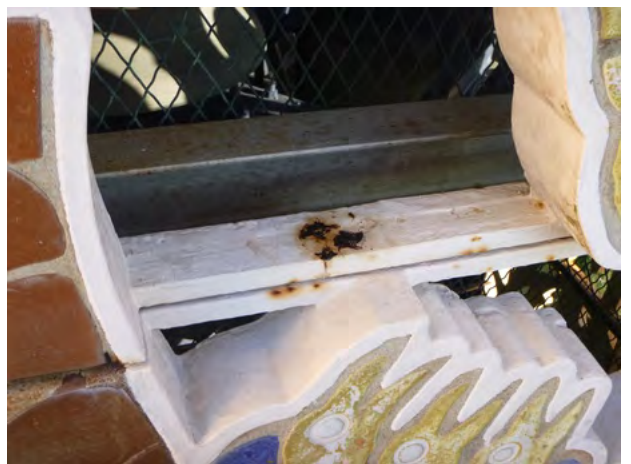
288-155 ArchMetal\_Corrosion Surface 2024-1.jpg

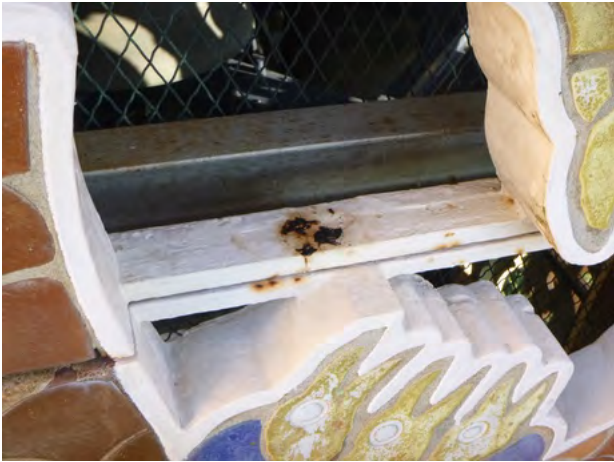
288-169 ArchMetal\_Coating Coating Failed 2024-1.jpg

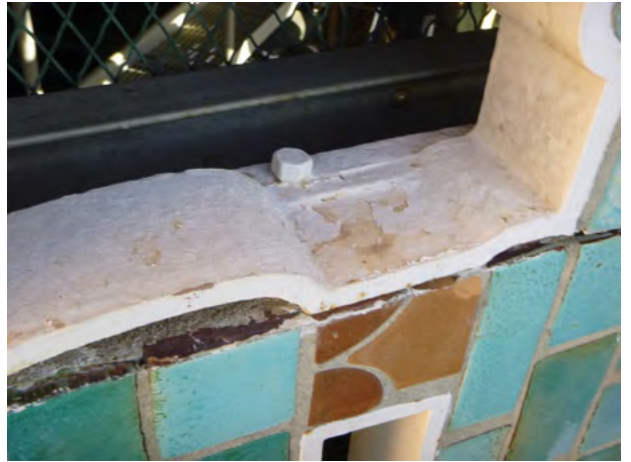
289-168 ArchMetal\_Corrosion Surface 2024-1.jpg

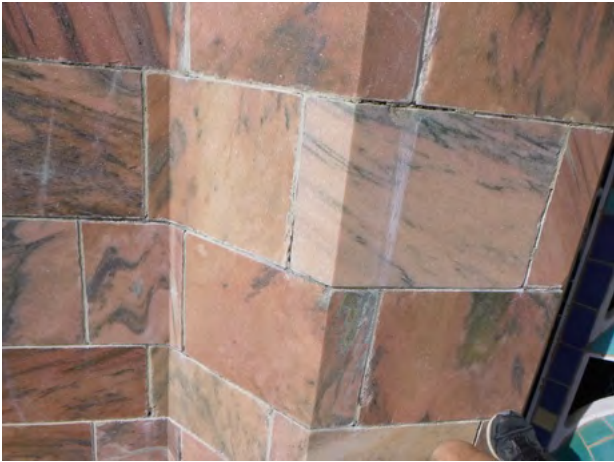
305-156 Stone\_Joints Mortar Failed 2024-1.jpg

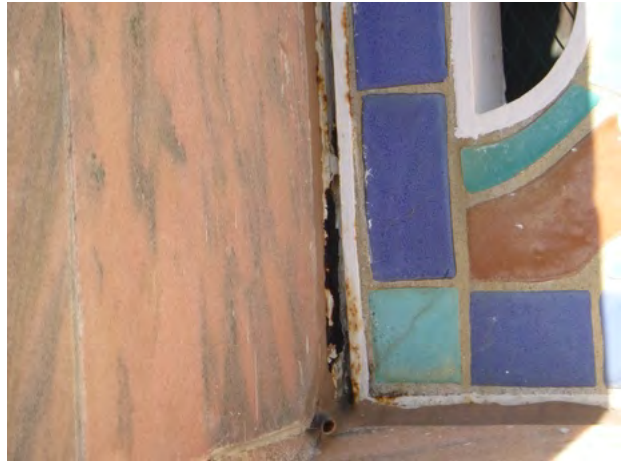
305-156 Stone\_Joints Mortar Failed 2024-2.jpg

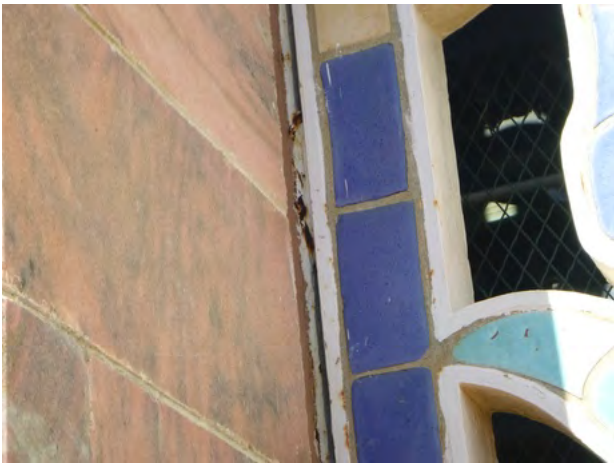
308-145 ArchMetal\_Corrosion Pitted 2024-1.jpg

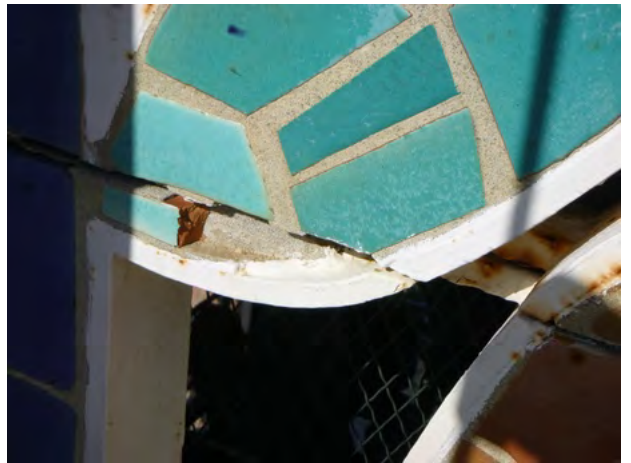
308-145 ArchMetal\_Corrosion Pitted 2024-2.jpg

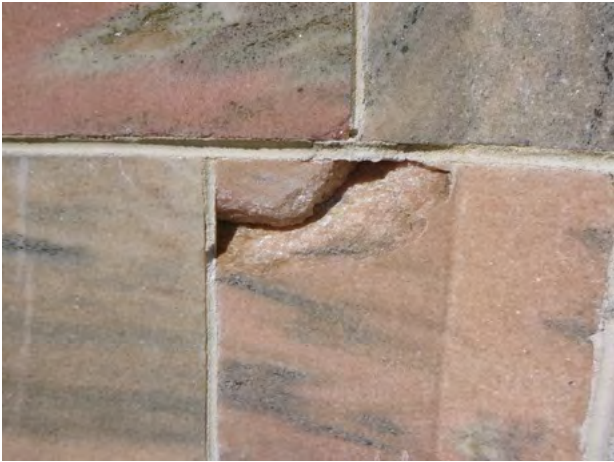
331-48 Stone\_Spall Removed 2024-2.jpg

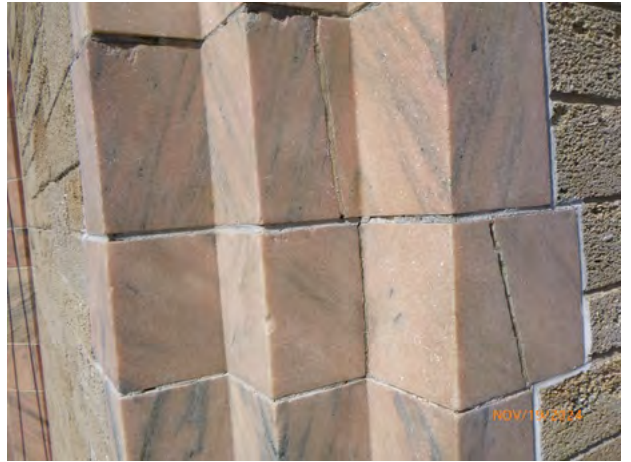
333-132 Stone\_Crack Repair failed 2024-1.jpg

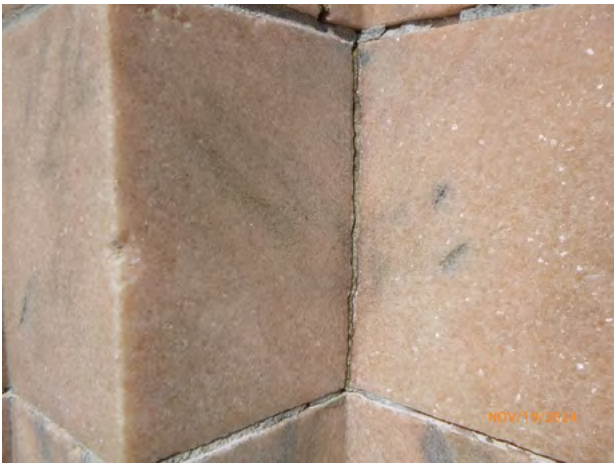
333-132 Stone\_Crack Repair failed 2024-2.jpg

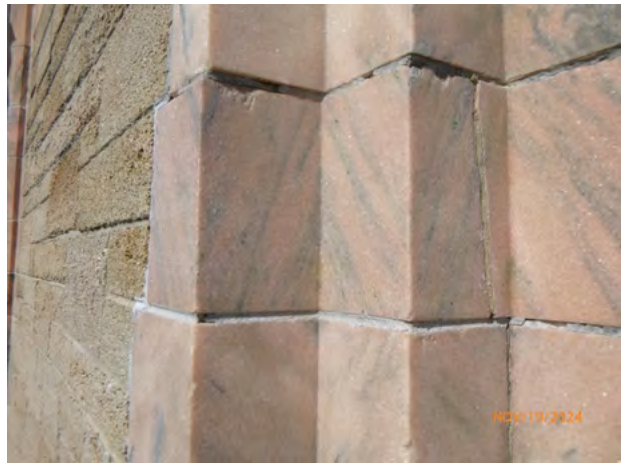
333-132 Stone\_Crack Repair failed 2024-3.jpg

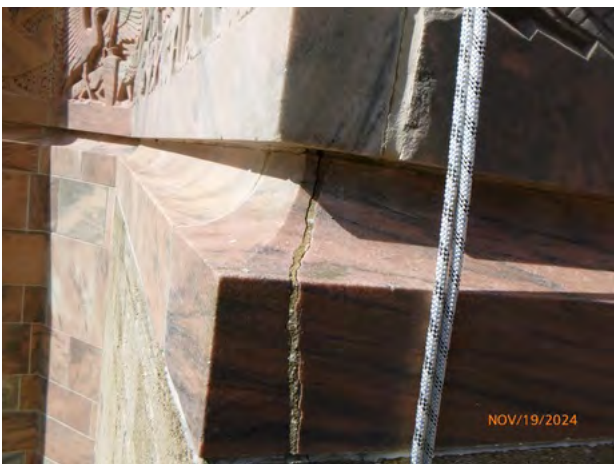
334-28 Stone\_Crack Repair failed 2024-1.jpg

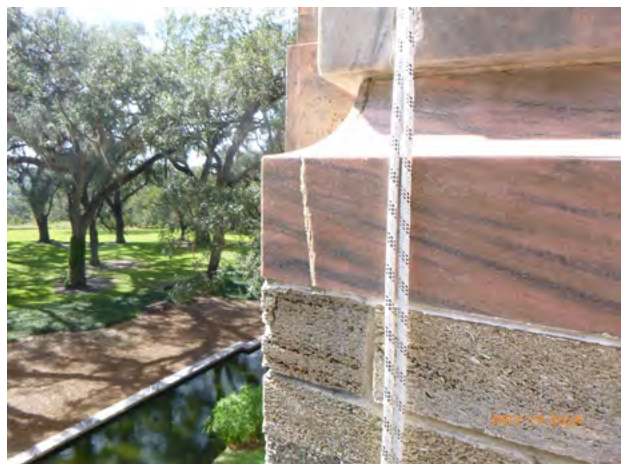
334-28 Stone\_Crack Repair failed 2024-2.jpg

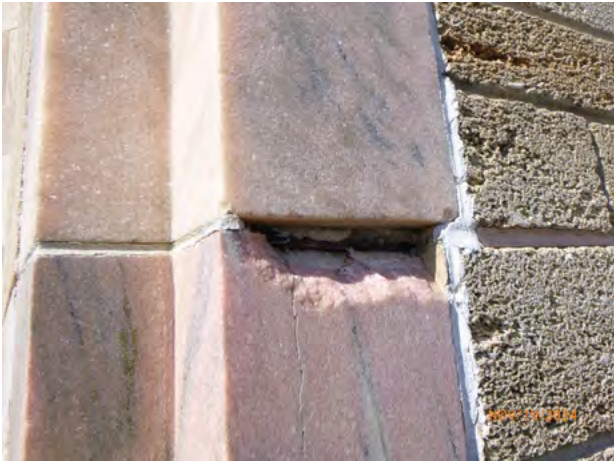
334-98 Stone\_Spall Missing + Steel 2024-1.jpg

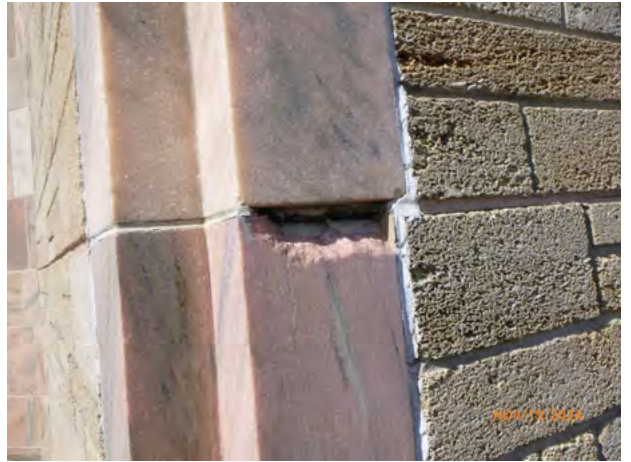
334-98 Stone\_Spall Missing + Steel 2024-2.jpg

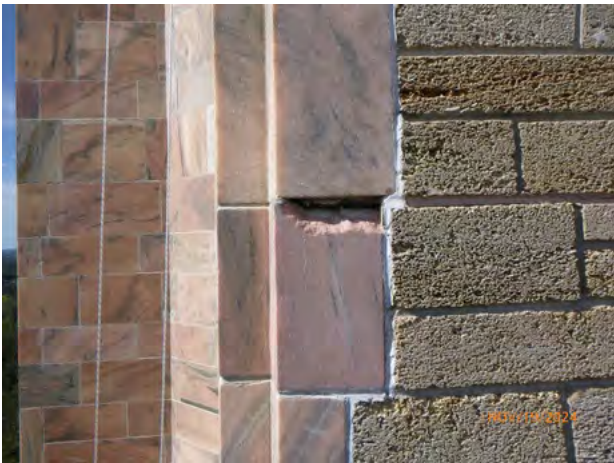
334-98 Stone\_Spall Missing + Steel 2024-3.jpg

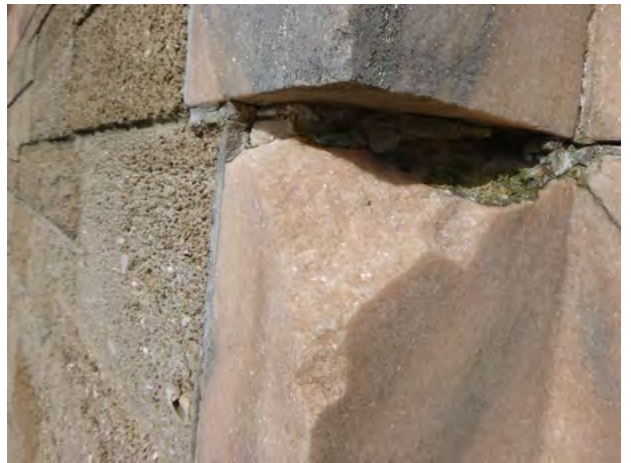
334-135 Stone\_Spall Missing 2024-1.jpg

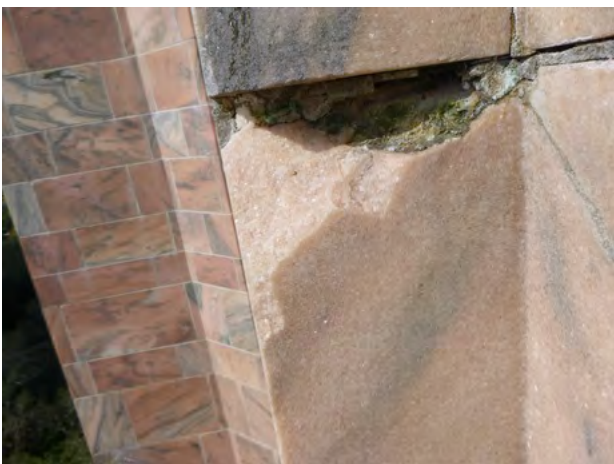
334-135 Stone\_Spall Removed 2024-1.jpg

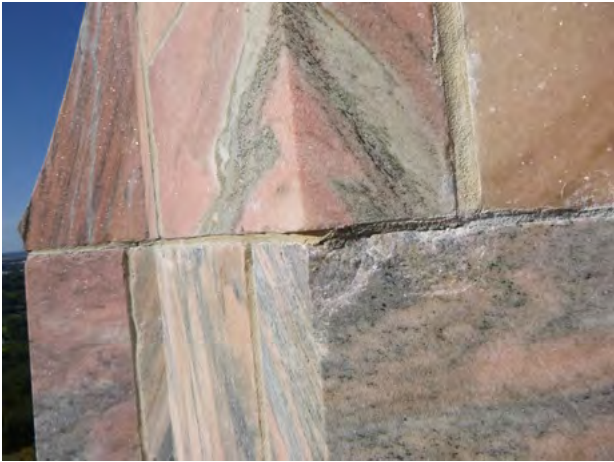
334-182 Stone\_SurfLoss Chipped 2024-1.jpg

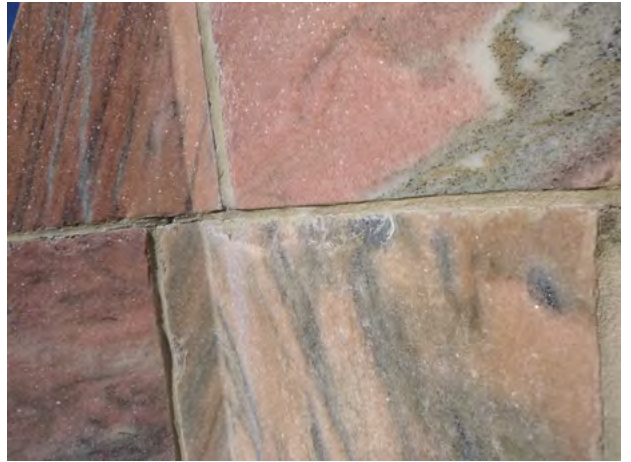
334-182 Stone\_SurfLoss Chipped 2024-2.jpg

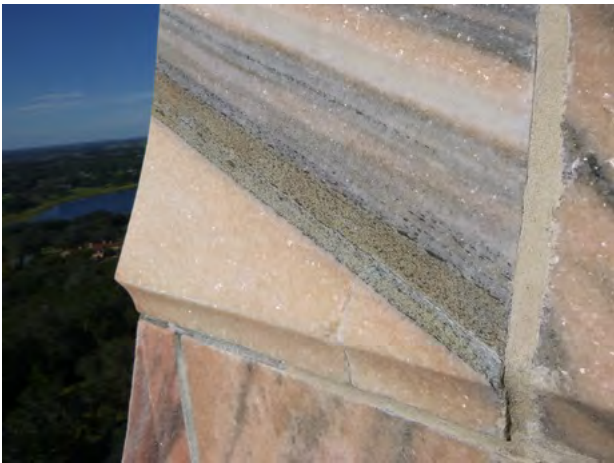
334-183 Stone\_Crack Single unit 2024-1.jpg

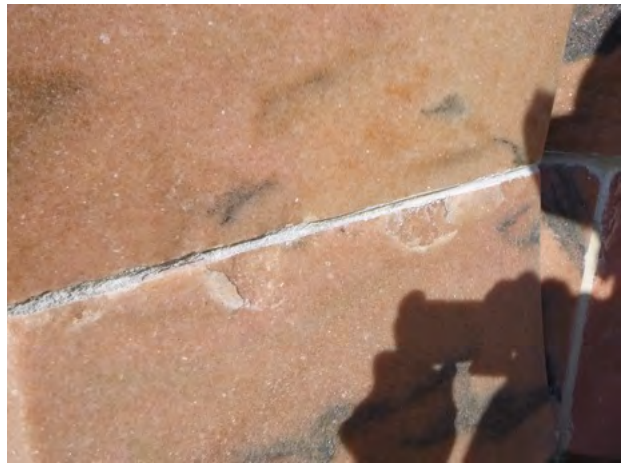
334-184 Stone\_SurfLoss Chipped 2024-1.jpg

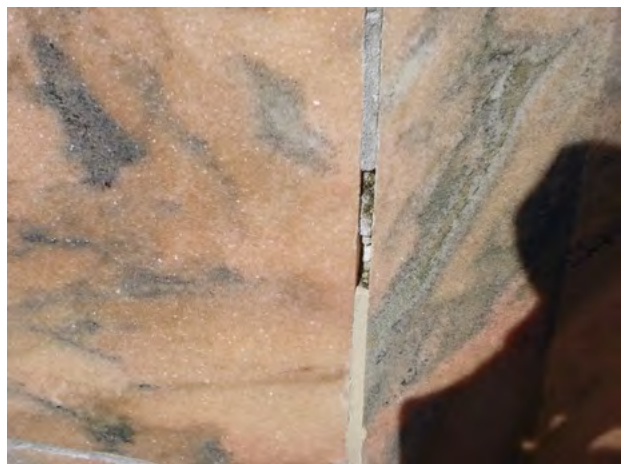
334-186 Stone\_Joints Mortar Failed 2024-2.jpg

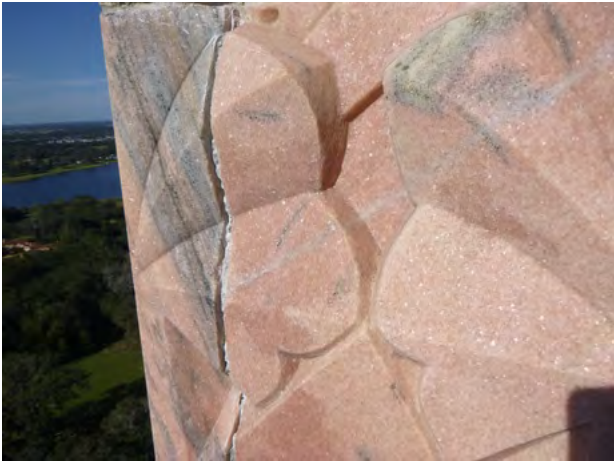
334-192 Stone\_Joints Mortar Failed 2024-1.jpg

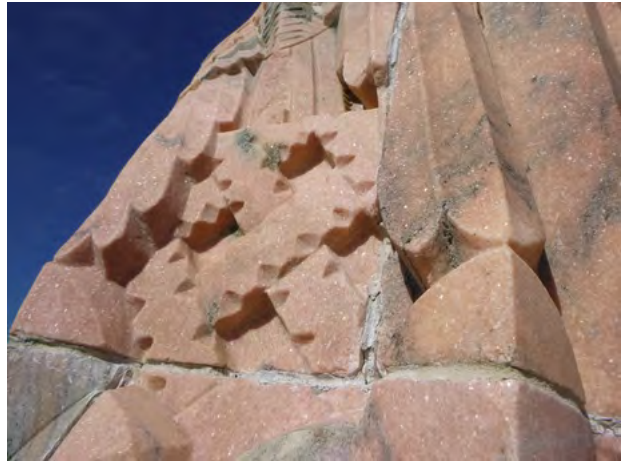
334-192 Stone\_Joints Mortar Failed 2024-2.jpg

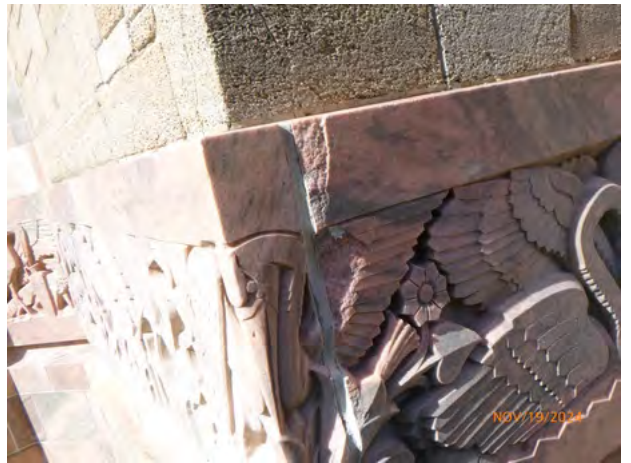
335-30 Stone\_SurfLoss Chipped 2024-1.jpg

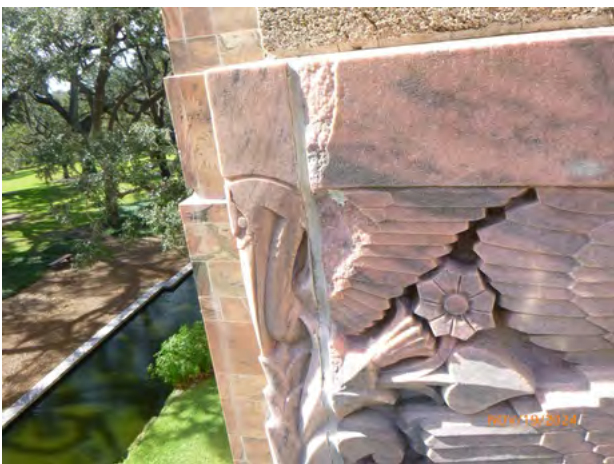
335-30 Stone\_SurfLoss Chipped 2024-2.jpg

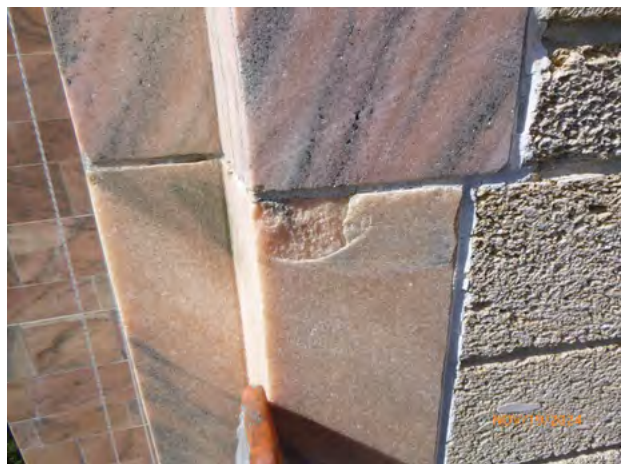
335-105 Stone\_SurfLoss Chipped 2024-1.jpg

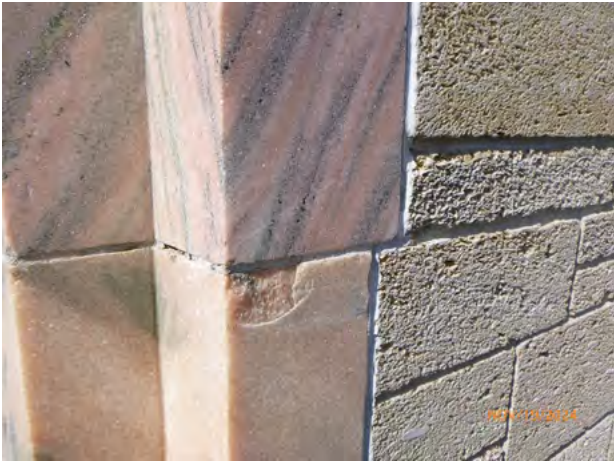
335-105 Stone\_SurfLoss Chipped 2024-2.jpg

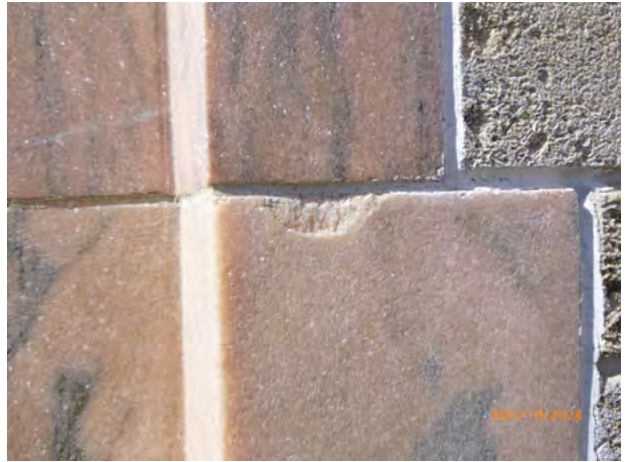
335-107 Stone\_SurfLoss Chipped 2024-1.jpg

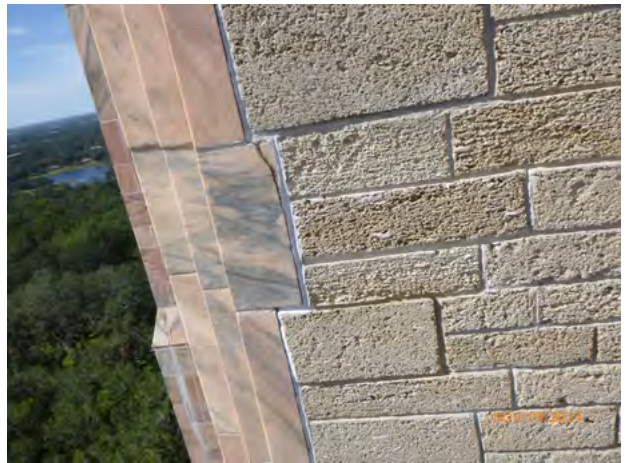
335-128 Stone\_Crack Repair failed 2024-2.jpg

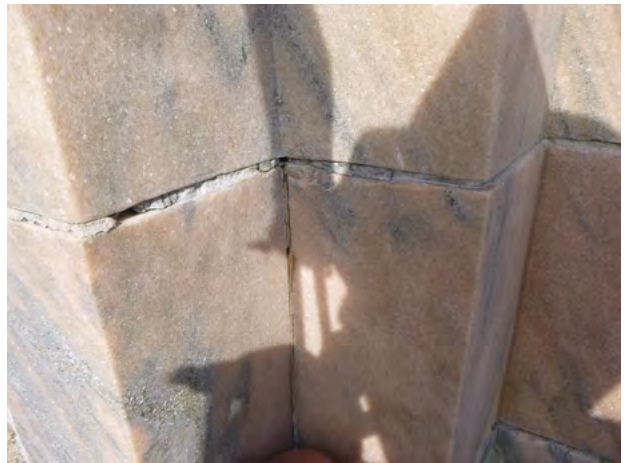
335-136 Stone\_Joints Mortar Failed 2024-1.jpg

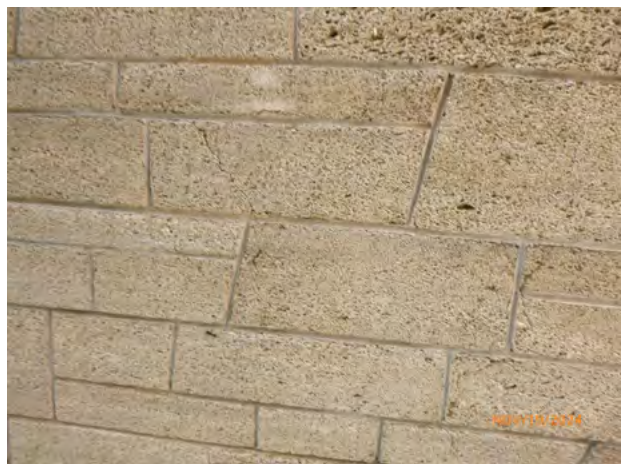
336-13 Stone\_Crack System units and joints 2024-1.jpg

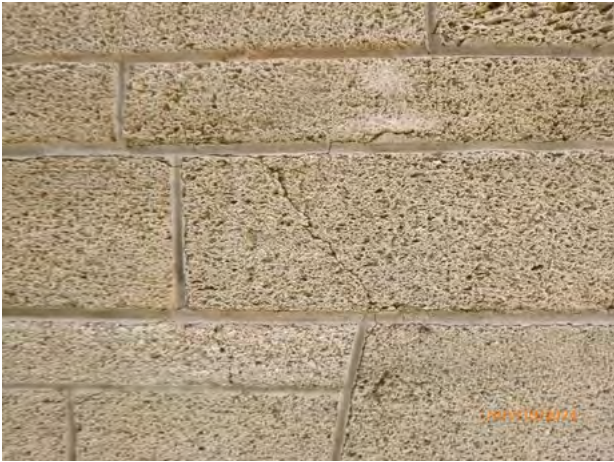
336-13 Stone\_Crack System units and joints 2024-2.jpg

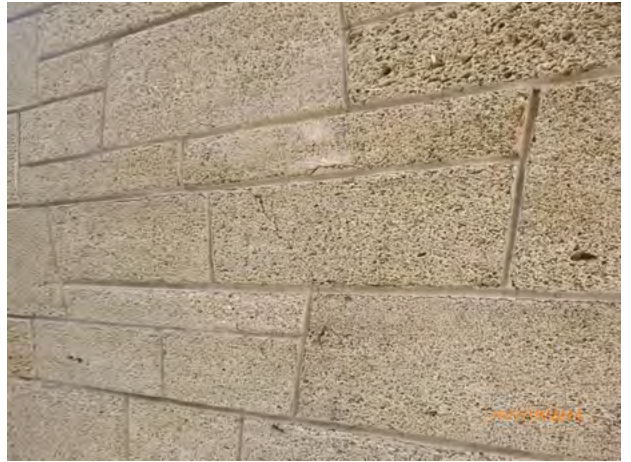
336-13 Stone\_Crack System units and joints 2024-3.jpg

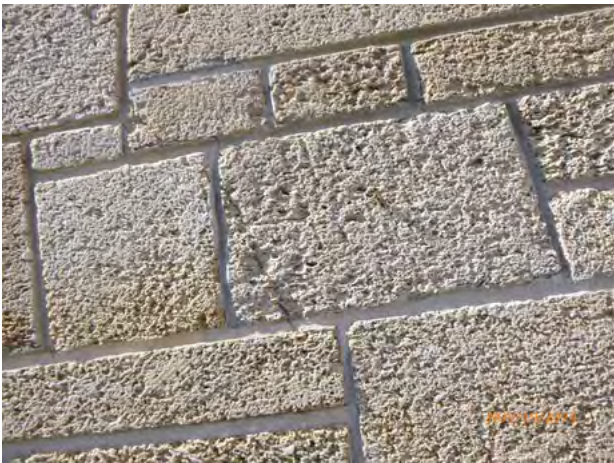
336-82 Stone\_Crack Single unit 2024-1.jpg

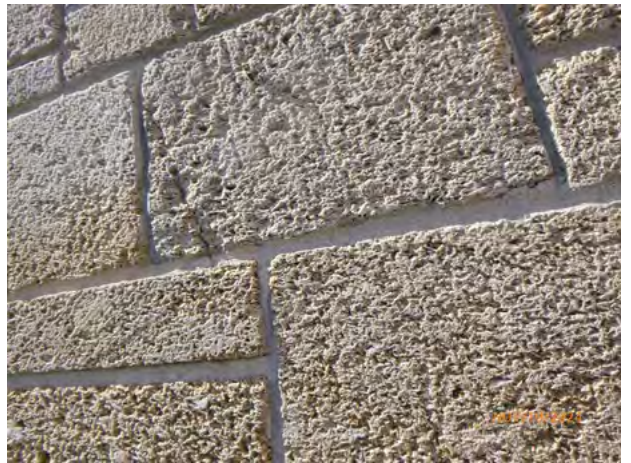
336-82 Stone\_Crack Single unit 2024-2.jpg

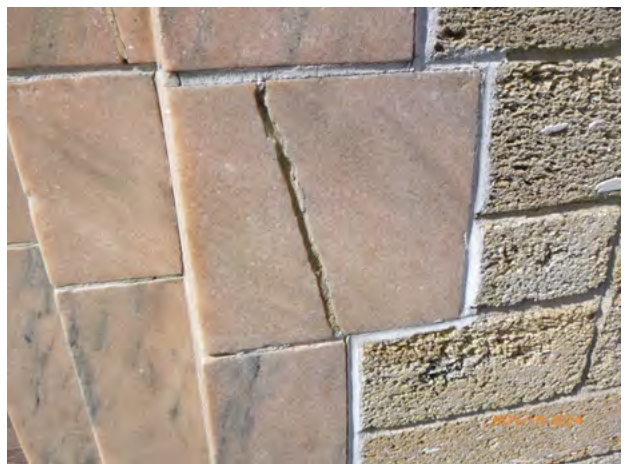
336-125 Stone\_Crack Single unit 2024-1.jpg

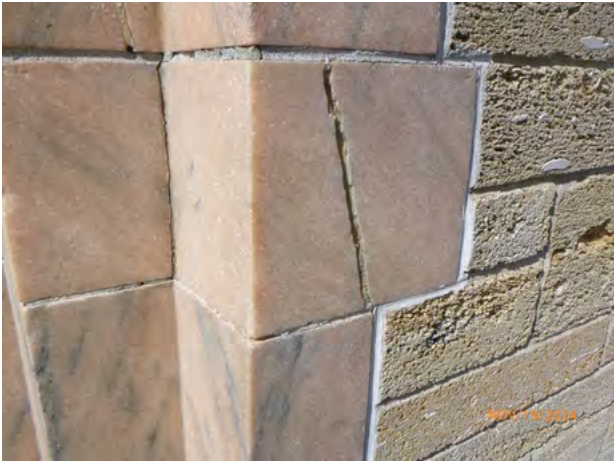
336-132 Stone\_Crack Repair failed 2024-1.jpg

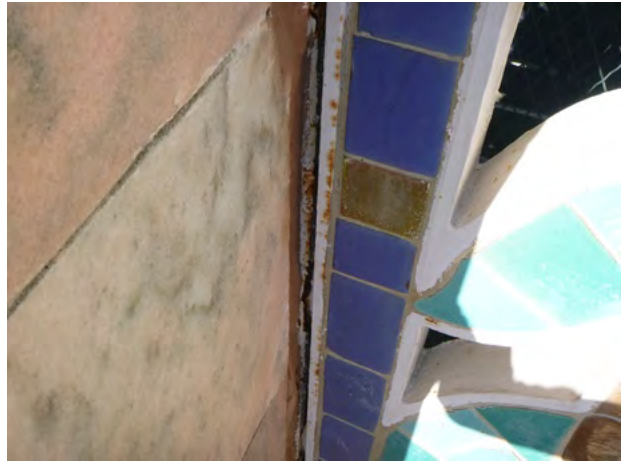
336-132 Stone\_Crack Repair failed 2024-2.jpg

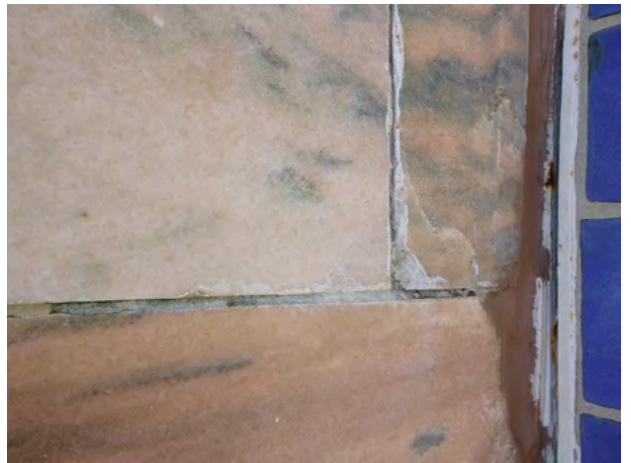
336-174 Stone\_Joints Mortar Failed 2024-1.jpg

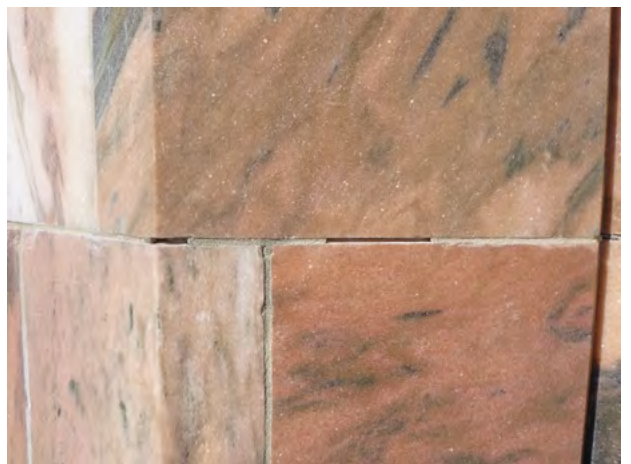
336-178 Stone\_SoilStain Leached Salts 2024-1.jpg

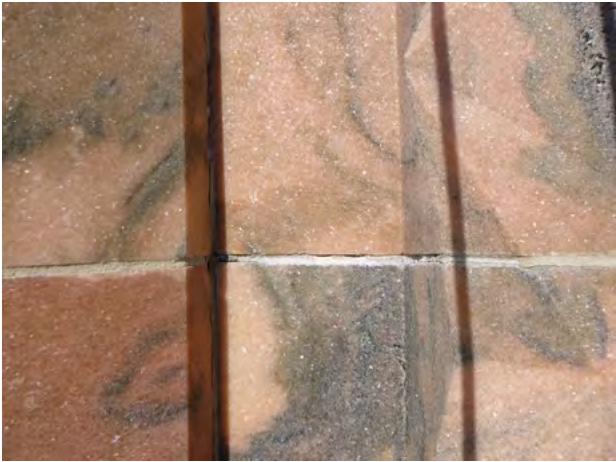
336-188 Stone\_Joints Mortar Failed 2024-1.jpg

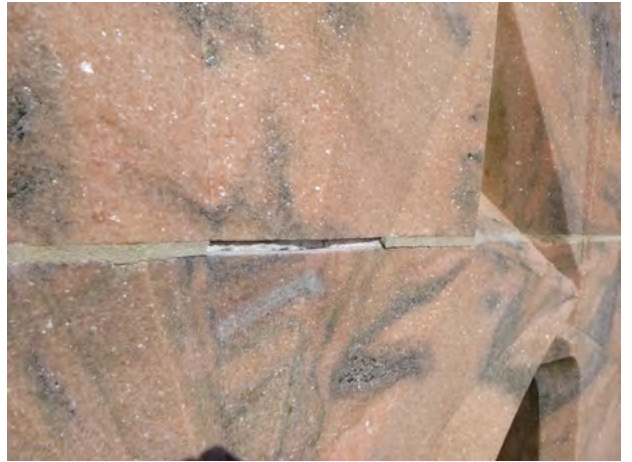
336-188 Stone\_Joints Mortar Failed 2024-2.jpg

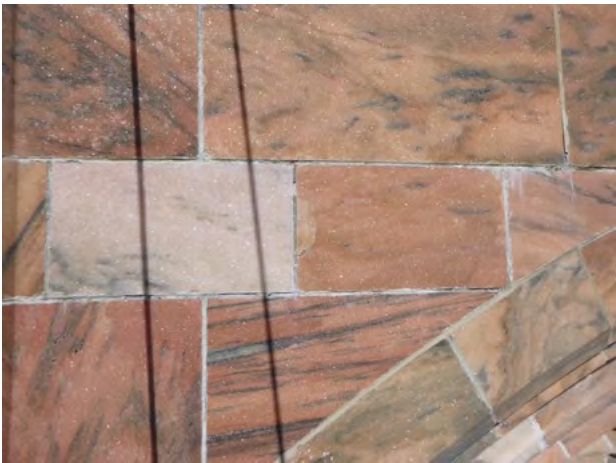
336-188 Stone\_Joints Mortar Failed 2024-3.jpg

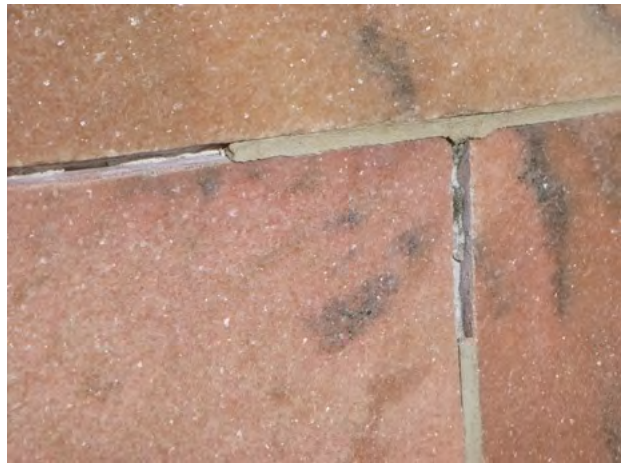
337-181 Stone\_Joints Mortar Failed 2024-1.jpg

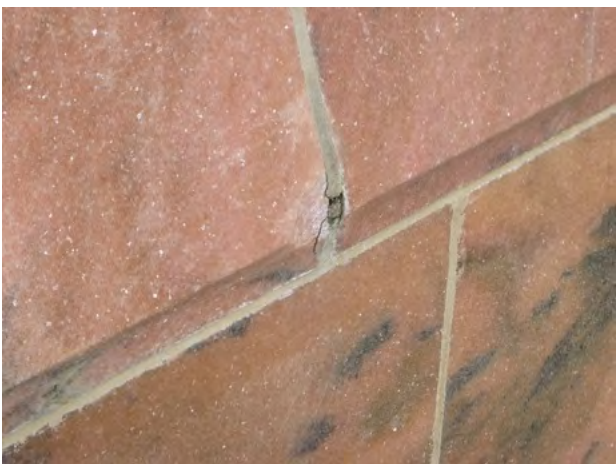
338-184 Stone\_Joints Mortar Failed 2024-1.jpg

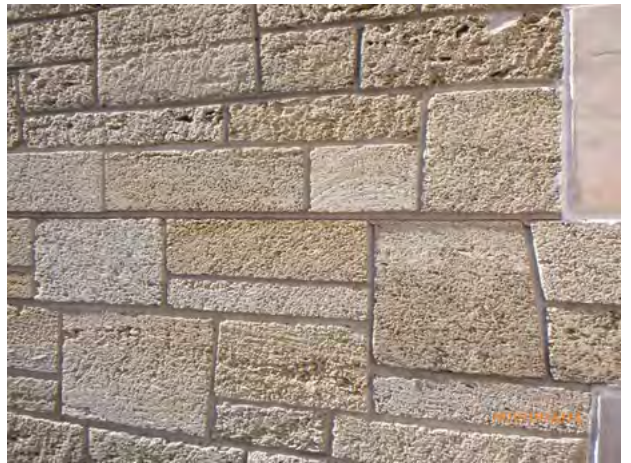
340-45 Stone\_Spall Bonded 2024-3.jpg

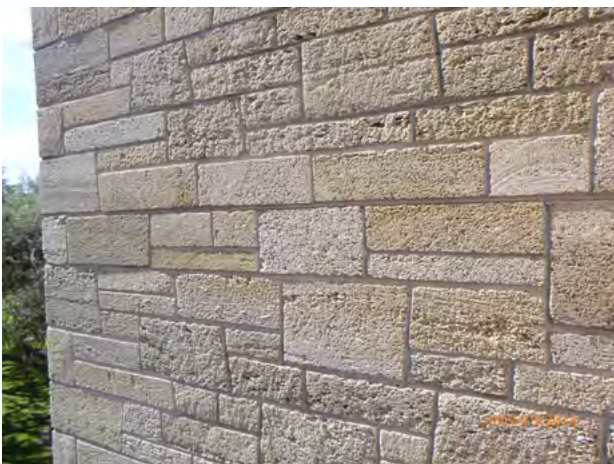
340-53 Stone\_Joints Sealant Failed 2024-1.jpg

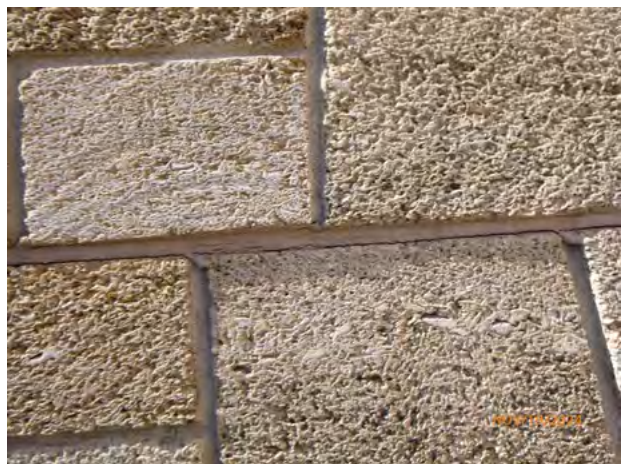
340-53 Stone\_Joints Sealant Failed 2024-2.jpg

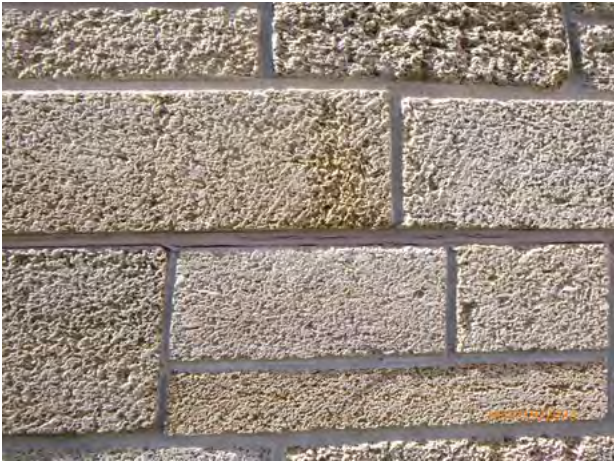
340-53 Stone\_Joints Sealant Failed 2024-3.jpg

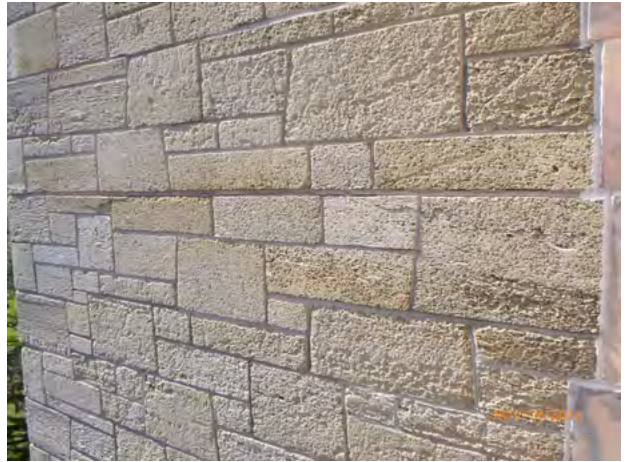
340-53 Stone\_Joints Sealant Failed 2024-4.jpg

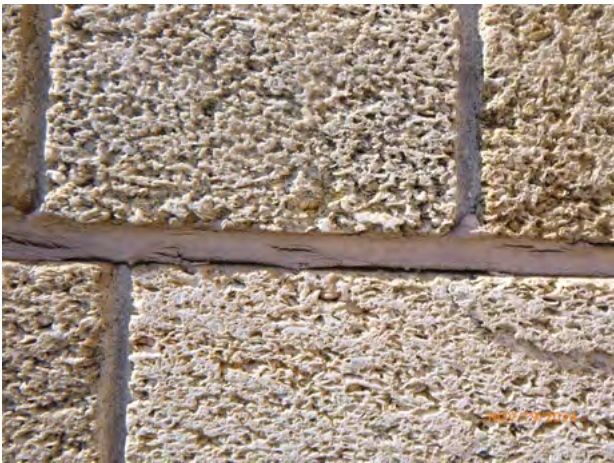
340-68 Stone\_Joints Sealant Failed 2024-1.jpg

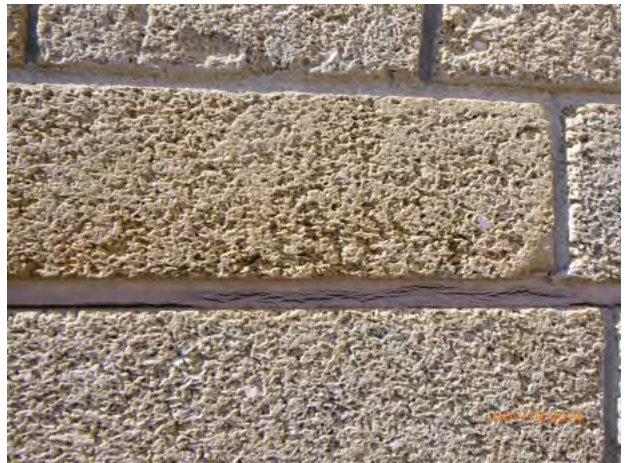
340-68 Stone\_Joints Sealant Failed 2024-2.jpg

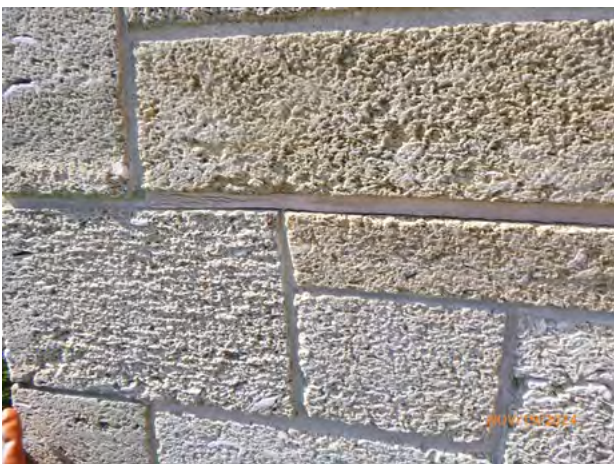
340-68 Stone\_Joints Sealant Failed 2024-3.jpg

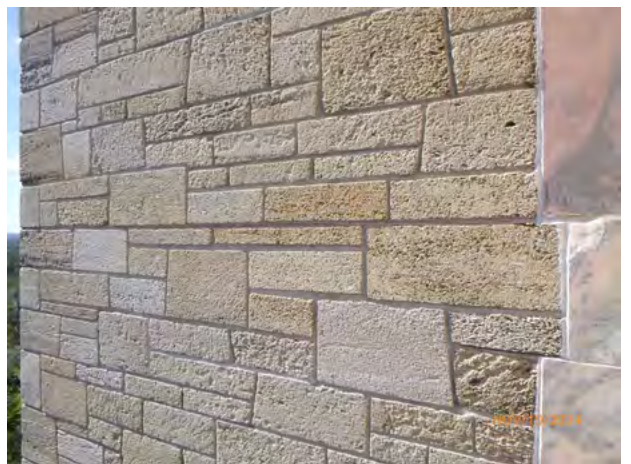
340-68 Stone\_Joints Sealant Failed 2024-4.jpg
