### ***Bok Singing Tower Roof Restoration and Replacement***

# Bok Singing Tower Conditions Assessment

T.Y. Lin (formerly Silman) was contracted to perform a conditions assessment of the Bok Singing Tower at Bok Tower Gardens in Lake Wales, Florida. The Singing Tower stands 205 feet tall at the southwest corner of the gardens. A moat surrounds the base of the tower with two bridges to access the island. The tower houses a 60-bell carillon, associated carillonneur studio and library spaces, the Bok Tower Gardens Chao Research archive, and the Founder's Room. It is a steel frame construction clad in a masonry exterior of coquina and Georgia pink Etowah marble with brick masonry at the interior.

## **Bok Tower Focused Condition Assessment**

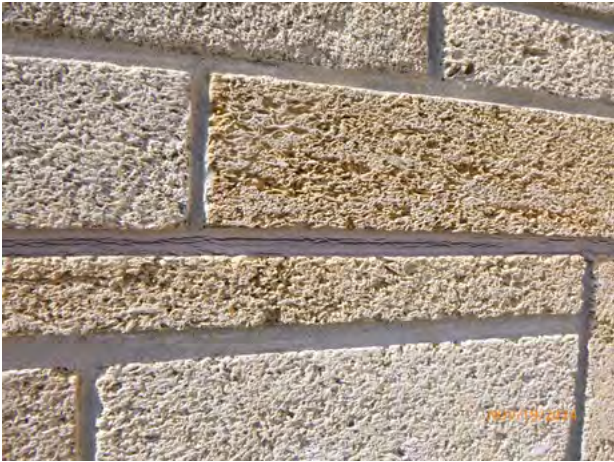
340-80 Stone\_Joints Sealant Failed 2024-1.jpg

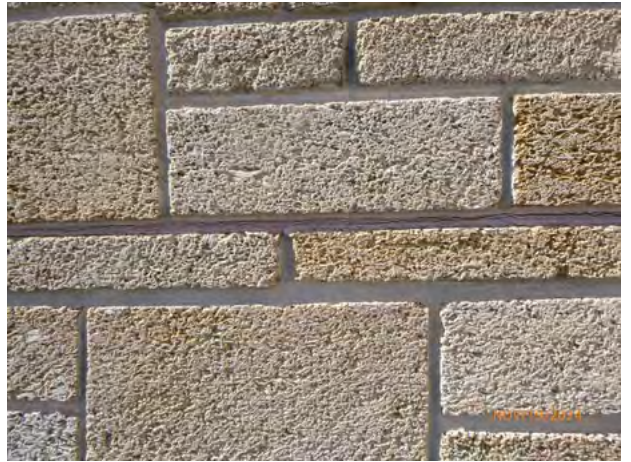
340-80 Stone\_Joints Sealant Failed 2024-2.jpg

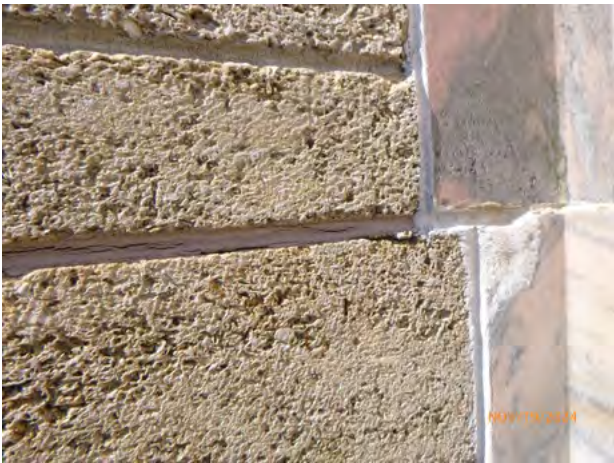
340-80 Stone\_Joints Sealant Failed 2024-3.jpg

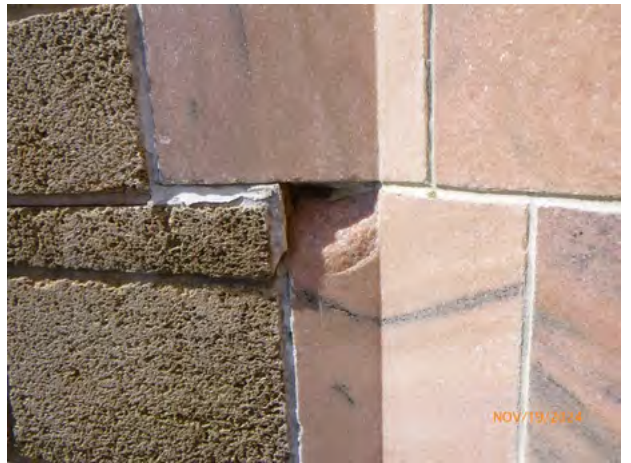
340-80 Stone\_Joints Sealant Failed 2024-4.jpg

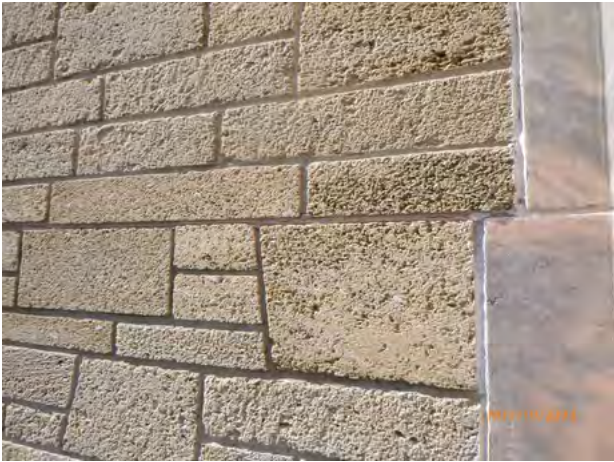
340-90 Stone\_Spall Missing + Steel 2024-3.jpg

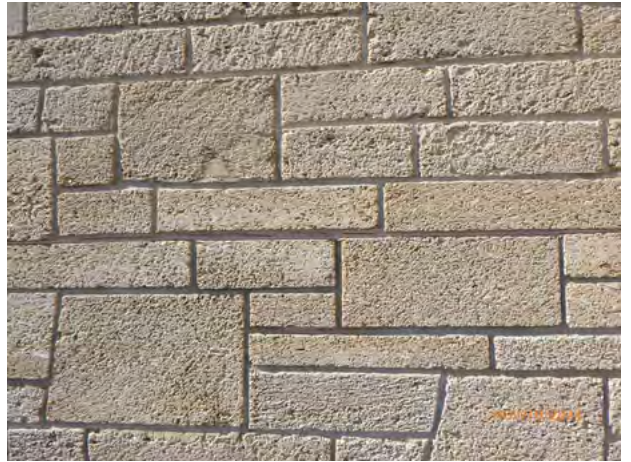
340-106 Stone\_Joints Sealant Failed 2024-1.jpg

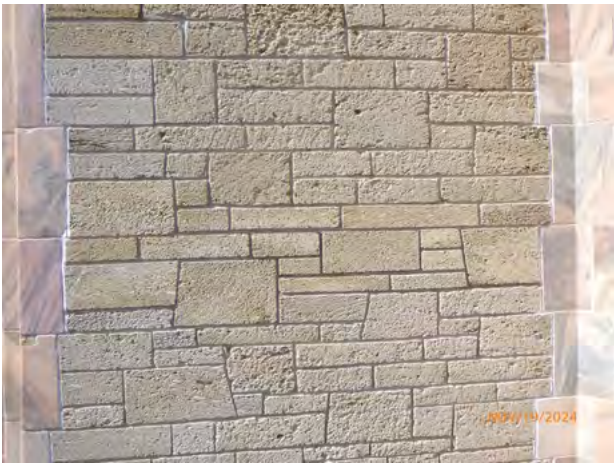
340-106 Stone\_Joints Sealant Failed 2024-2.jpg

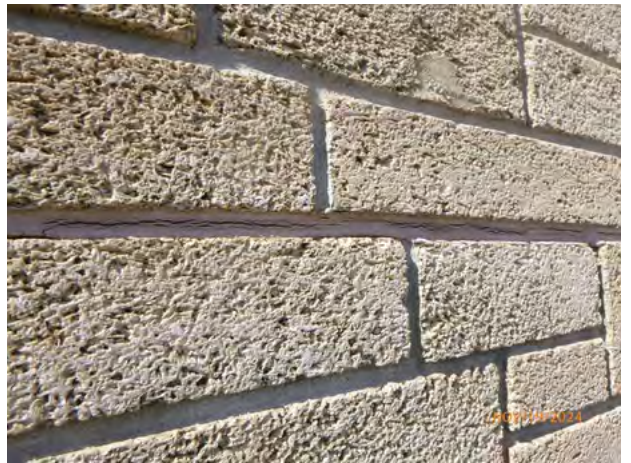
340-106 Stone\_Joints Sealant Failed 2024-3.jpg

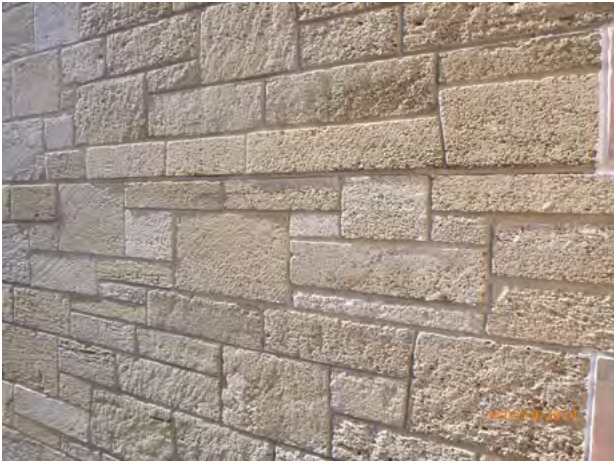
341-21 Stone\_SurfLoss Chipped 2024-2.jpg

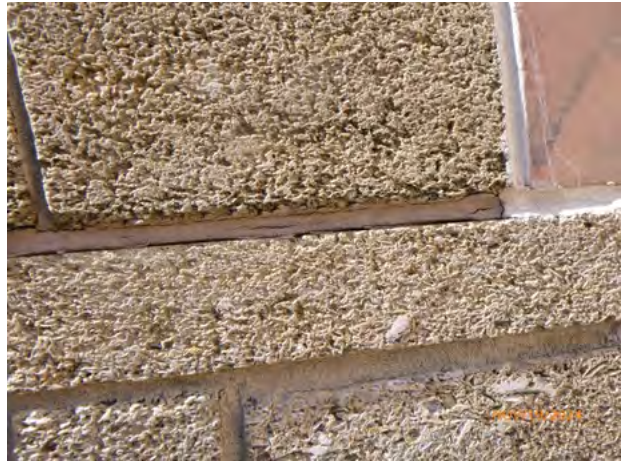
341-45 Stone\_Joints Sealant Failed 2024-1.jpg

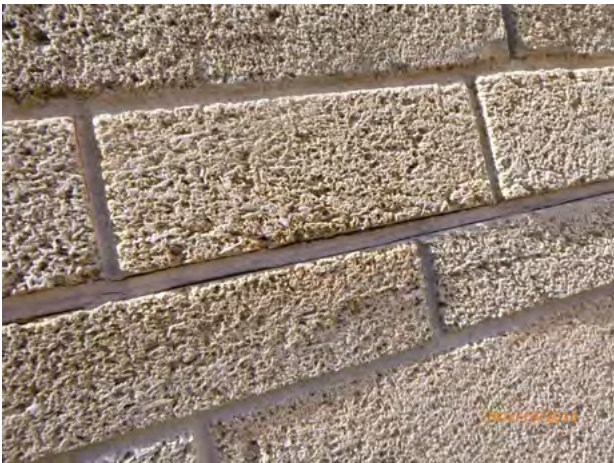
341-45 Stone\_Joints Sealant Failed 2024-2.jpg

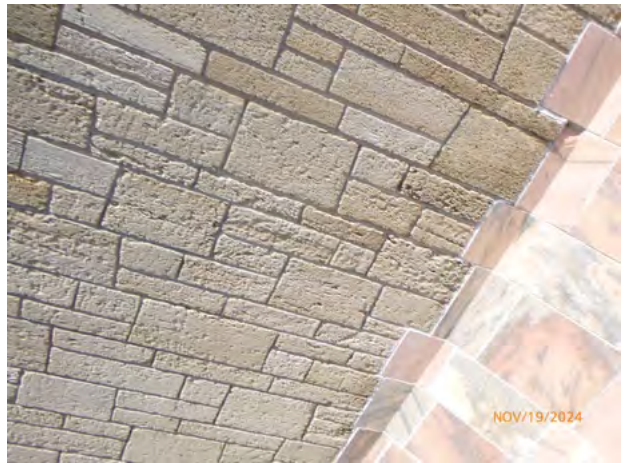
341-45 Stone\_Joints Sealant Failed 2024-3.jpg

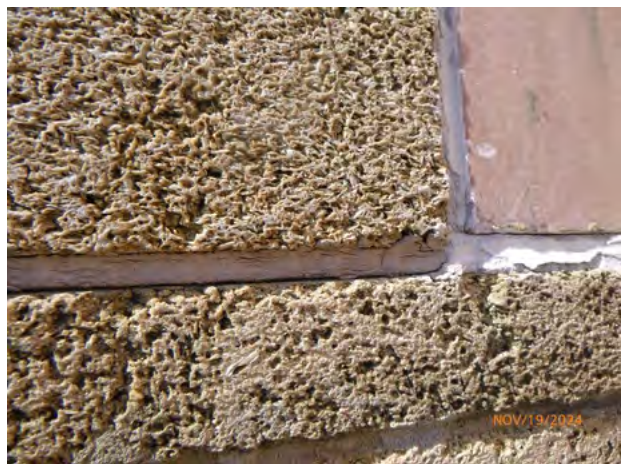
341-89 Stone\_Joints Sealant Failed 2024-2.jpg

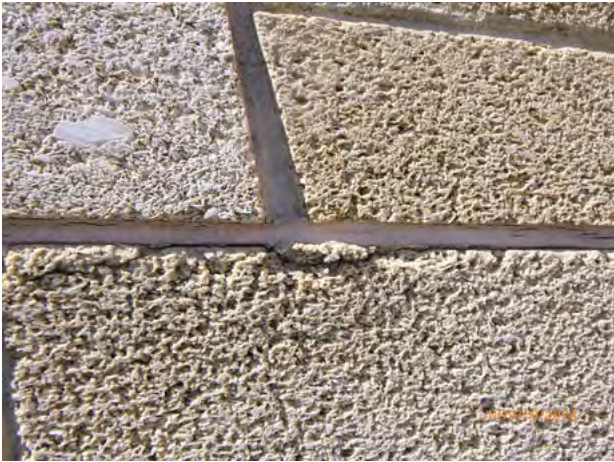
341-89 Stone\_Joints Sealant Failed 2024-3.jpg

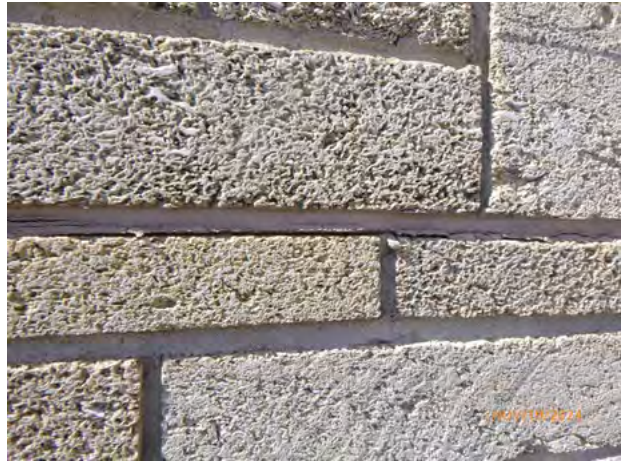
341-89 Stone\_Joints Sealant Failed 2024-4.jpg

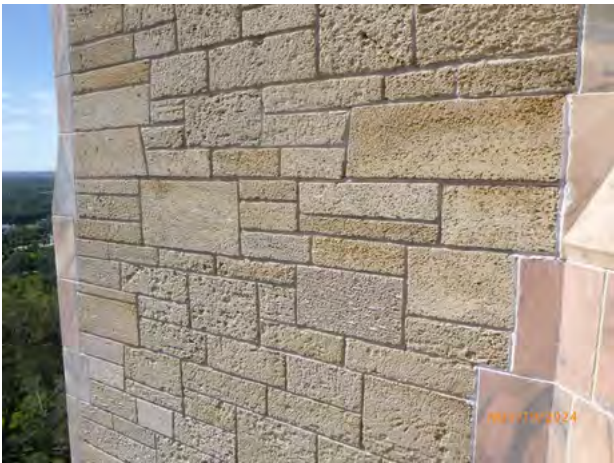
341-89 Stone\_Joints Sealant Failed 2024-5.jpg

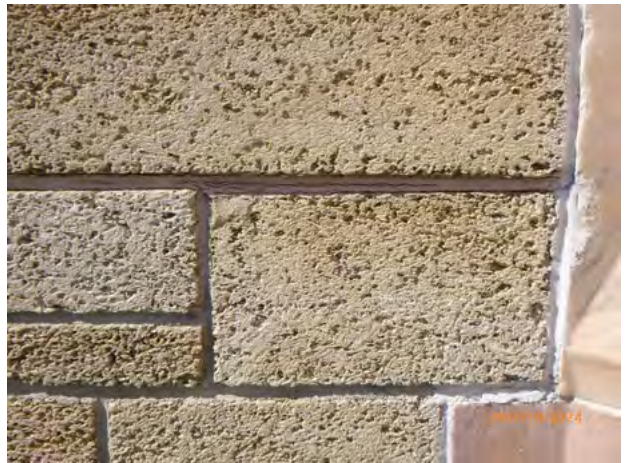
341-122 Stone\_Joints Sealant Failed 2024-1.jpg

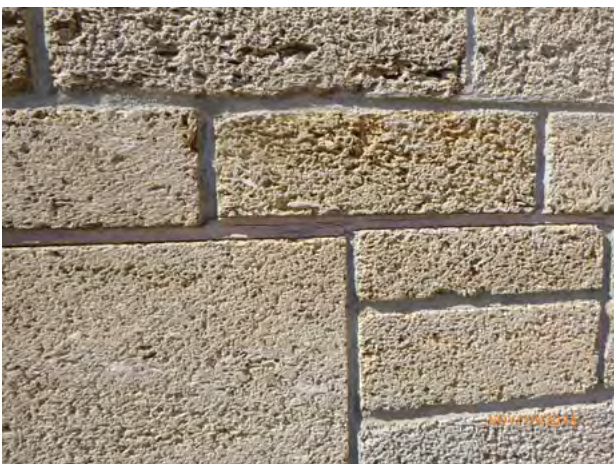
341-122 Stone\_Joints Sealant Failed 2024-2.jpg

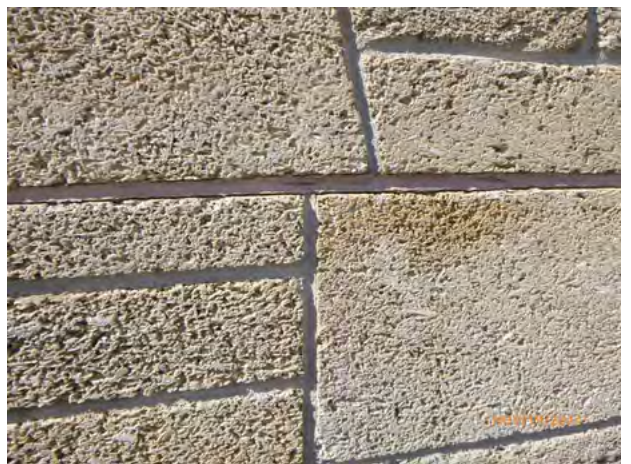
341-122 Stone\_Joints Sealant Failed 2024-3.jpg

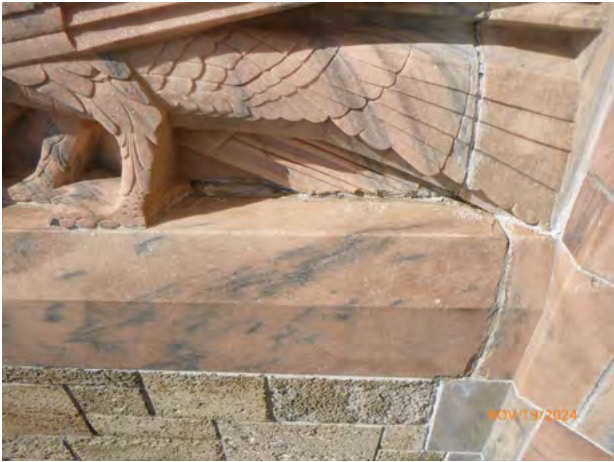
341-122 Stone\_Joints Sealant Failed 2024-4.jpg

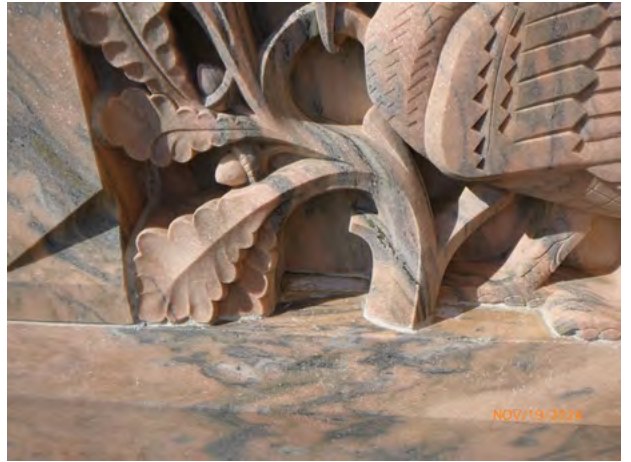
341-139 Stone\_Joints Mortar Failed 2024-1.jpg

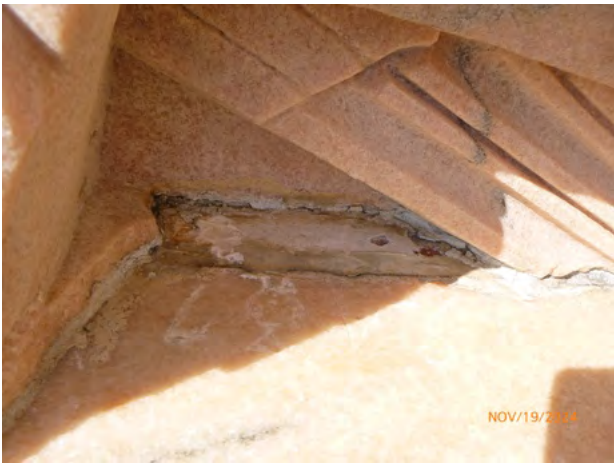
341-139 Stone\_Joints Mortar Failed 2024-2.jpg

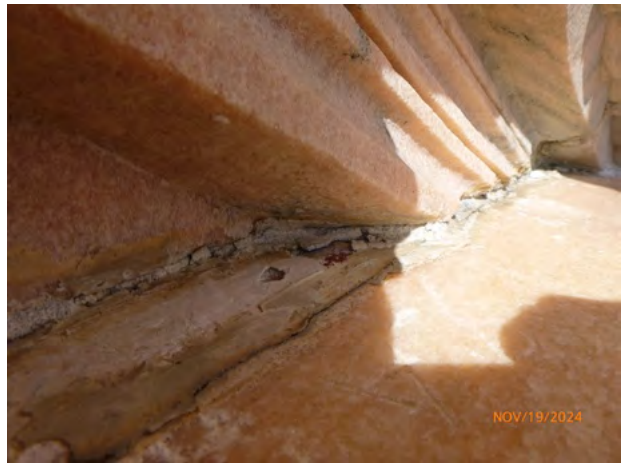
341-139 Stone\_Joints Mortar Failed 2024-3.jpg

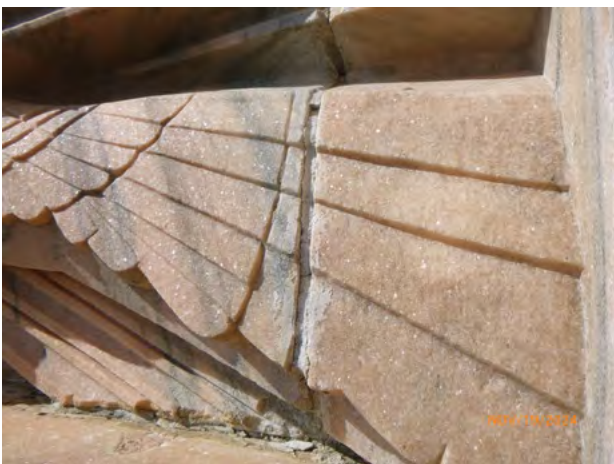
341-139 Stone\_Joints Mortar Failed 2024-4.jpg

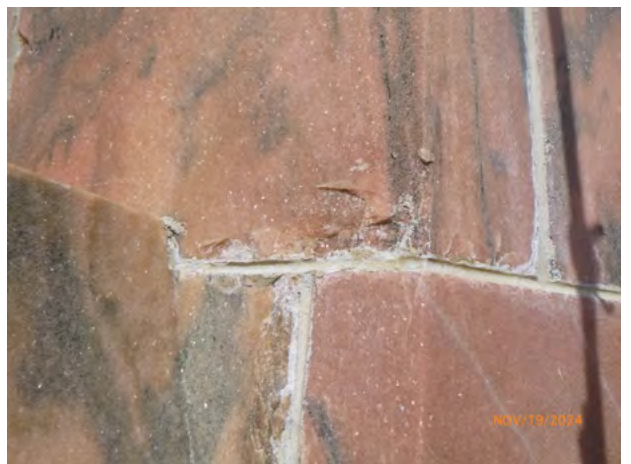
341-139 Stone\_Joints Mortar Failed 2024-5.jpg

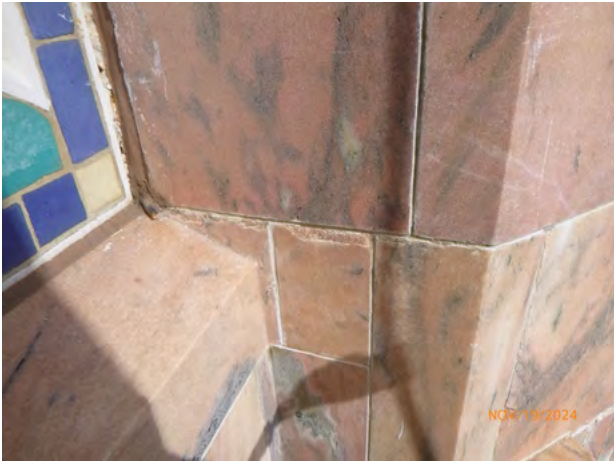
341-141 Stone\_SurfLoss Chipped 2024-1.jpg

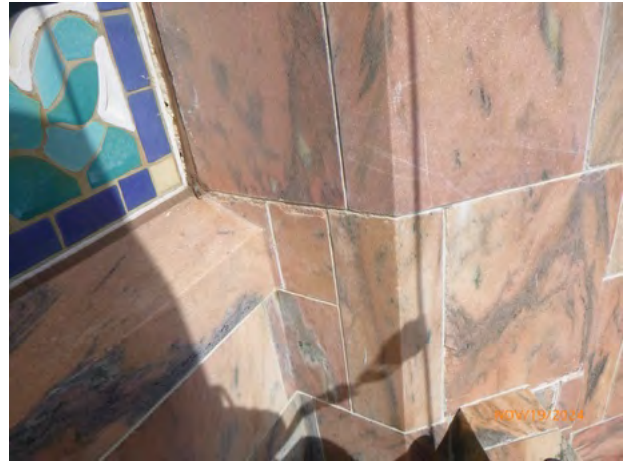
341-143 Stone\_SurfLoss Chipped 2024-1.jpg

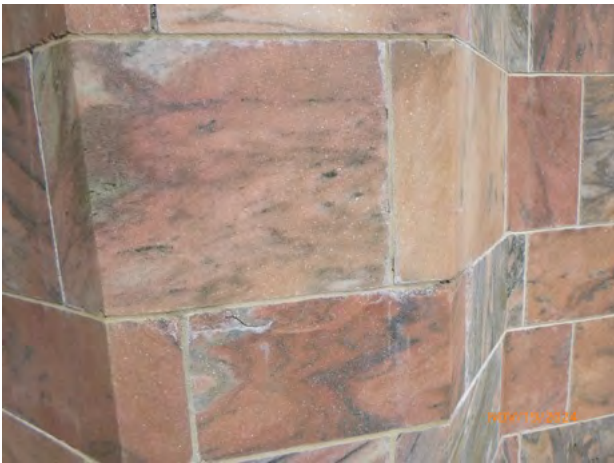
341-143 Stone\_SurfLoss Chipped 2024-2.jpg

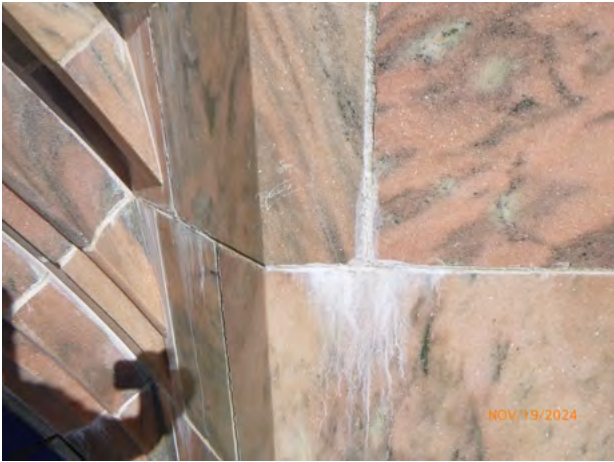
341-176 Stone\_SoilStain Leached Salts 2024-1.jpg

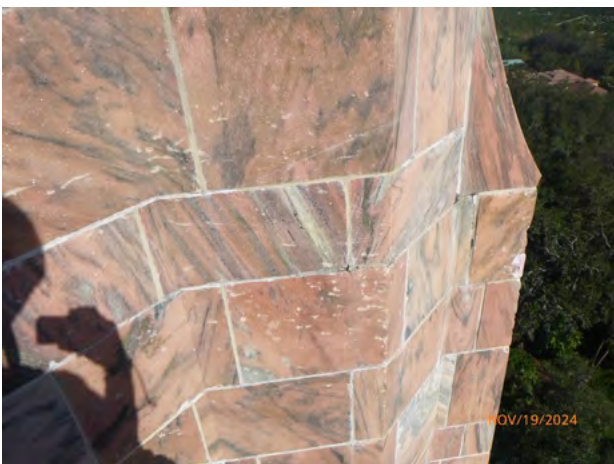
341-181 Stone\_SurfLoss Chipped 2024-1.jpg

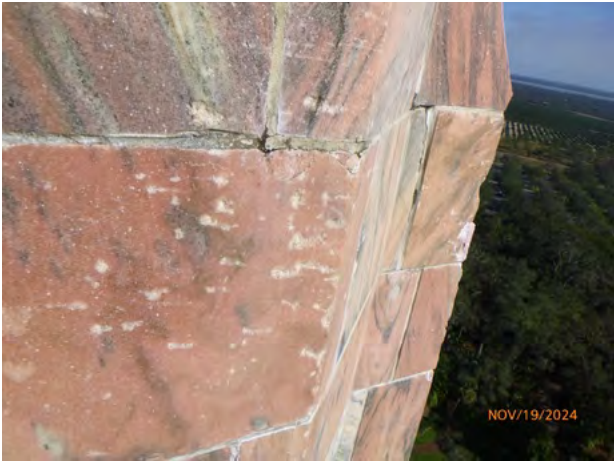
341-181 Stone\_SurfLoss Chipped 2024-3.jpg

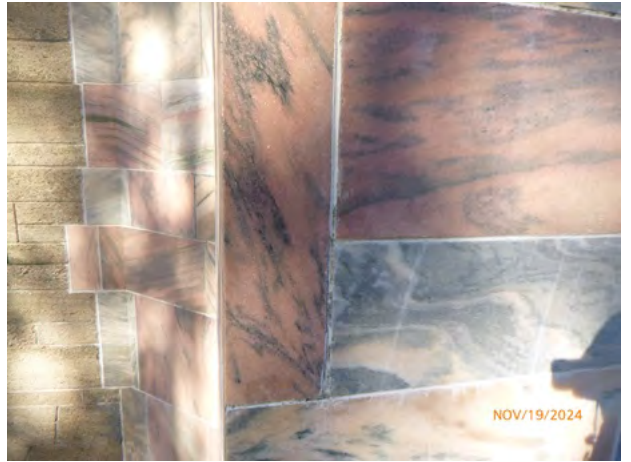
341-181 Stone\_SurfLoss Chipped 2024-4.jpg

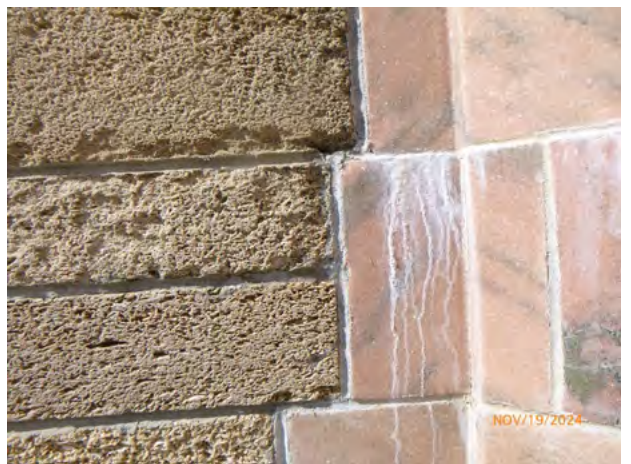
342-131 Stone\_SoilStain Leached Salts 2024-1.jpg

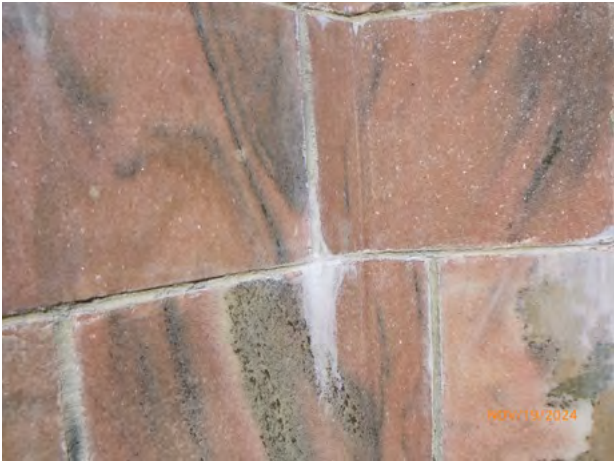
342-131 Stone\_SoilStain Leached Salts 2024-2.jpg

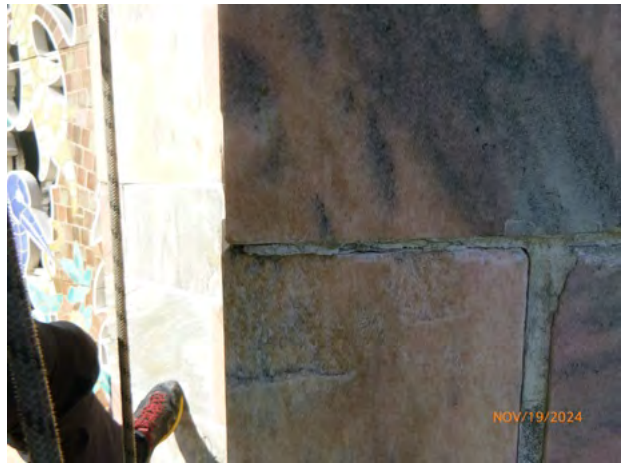
342-151 Stone\_Spall Missing 2024-1.jpg

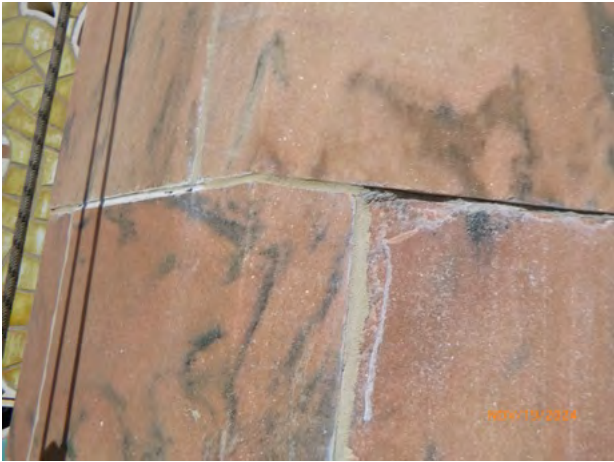
342-158 Stone\_SurfLoss Chipped 2024-2.jpg

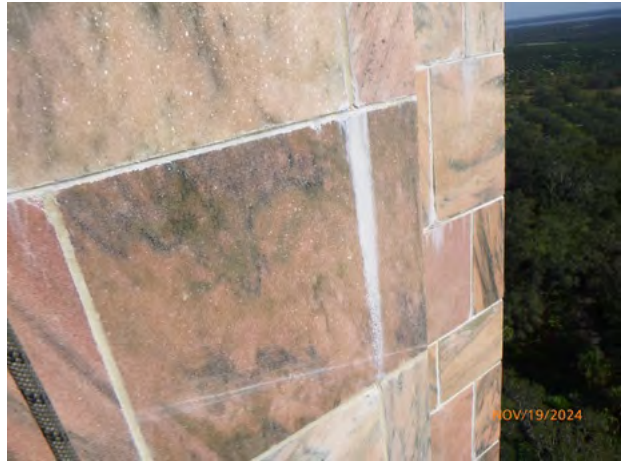
342-158 Stone\_SurfLoss Chipped 2024-3.jpg

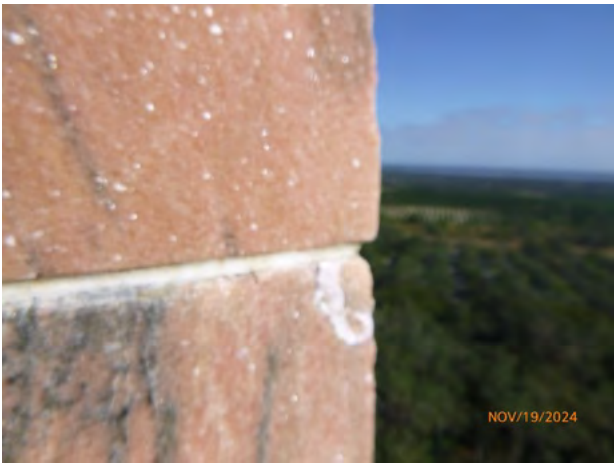
342-175 Stone\_SoilStain Leached Salts 2024-1.jpg

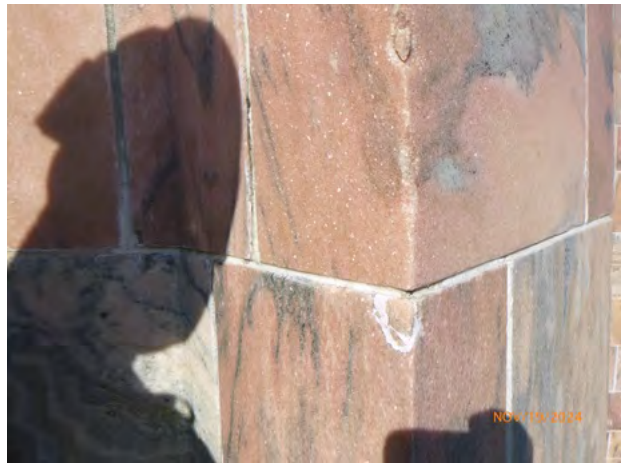
342-181 Stone\_Repair Patch Sound 2024-1.jpg

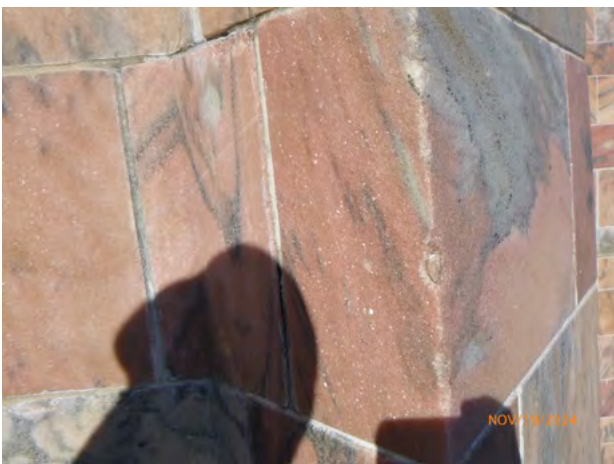
342-181 Stone\_Repair Patch Sound 2024-2.jpg

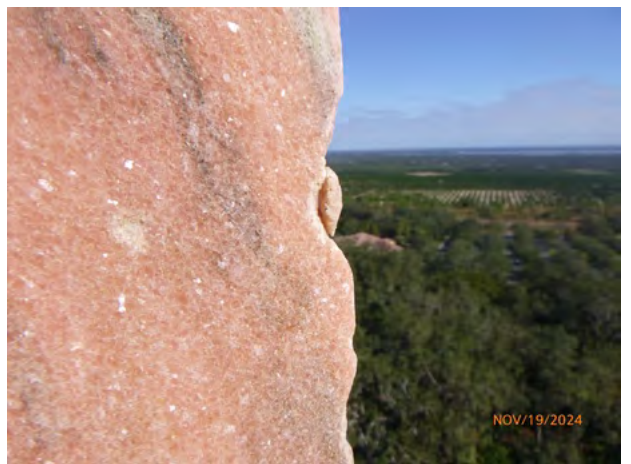
342-182 Stone\_Repair Patch Failed 2024-1.jpg

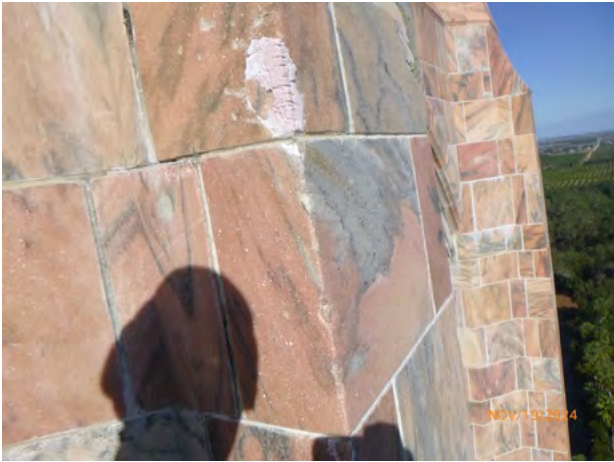
342-182 Stone\_Repair Patch Failed 2024-2.jpg

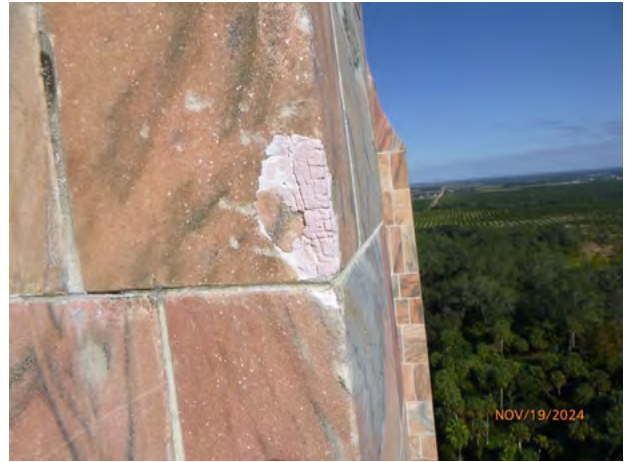
342-182 Stone\_Repair Patch Failed 2024-3.jpg

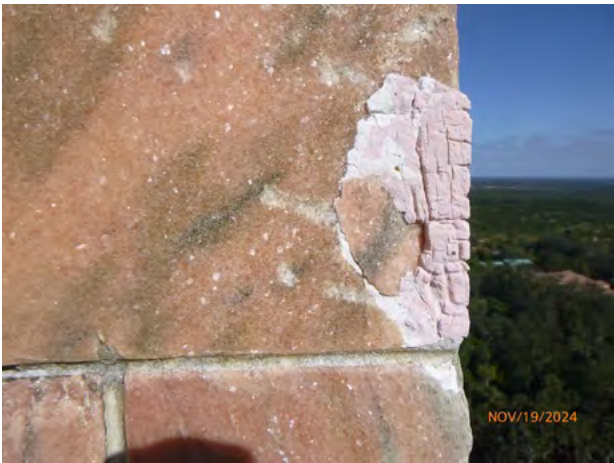
342-183 Stone\_Repair Patch Failed 2024-1.jpg

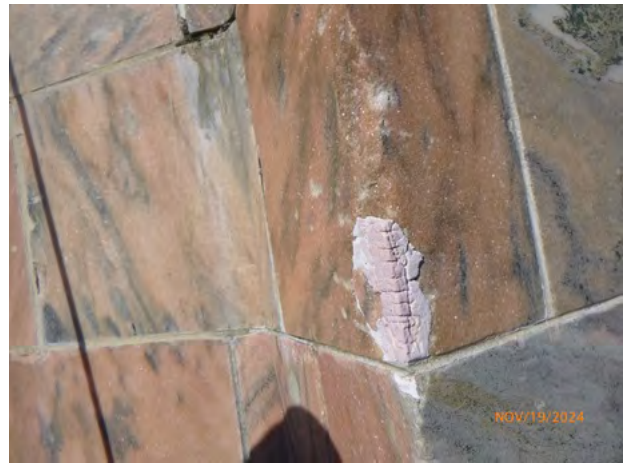
342-183 Stone\_Repair Patch Failed 2024-2.jpg

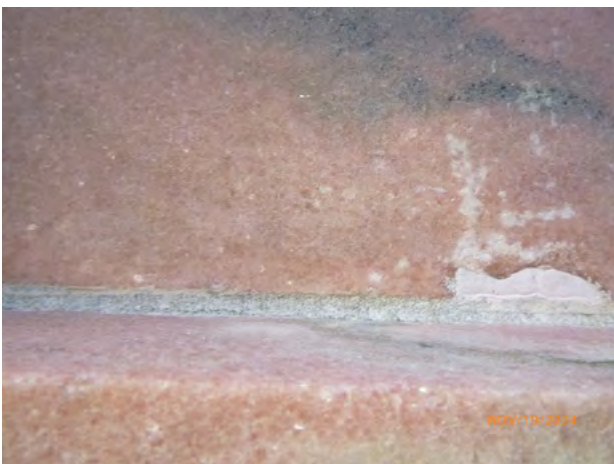
342-183 Stone\_Repair Patch Failed 2024-3.jpg

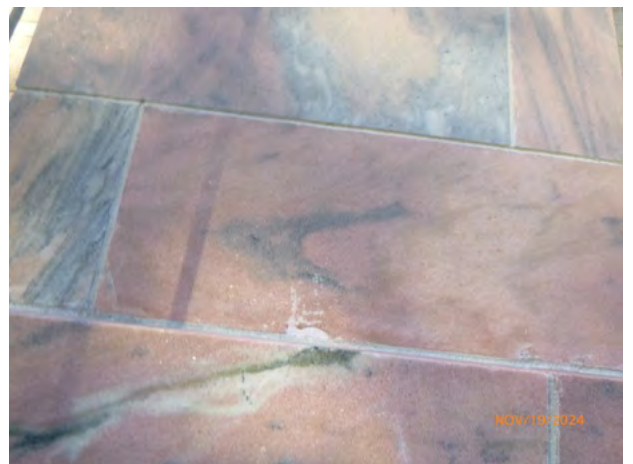
343-32 Stone\_Repair Patch Failed 2024-1.jpg

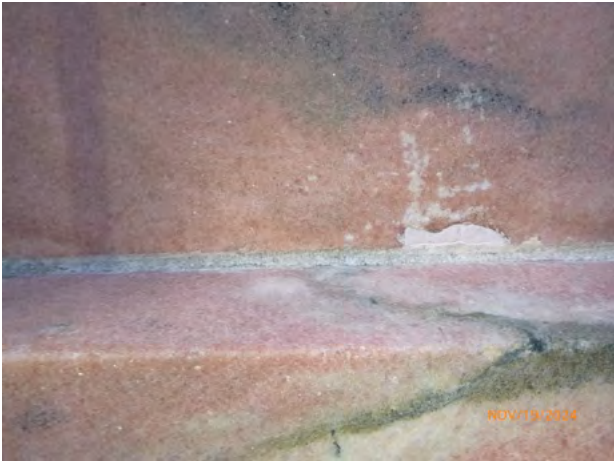
343-32 Stone\_Repair Patch Failed 2024-2.jpg

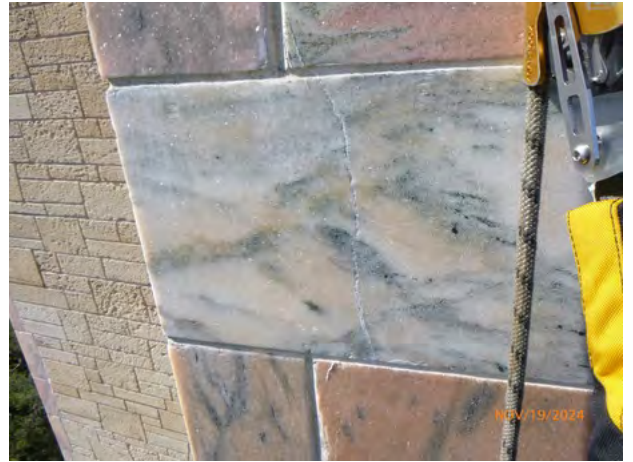
343-32 Stone\_Repair Patch Failed 2024-3.jpg

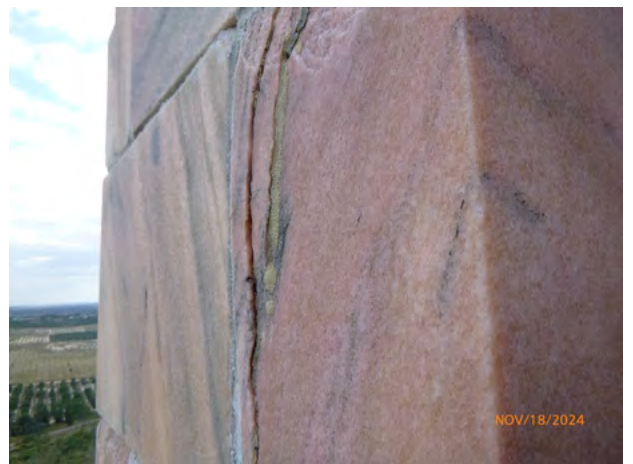
343-150 Stone\_Crack Single unit 2024-2.jpg

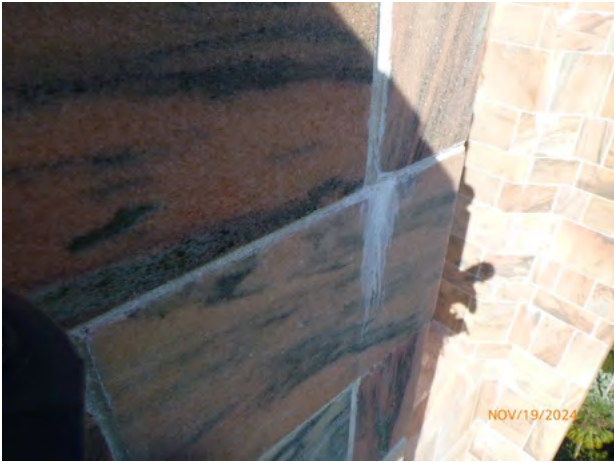
343-150 Stone\_Crack Single unit 2024-3.jpg

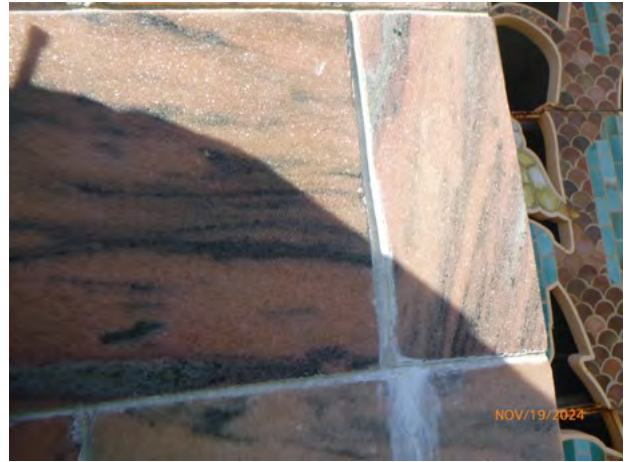
343-154 Stone\_SoilStain Leached Salts 2024-1.jpg

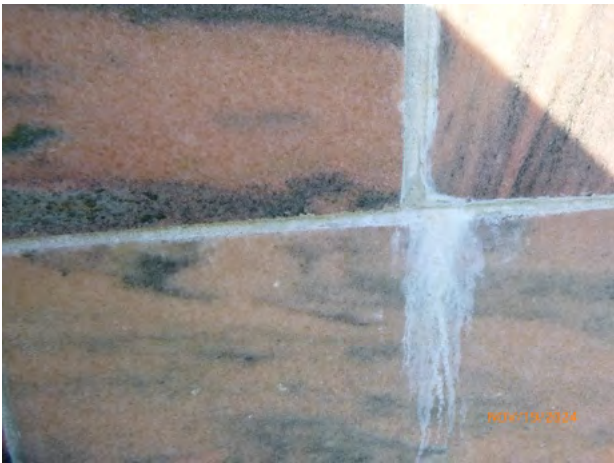
343-154 Stone\_SoilStain Leached Salts 2024-2.jpg

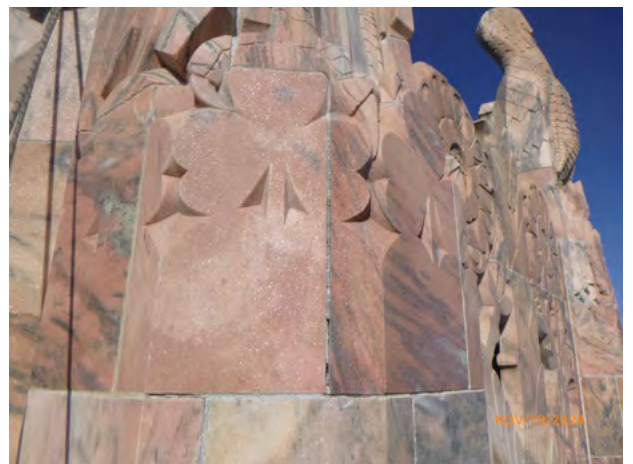
343-168 Stone\_SoilStain Leached Salts 2024-2.jpg

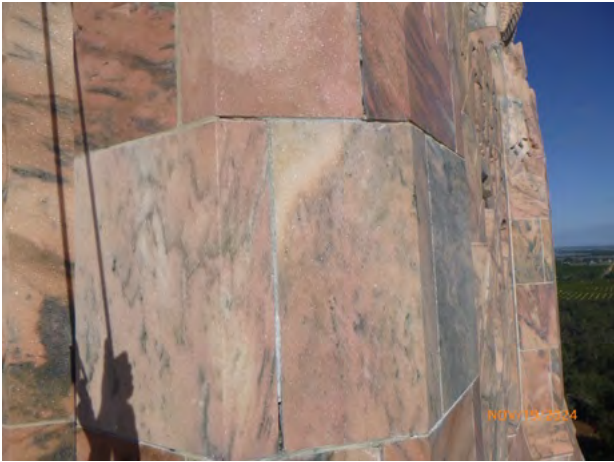
343-185 Stone\_Joints Mortar Failed 2024-1.jpg

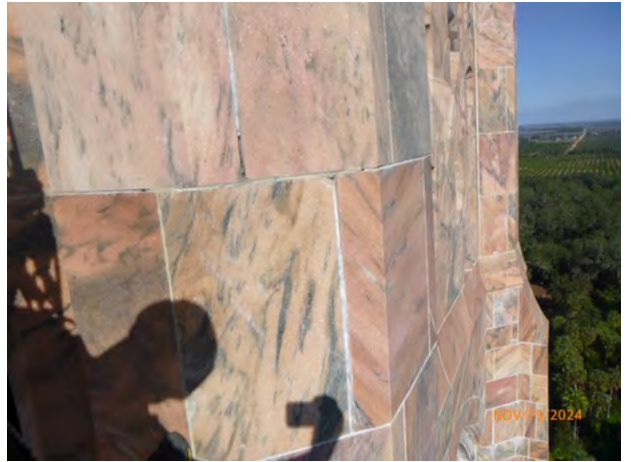
343-185 Stone\_Joints Mortar Failed 2024-2.jpg

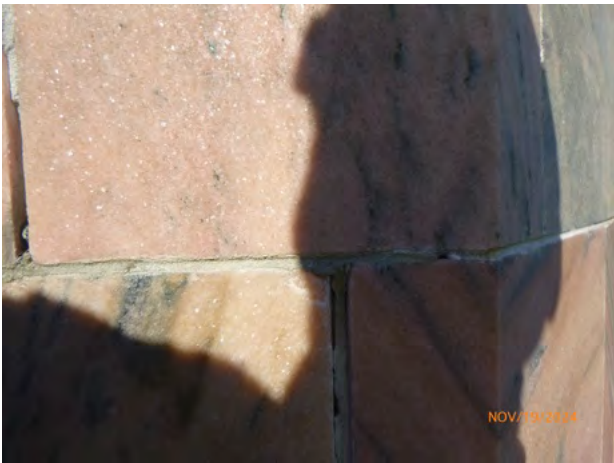
343-185 Stone\_Joints Mortar Failed 2024-3.jpg

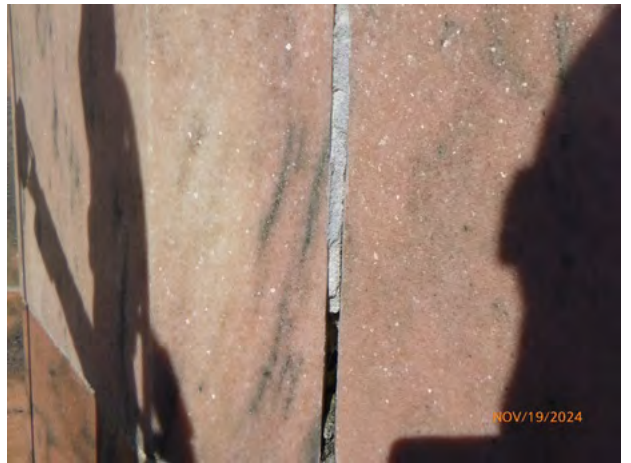
343-185 Stone\_Joints Mortar Failed 2024-4.jpg

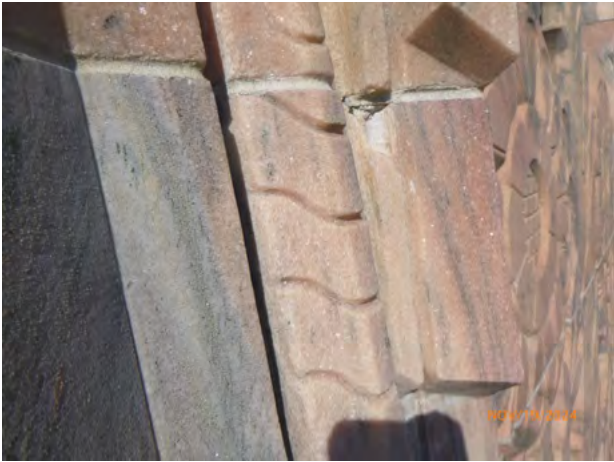
343-198 Stone\_Spall Missing 2024-1.jpg

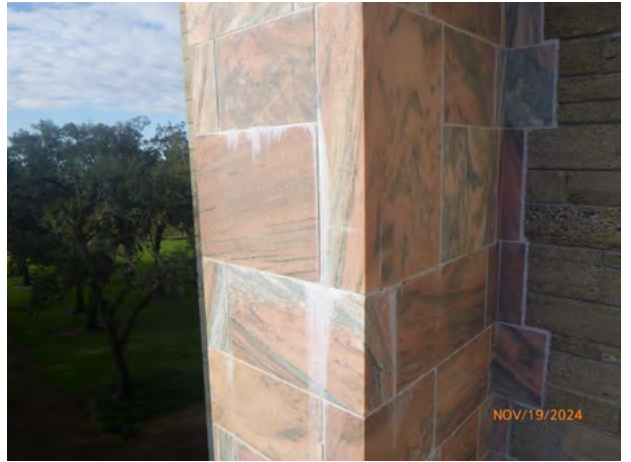
343-198 Stone\_Spall Missing 2024-2.jpg

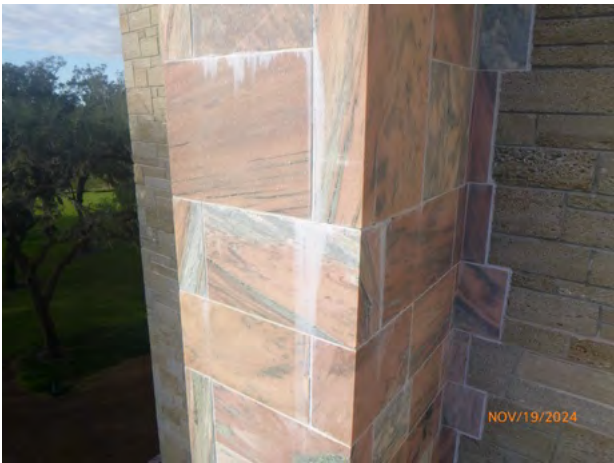
344-52 Stone\_SoilStain Leached Salts 2024-1.jpg

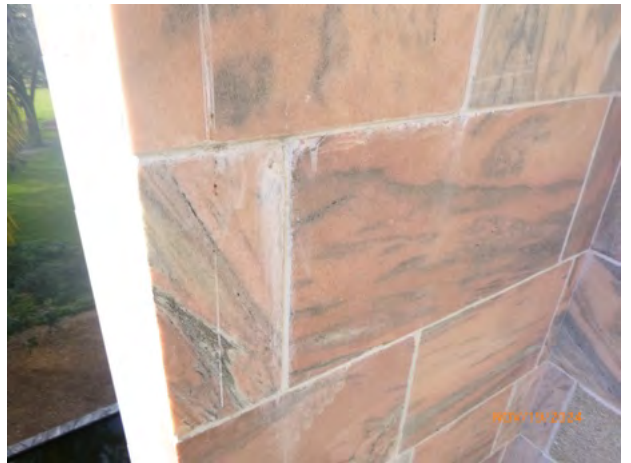
344-52 Stone\_SoilStain Leached Salts 2024-2.jpg

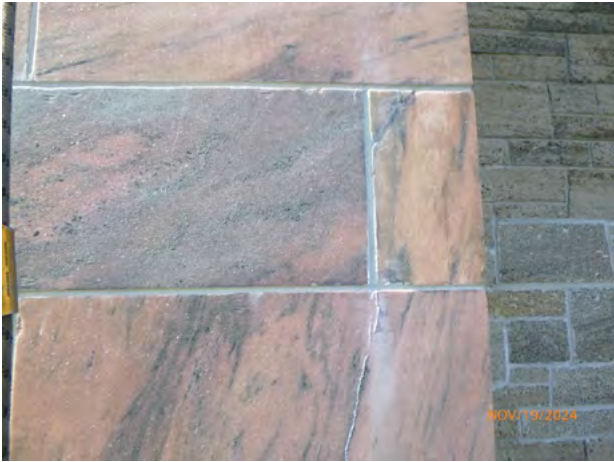
344-52 Stone\_SoilStain Leached Salts 2024-5.jpg

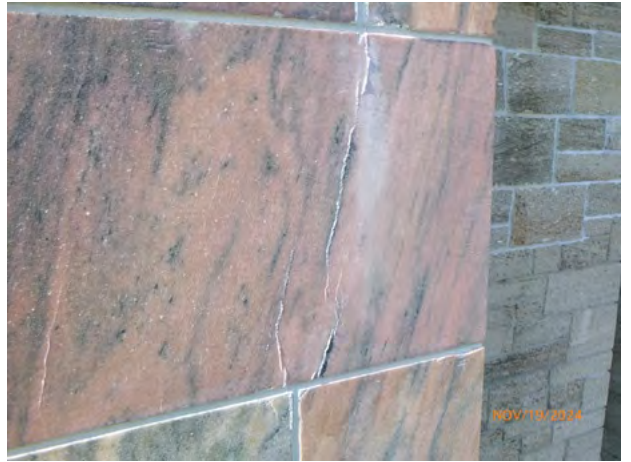
344-88 Stone\_Crack System units and joints 2024-1.jpg

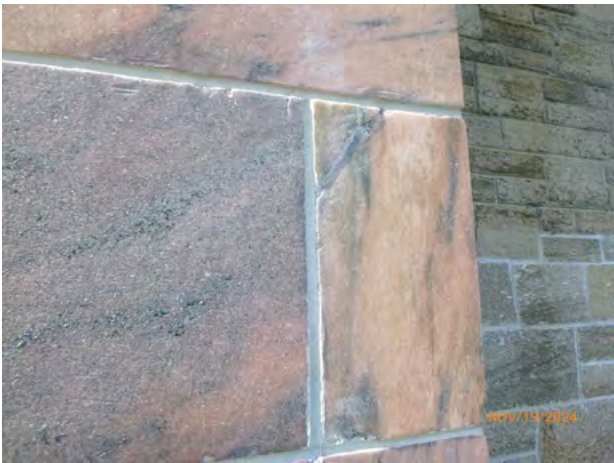
344-88 Stone\_Crack System units and joints 2024-2.jpg

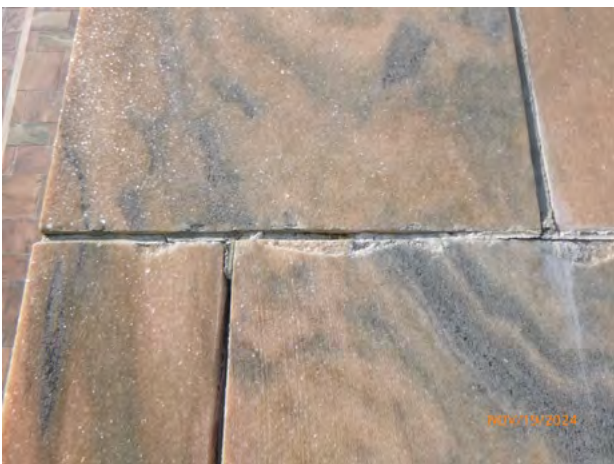
344-141 Stone\_Joints Mortar Failed 2024-1.jpg

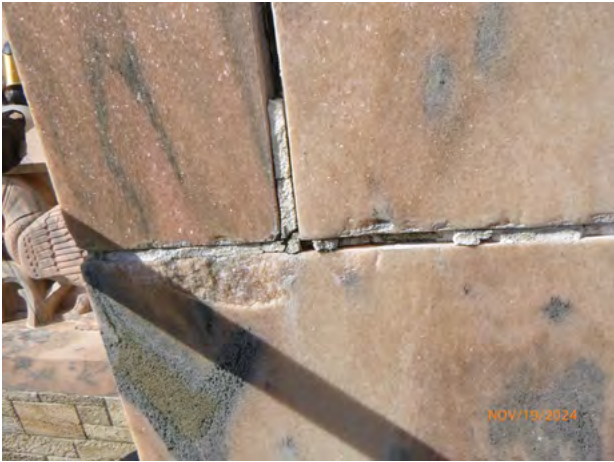
344-141 Stone\_Joints Mortar Failed 2024-3.jpg

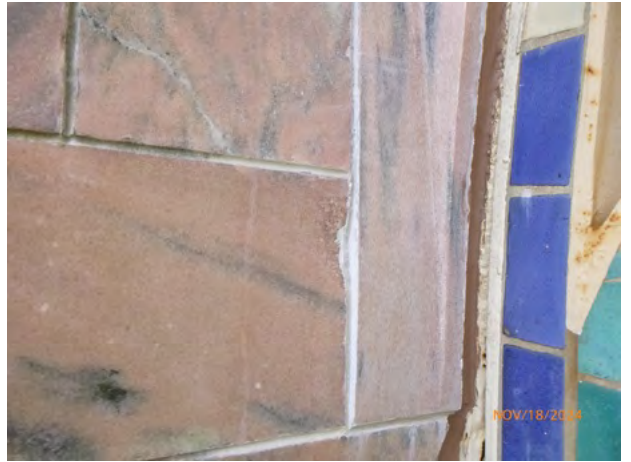
344-141 Stone\_Joints Mortar Failed 2024-4.jpg

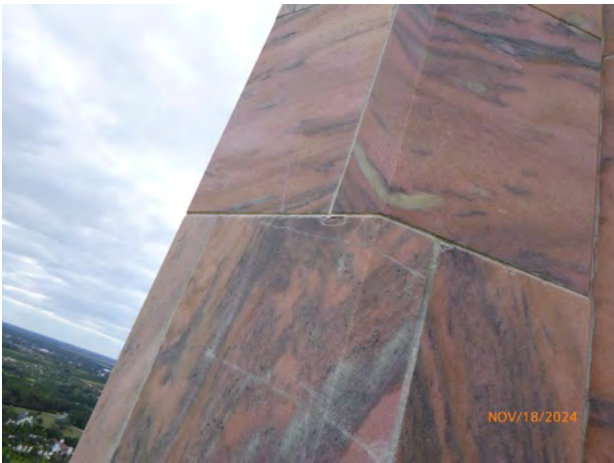
344-173 Stone\_SurfLoss Chipped 2024-1.jpg

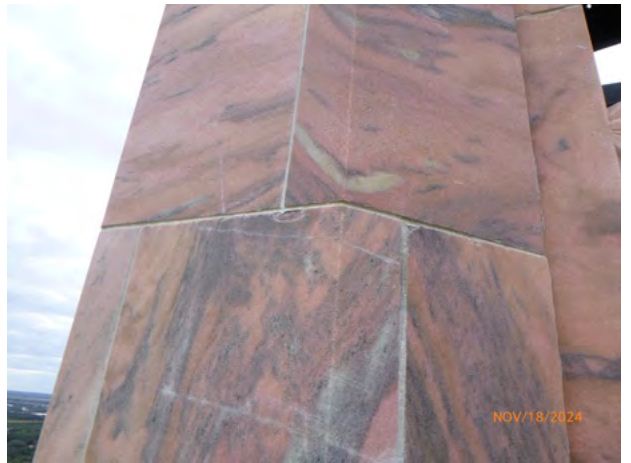
344-186 Stone\_SurfLoss Chipped 2024-1.jpg

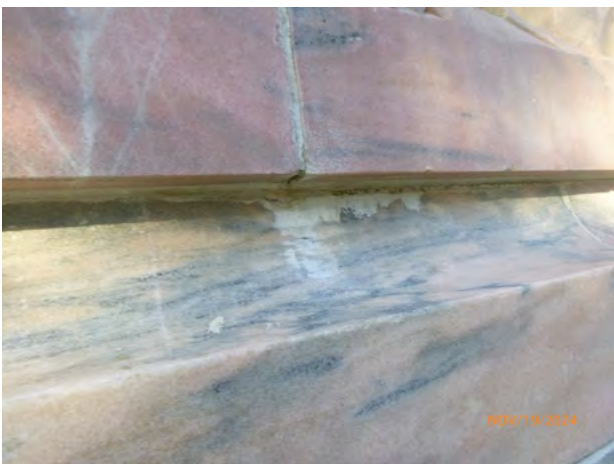
344-186 Stone\_SurfLoss Chipped 2024-2.jpg

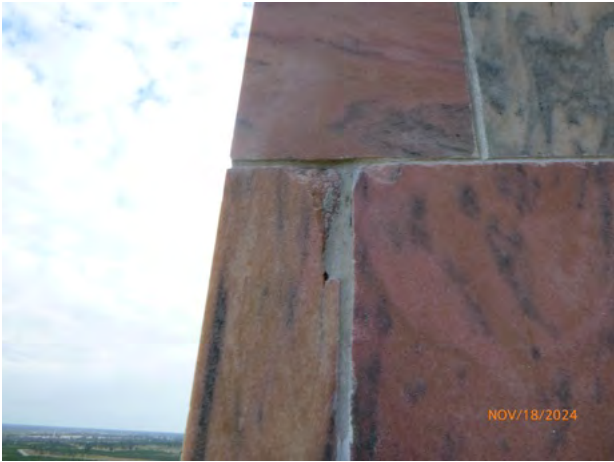
345-148 Stone\_Repair Patch Failed 2024-1.jpg

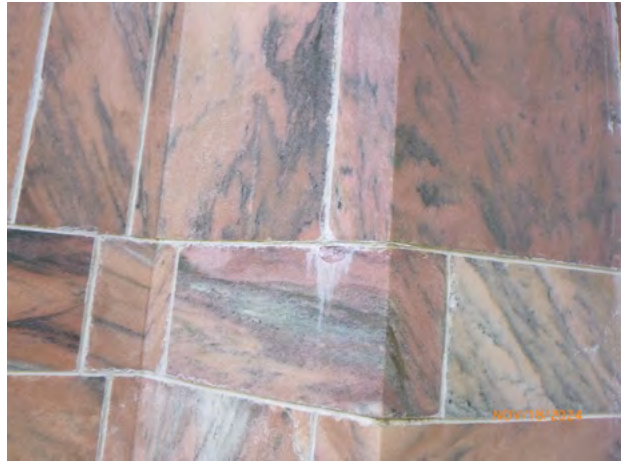
345-148 Stone\_Repair Patch Failed 2024-2.jpg

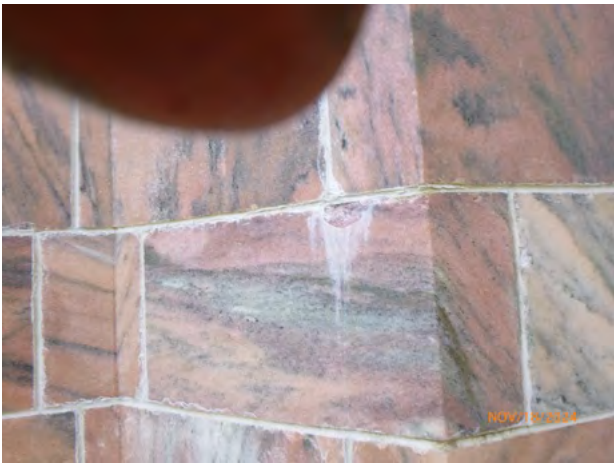
345-168 Stone\_SoilStain Leached Salts 2024-1.jpg

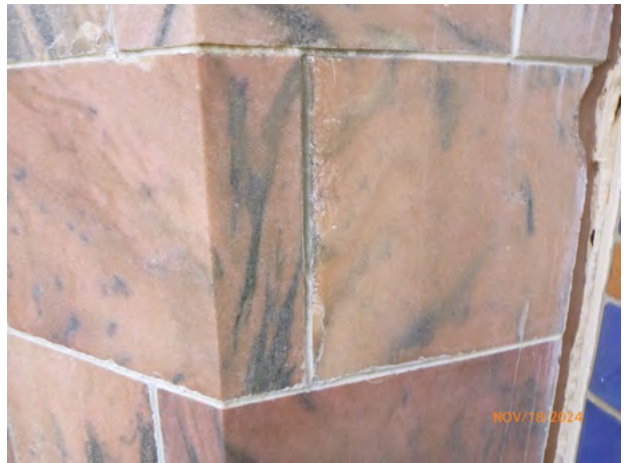
345-168 Stone\_SoilStain Leached Salts 2024-2.jpg

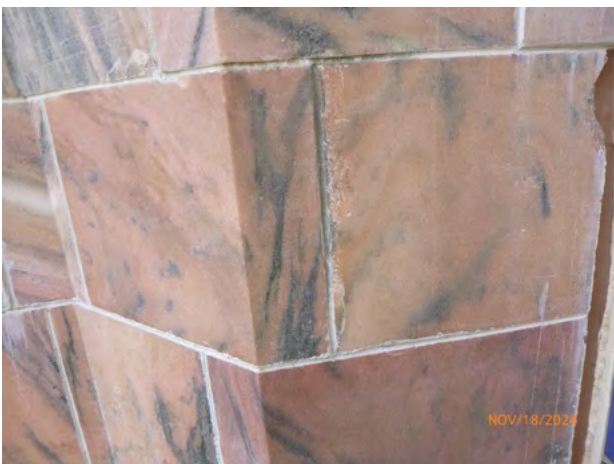
345-171 Stone\_SurfLoss Chipped 2024-1.jpg
