### ***Bok Singing Tower Roof Restoration and Replacement***

# Bok Singing Tower Conditions Assessment

T.Y. Lin (formerly Silman) was contracted to perform a conditions assessment of the Bok Singing Tower at Bok Tower Gardens in Lake Wales, Florida. The Singing Tower stands 205 feet tall at the southwest corner of the gardens. A moat surrounds the base of the tower with two bridges to access the island. The tower houses a 60-bell carillon, associated carillonneur studio and library spaces, the Bok Tower Gardens Chao Research archive, and the Founder's Room. It is a steel frame construction clad in a masonry exterior of coquina and Georgia pink Etowah marble with brick masonry at the interior.

## **Bok Tower Focused Condition Assessment**

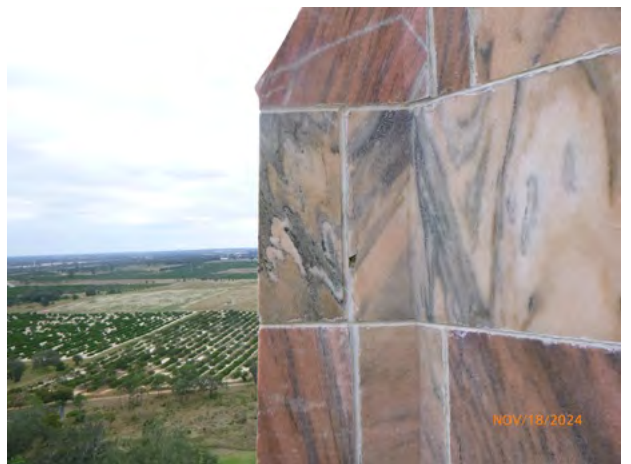
345-171 Stone\_SurfLoss Chipped 2024-2.jpg

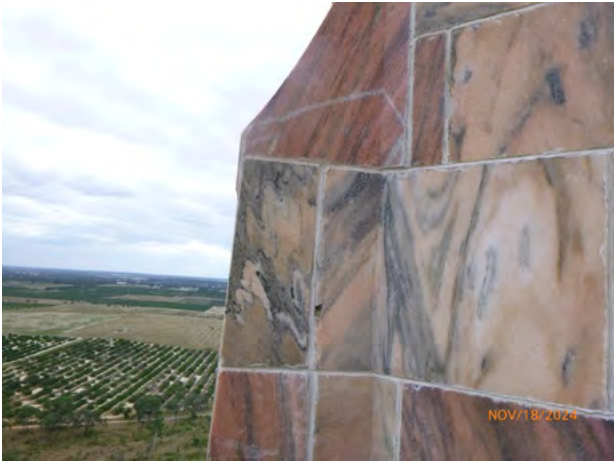
345-181 Stone\_Joints Mortar Failed 2024-1.jpg

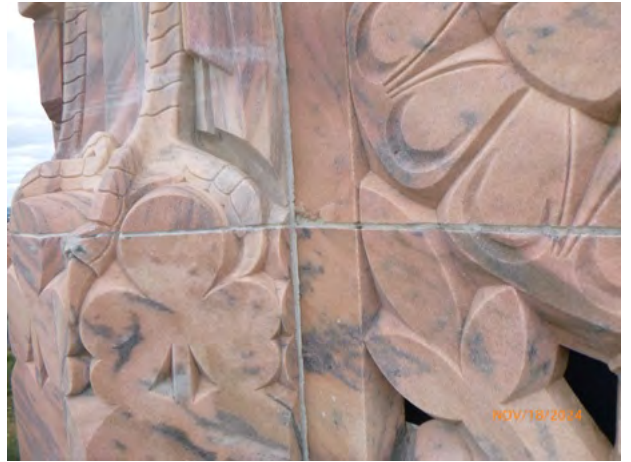
345-181 Stone\_Joints Mortar Failed 2024-2.jpg

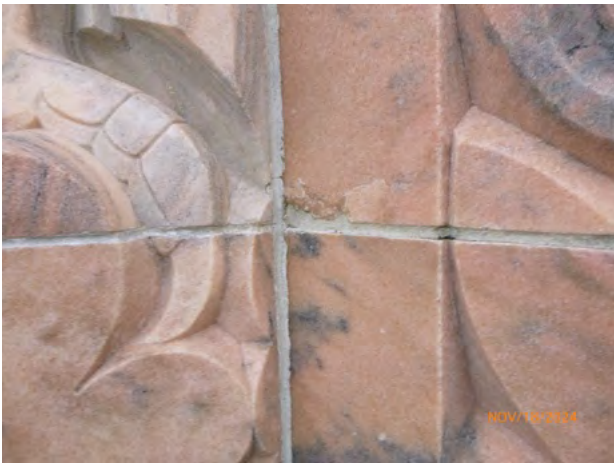
345-194 Stone\_SurfLoss Chipped 2024-1.jpg

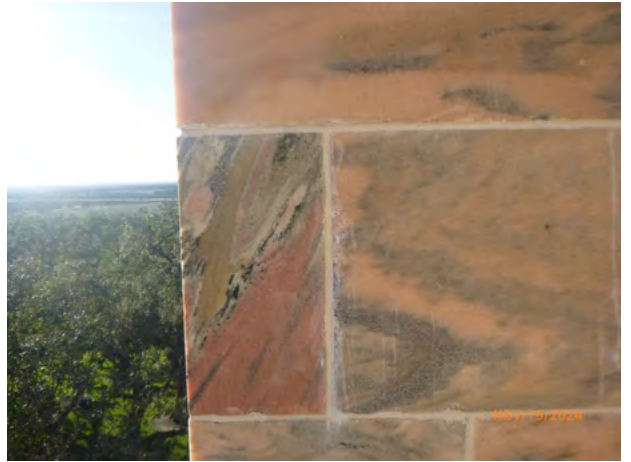
346-78 Stone\_SurfLoss Chipped 2024-1.jpg

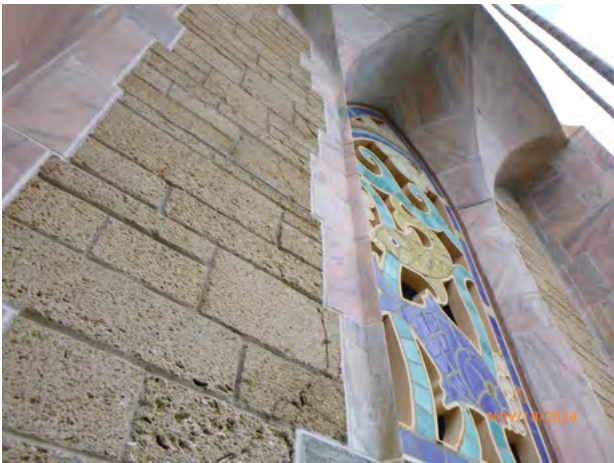
346-78 Stone\_SurfLoss Chipped 2024-2.jpg

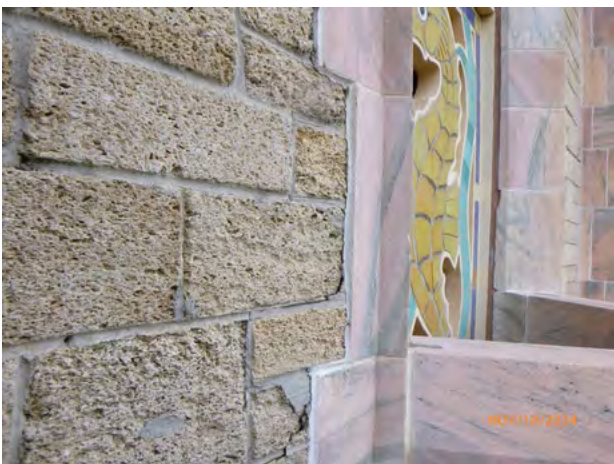
346-104 Stone\_Crack System units and joints 2024-2.jpg

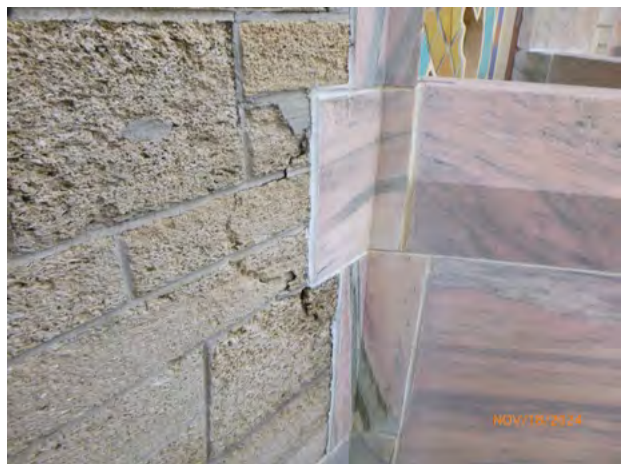
346-104 Stone\_Crack System units and joints 2024-3.jpg

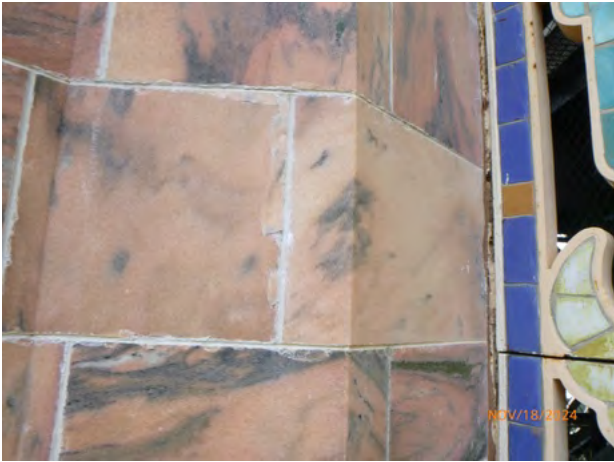
346-104 Stone\_Crack System units and joints 2024-4.jpg

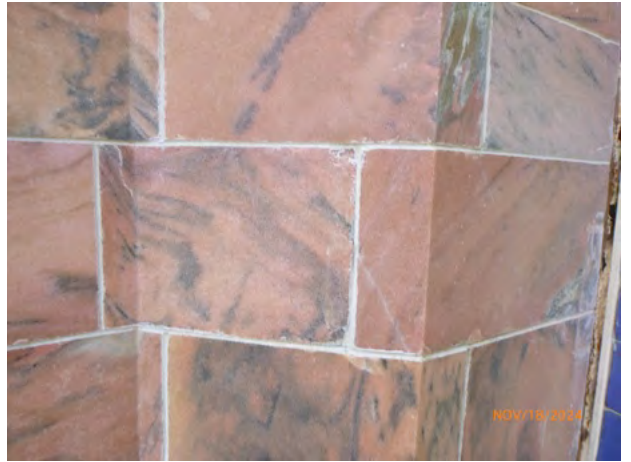
346-160 Stone\_SurfLoss Chipped 2024-1.jpg

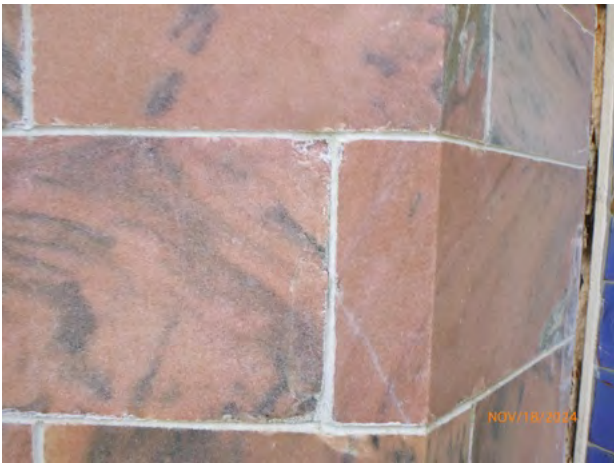
346-162 Stone\_SurfLoss Chipped 2024-1.jpg

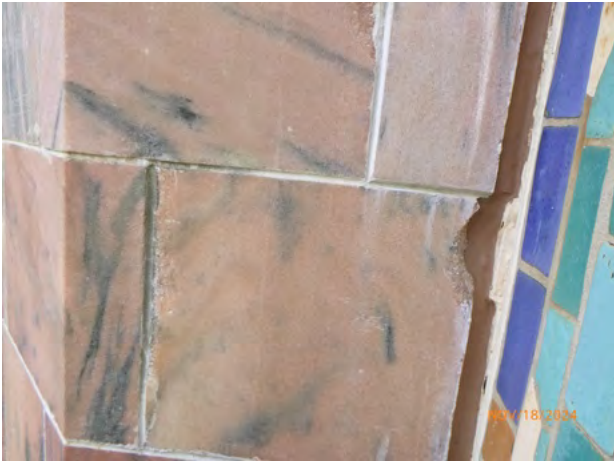
346-172 Stone\_Repair Patch Sound 2024-1.jpg

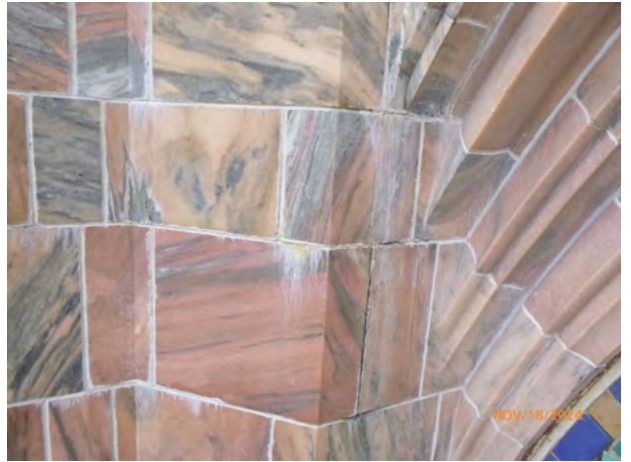
346-172 Stone\_Repair Patch Sound 2024-2.jpg

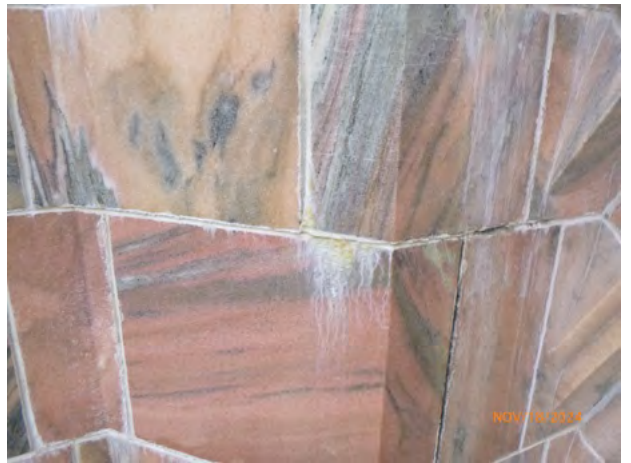
346-176 Stone\_SoilStain Leached Salts 2024-2.jpg

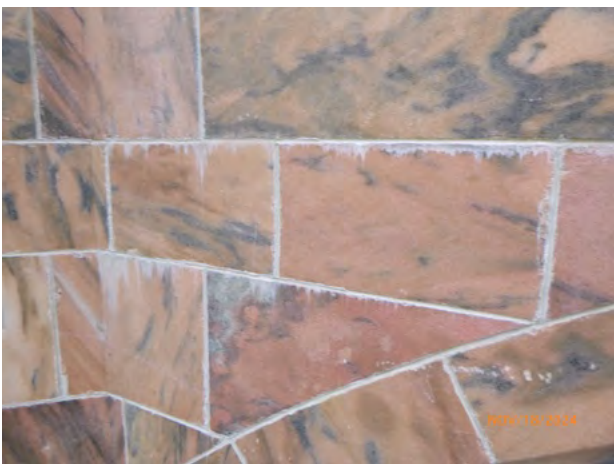
346-176 Stone\_SoilStain Leached Salts 2024-3.jpg

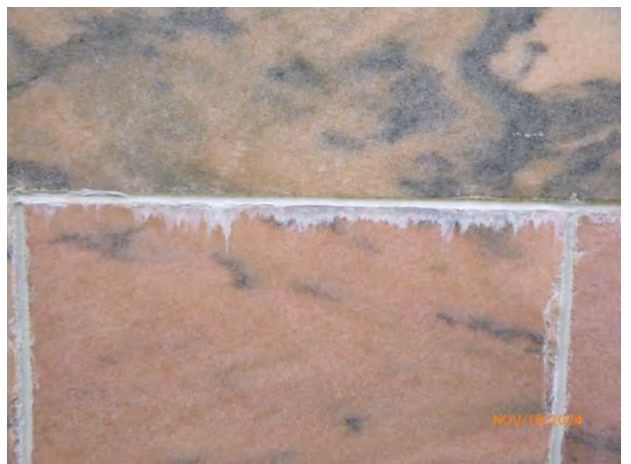
350-182 Stone\_SoilStain Leached Salts 2024-1.jpg

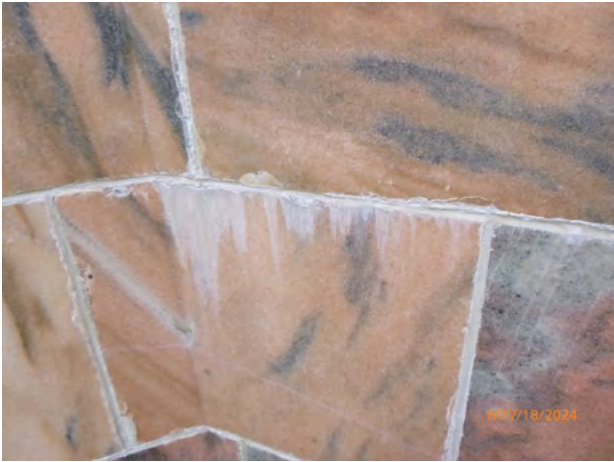
350-182 Stone\_SoilStain Leached Salts 2024-2.jpg

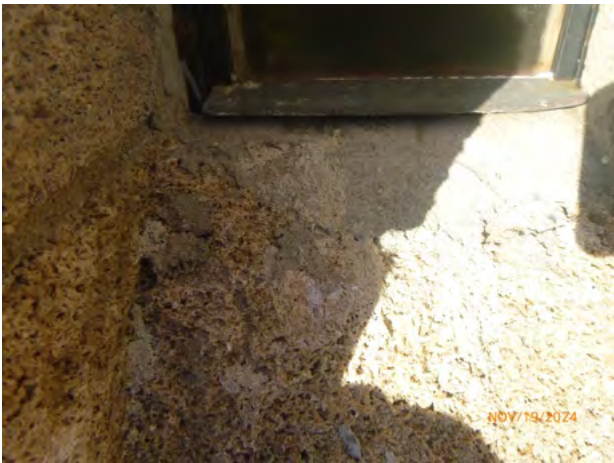
351-86 Stone\_Joints Mortar Failed 2024-1.jpg

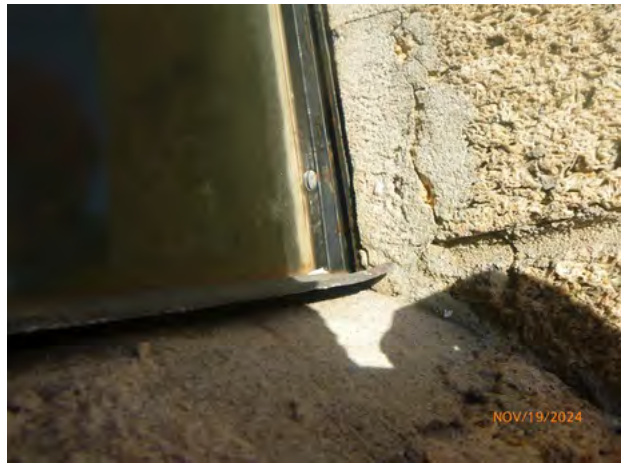
351-86 Stone\_Joints Mortar Failed 2024-2.jpg

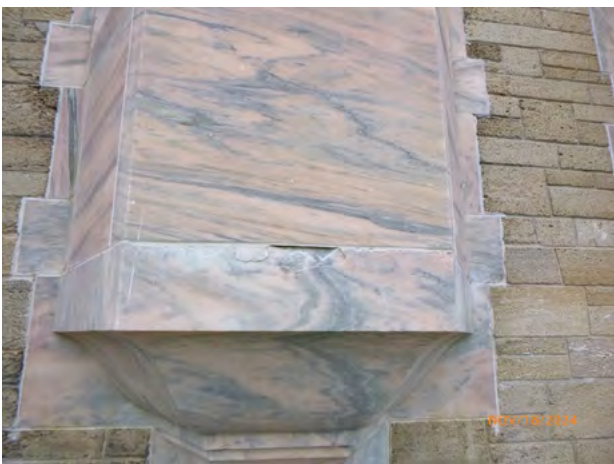
351-86 Stone\_Joints Mortar Failed 2024-3.jpg

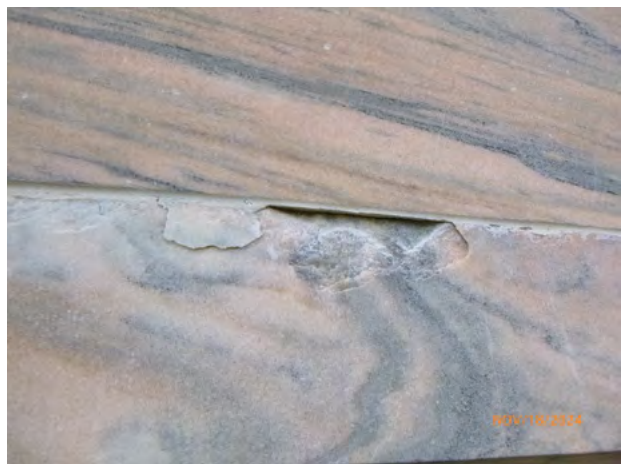
351-102 Stone\_SurfLoss Chipped 2024-1.jpg

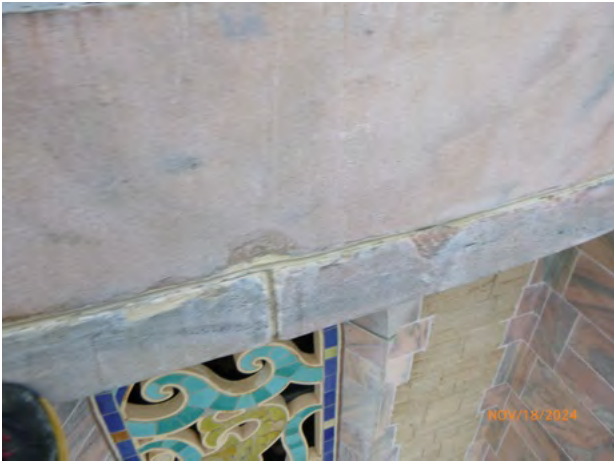
351-102 Stone\_SurfLoss Chipped 2024-2.jpg

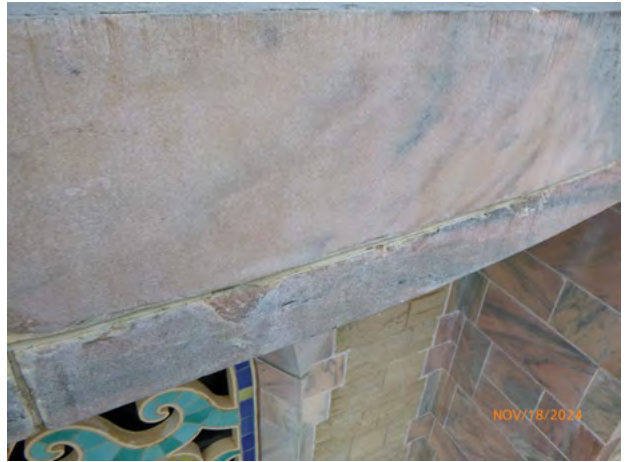
351-122 Stone\_SurfLoss Chipped 2024-1.jpg

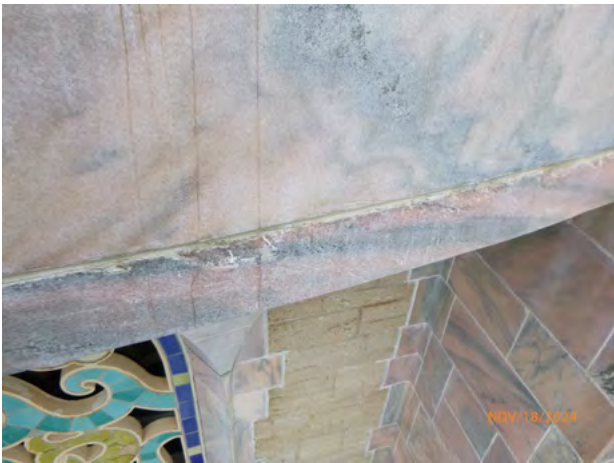
351-122 Stone\_SurfLoss Chipped 2024-2.jpg

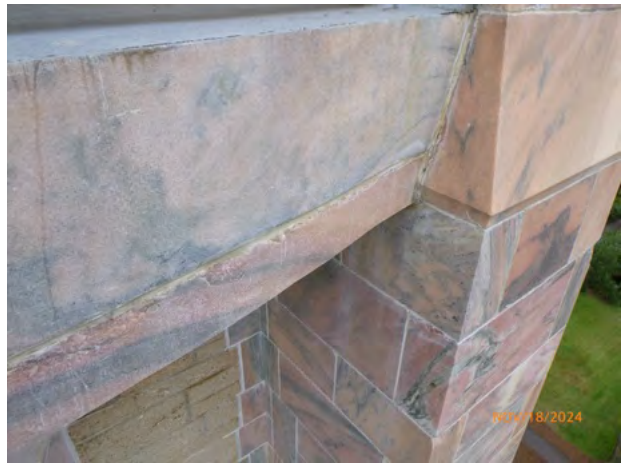
351-122 Stone\_SurfLoss Chipped 2024-3.jpg

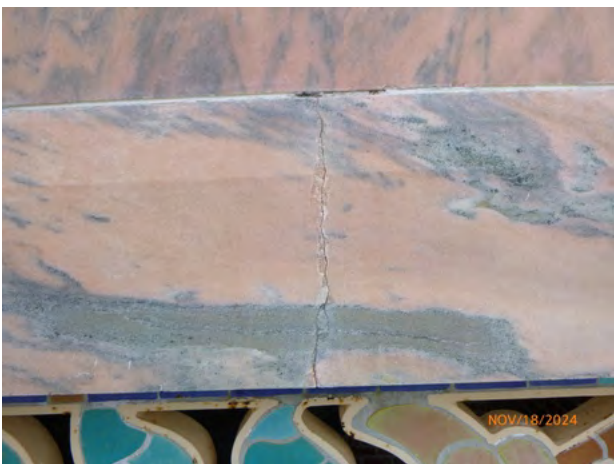
351-122 Stone\_SurfLoss Chipped 2024-4.jpg

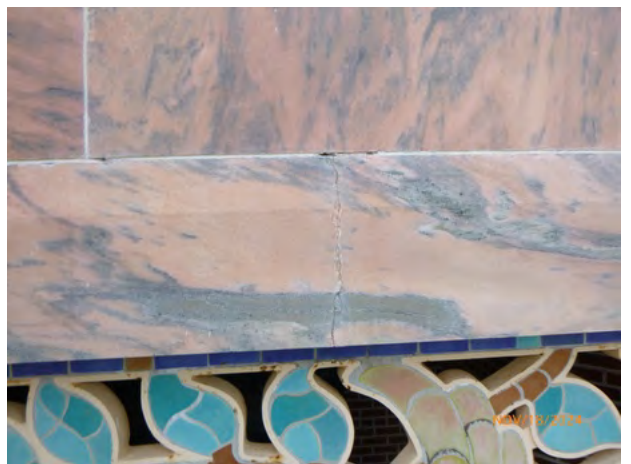
351-138 Stone\_Crack Single unit 2024-1.jpg

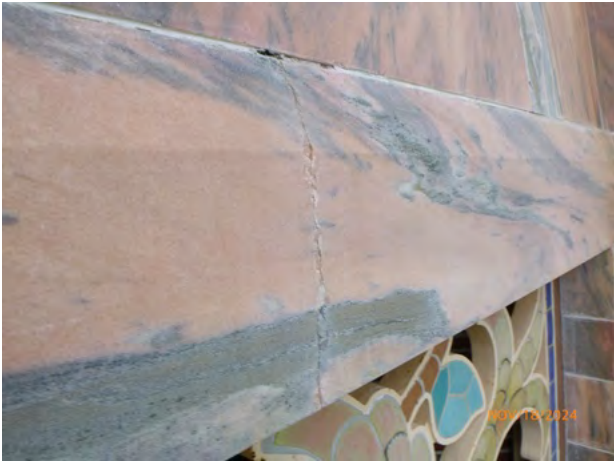
351-138 Stone\_Crack Single unit 2024-2.jpg

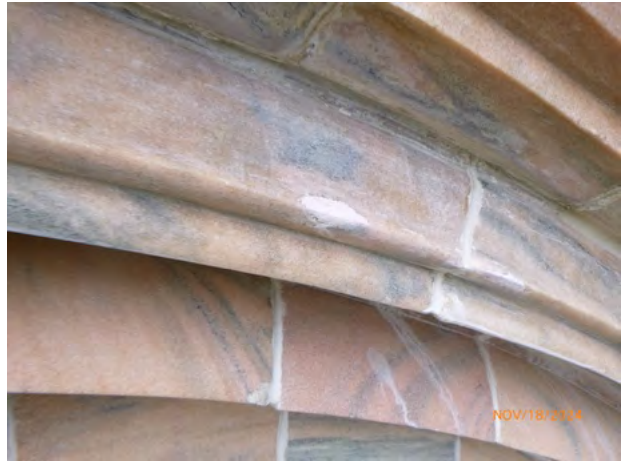
351-138 Stone\_Crack Single unit 2024-3.jpg

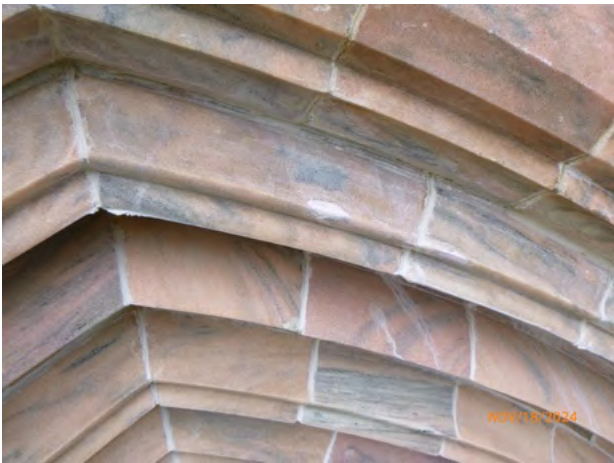
351-181 Stone\_Repair Patch Failed 2024-1.jpg

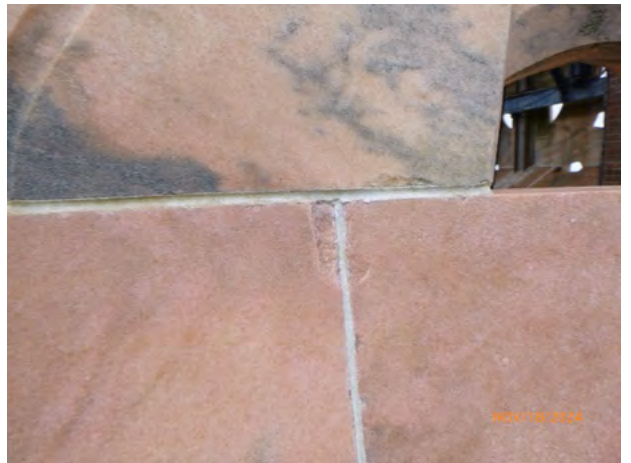
351-181 Stone\_Repair Patch Failed 2024-2.jpg

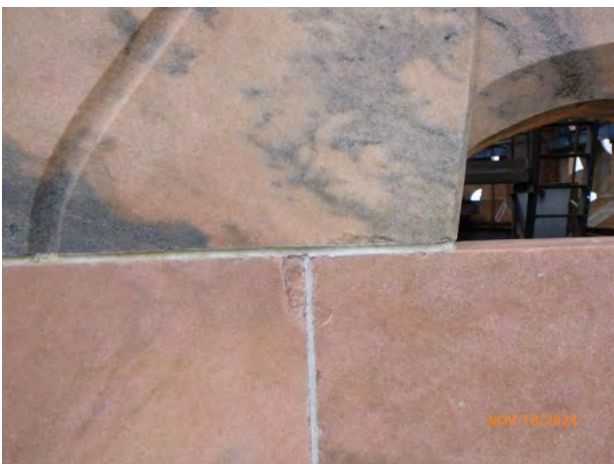
352-184 Stone\_SurfLoss Chipped 2024-1.jpg

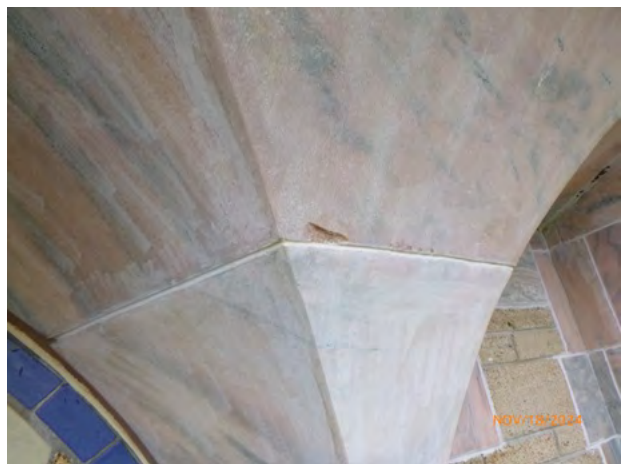
352-184 Stone\_SurfLoss Chipped 2024-2.jpg

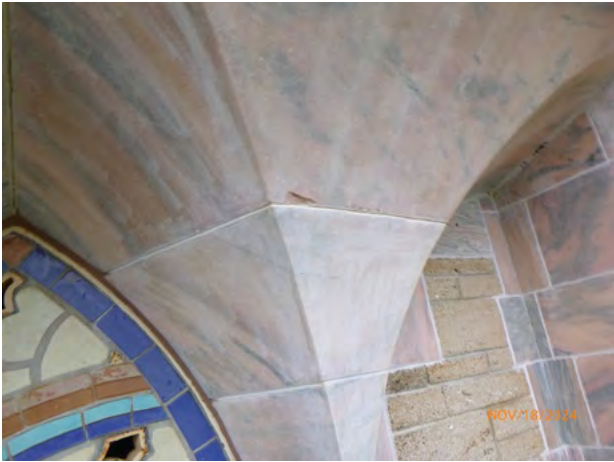
353-119 Stone\_SurfLoss Chipped 2024-1.jpg

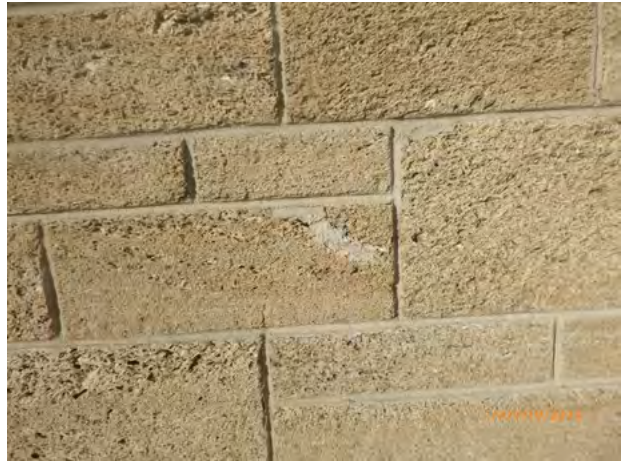
353-119 Stone\_SurfLoss Chipped 2024-2.jpg

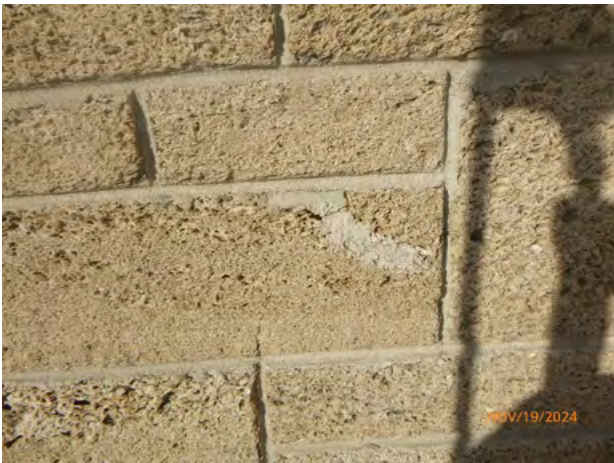
354-71 Stone\_Repair Patch Failed 2024-1.jpg

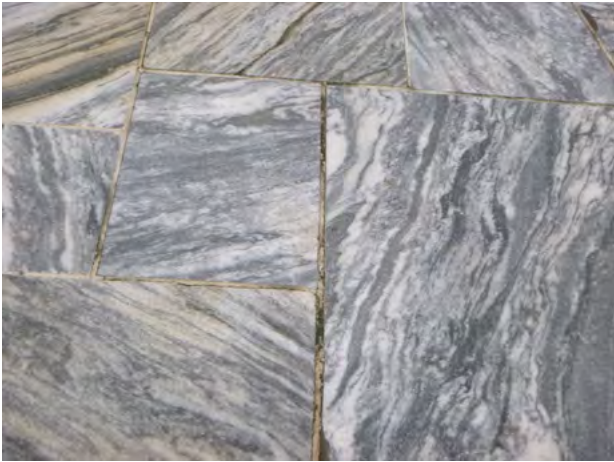
354-85 Stone\_Crack System units and joints 2024-3.jpg

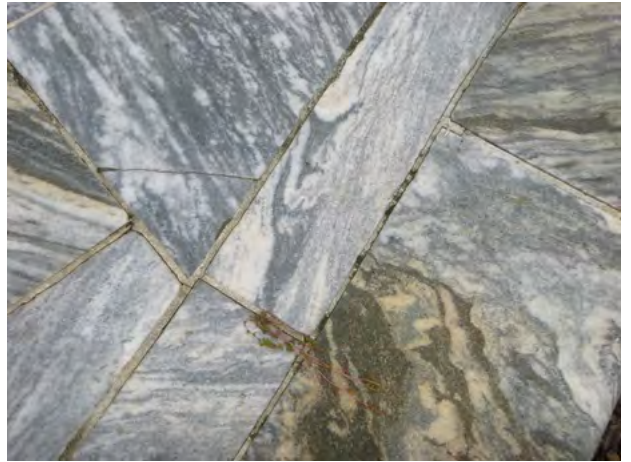
355-1 Stone\_Joints Mortar Failed 2024-1.jpg

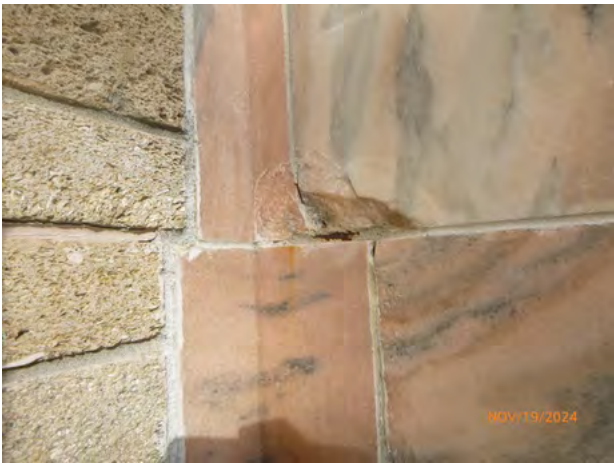
355-1 Stone\_Joints Mortar Failed 2024-2.jpg

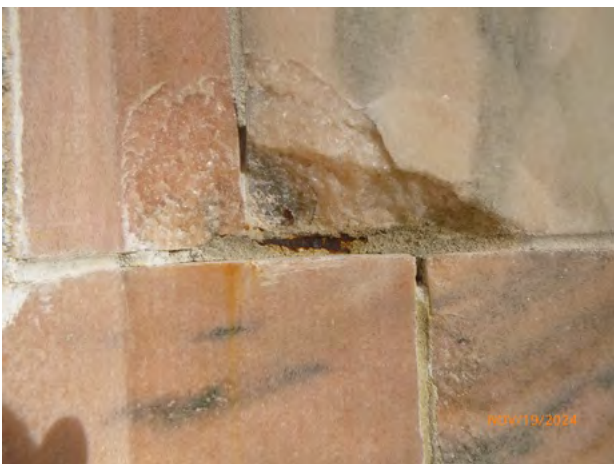
355-38 Stone\_Spall Missing + Steel 2024-2.jpg

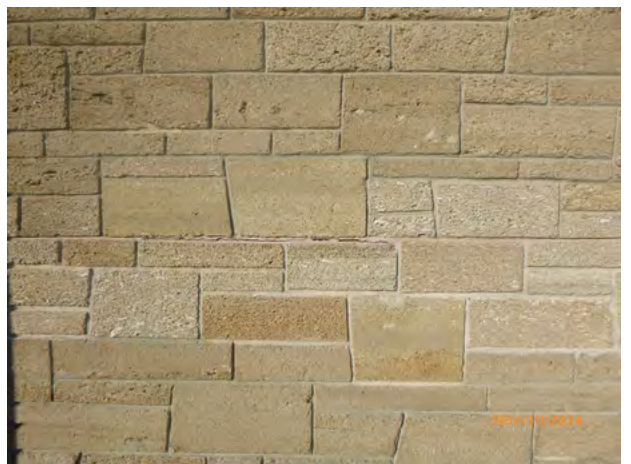
355-38 Stone\_Spall Missing + Steel 2024-3.jpg

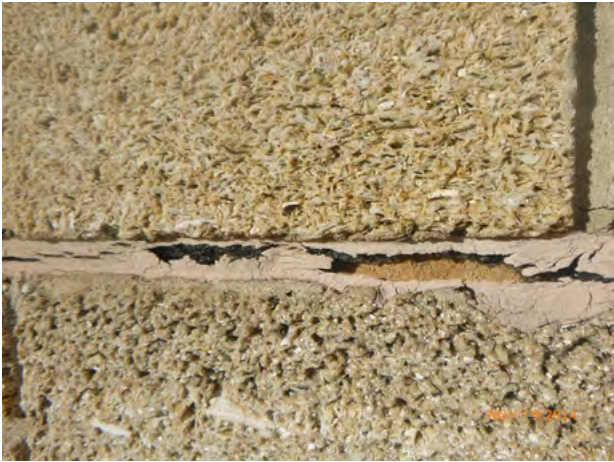
355-68 Stone\_Joints Sealant Failed 2024-1.jpg

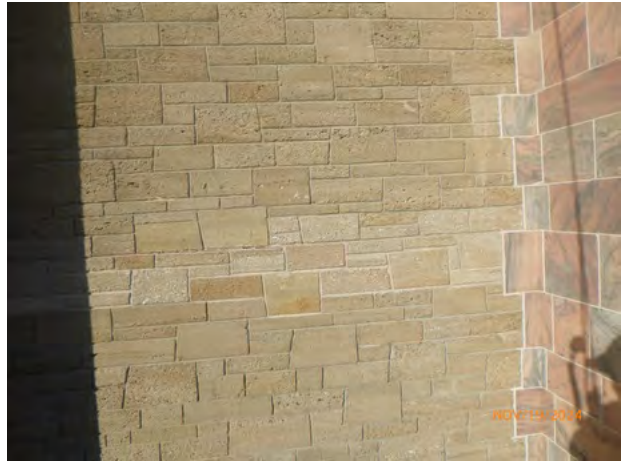
355-68 Stone\_Joints Sealant Failed 2024-2.jpg

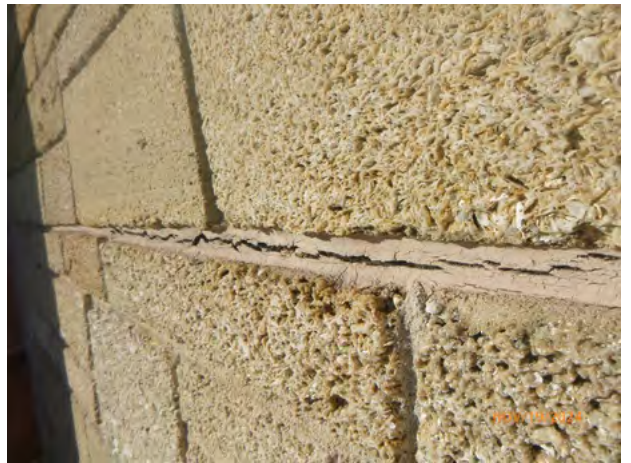
355-68 Stone\_Joints Sealant Failed 2024-4.jpg

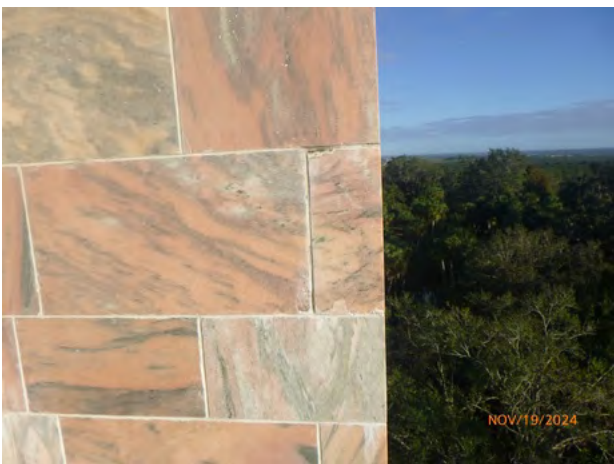
355-68 Stone\_Joints Sealant Failed 2024-5.jpg

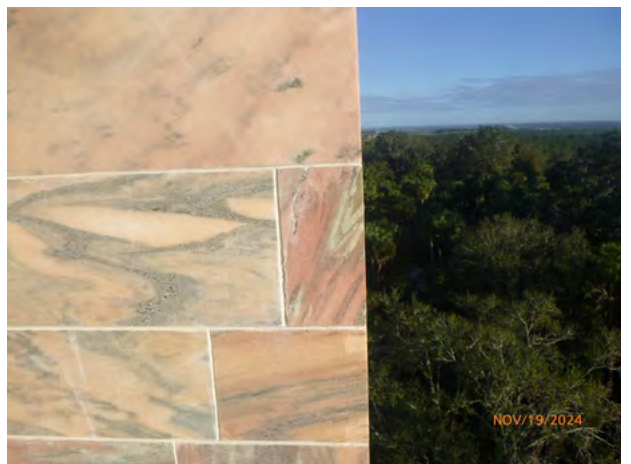
355-72 Stone\_SurfLoss Chipped 2024-1.jpg

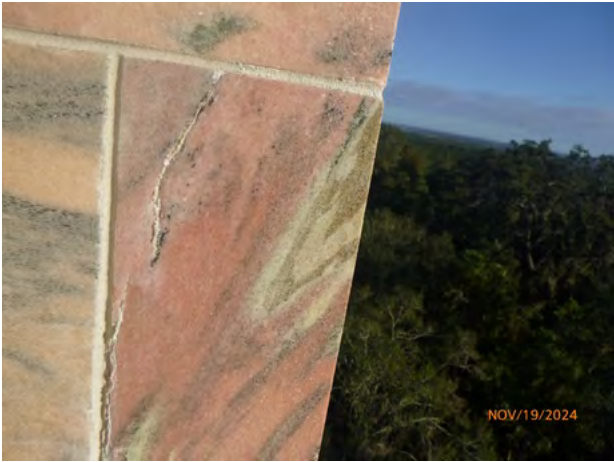
355-78 Stone\_Crack Single unit 2024-1.jpg

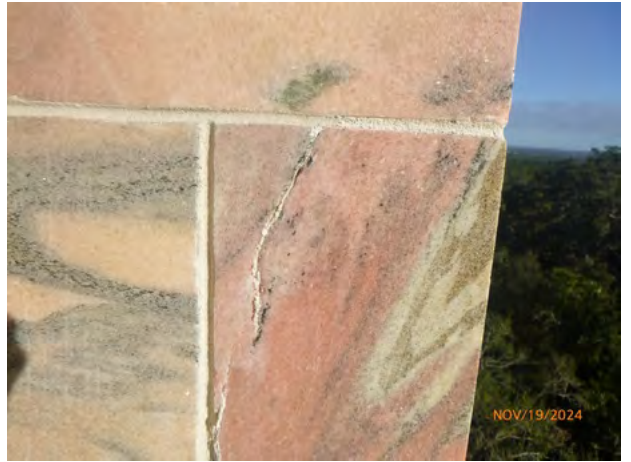
355-78 Stone\_Crack Single unit 2024-2.jpg

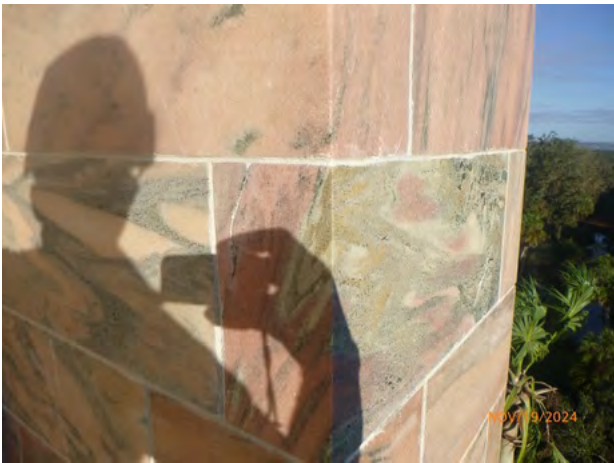
355-78 Stone\_Crack Single unit 2024-3.jpg

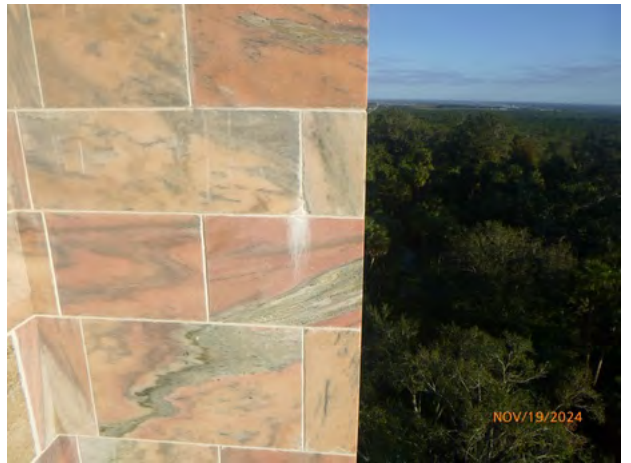
355-78 Stone\_Crack Single unit 2024-4.jpg

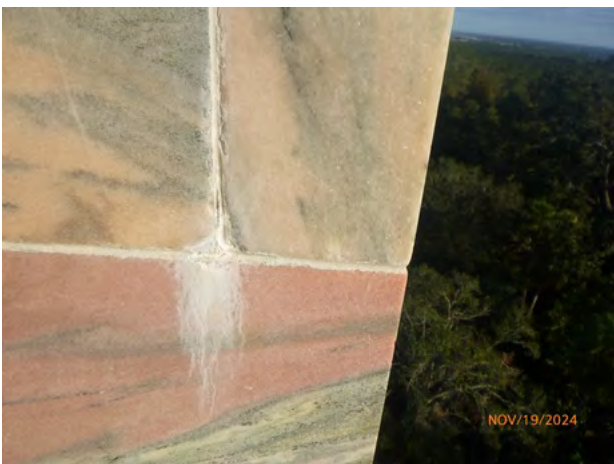
355-86 Stone\_SoilStain Leached Salts 2024-1.jpg

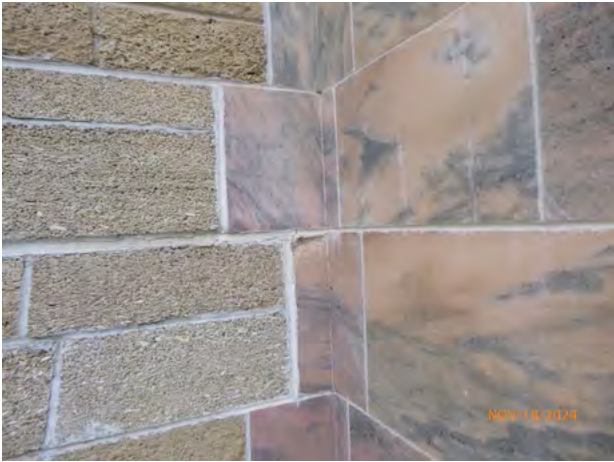
355-90 Stone\_Spall Missing 2024-1.jpg

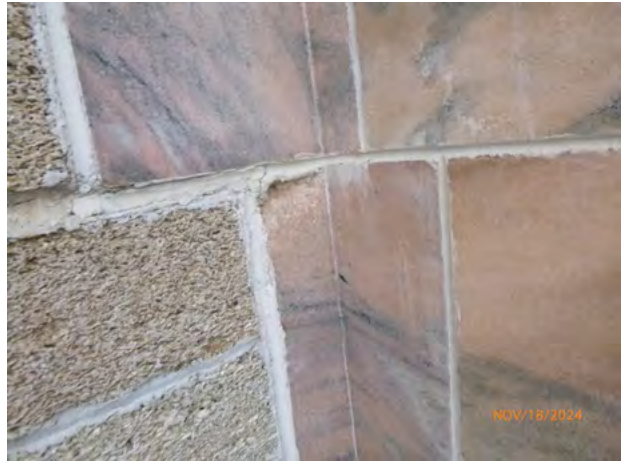
355-90 Stone\_Spall Missing 2024-2.jpg

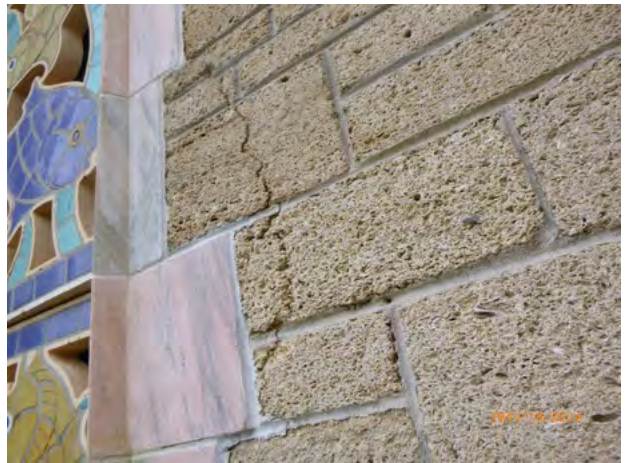
355-108 Stone\_Crack System units and joints 2024-1.jpg

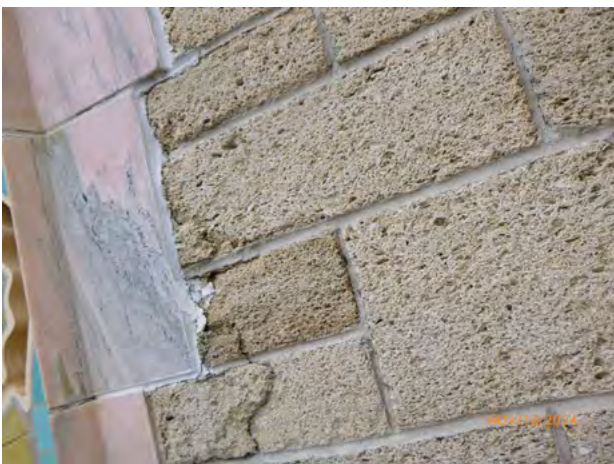
355-108 Stone\_Crack System units and joints 2024-2.jpg

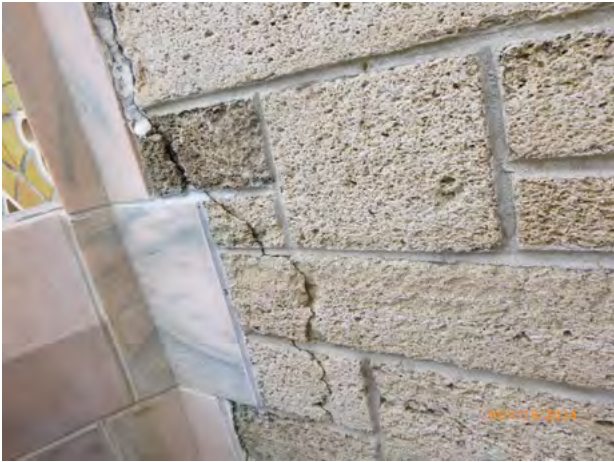
355-108 Stone\_Crack System units and joints 2024-4.jpg

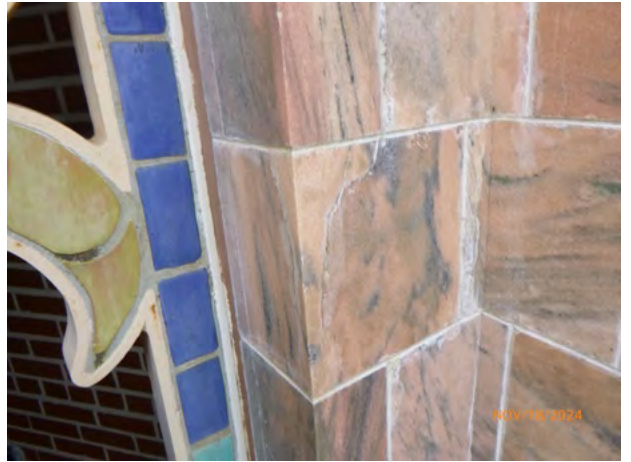
355-108 Stone\_Crack System units and joints 2024-5.jpg

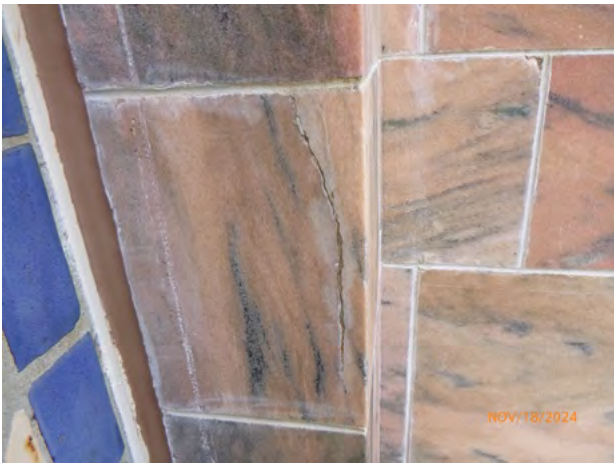
355-135 Stone\_Crack Single unit 2024-1.jpg

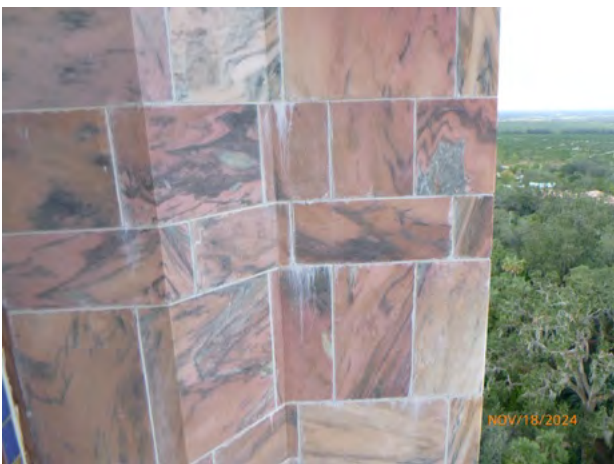
355-135 Stone\_Crack Single unit 2024-3.jpg

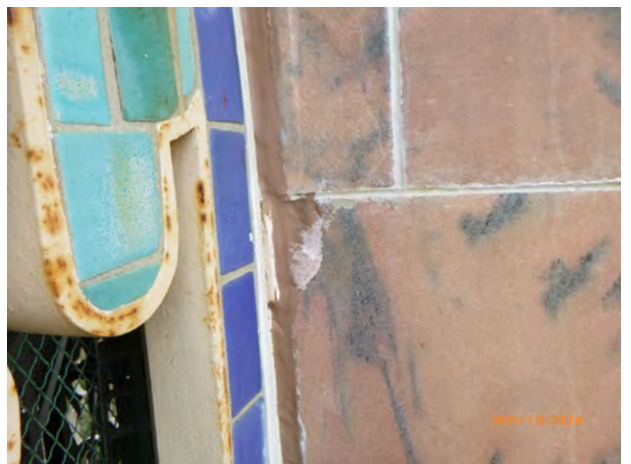
355-144 Stone\_SoilStain Leached Salts 2024-1.jpg

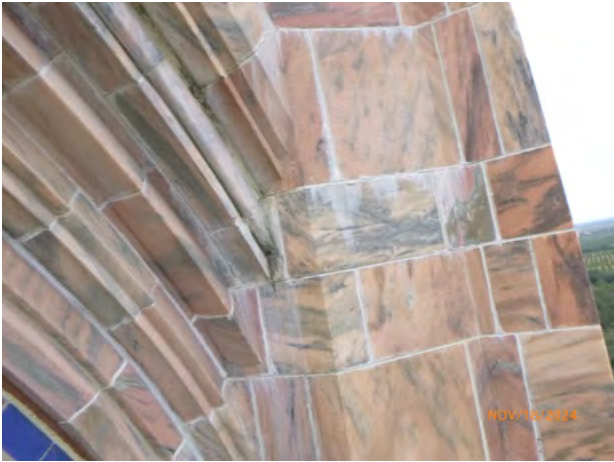
355-172 Stone\_Repair Patch Failed 2024-1.jpg

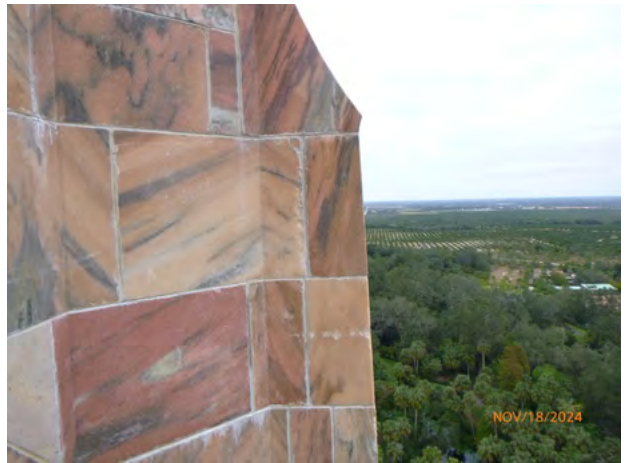
355-176 Stone\_SoilStain Leached Salts 2024-3.jpg

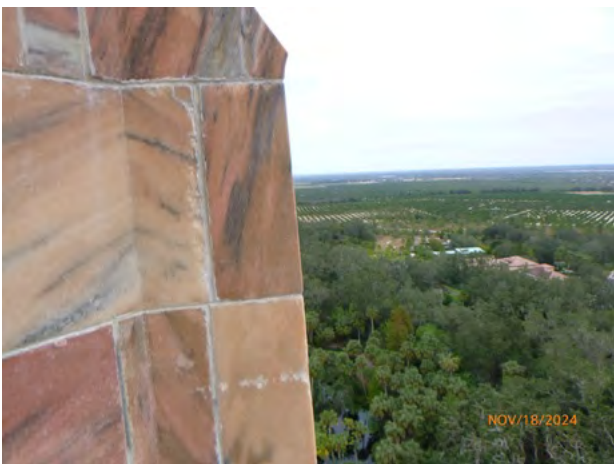
355-181 Stone\_SurfLoss Chipped 2024-1.jpg

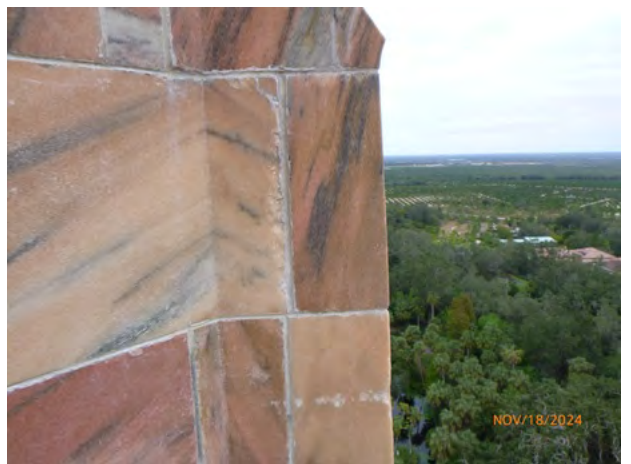
355-181 Stone\_SurfLoss Chipped 2024-2.jpg

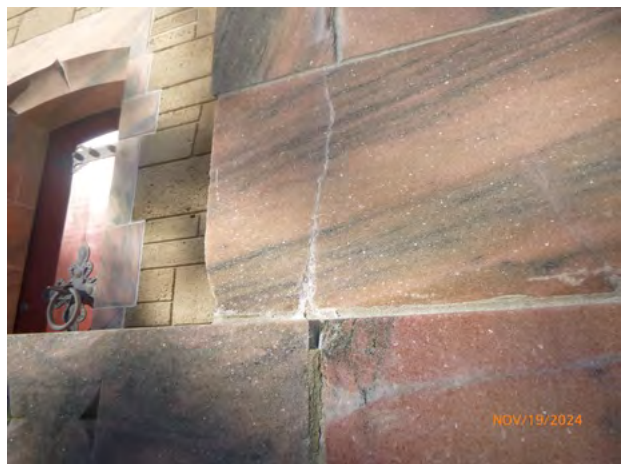
356-29 Stone\_SoilStain Biological 2024-5.jpg

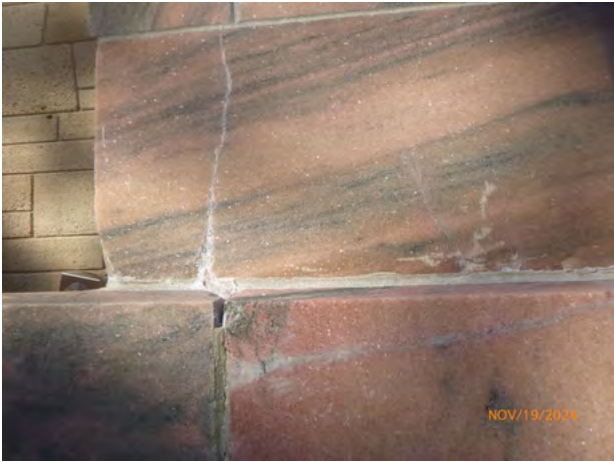
356-32 Stone\_Crack Single unit 2024-1.jpg

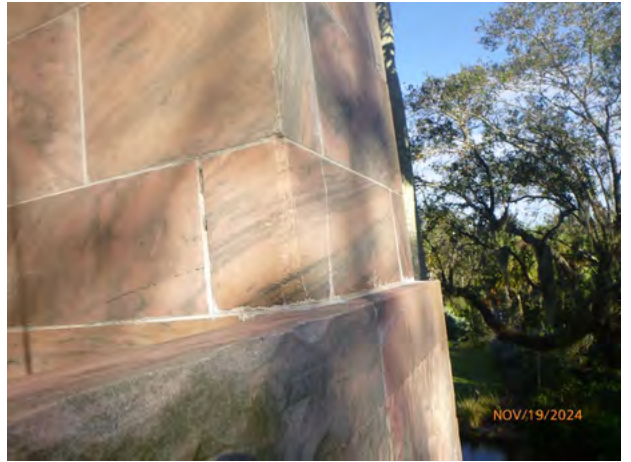
356-32 Stone\_Crack Single unit 2024-2.jpg

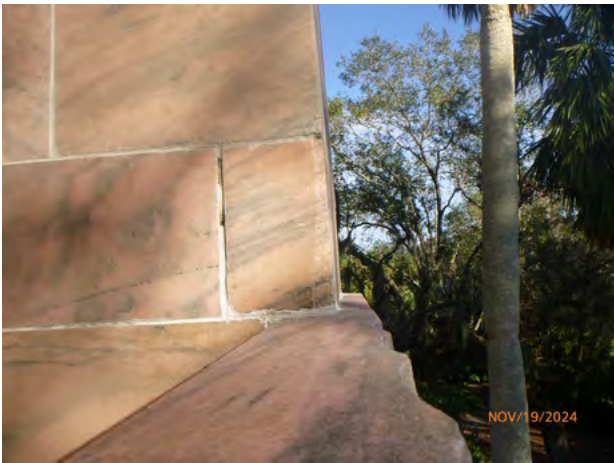
356-32 Stone\_Spall Missing 2024-1.jpg

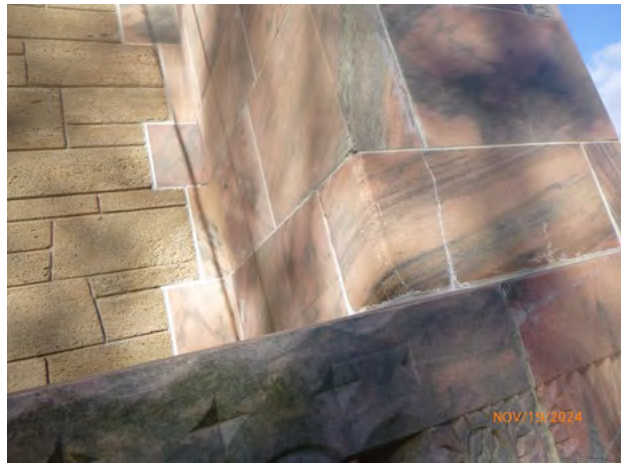
356-32 Stone\_Spall Missing 2024-2.jpg

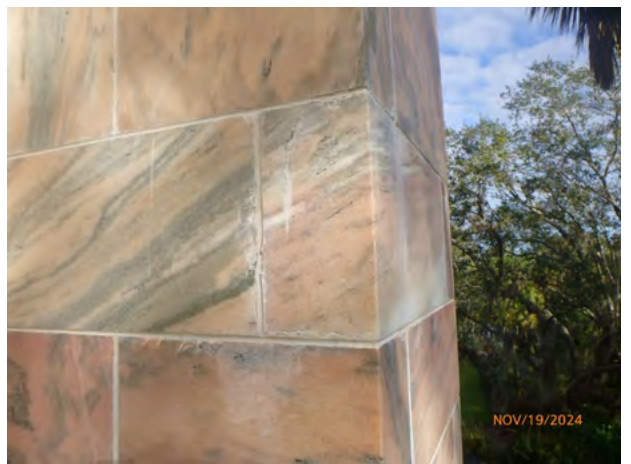
356-32 Stone\_Spall Missing 2024-4.jpg

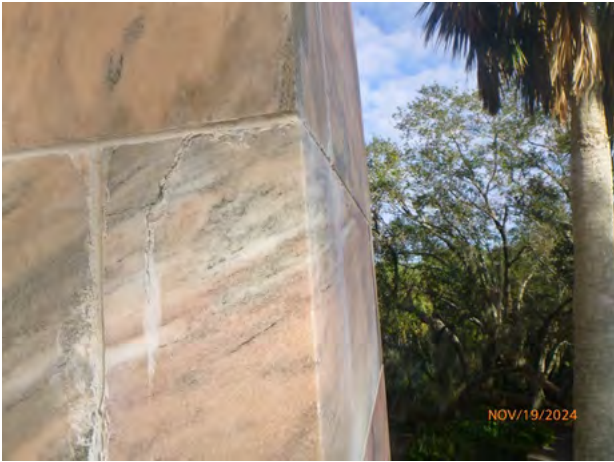
356-37 Stone\_SurfLoss Chipped 2024-1.jpg

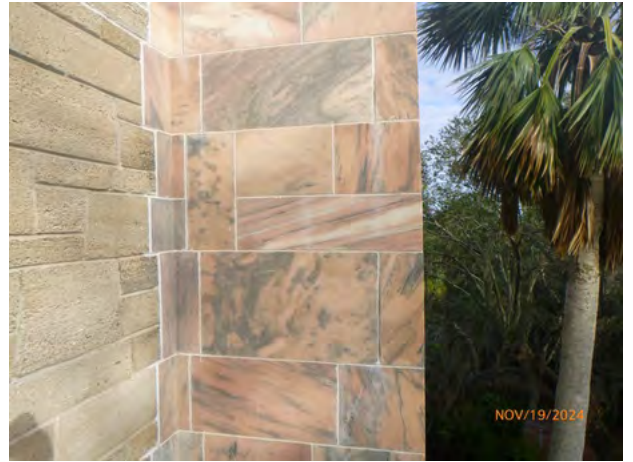
356-37 Stone\_SurfLoss Chipped 2024-2.jpg

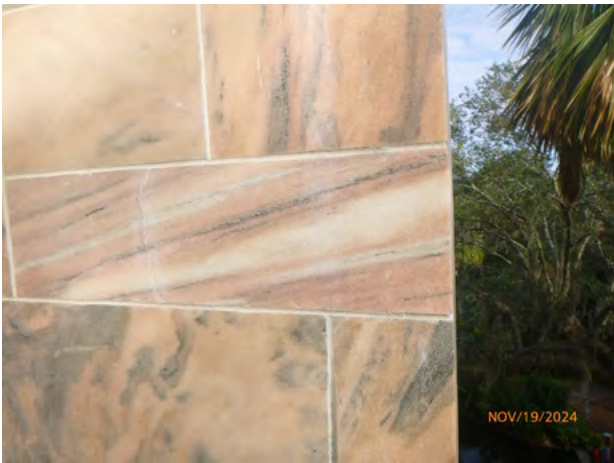
356-41 Stone\_Crack Single unit 2024-1.jpg

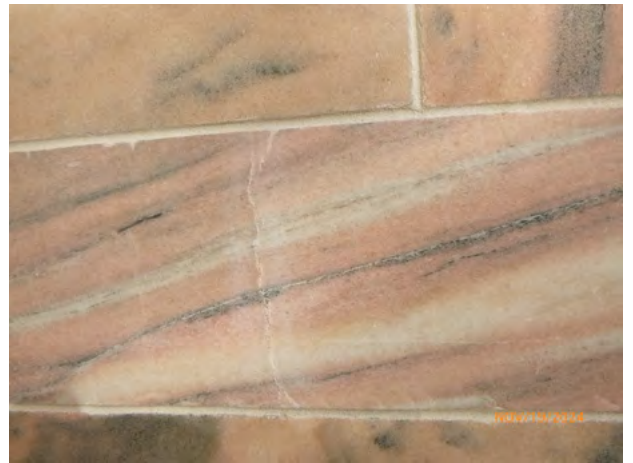
356-41 Stone\_Crack Single unit 2024-2.jpg

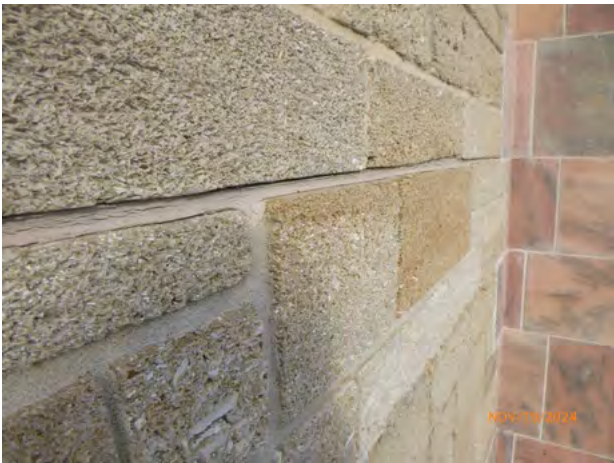
356-52 Stone\_Joints Sealant Failed 2024-1.jpg

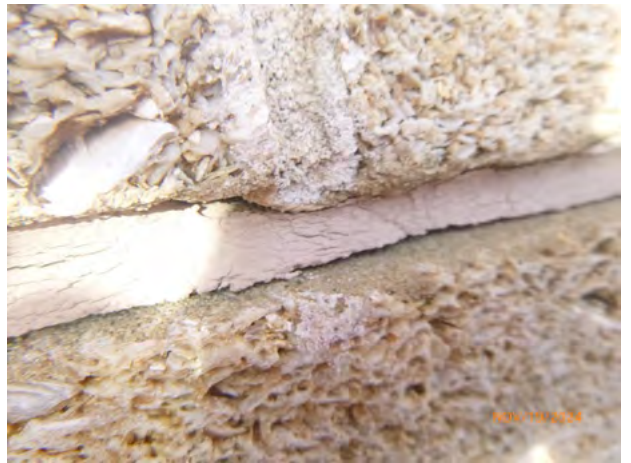
356-52 Stone\_Joints Sealant Failed 2024-2.jpg
