### ***Bok Singing Tower Roof Restoration and Replacement***

# Bok Singing Tower Conditions Assessment

T.Y. Lin (formerly Silman) was contracted to perform a conditions assessment of the Bok Singing Tower at Bok Tower Gardens in Lake Wales, Florida. The Singing Tower stands 205 feet tall at the southwest corner of the gardens. A moat surrounds the base of the tower with two bridges to access the island. The tower houses a 60-bell carillon, associated carillonneur studio and library spaces, the Bok Tower Gardens Chao Research archive, and the Founder's Room. It is a steel frame construction clad in a masonry exterior of coquina and Georgia pink Etowah marble with brick masonry at the interior.

## **Bok Tower Focused Condition Assessment**

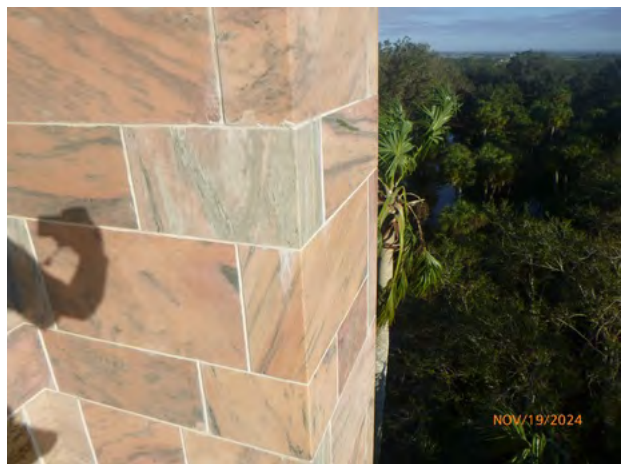
356-52 Stone\_Joints Sealant Failed 2024-4.jpg

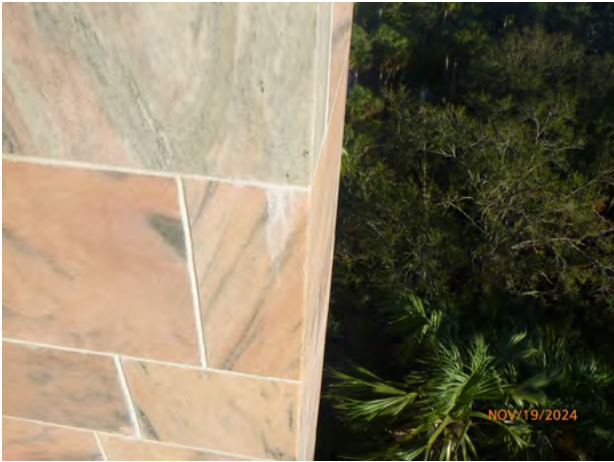
356-71 Stone\_SoilStain Leached Salts 2024-1.jpg

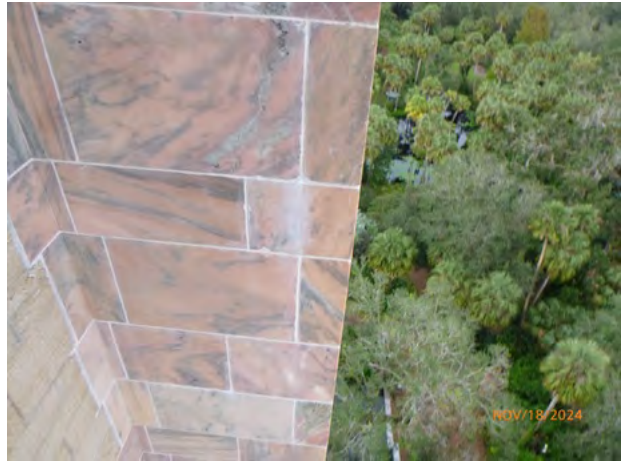
356-71 Stone\_SoilStain Leached Salts 2024-2.jpg

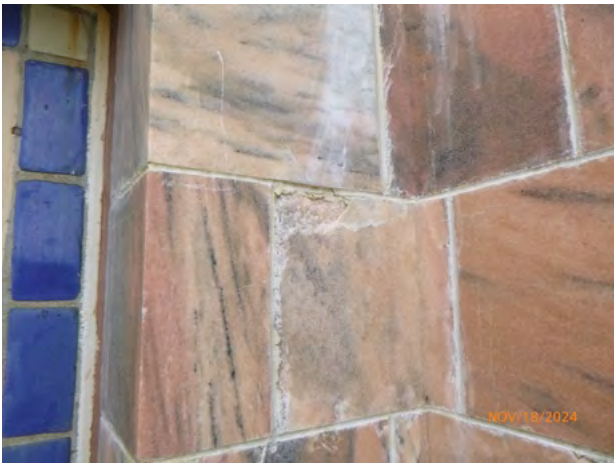
356-110 Stone\_SoilStain Leached Salts 2024-1.jpg

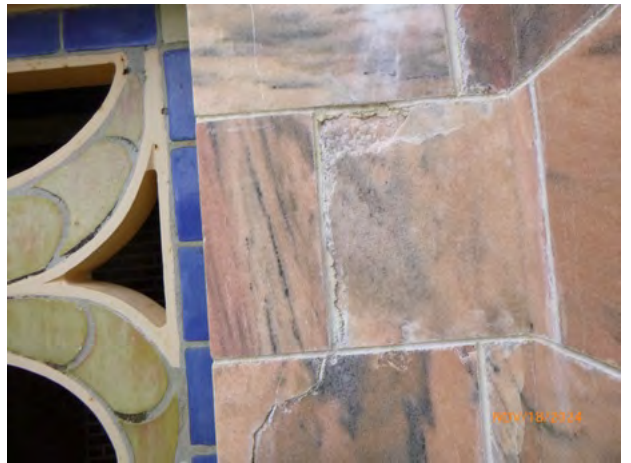
356-137 Stone\_SurfLoss Chipped 2024-1.jpg

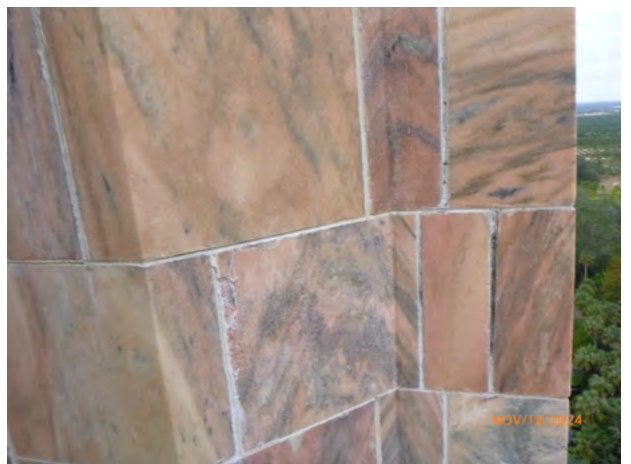
356-174 Stone\_SurfLoss Chipped 2024-1.jpg

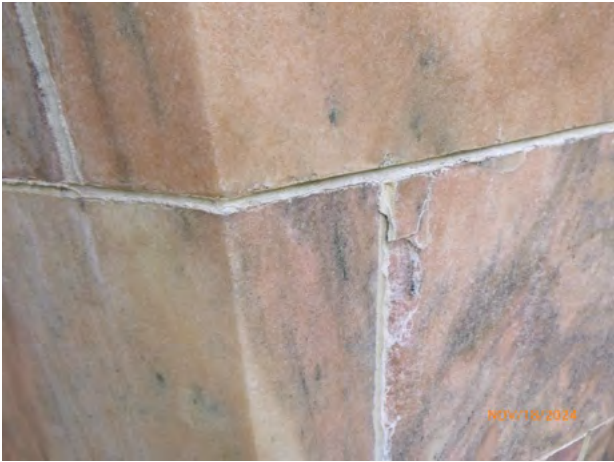
356-174 Stone\_SurfLoss Chipped 2024-2.jpg

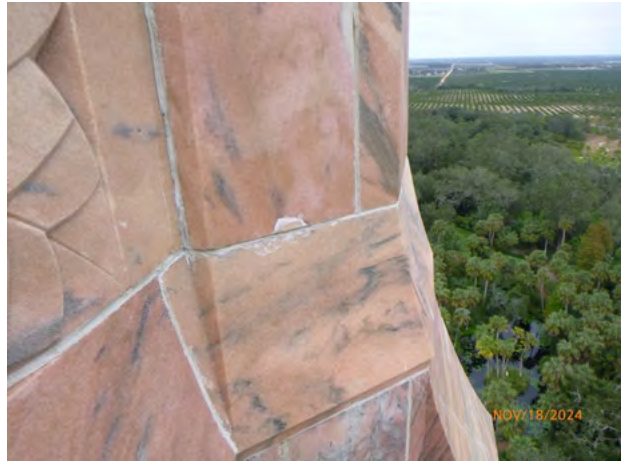
356-174 Stone\_SurfLoss Chipped 2024-3.jpg

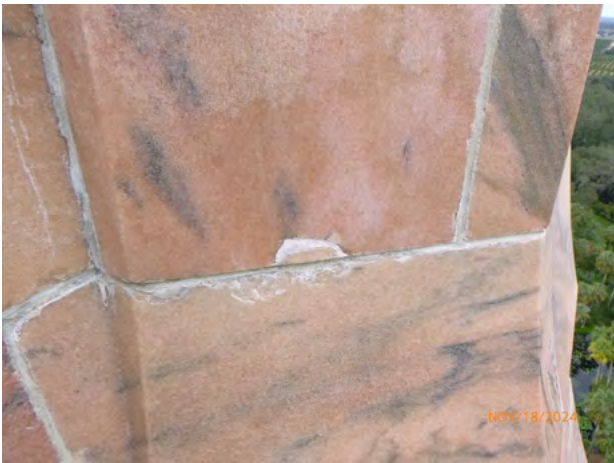
356-185 Stone\_SurfLoss Chipped 2024-1.jpg

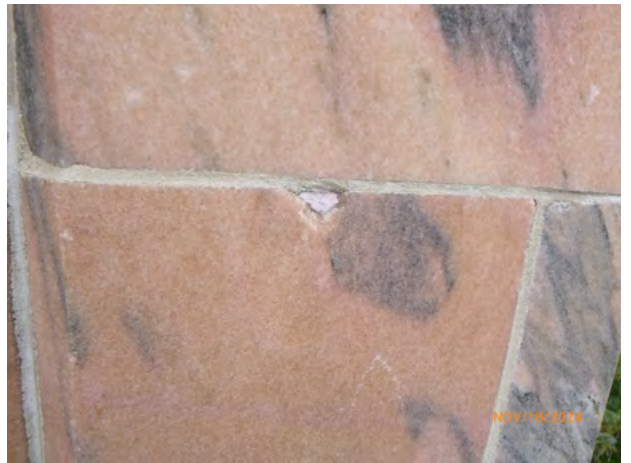
356-185 Stone\_SurfLoss Chipped 2024-2.jpg

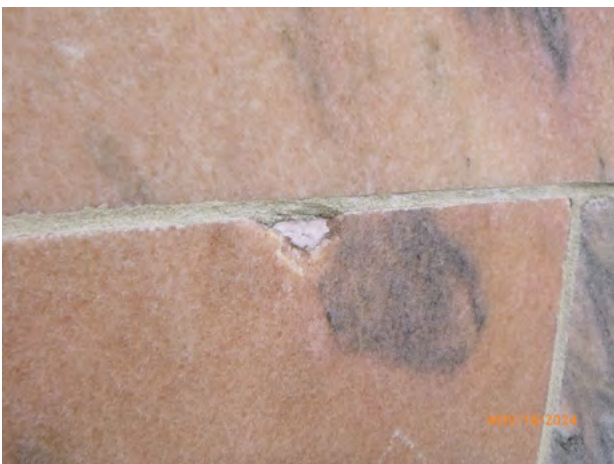
356-187 Stone\_SurfLoss Chipped 2024-1.jpg

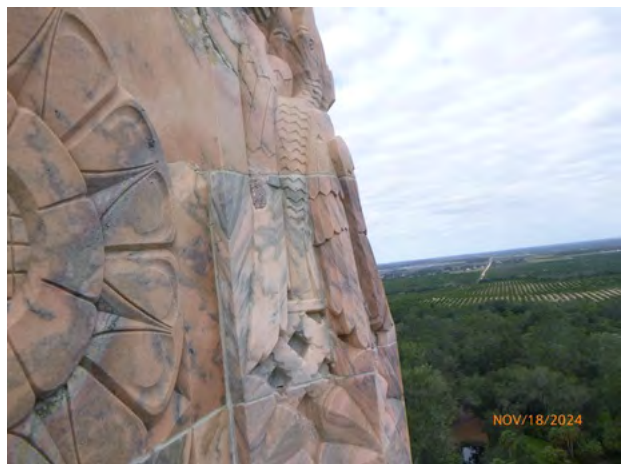
356-187 Stone\_SurfLoss Chipped 2024-2.jpg

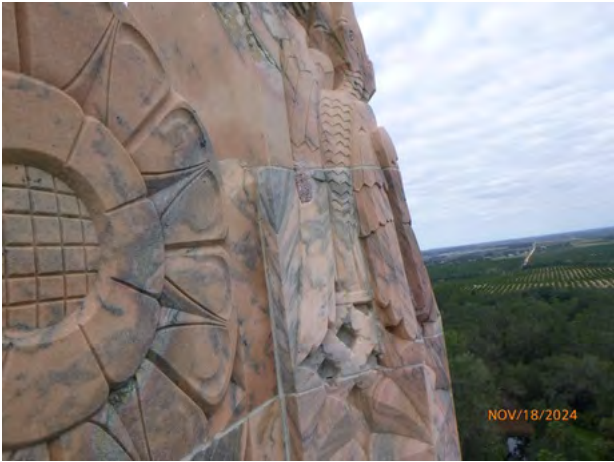
356-197 Stone\_Spall Missing 2024-1.jpg

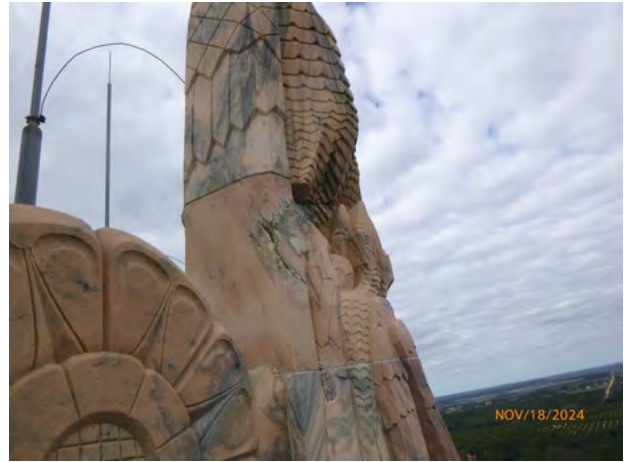
356-197 Stone\_Spall Missing 2024-2.jpg

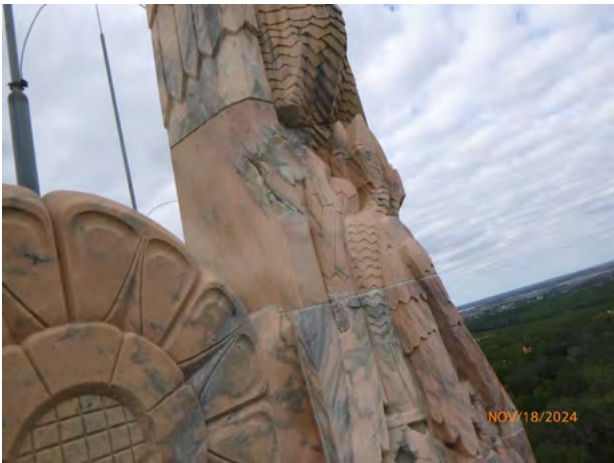
356-201 Stone\_Spall Missing 2024-1.jpg

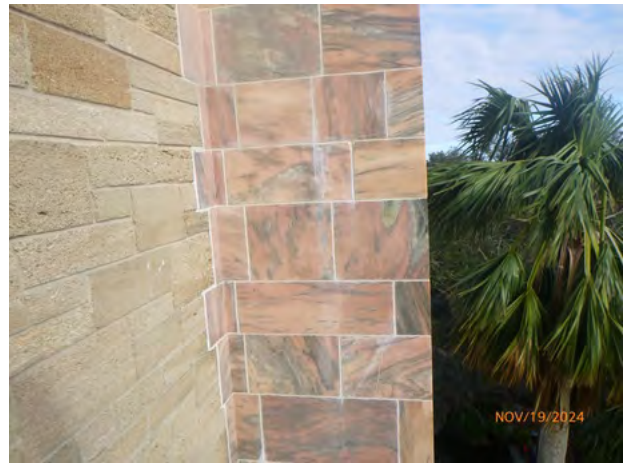
356-201 Stone\_Spall Missing 2024-2.jpg

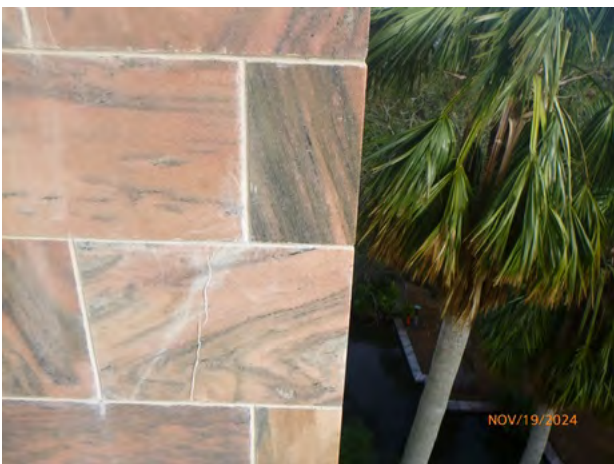
357-45 Stone\_SoilStain Leached Salts 2024-1.jpg

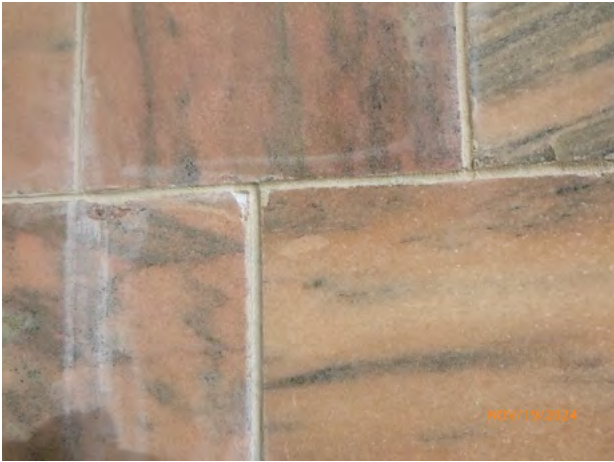
357-45 Stone\_SoilStain Leached Salts 2024-3.jpg

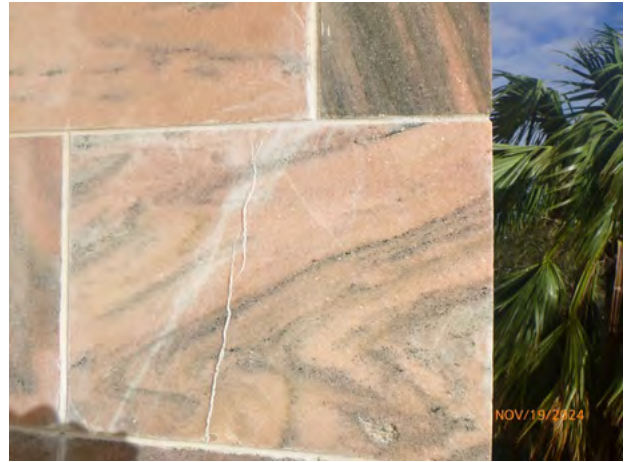
357-45 Stone\_SoilStain Leached Salts 2024-4.jpg

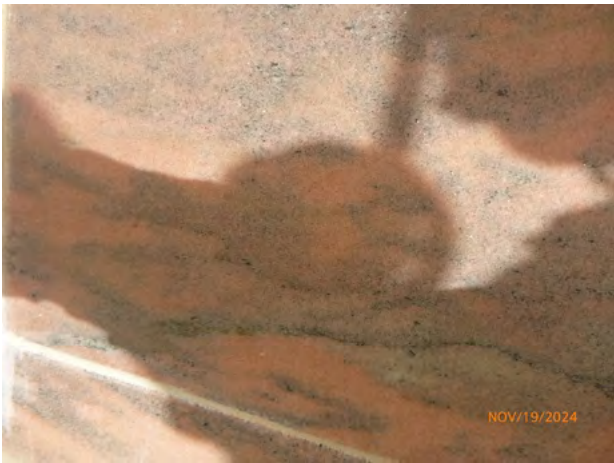
357-45 Stone\_SoilStain Leached Salts 2024-6.jpg

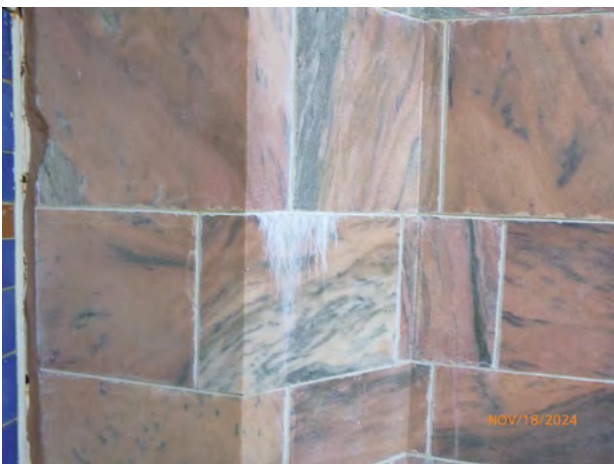
357-152 Stone\_SoilStain Leached Salts 2024-1.jpg

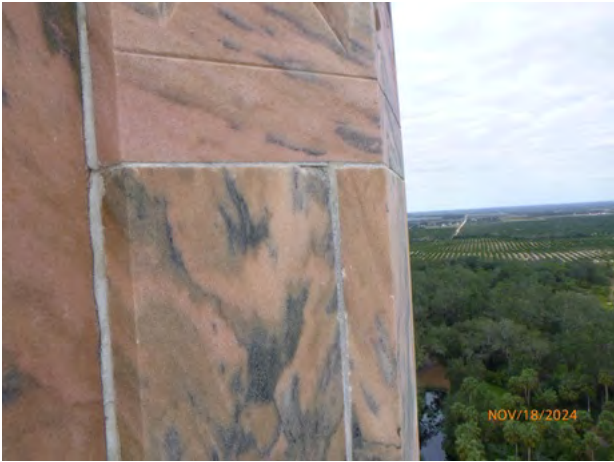
357-191 Stone\_SurfLoss Chipped 2024-1.jpg

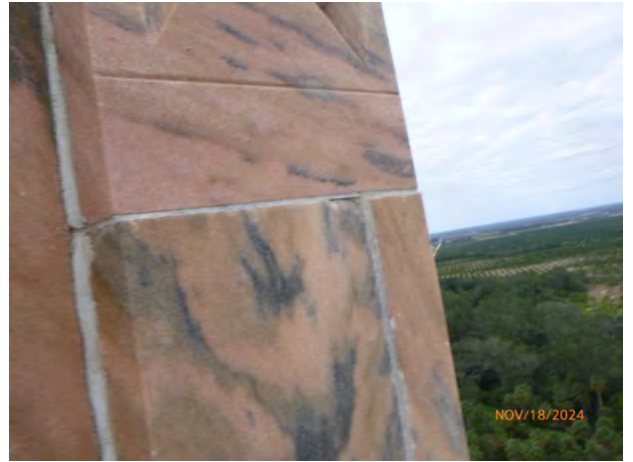
357-191 Stone\_SurfLoss Chipped 2024-2.jpg

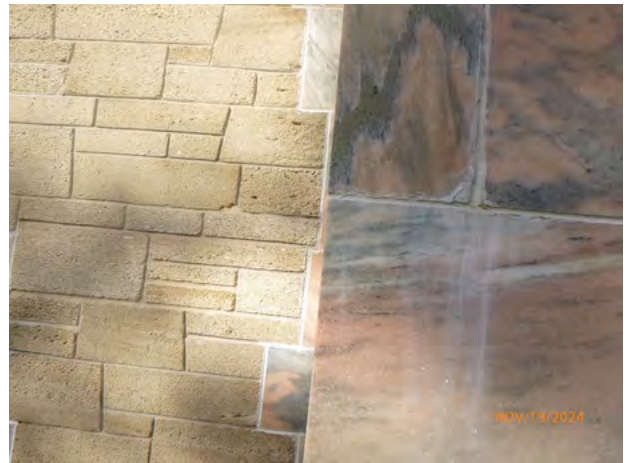
358-37 Stone\_SoilStain Leached Salts 2024-2.jpg

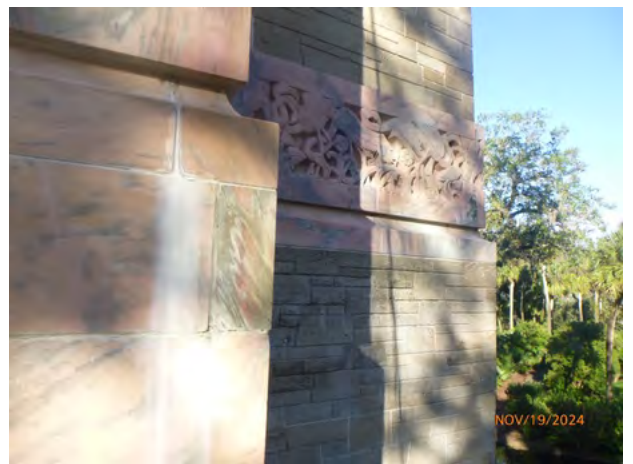
359-21 Stone\_SoilStain Leached Salts 2024-2.jpg

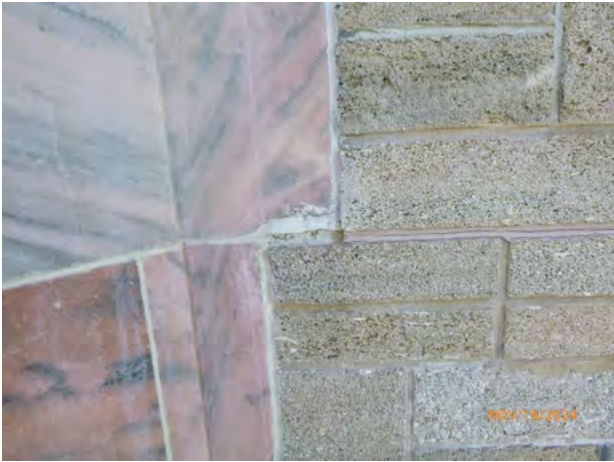
360-131 Stone\_Repair Patch Failed 2024-1.jpg

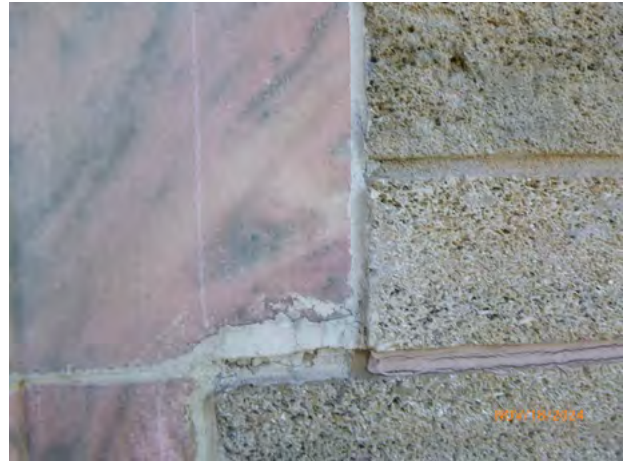
360-131 Stone\_Repair Patch Failed 2024-2.jpg

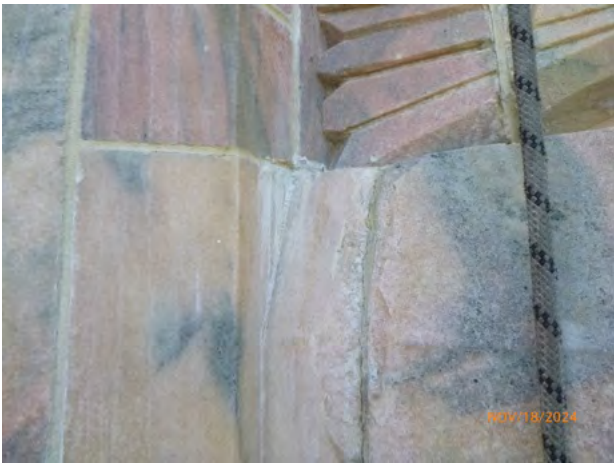
360-138 Stone\_SoilStain Leached Salts 2024-1.jpg

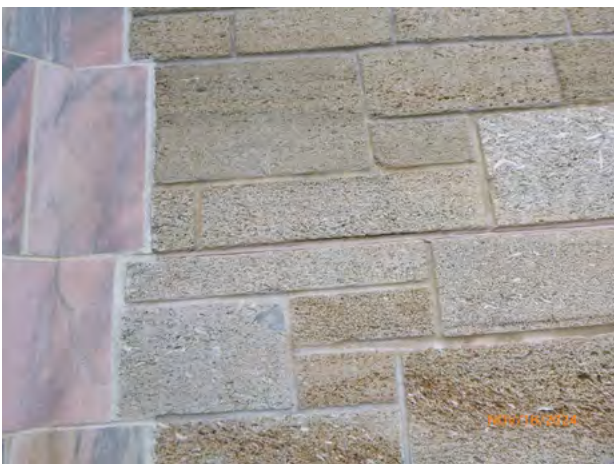
361-96 Stone\_Joints Sealant Failed 2024-1.jpg

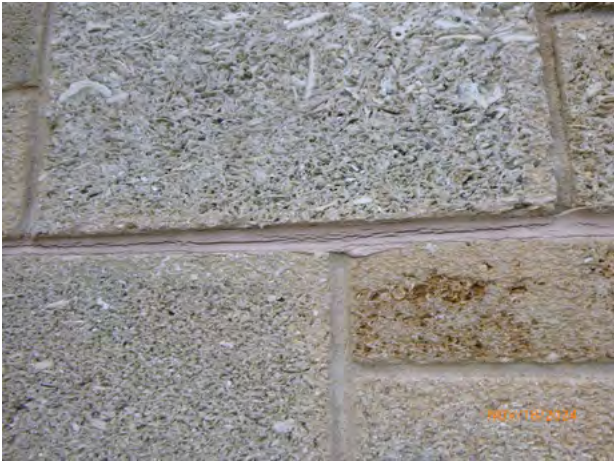
361-96 Stone\_Joints Sealant Failed 2024-3.jpg

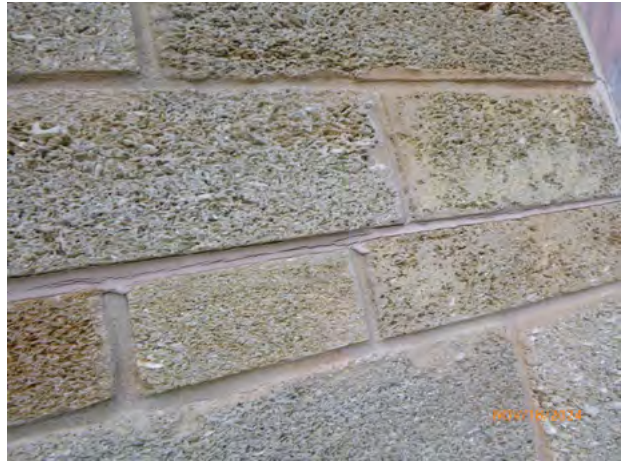
361-96 Stone\_Joints Sealant Failed 2024-4.jpg

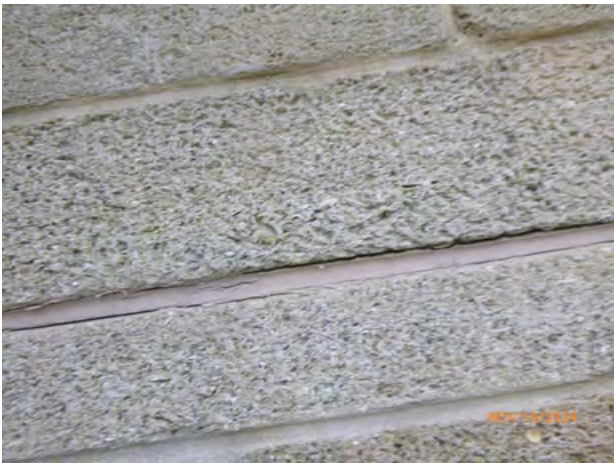
361-96 Stone\_Joints Sealant Failed 2024-5.jpg

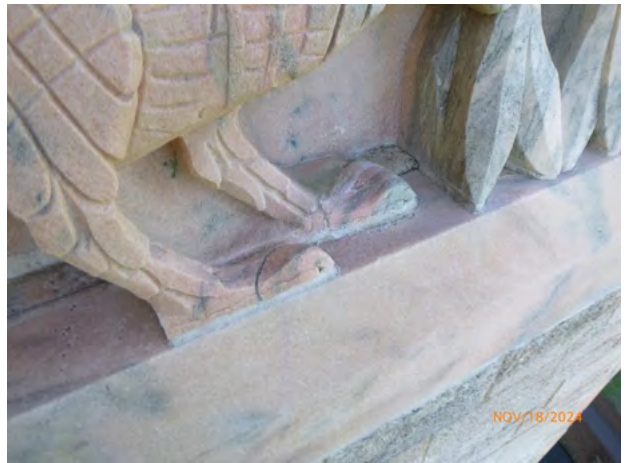
361-138 Stone\_Crack Single unit 2024-1.jpg

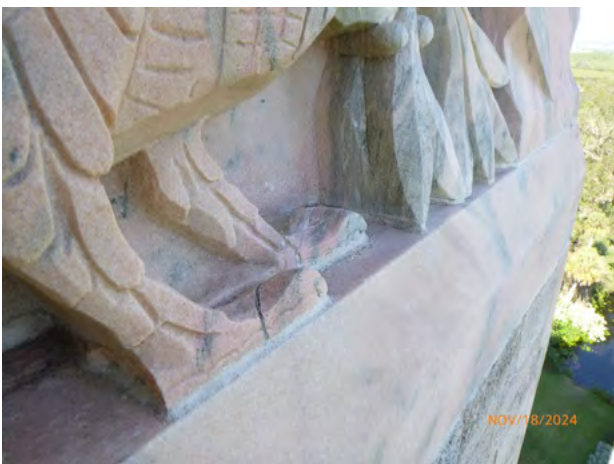
361-138 Stone\_Crack Single unit 2024-2.jpg

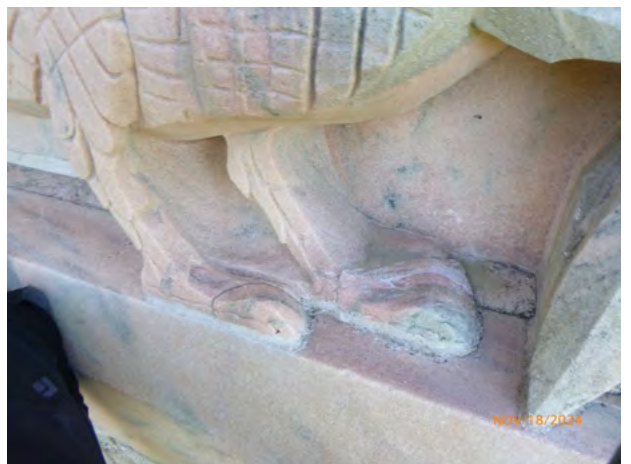
361-138 Stone\_Crack Single unit 2024-3.jpg

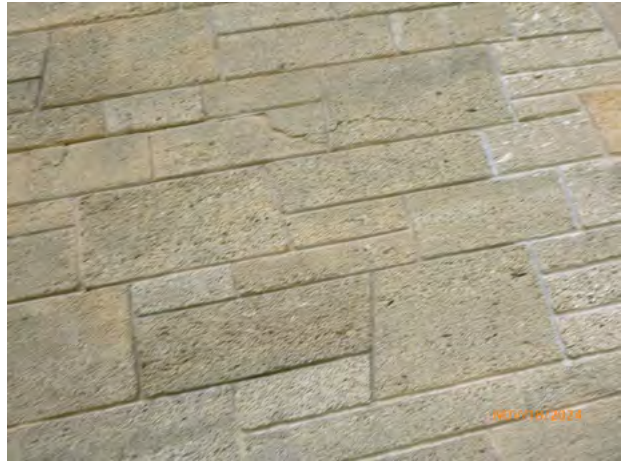
364-13 Stone\_Crack System units and joints 2024-1.jpg

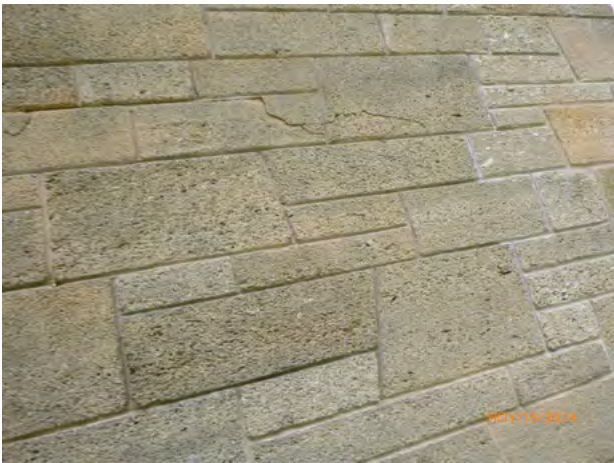
364-13 Stone\_Crack System units and joints 2024-2.jpg

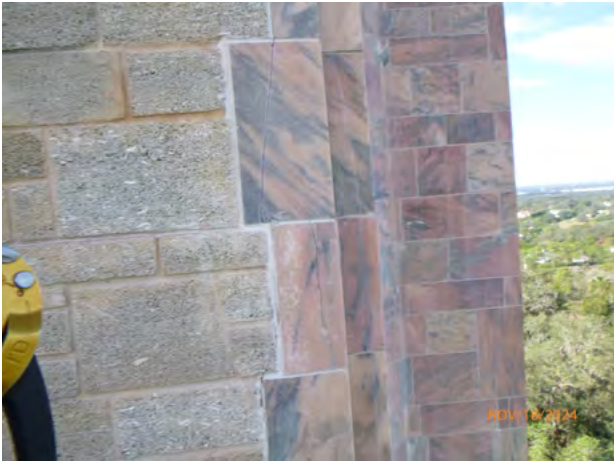
365-107 Stone\_Crack System units and joints 2024-1.jpg

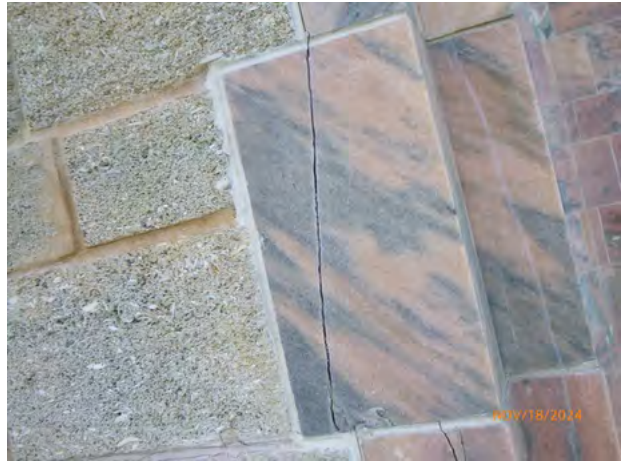
365-107 Stone\_Crack System units and joints 2024-2.jpg

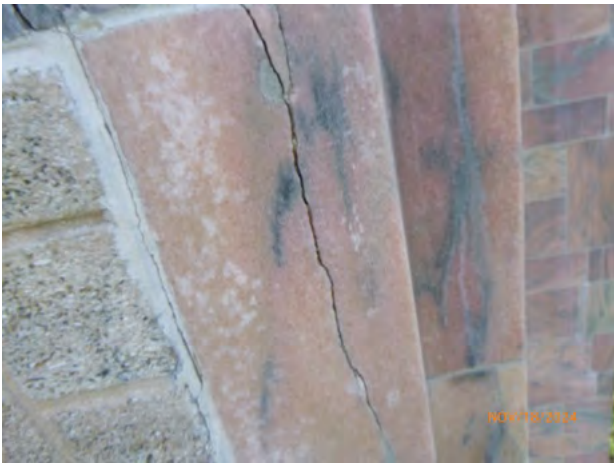
365-107 Stone\_Crack System units and joints 2024-3.jpg

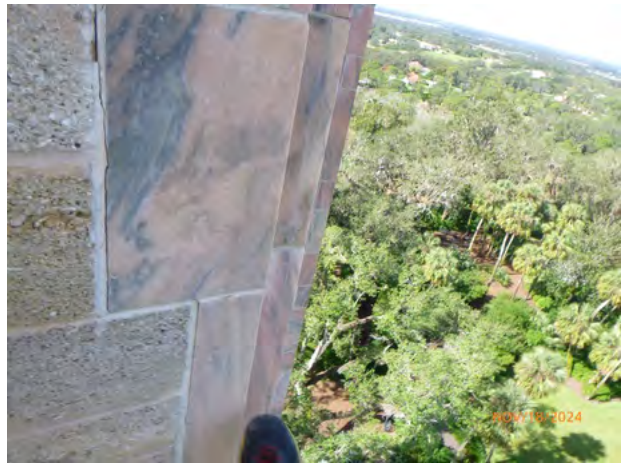
365-107 Stone\_Crack System units and joints 2024-4.jpg

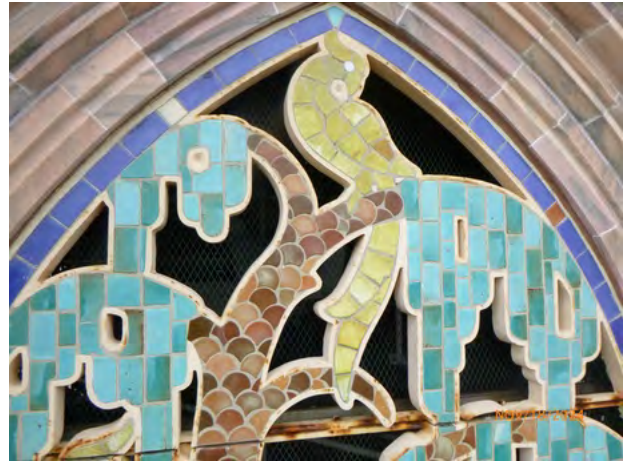
392-174 ArchMetal\_Coating Coating Failed 2024-1.jpg

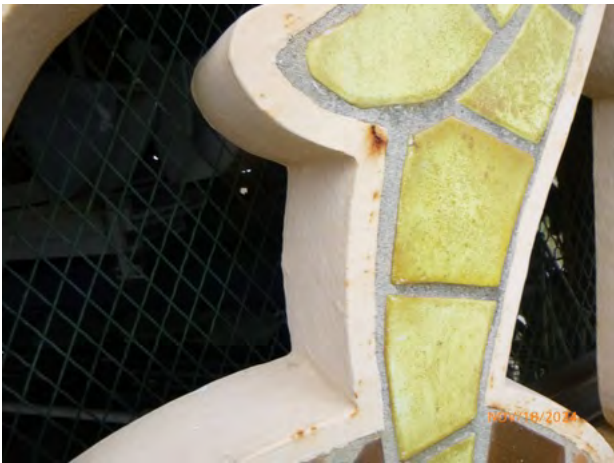
392-174 ArchMetal\_Coating Coating Failed 2024-2.jpg

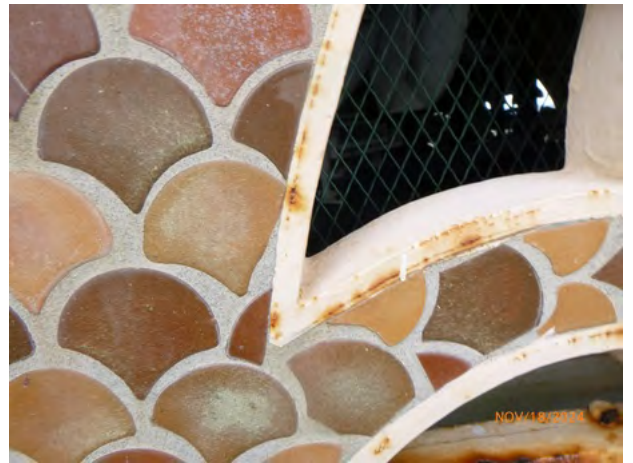
392-174 ArchMetal\_Coating Coating Failed 2024-3.jpg

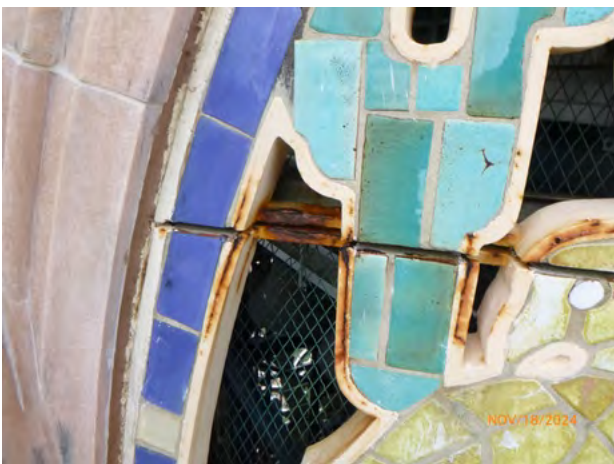
392-174 ArchMetal\_Coating Coating Failed 2024-4.jpg

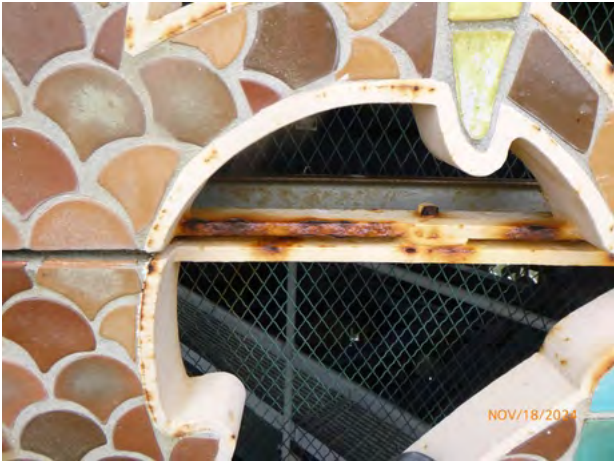
392-174 ArchMetal\_Coating Coating Failed 2024-6.jpg

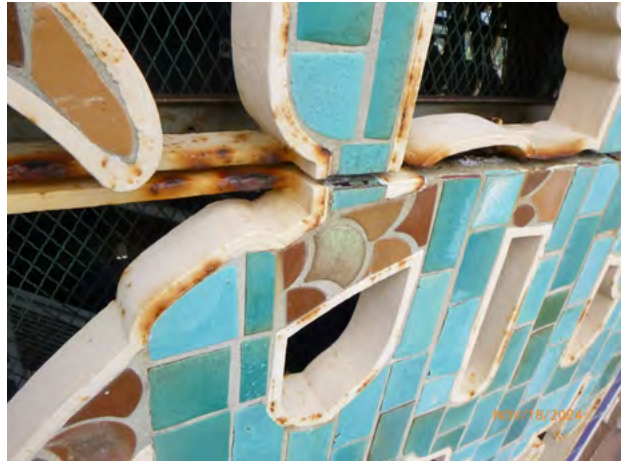
392-174 ArchMetal\_Coating Coating Failed 2024-7.jpg

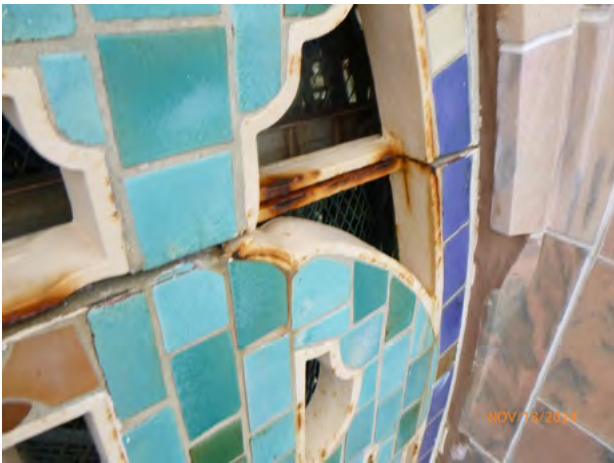
392-174 ArchMetal\_Coating Coating Failed 2024-8.jpg

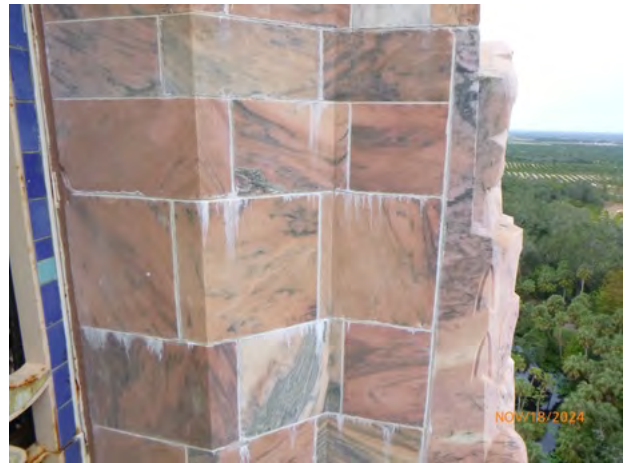
397-156 Stone\_SoilStain Leached Salts 2024-1.jpg

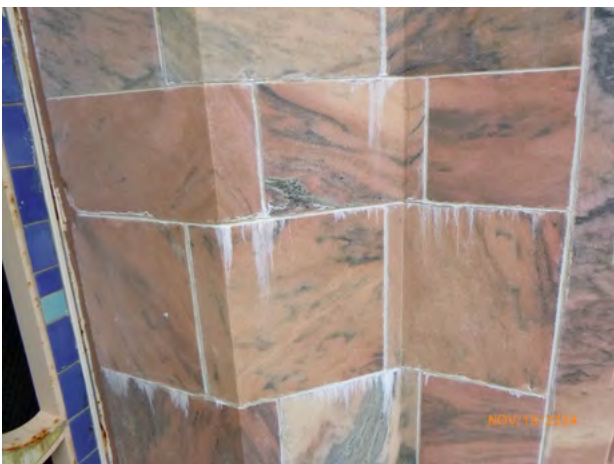
397-156 Stone\_SoilStain Leached Salts 2024-2.jpg

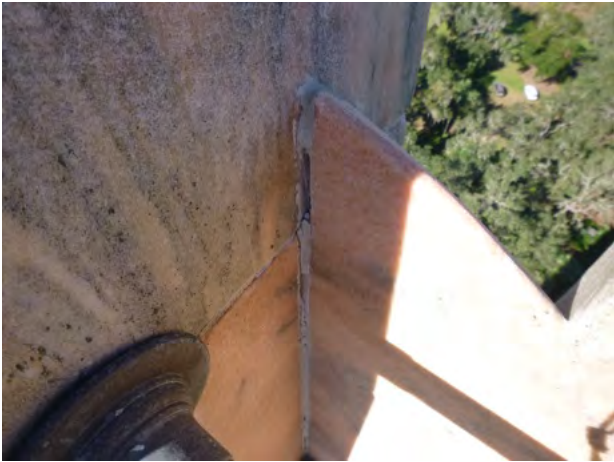
530-204 Stone\_Joints Mortar Failed 2024-1.jpg

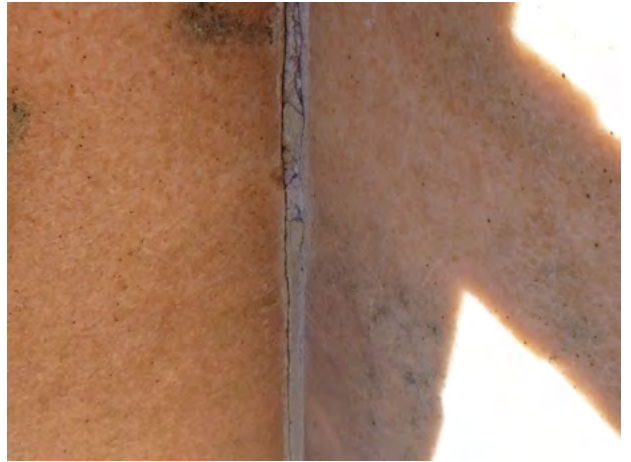
531-191 Stone\_Joints Mortar Failed 2024-1.jpg

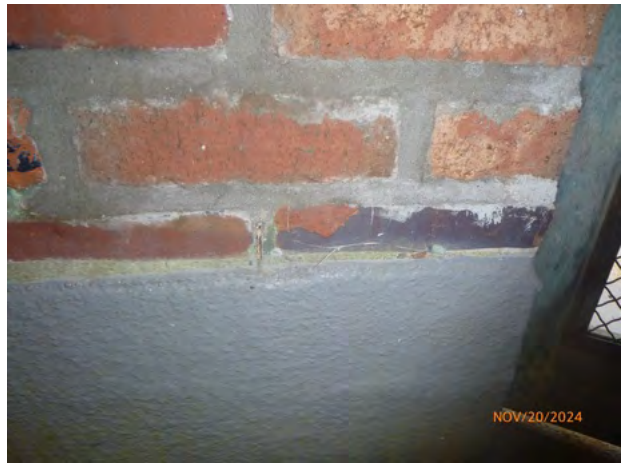
532-193 ArchMetal\_Corrosion Surface 2024-1.jpg

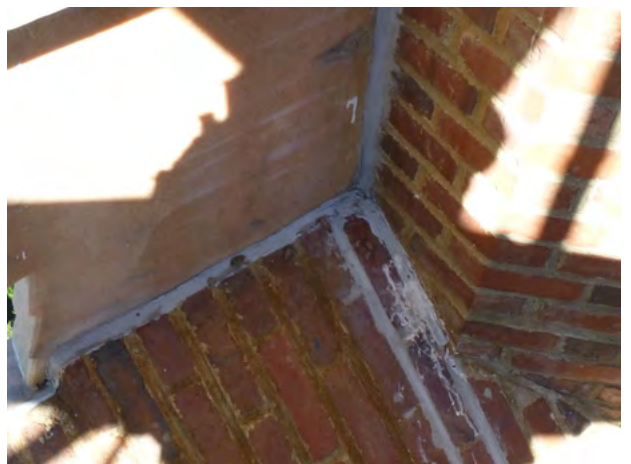
533-190 Stone\_SoilStain Biological 2024-1.jpg

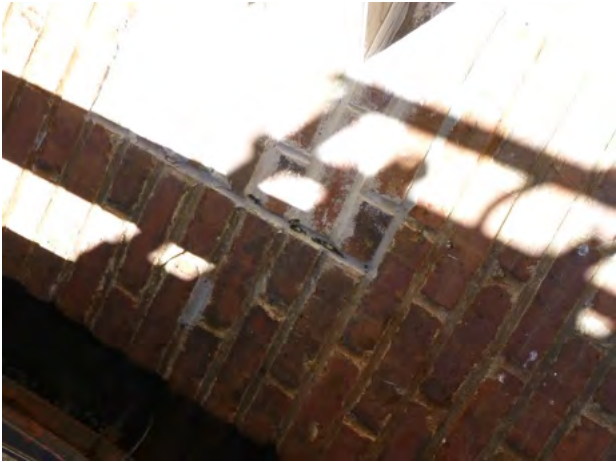
535-185 Brick\_Joints Sealant Failed 2024-1.jpg

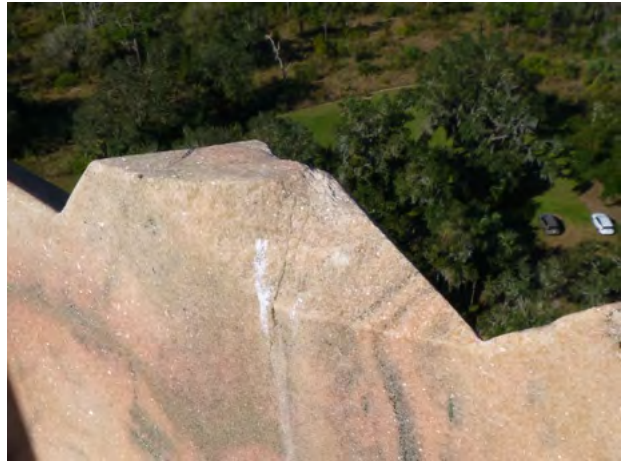
535-185 Brick\_Joints Sealant Failed 2024-2.jpg

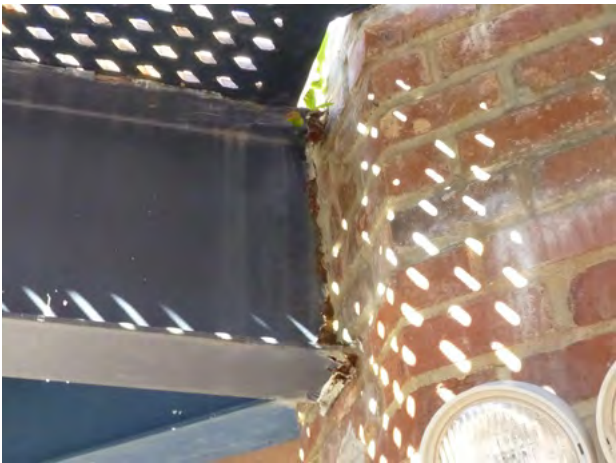
535-196 Stone\_Spall Missing 2024-1.jpg

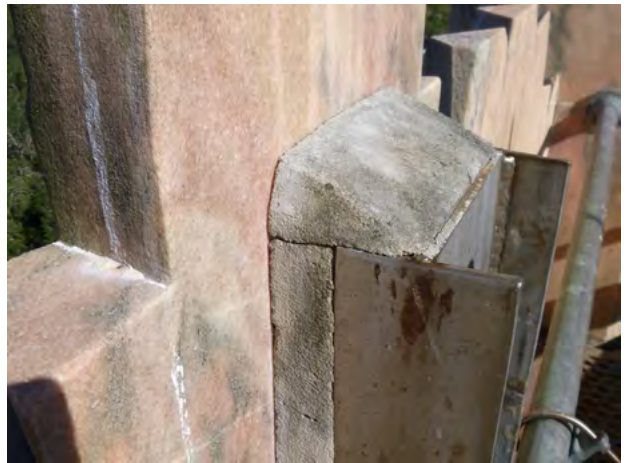
536-193 ArchMetal\_Corrosion Surface 2024-1.jpg

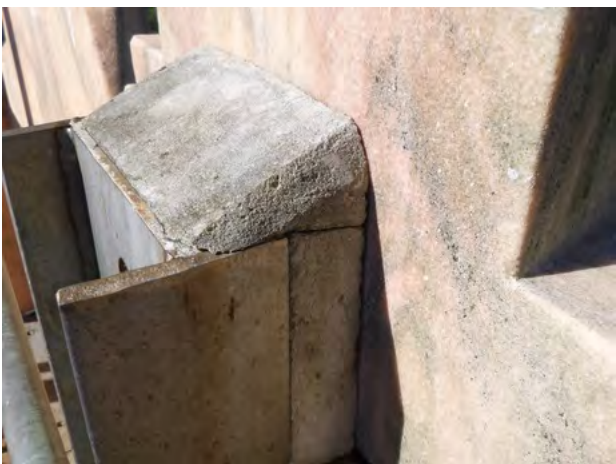
536-197 Concrete\_Crack Single unit 2024-1.jpg

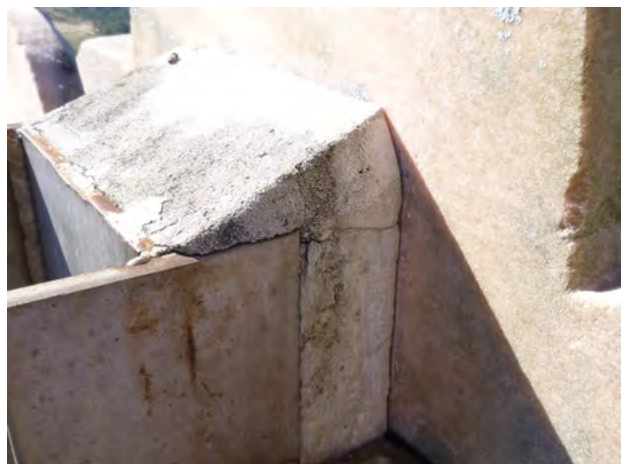
536-197 Concrete\_Crack Single unit 2024-2.jpg

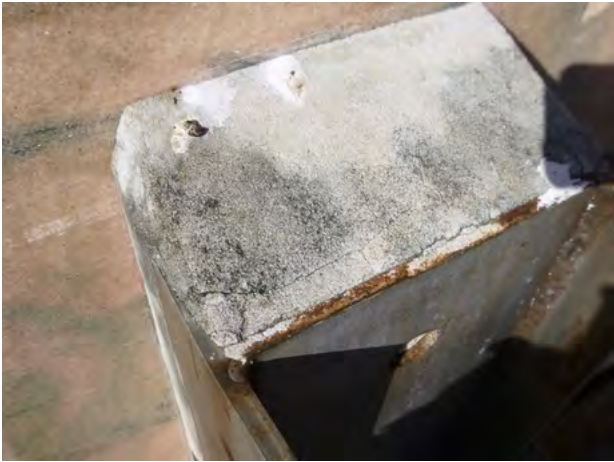
536-197 Concrete\_Crack Single unit 2024-3.jpg

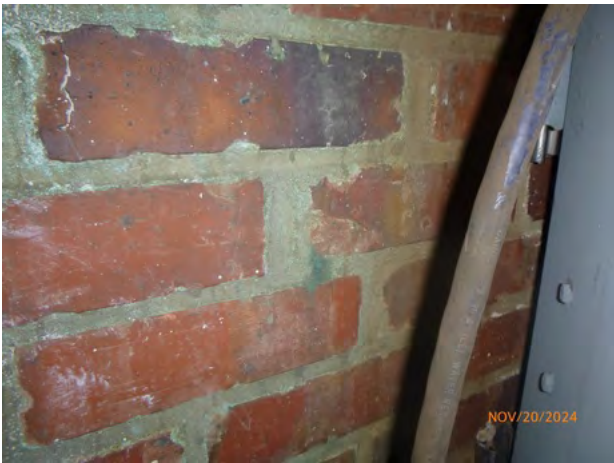
537-138 Brick\_Crack Single unit 2024-1.jpg

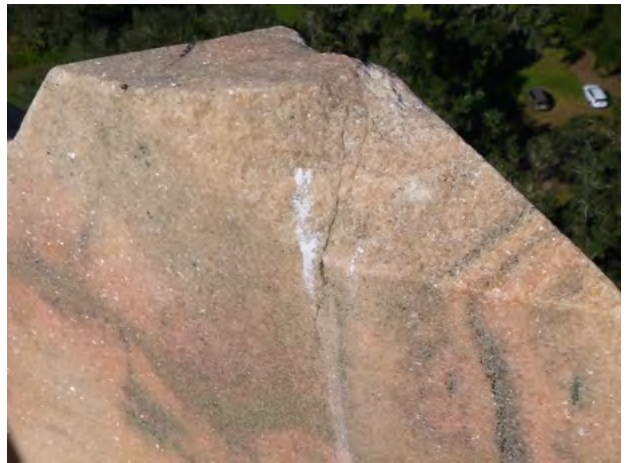
537-141 Brick\_Spall Missing 2024-1.jpg

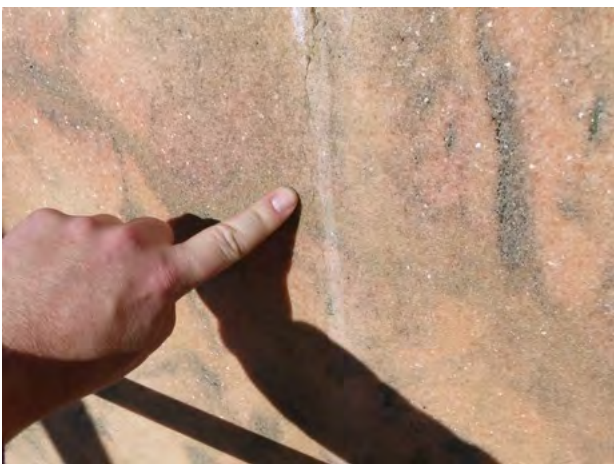
537-195 Stone\_Crack Single unit 2024-1.jpg

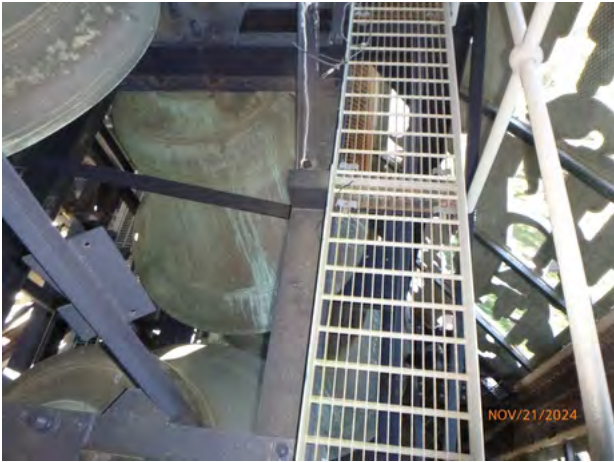
538-143 ArchMetal\_Corrosion Pitted 2024-1.jpg

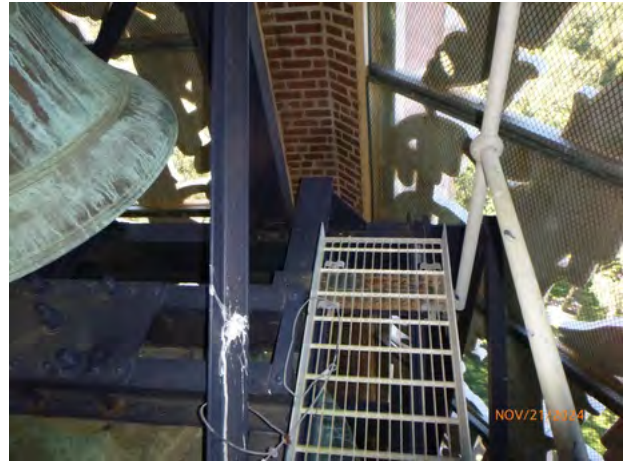
538-170 ArchMetal\_Coating Coating Failed 2024-1.jpg

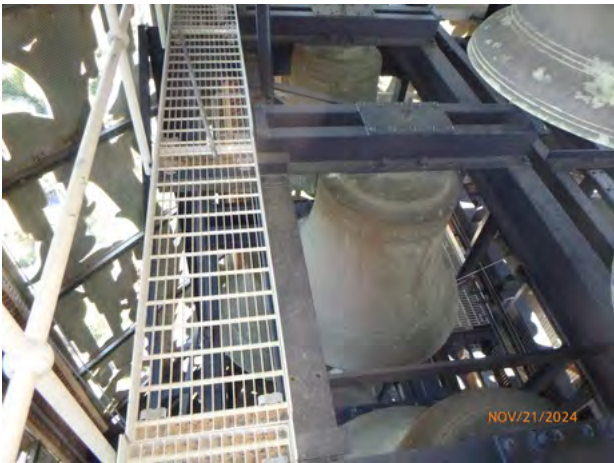
538-170 ArchMetal\_Coating Coating Failed 2024-2.jpg

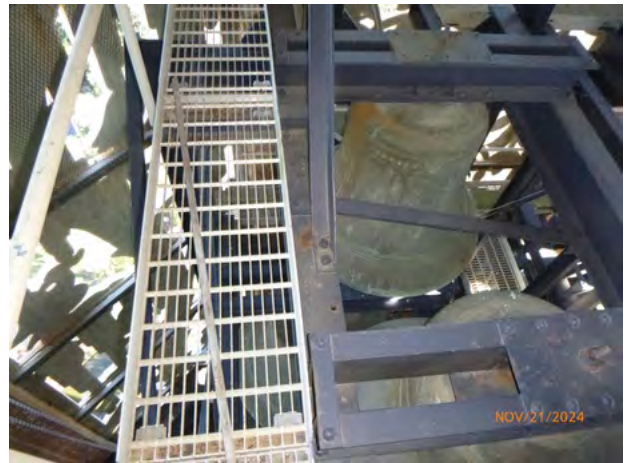
538-170 ArchMetal\_Coating Coating Failed 2024-3.jpg

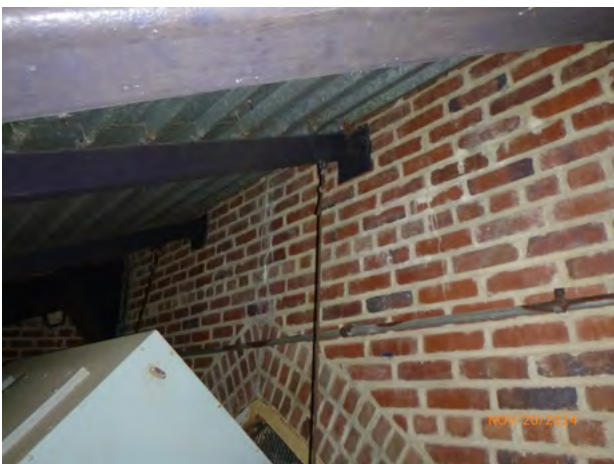
538-170 ArchMetal\_Coating Coating Failed 2024-4.jpg

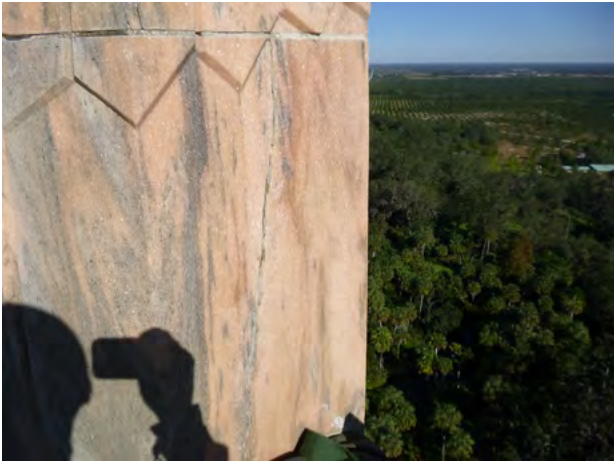
538-201 Stone\_Crack Repair failed 2024-1.jpg

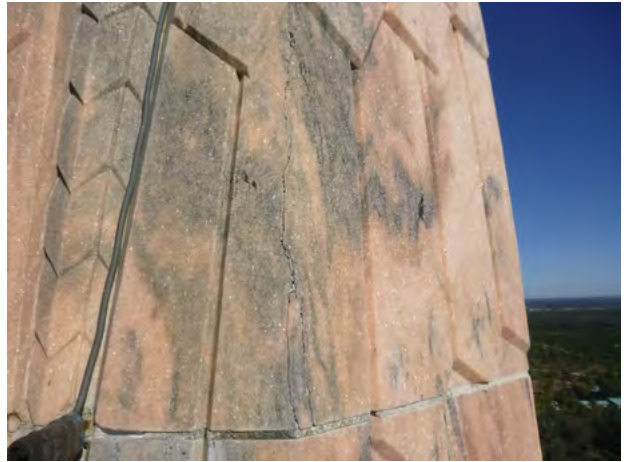
538-201 Stone\_Crack Repair failed 2024-2.jpg

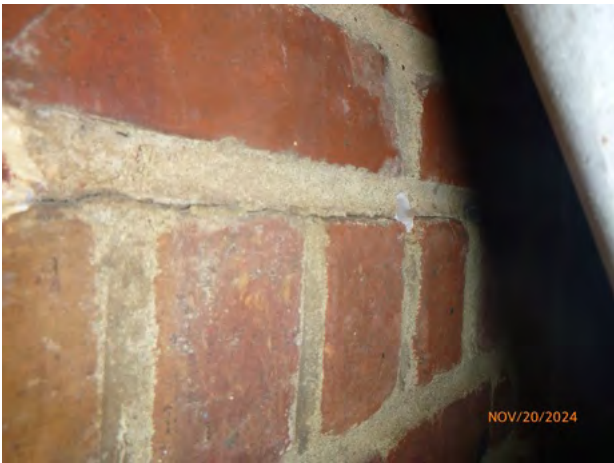
538-201 Stone\_Crack Repair failed 2024-3.jpg

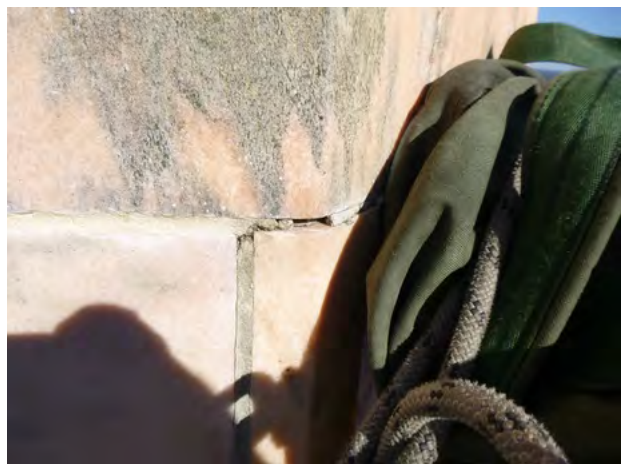
539-193 Stone\_Joints Mortar Failed 2024-1.jpg

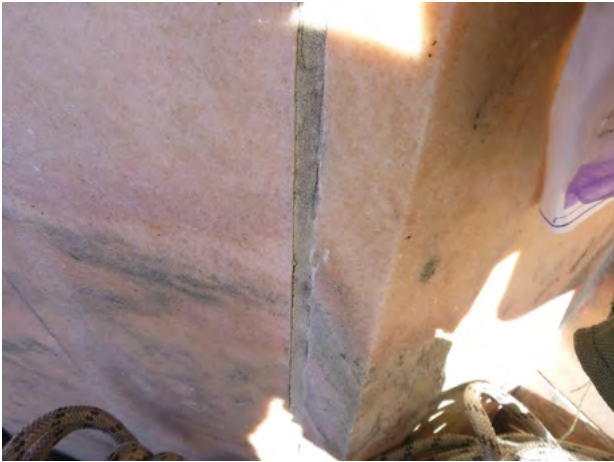
539-193 Stone\_Joints Mortar Failed 2024-2.jpg

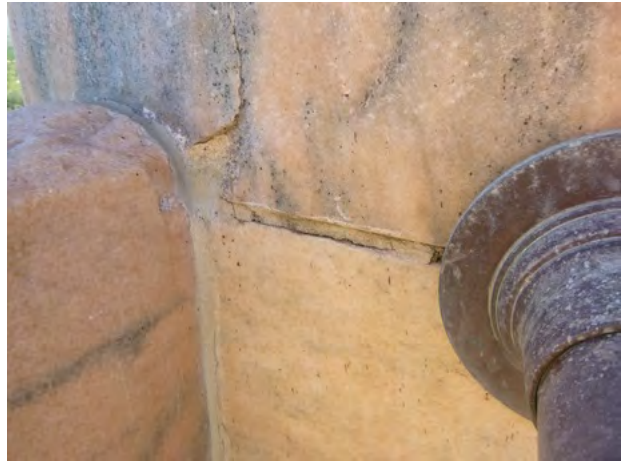
539-193 Stone\_Joints Mortar Failed 2024-3.jpg

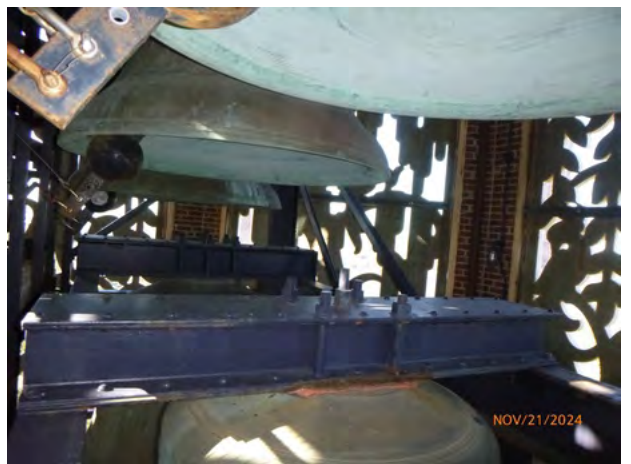
540-158 ArchMetal\_Coating Coating Failed 2024-1.jpg
