### ***Bok Singing Tower Roof Restoration and Replacement***

# Bok Singing Tower Conditions Assessment

T.Y. Lin (formerly Silman) was contracted to perform a conditions assessment of the Bok Singing Tower at Bok Tower Gardens in Lake Wales, Florida. The Singing Tower stands 205 feet tall at the southwest corner of the gardens. A moat surrounds the base of the tower with two bridges to access the island. The tower houses a 60-bell carillon, associated carillonneur studio and library spaces, the Bok Tower Gardens Chao Research archive, and the Founder's Room. It is a steel frame construction clad in a masonry exterior of coquina and Georgia pink Etowah marble with brick masonry at the interior.

## **Bok Tower Focused Condition Assessment**

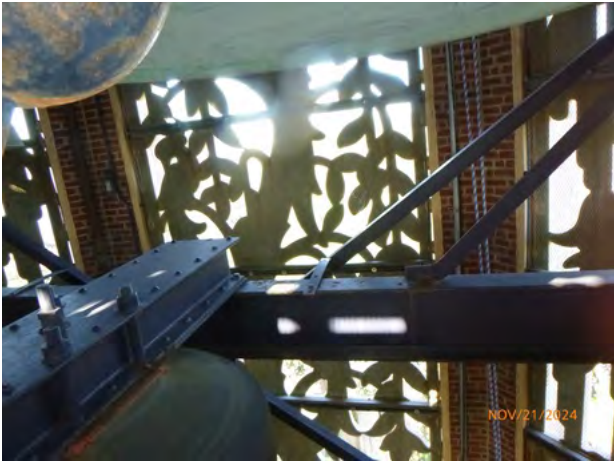
540-158 ArchMetal\_Coating Coating Failed 2024-2.jpg

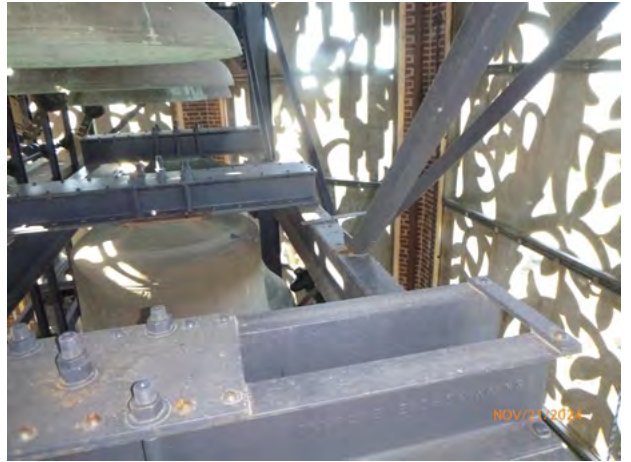
540-158 ArchMetal\_Coating Coating Failed 2024-3.jpg

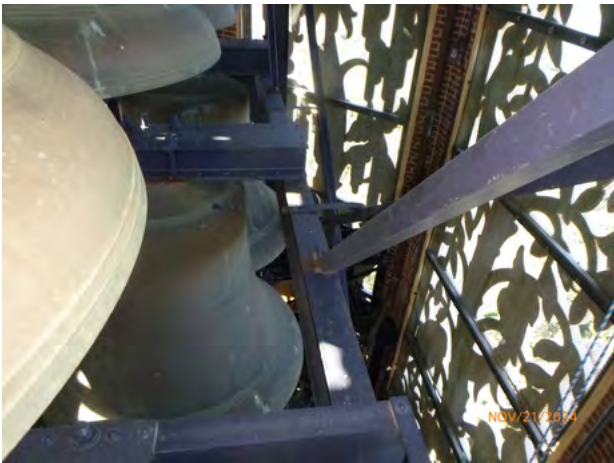
540-158 ArchMetal\_Coating Coating Failed 2024-4.jpg

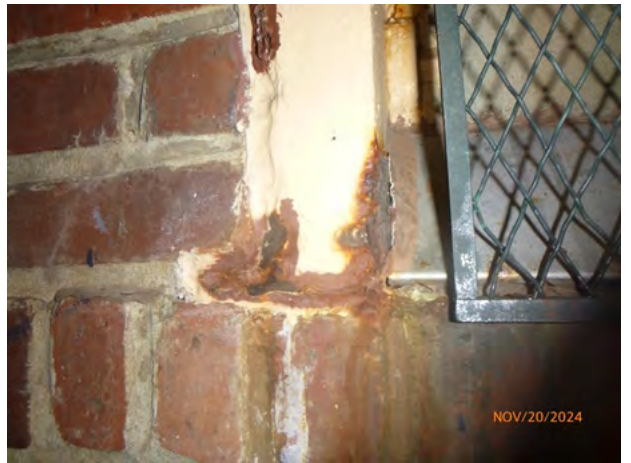
540-158 ArchMetal\_Coating Coating Failed 2024-5.jpg

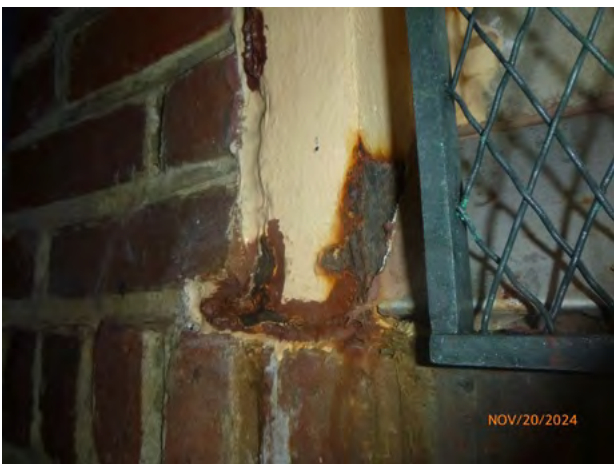
541-144 ArchMetal\_Corrosion Pitted 2024-1.jpg

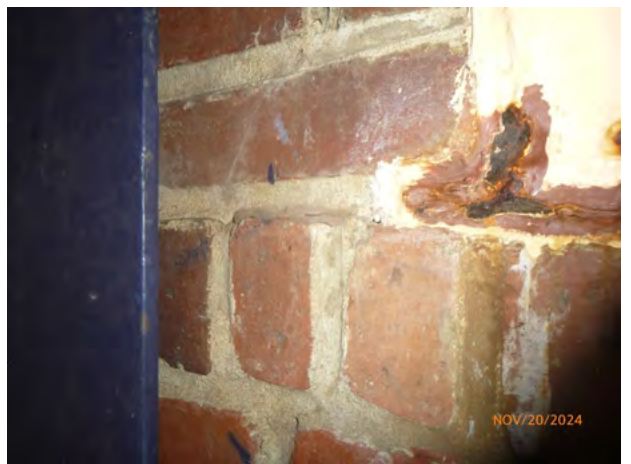
541-144 ArchMetal\_Corrosion Pitted 2024-2.jpg

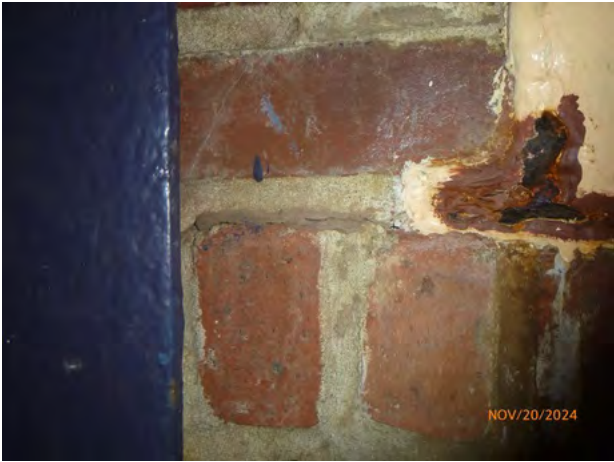
541-144 Brick\_Crack Repair failed 2024-1.jpg

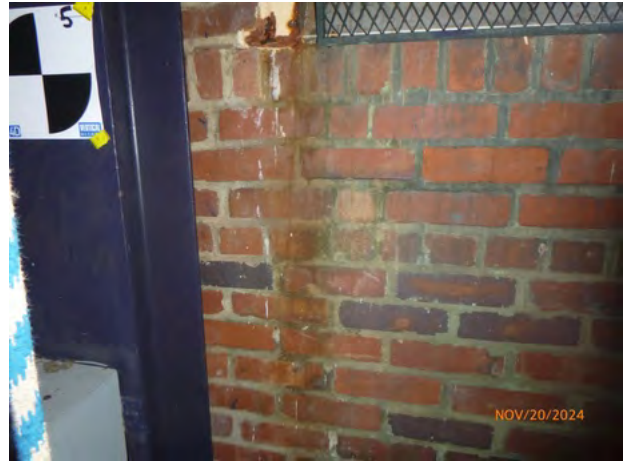
541-144 Brick\_Crack Repair failed 2024-2.jpg

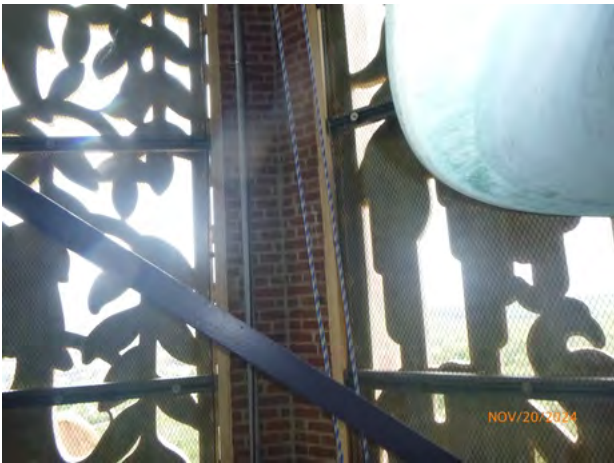
542-142 Brick\_SoilStain Rust 2024-1.jpg

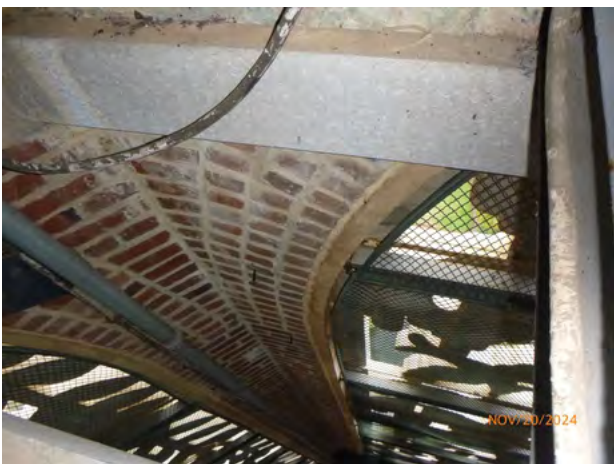
542-157 Brick\_SoilStain Leached Salts 2024-2.jpg

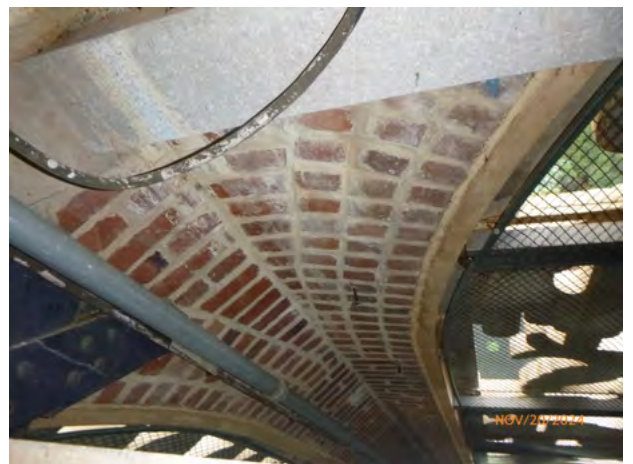
542-171 Brick\_SoilStain Paint 2024-1.jpg

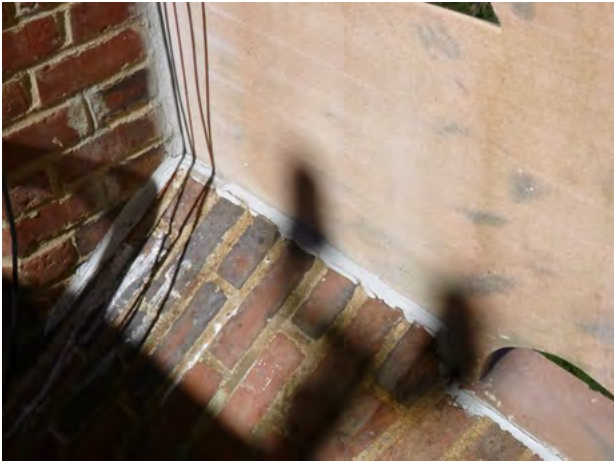
542-171 Brick\_SoilStain Paint 2024-2.jpg

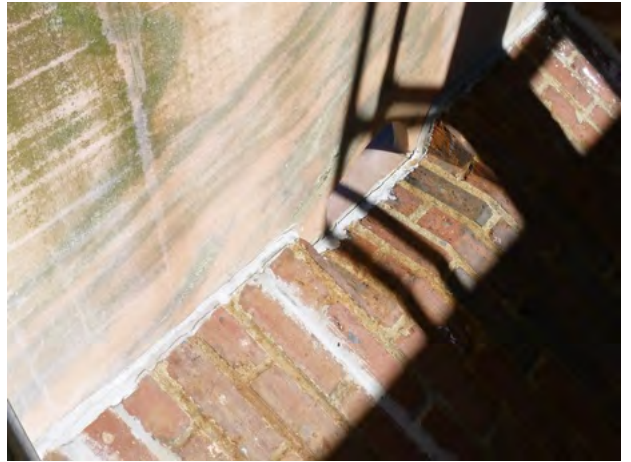
543-185 Brick\_Joints Sealant Failed 2024-1.jpg

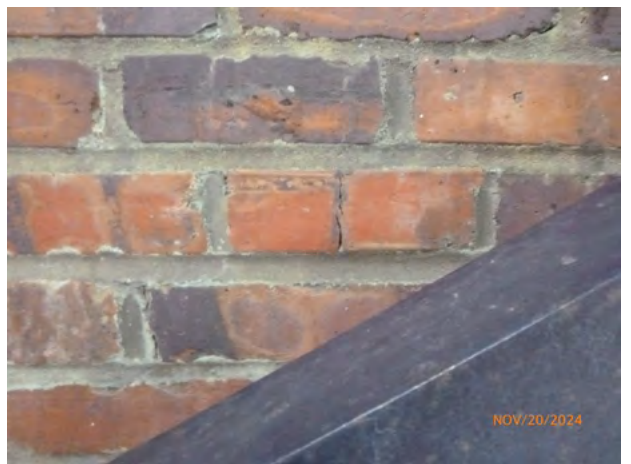
544-142 Brick\_Crack Single unit 2024-1.jpg

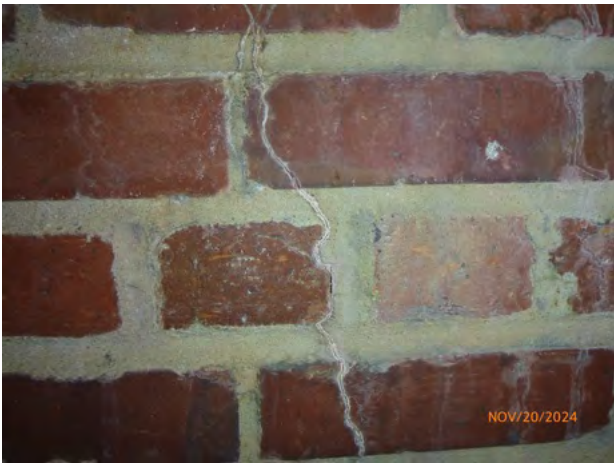
546-181 Brick\_Crack System units and joints 2024-1.jpg

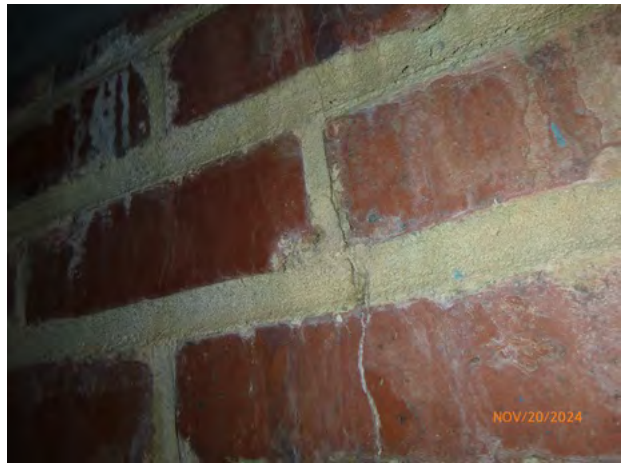
546-181 Brick\_Crack System units and joints 2024-2.jpg

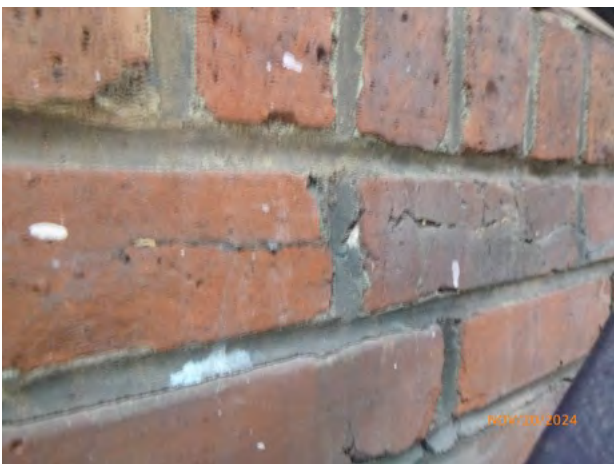
546-181 Brick\_Crack System units and joints 2024-3.jpg

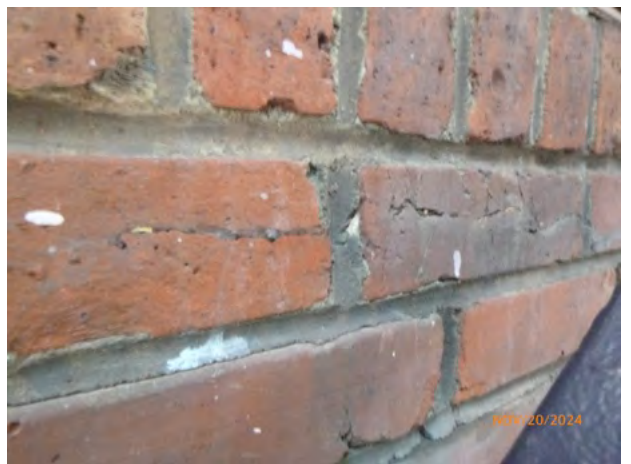
547-143 Brick\_Crack System units and joints 2024-1.jpg

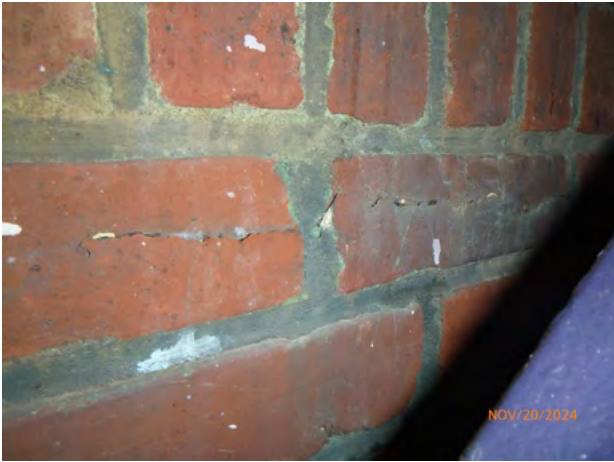
547-143 Brick\_Crack System units and joints 2024-2.jpg

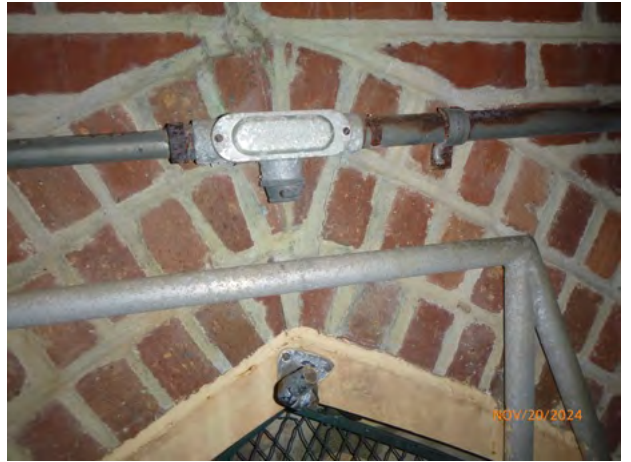
547-143 Brick\_Crack System units and joints 2024-3.jpg

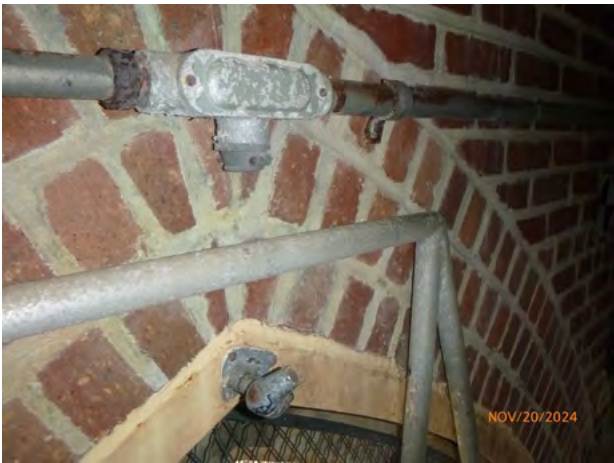
547-178 Brick\_Joints Mortar Failed 2024-1.jpg

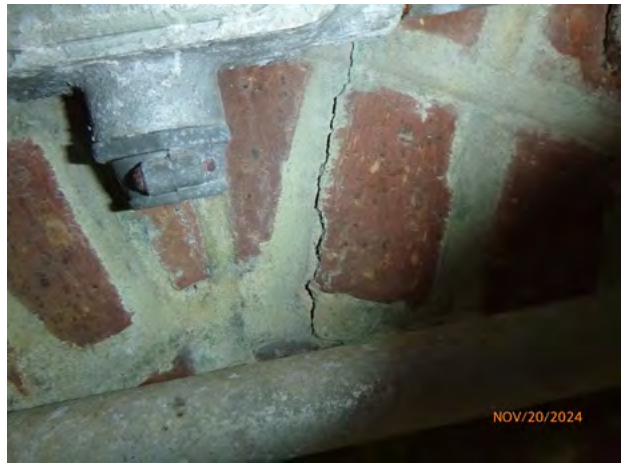
547-178 Brick\_Joints Mortar Failed 2024-2.jpg

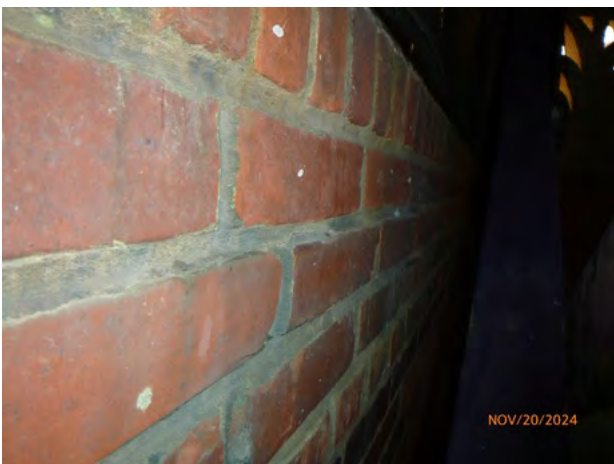
547-178 Brick\_Joints Mortar Failed 2024-3.jpg

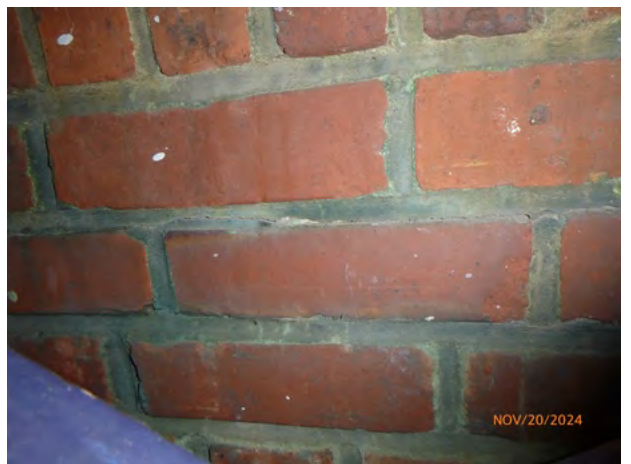
548-143 Brick\_Joints Mortar Failed 2024-1.jpg

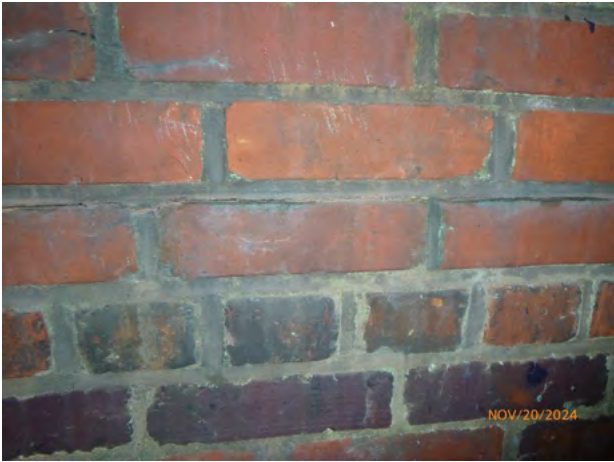
548-143 Brick\_Joints Mortar Failed 2024-2.jpg

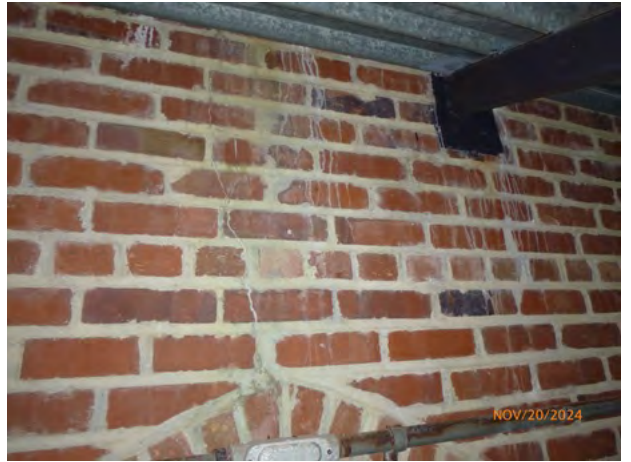
548-143 Brick\_Joints Mortar Failed 2024-3.jpg

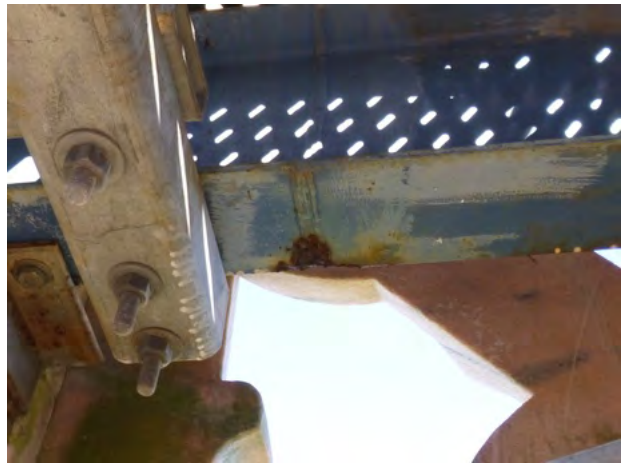
548-195 Stone\_Crack Single unit 2024-1.jpg

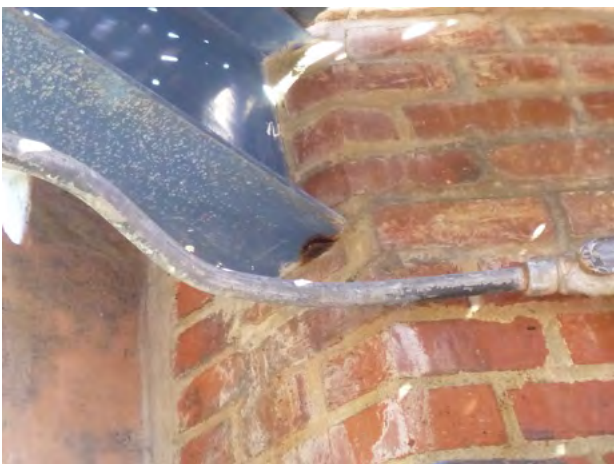
549-193 ArchMetal\_Corrosion Surface 2024-1.jpg

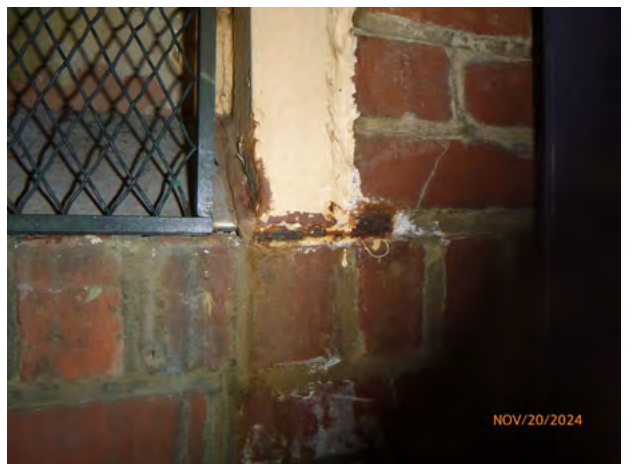
549-193 ArchMetal\_Corrosion Surface 2024-2.jpg

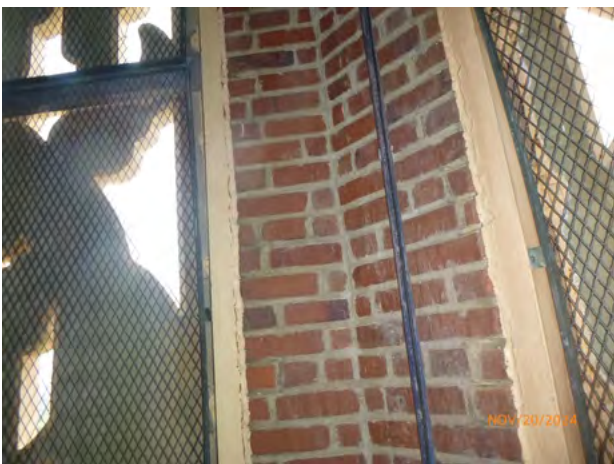
553-156 Brick\_Joints Mortar Failed 2024-1.jpg

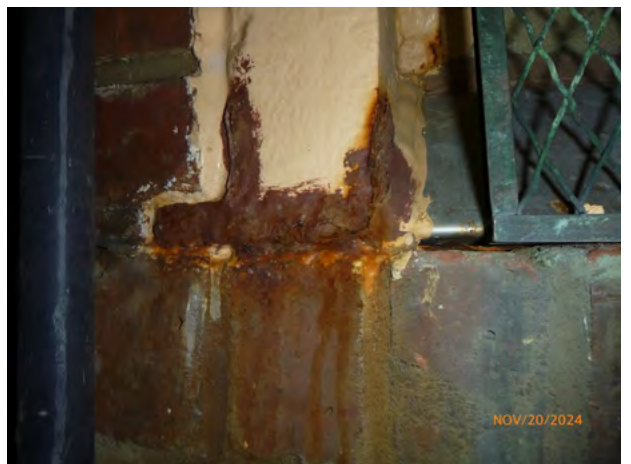
555-143 ArchMetal\_Corrosion Pitted 2024-1.jpg

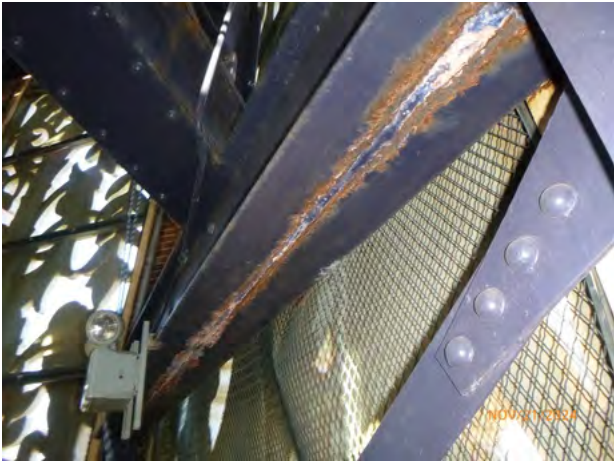
555-145 ArchMetal\_Coating Coating Failed 2024-1.jpg

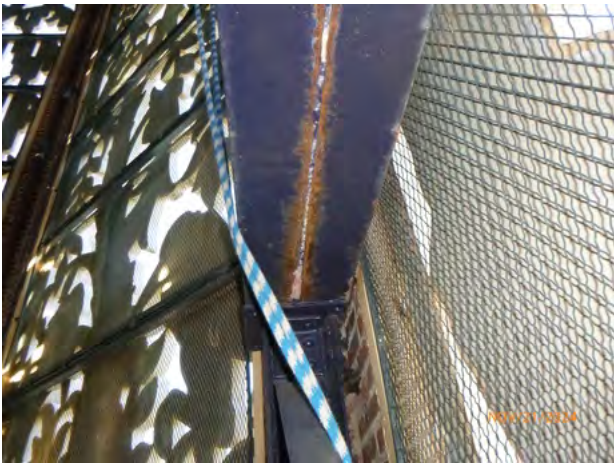
555-145 ArchMetal\_Coating Coating Failed 2024-3.jpg

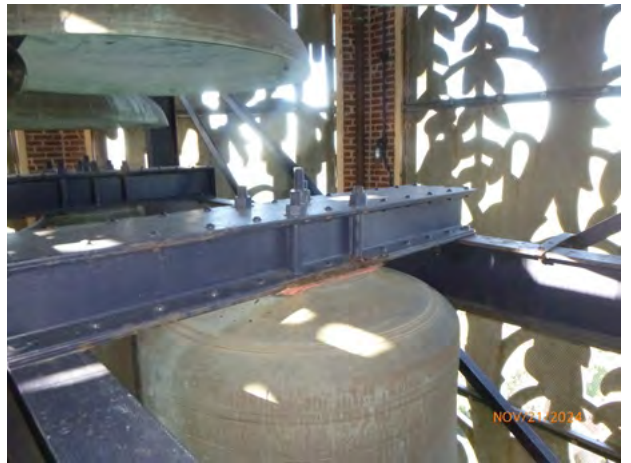
555-160 ArchMetal\_Coating Coating Failed 2024-1.jpg

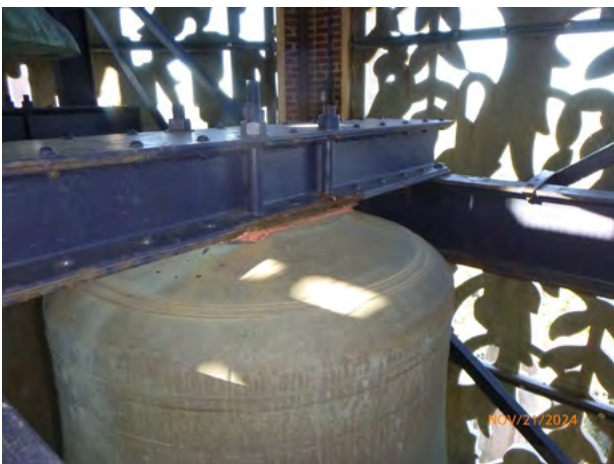
555-160 ArchMetal\_Coating Coating Failed 2024-2.jpg

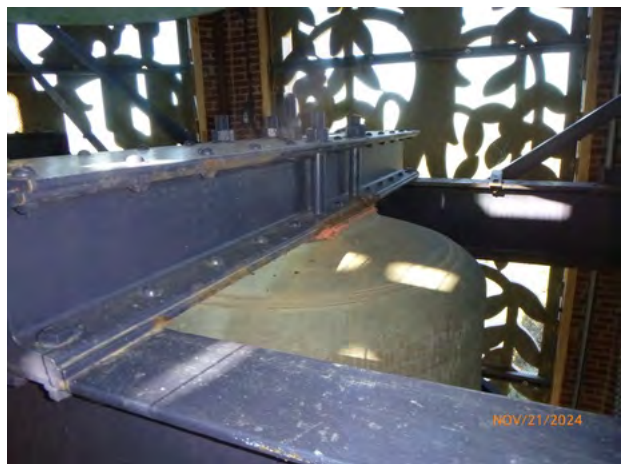
555-160 ArchMetal\_Coating Coating Failed 2024-3.jpg

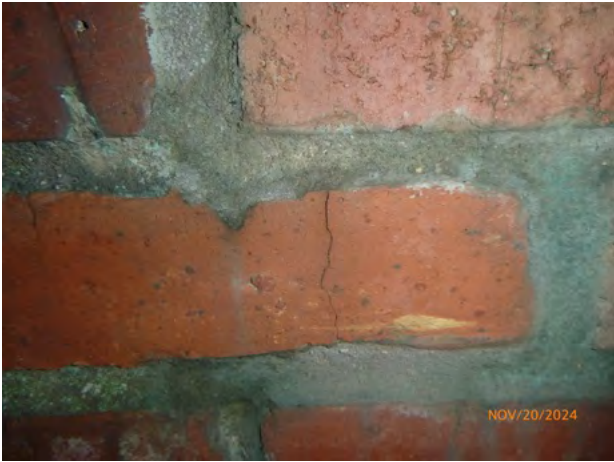
556-140 Brick\_Crack Single unit 2024-1.jpg

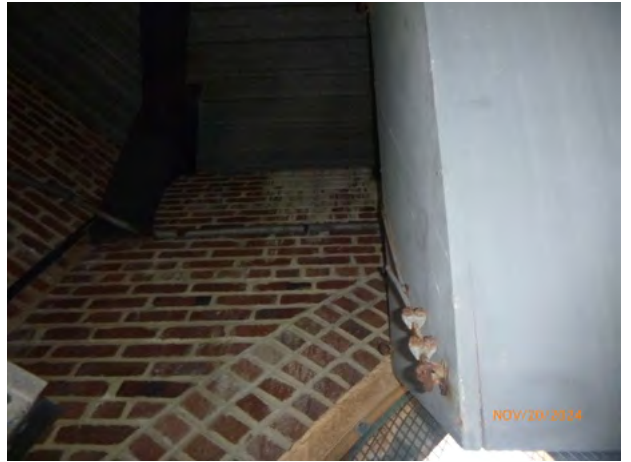
558-178 Brick\_SoilStain Paint 2024-1.jpg

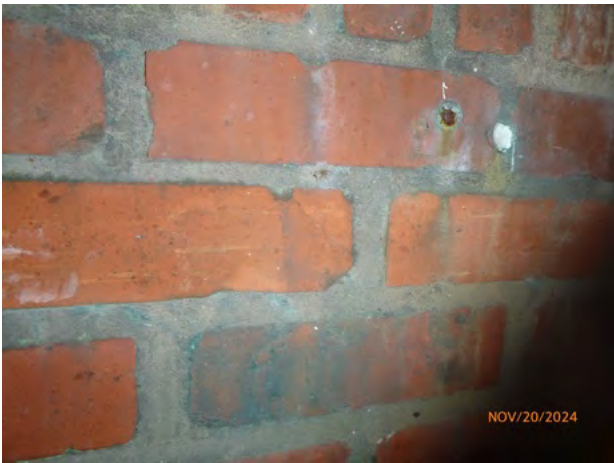
559-143 Brick\_Crack Single unit 2024-1.jpg

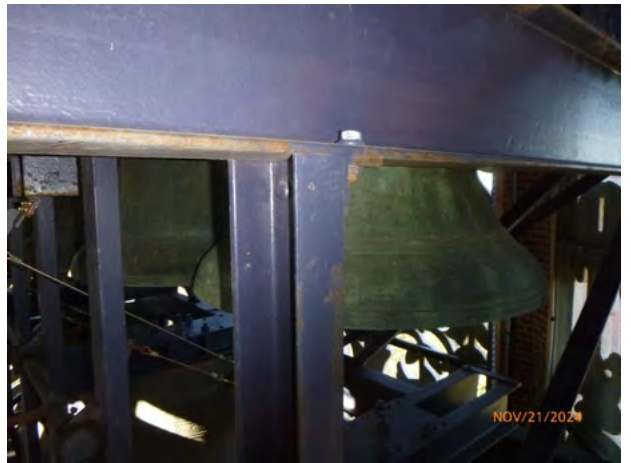
559-162 ArchMetal\_Coating Coating Failed 2024-1.jpg

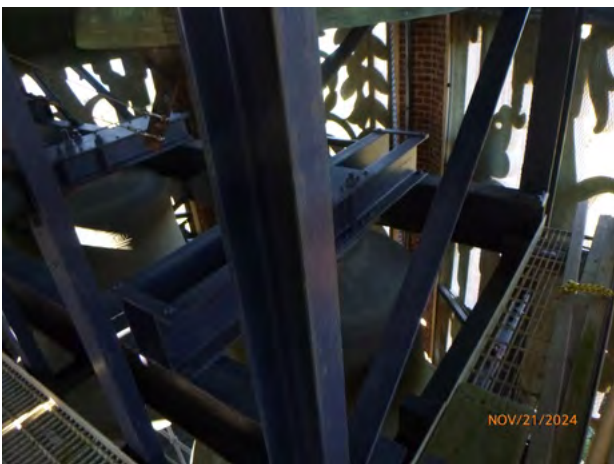
559-162 ArchMetal\_Coating Coating Failed 2024-2.jpg

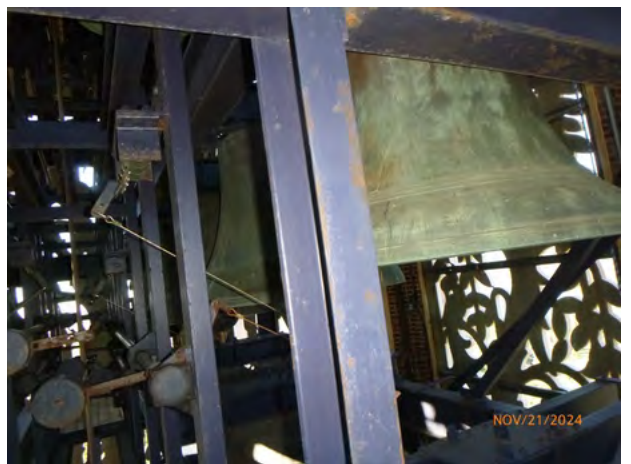
559-162 ArchMetal\_Coating Coating Failed 2024-3.jpg

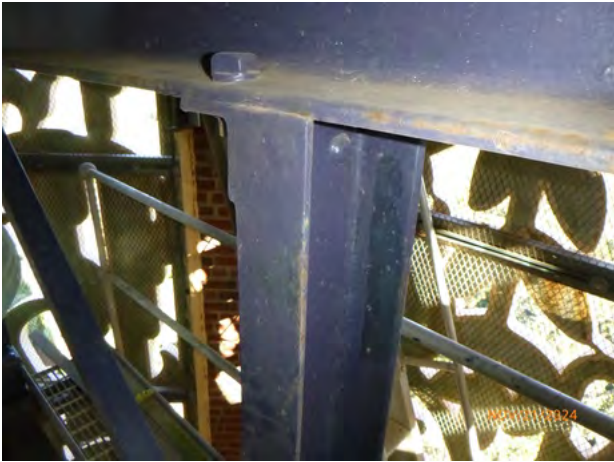
559-162 ArchMetal\_Coating Coating Failed 2024-4.jpg

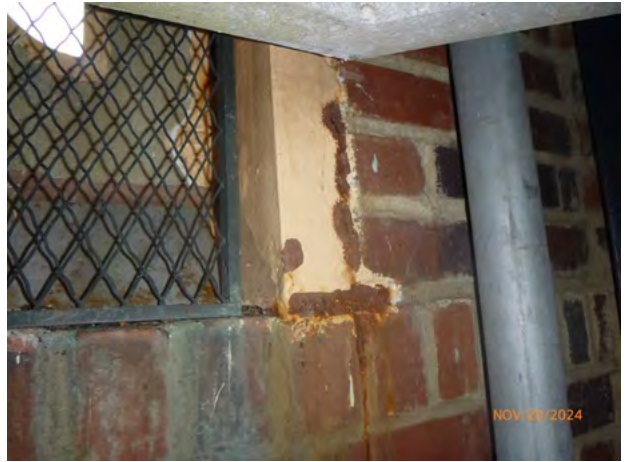
560-143 ArchMetal\_Corrosion Pitted 2024-1.jpg

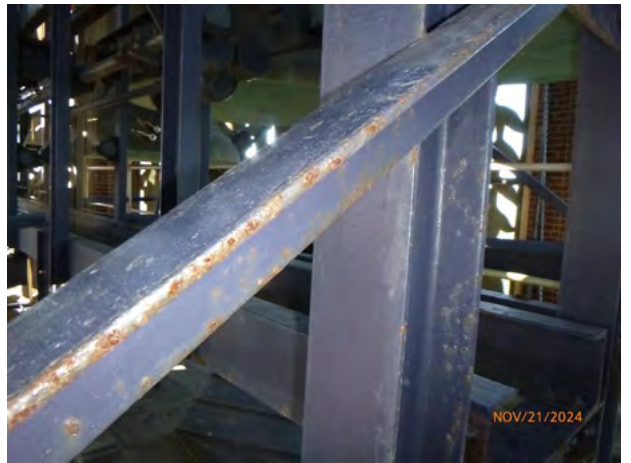
560-148 ArchMetal\_Corrosion Surface 2024-2.jpg

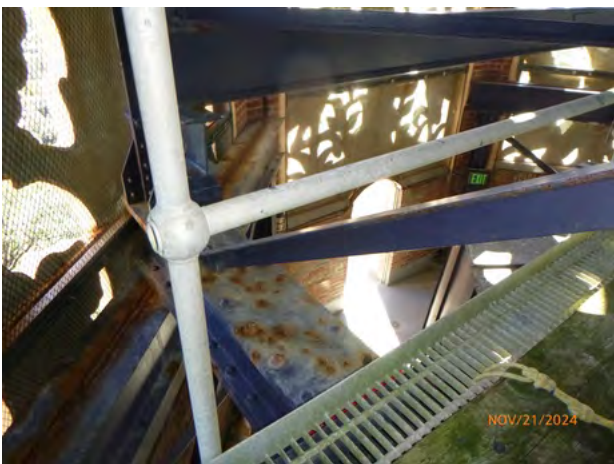
560-148 ArchMetal\_Corrosion Surface 2024-3.jpg

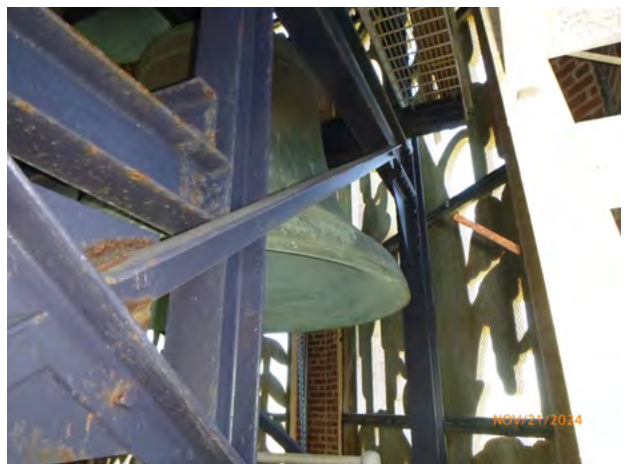
560-148 ArchMetal\_Corrosion Surface 2024-4.jpg

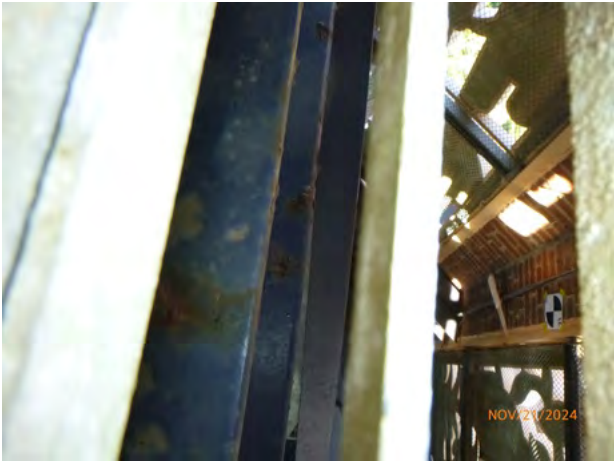
561-157 ArchMetal\_Coating Coating Failed 2024-1.jpg

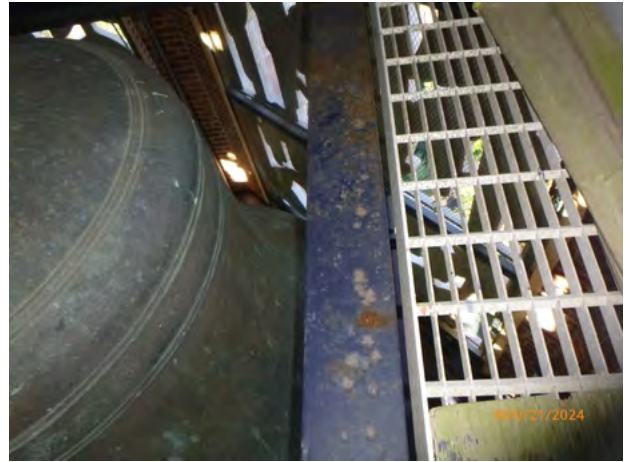
561-157 ArchMetal\_Coating Coating Failed 2024-2.jpg

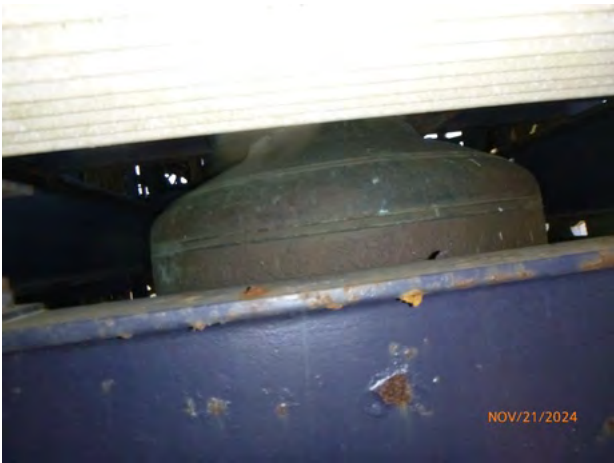
561-157 ArchMetal\_Coating Coating Failed 2024-3.jpg

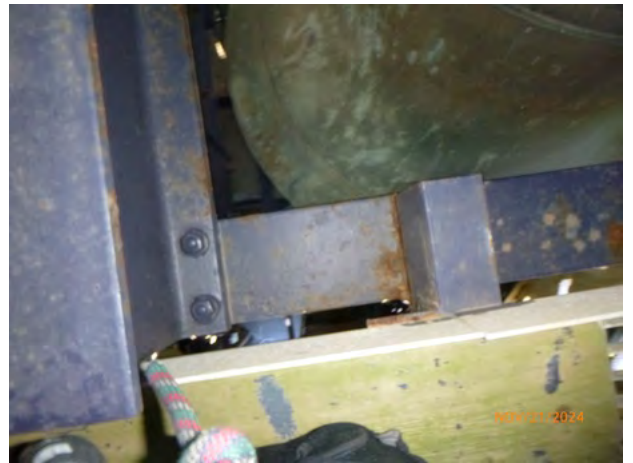
561-157 ArchMetal\_Coating Coating Failed 2024-4.jpg

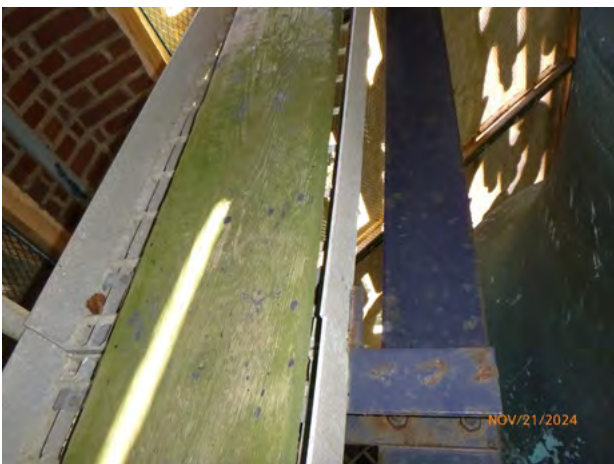
561-157 ArchMetal\_Coating Coating Failed 2024-5.jpg

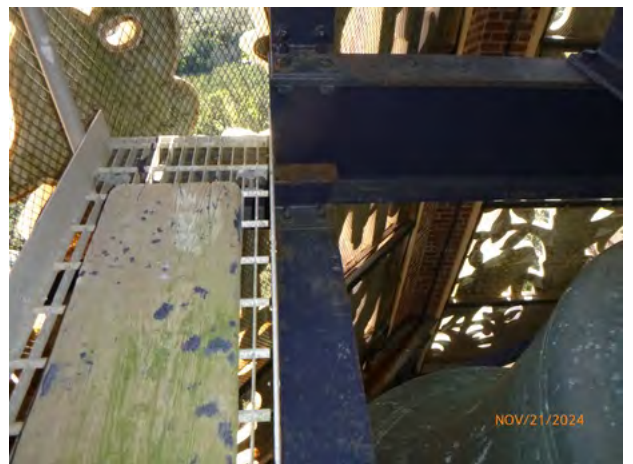
561-157 ArchMetal\_Coating Coating Failed 2024-6.jpg

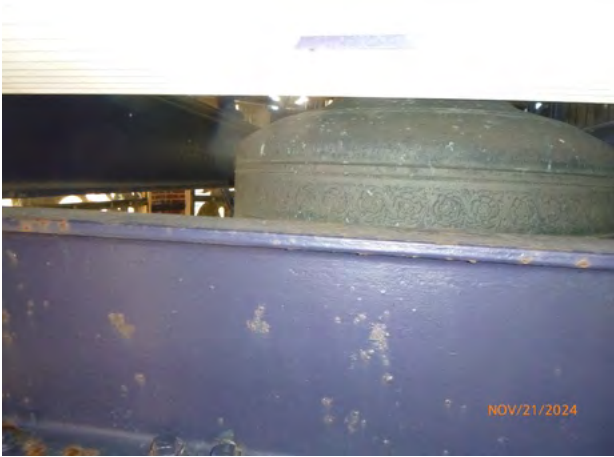
561-157 ArchMetal\_Coating Coating Failed 2024-7.jpg

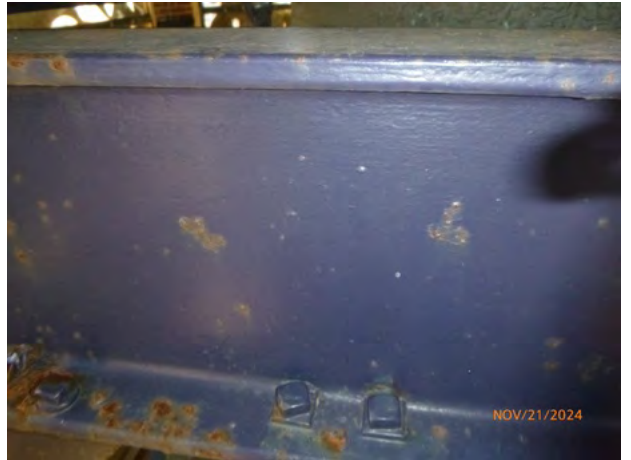
561-157 ArchMetal\_Coating Coating Failed 2024-8.jpg

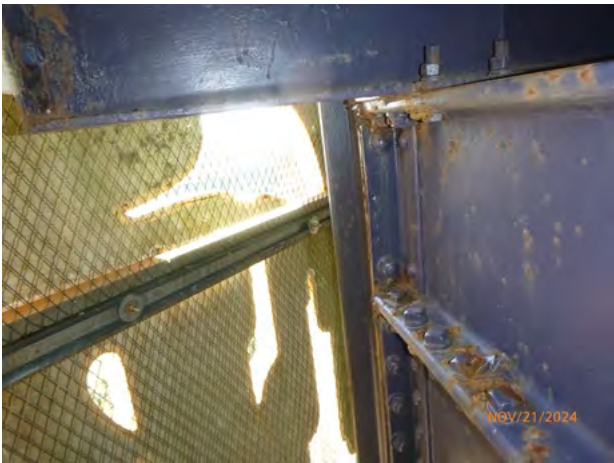
561-157 ArchMetal\_Coating Coating Failed 2024-9.jpg

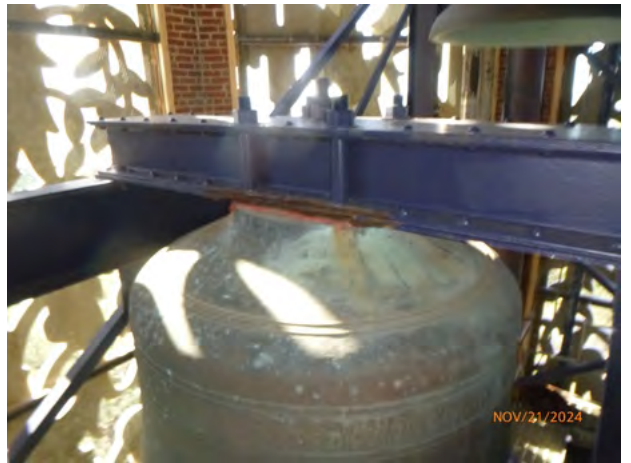
561-160 ArchMetal\_Coating Coating Failed 2024-1.jpg

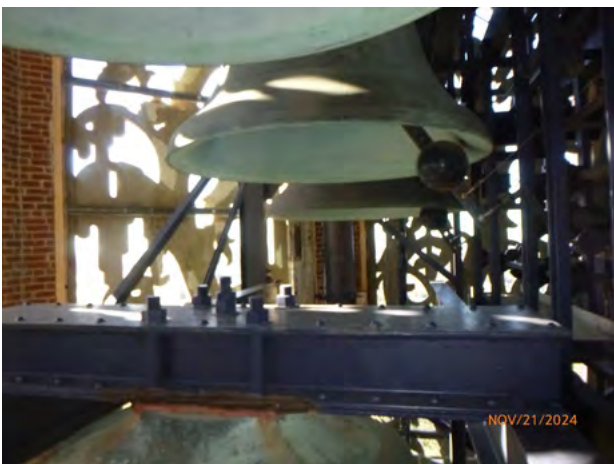
561-160 ArchMetal\_Coating Coating Failed 2024-2.jpg

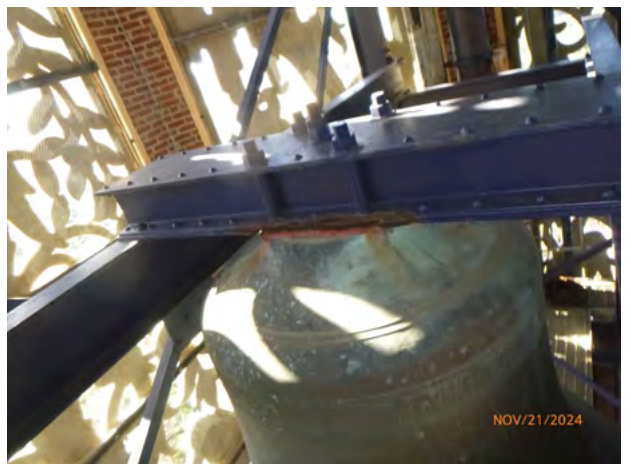
561-160 ArchMetal\_Coating Coating Failed 2024-3.jpg

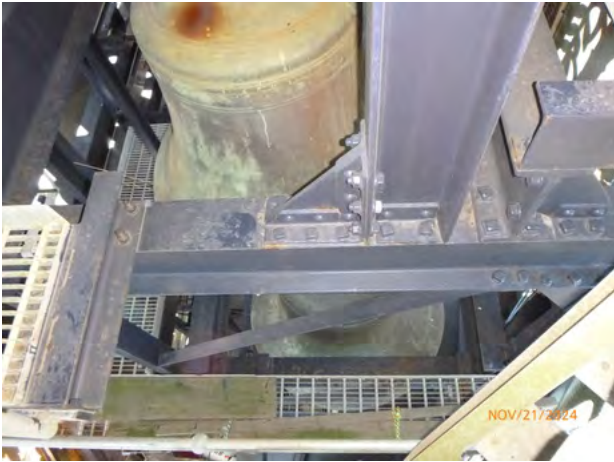
562-170 ArchMetal\_Coating Coating Failed 2024-1.jpg

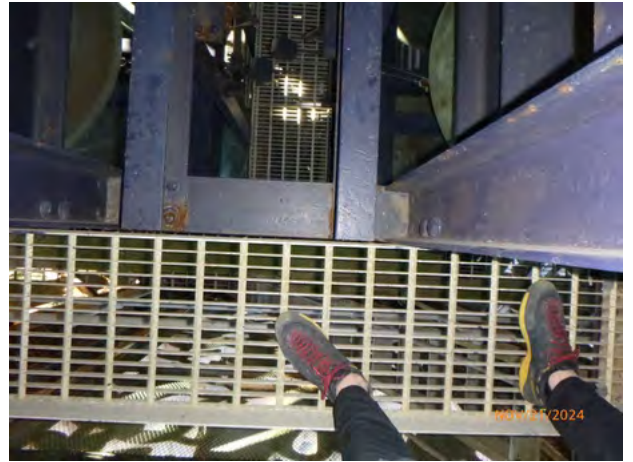
562-170 ArchMetal\_Coating Coating Failed 2024-2.jpg

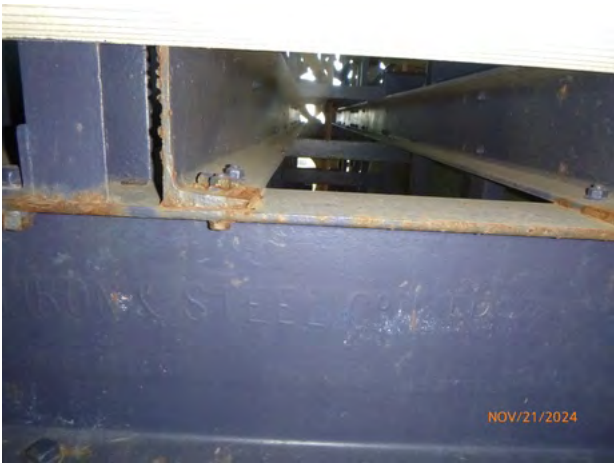
562-170 ArchMetal\_Coating Coating Failed 2024-3.jpg

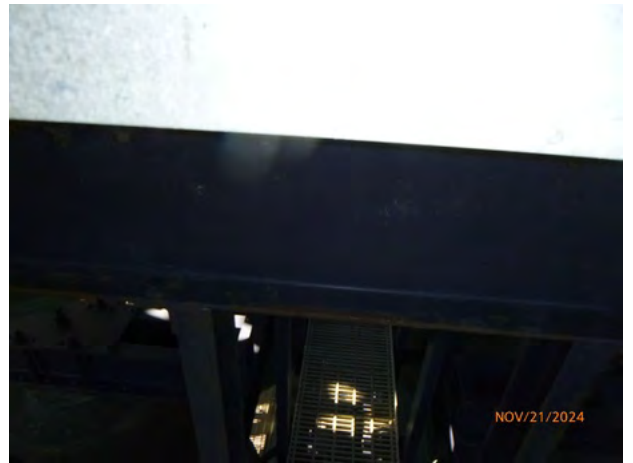
562-170 ArchMetal\_Coating Coating Failed 2024-4.jpg

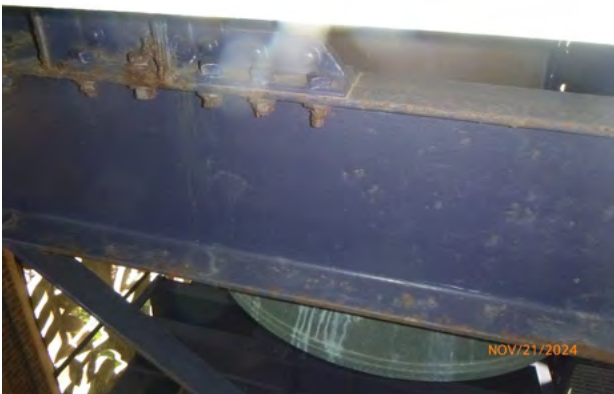
562-170 ArchMetal\_Coating Coating Failed 2024-5.jpg

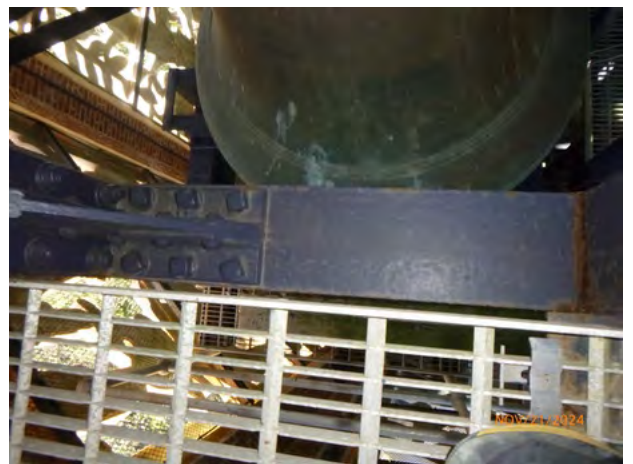
562-170 ArchMetal\_Coating Coating Failed 2024-6.jpg

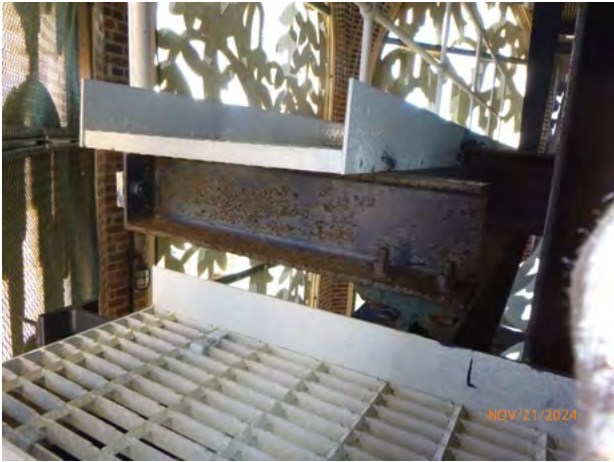
562-172 ArchMetal\_Corrosion Surface 2024-1.jpg

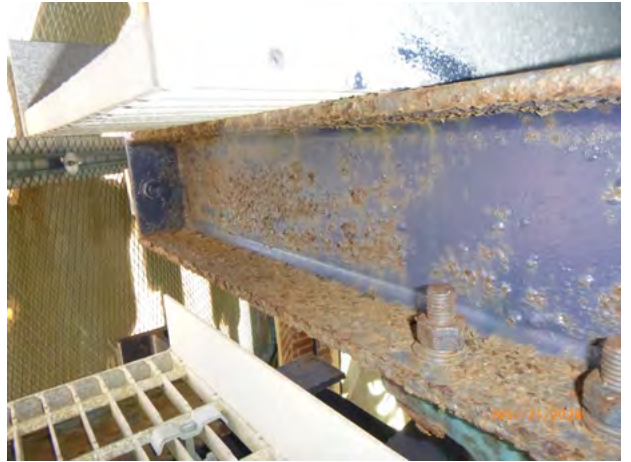
562-172 ArchMetal\_Corrosion Surface 2024-2.jpg

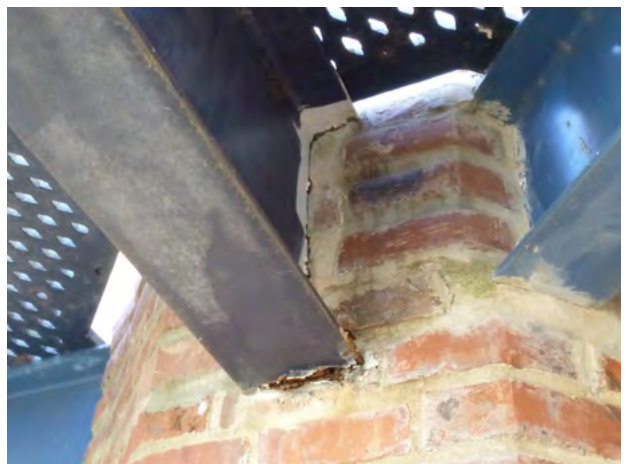
634-193 ArchMetal\_Corrosion Surface 2024-1.jpg

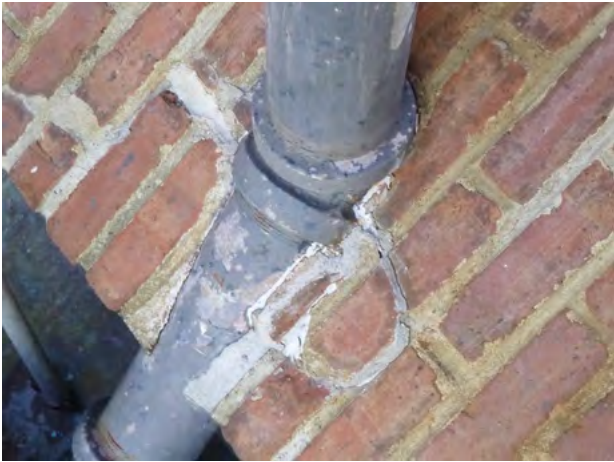
635-185 Brick\_Joints Mortar Failed 2024-1.jpg

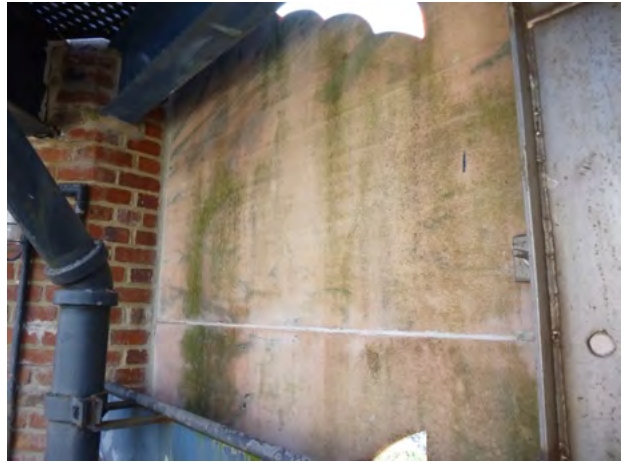
636-189 Brick\_SoilStain Biological 2024-1.jpg

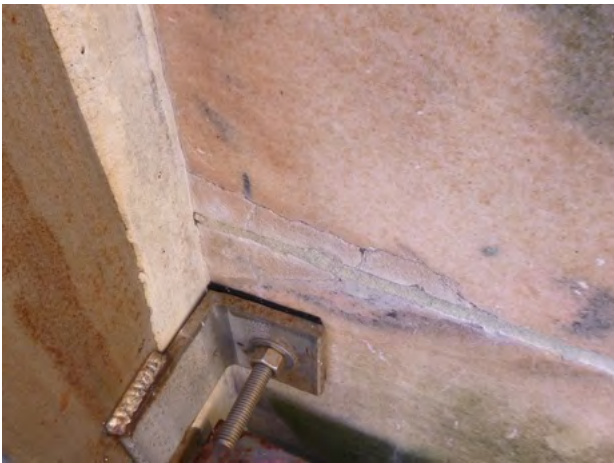
637-193 Stone\_Repair Patch Failed 2024-1.jpg

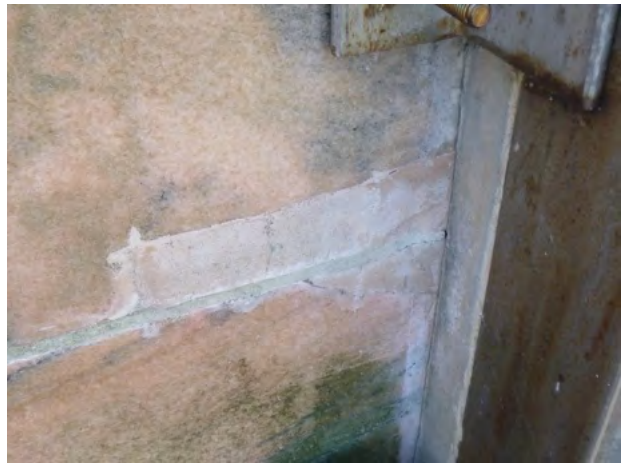
637-193 Stone\_Repair Patch Failed 2024-2.jpg

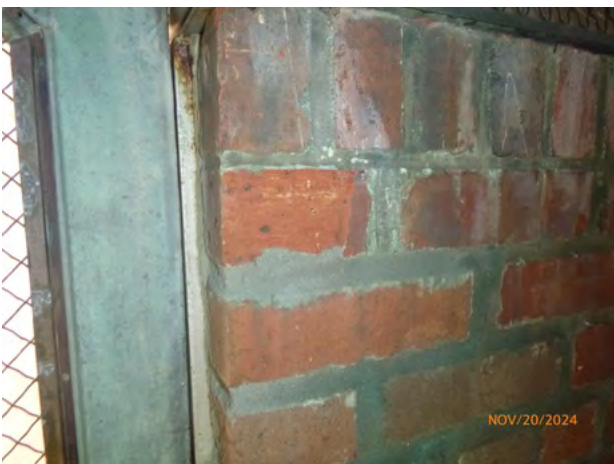
639-143 Brick\_Spall Missing 2024-1.jpg

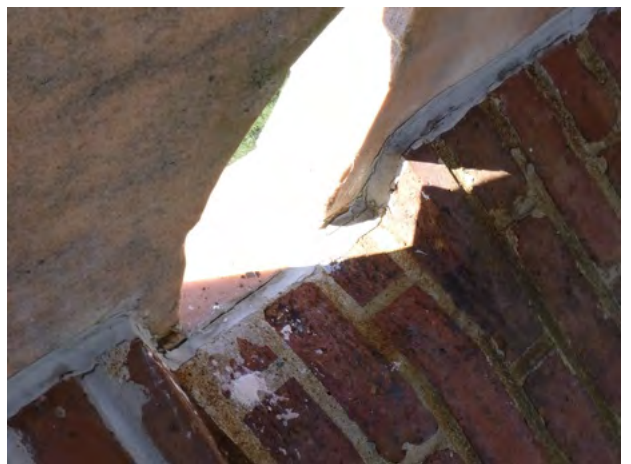
639-185 Brick\_Joints Sealant Failed 2024-1.jpg

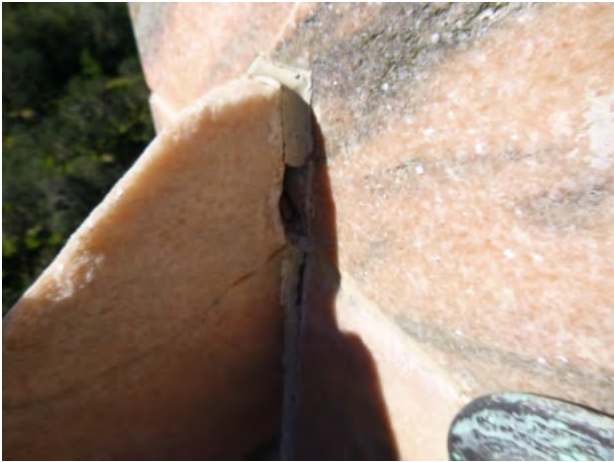
639-194 Stone\_Joints Mortar Failed 2024-1.jpg

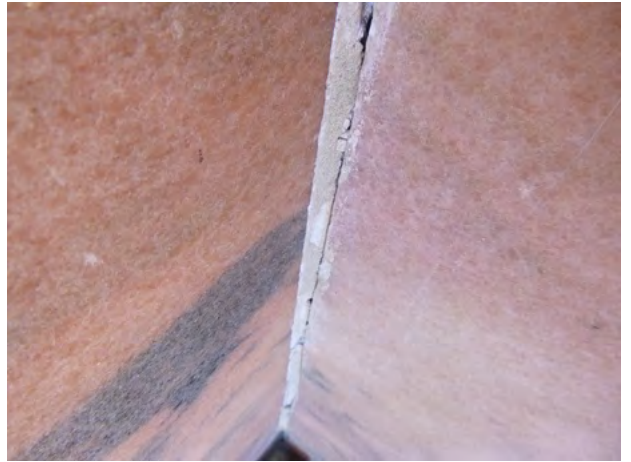
639-194 Stone\_Joints Mortar Failed 2024-2.jpg
