### ***Bok Singing Tower Roof Restoration and Replacement***

# Bok Singing Tower Conditions Assessment

T.Y. Lin (formerly Silman) was contracted to perform a conditions assessment of the Bok Singing Tower at Bok Tower Gardens in Lake Wales, Florida. The Singing Tower stands 205 feet tall at the southwest corner of the gardens. A moat surrounds the base of the tower with two bridges to access the island. The tower houses a 60-bell carillon, associated carillonneur studio and library spaces, the Bok Tower Gardens Chao Research archive, and the Founder's Room. It is a steel frame construction clad in a masonry exterior of coquina and Georgia pink Etowah marble with brick masonry at the interior.

## **Bok Tower Focused Condition Assessment**

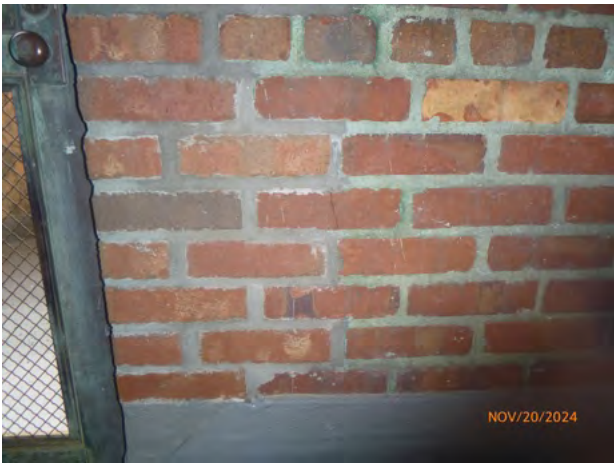
640-139 Brick\_Crack Single unit 2024-1.jpg

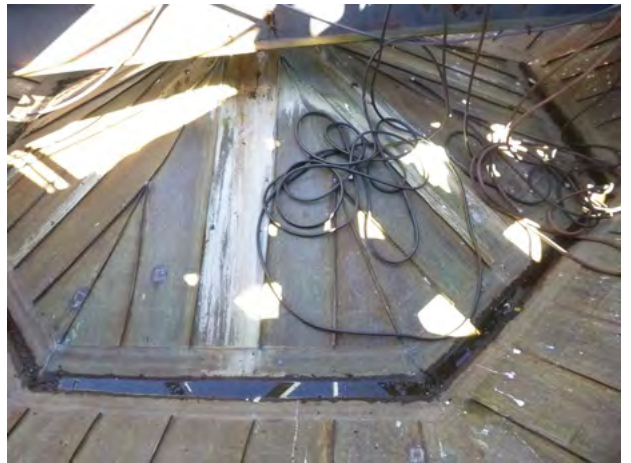
640-182 SheetMetal\_Note Photo-active leak 2024-1.jpg

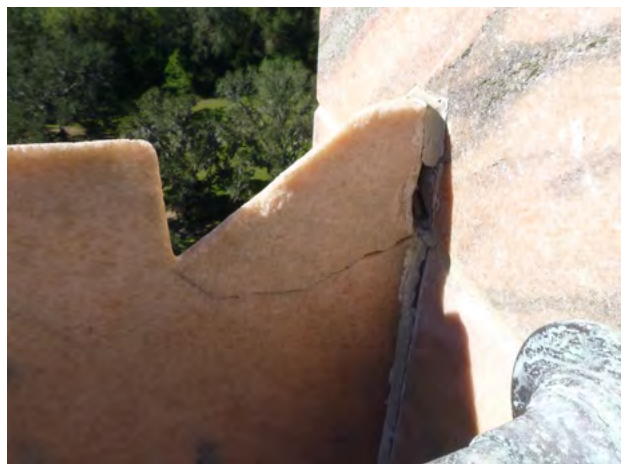
640-198 Stone\_Crack Single unit 2024-1.jpg

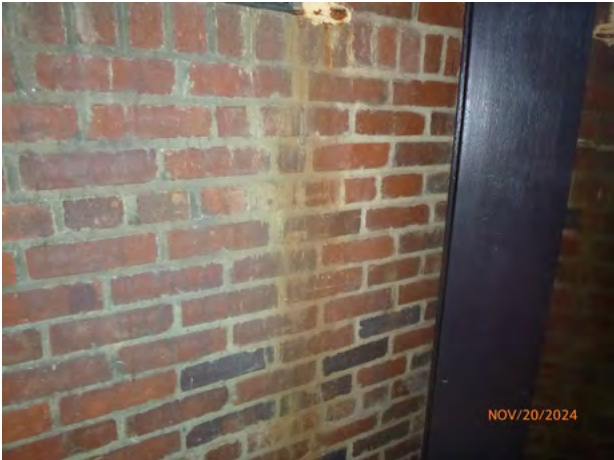
642-140 Brick\_SoilStain Rust 2024-1.jpg

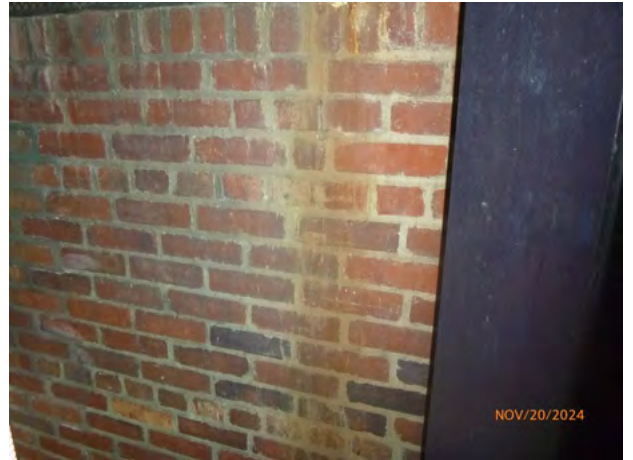
642-140 Brick\_SoilStain Rust 2024-2.jpg

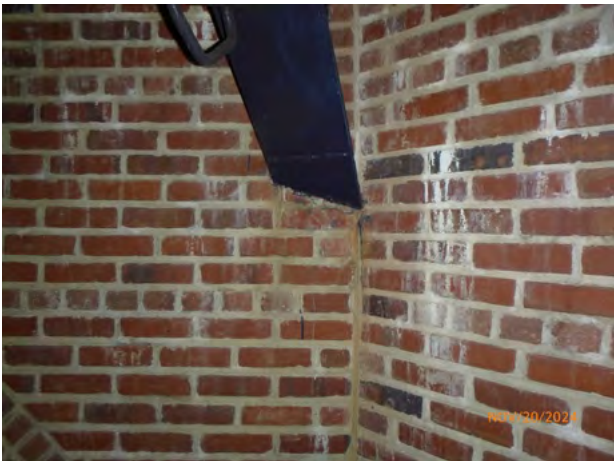
642-179 Brick\_Spall Bonded 2024-1.jpg

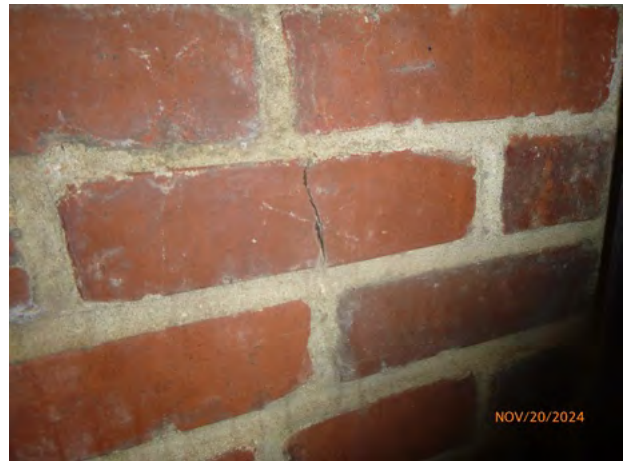
643-143 Brick\_Crack Single unit 2024-1.jpg

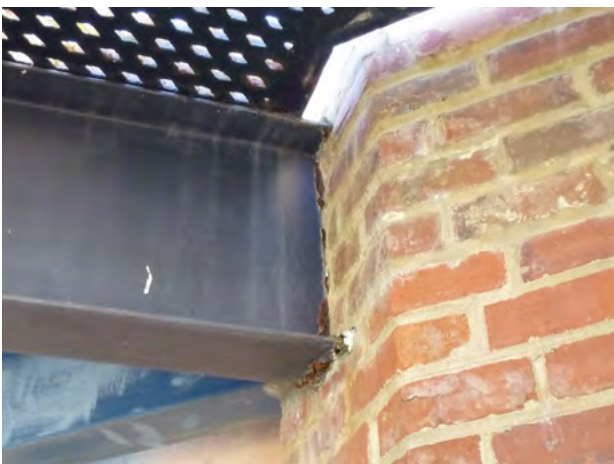
643-193 ArchMetal\_Corrosion Surface 2024-1.jpg

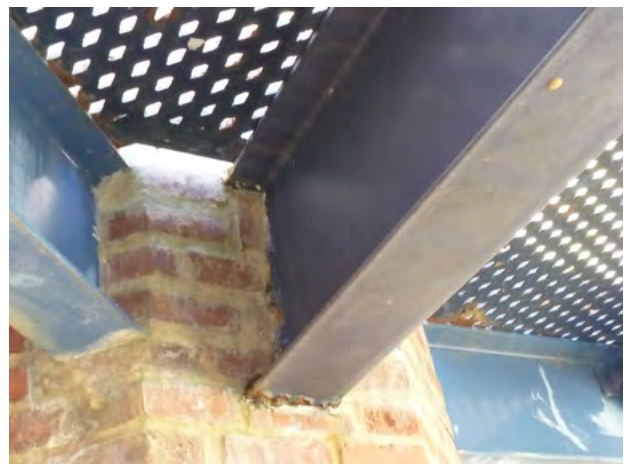
643-193 ArchMetal\_Corrosion Surface 2024-2.jpg

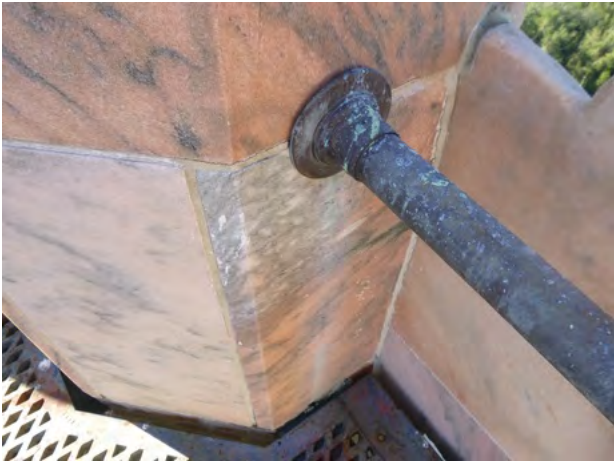
643-196 Stone\_Joints Mortar Failed 2024-1.jpg

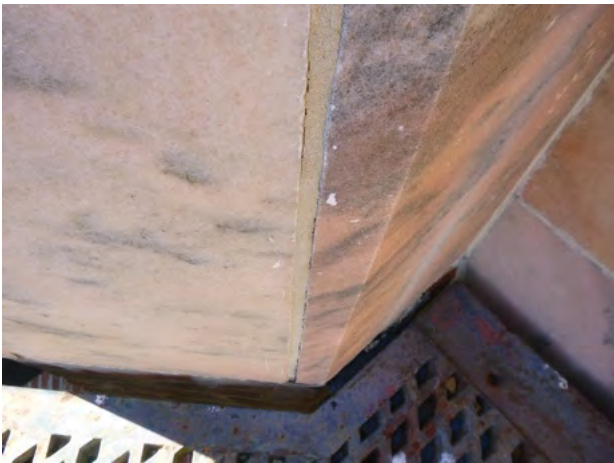
643-196 Stone\_Joints Mortar Failed 2024-3.jpg

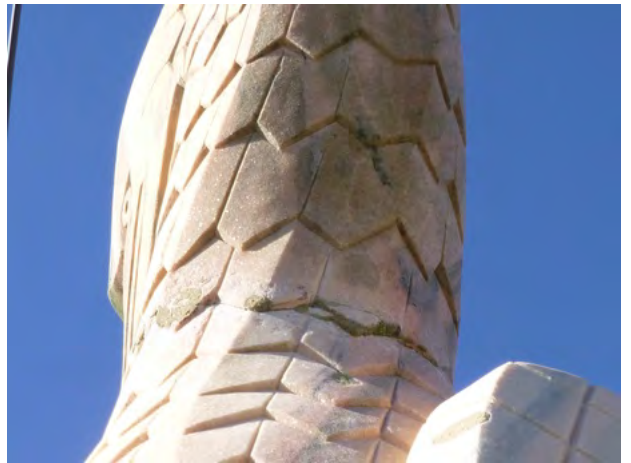
644-206 Stone\_Crack Repair failed 2024-1.jpg

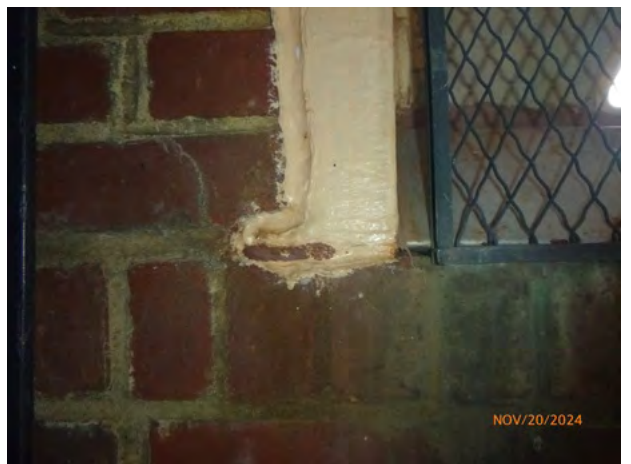
645-144 ArchMetal\_Corrosion Surface 2024-1.jpg

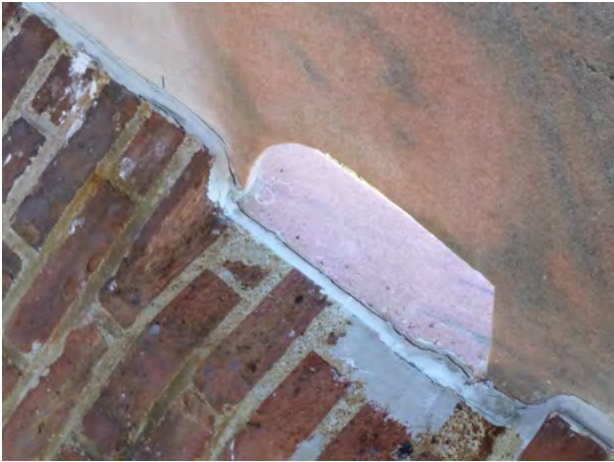
645-185 Brick\_Joints Sealant Failed 2024-1.jpg

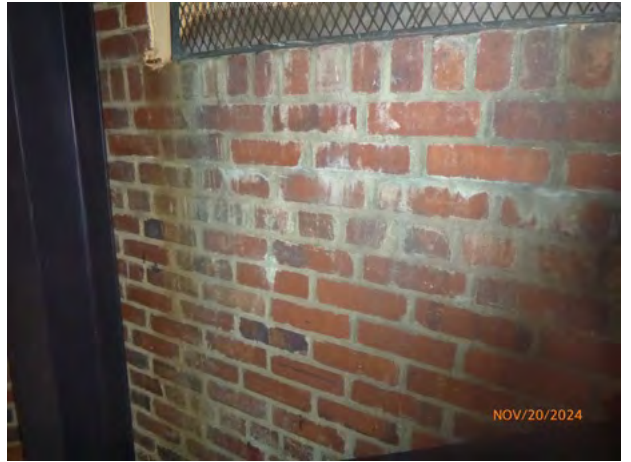
646-139 Brick\_SoilStain Leached Salts 2024-1.jpg

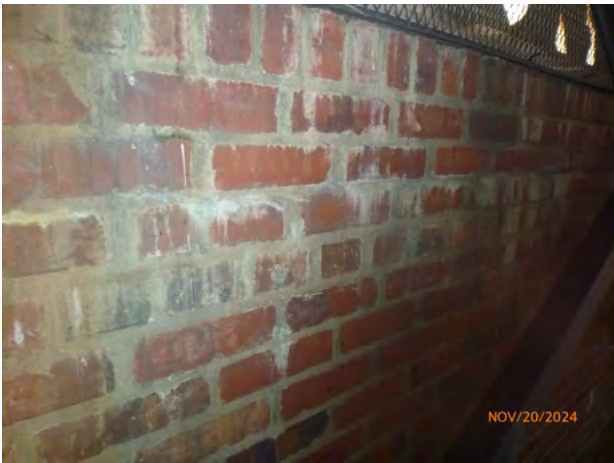
646-139 Brick\_SoilStain Leached Salts 2024-2.jpg

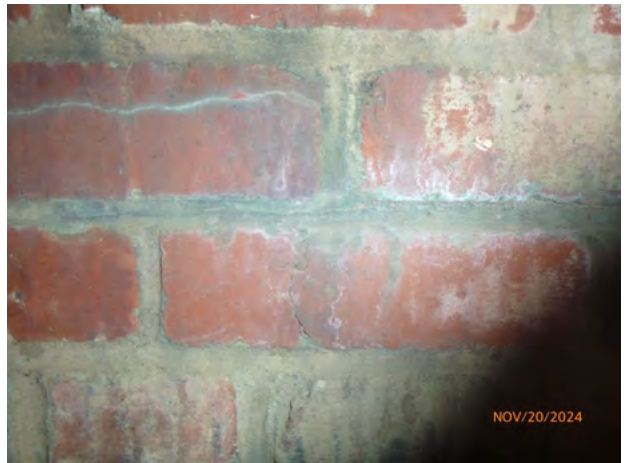
650-142 Brick\_Crack Single unit 2024-1.jpg

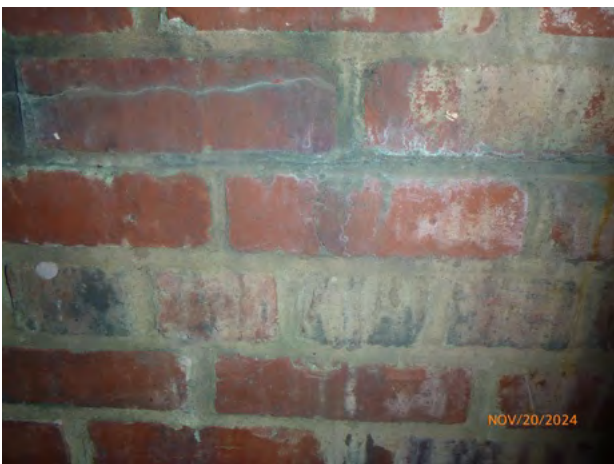
650-142 Brick\_Crack Single unit 2024-2.jpg

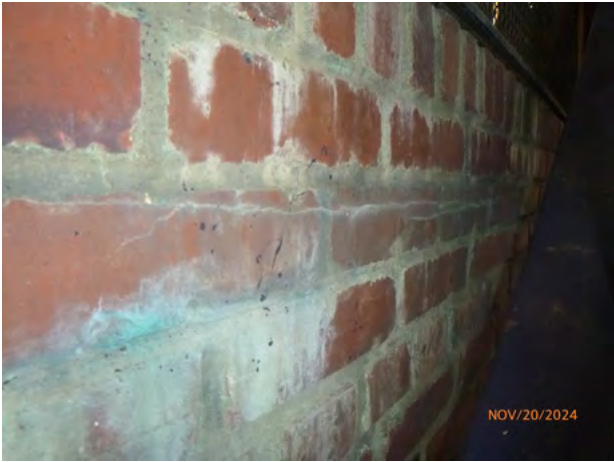
651-142 Brick\_Crack System units and joints 2024-1.jpg

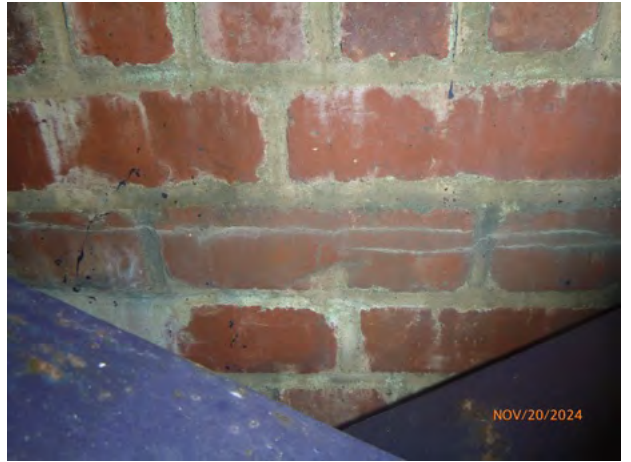
651-142 Brick\_Crack System units and joints 2024-2.jpg

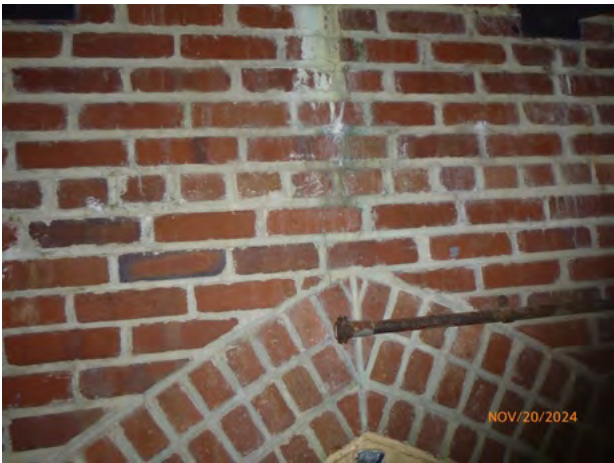
651-142 Brick\_Crack System units and joints 2024-3.jpg

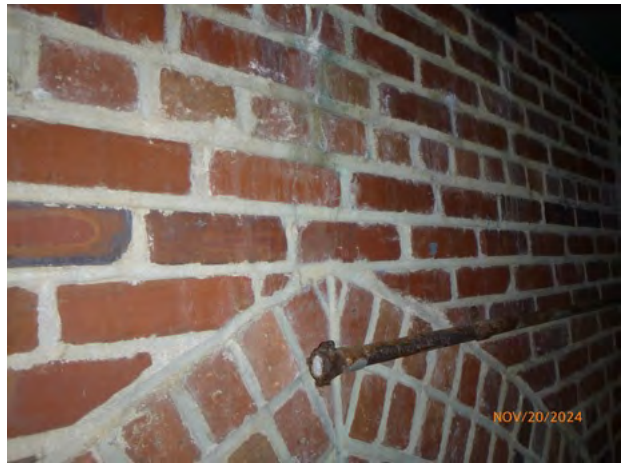
651-179 Brick\_Crack System units and joints 2024-1.jpg

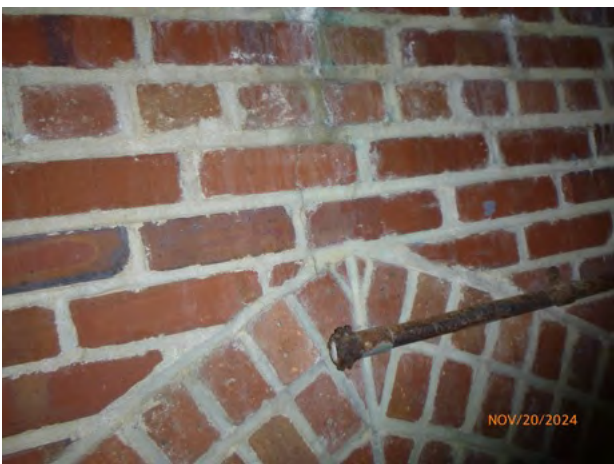
651-179 Brick\_Crack System units and joints 2024-2.jpg

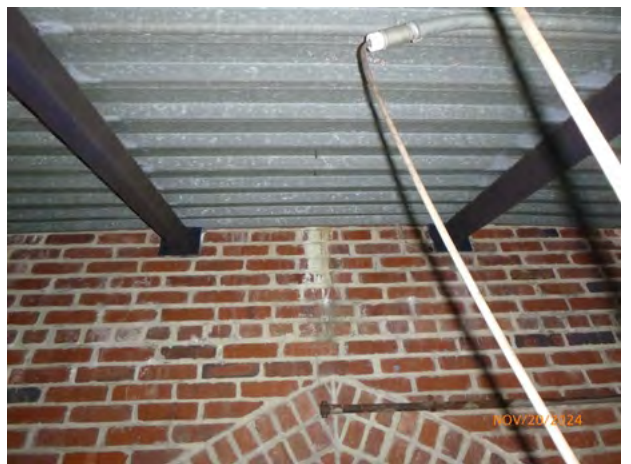
651-179 Brick\_Crack System units and joints 2024-3.jpg

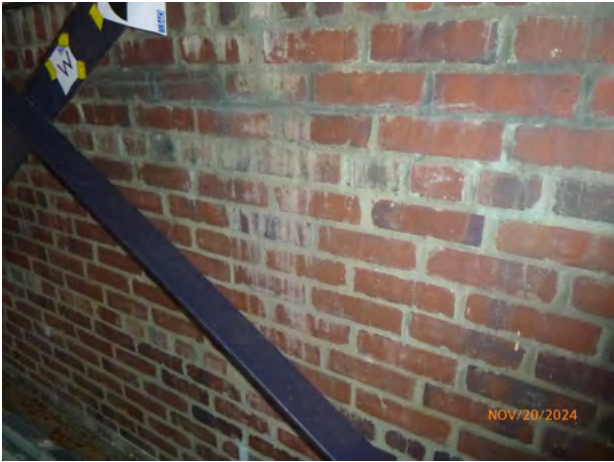
651-182 Brick\_SoilStain Paint 2024-1.jpg

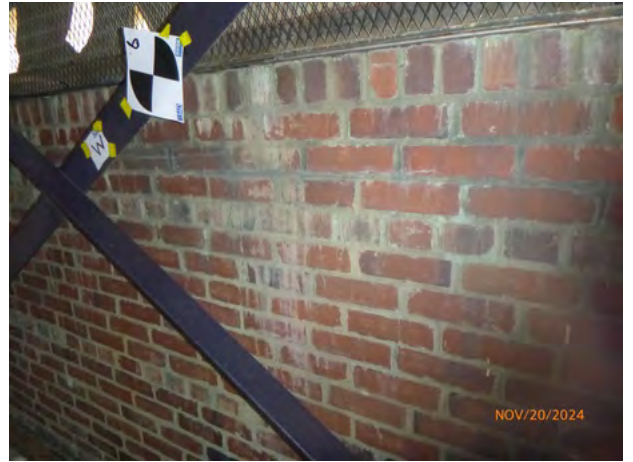
652-139 Brick\_SoilStain Paint 2024-1.jpg

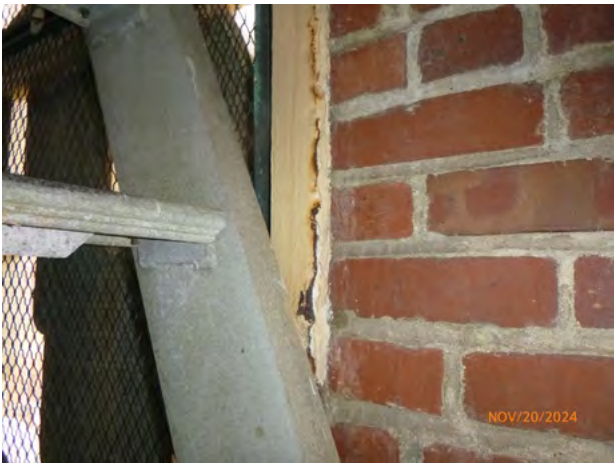
652-139 Brick\_SoilStain Paint 2024-2.jpg

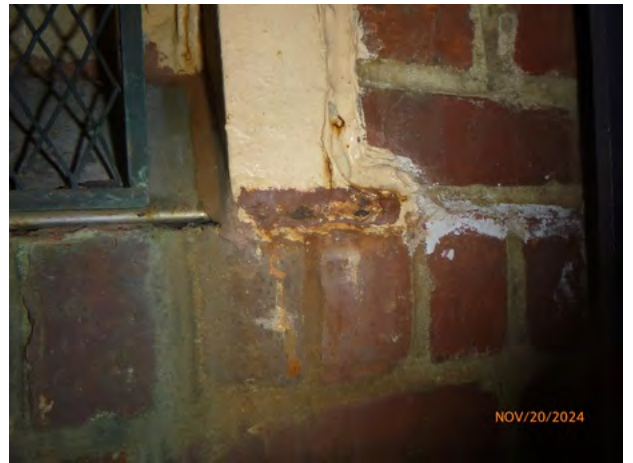
653-163 ArchMetal\_Coating Coating Failed 2024-1.jpg

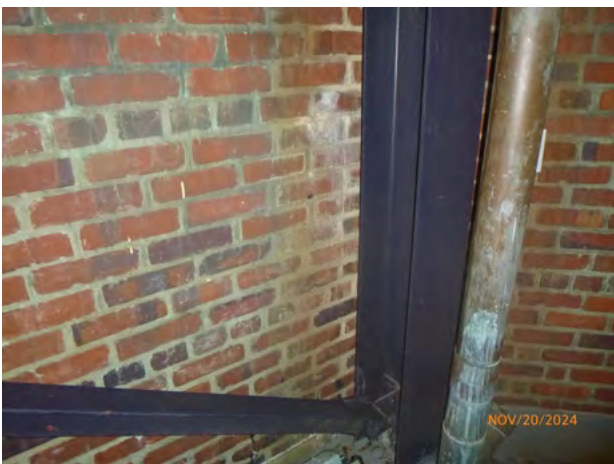
655-144 ArchMetal\_Corrosion Pitted 2024-1.jpg

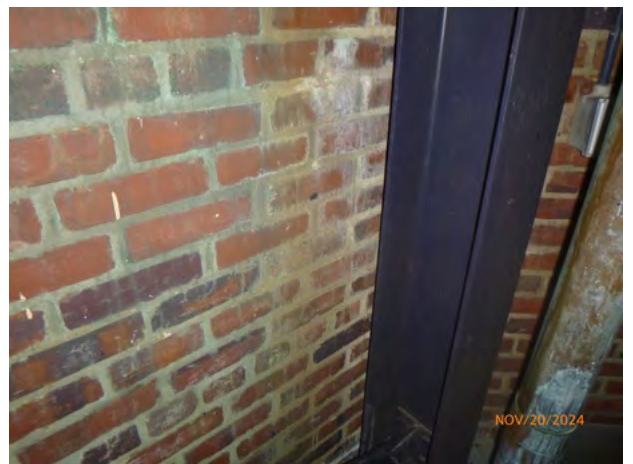
656-140 Brick\_SoilStain Paint 2024-1.jpg

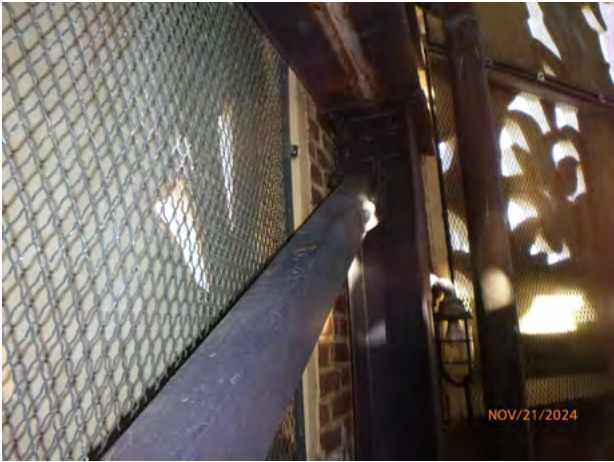
656-140 Brick\_SoilStain Paint 2024-2.jpg

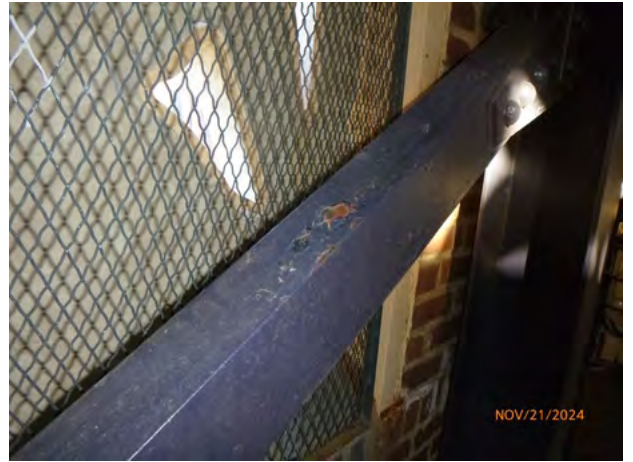
656-144 ArchMetal\_Coating Coating Failed 2024-1.jpg

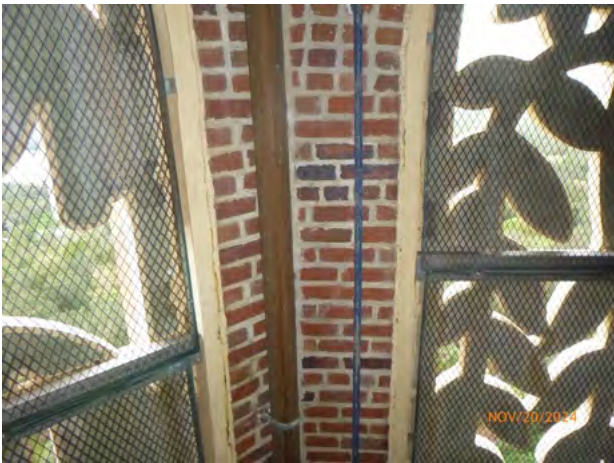
656-144 ArchMetal\_Coating Coating Failed 2024-2.jpg

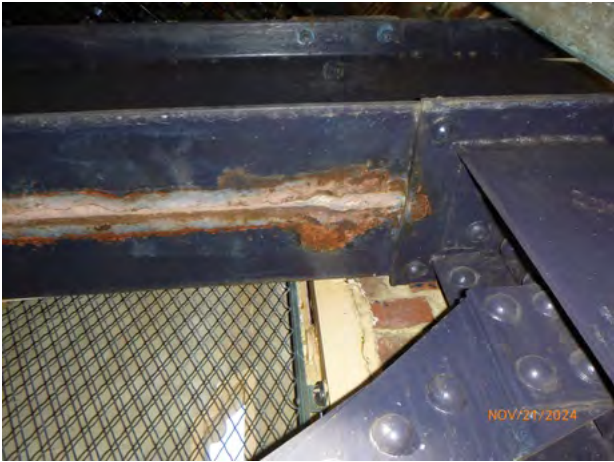
657-144 ArchMetal\_Coating Coating Failed 2024-1.jpg

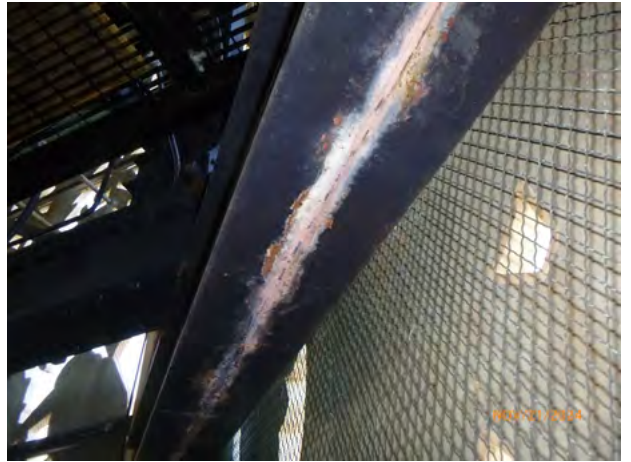
657-144 ArchMetal\_Coating Coating Failed 2024-2.jpg

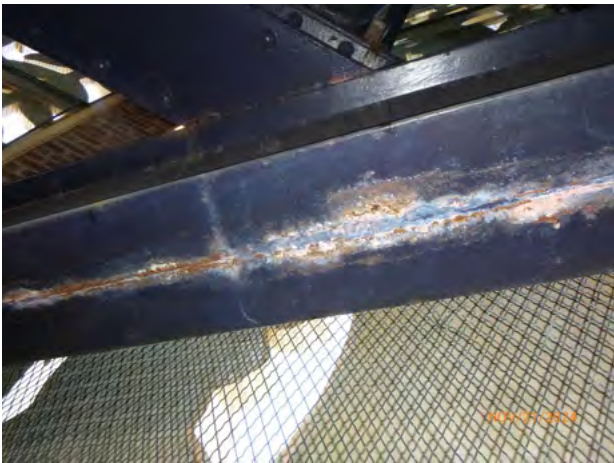
657-144 ArchMetal\_Coating Coating Failed 2024-3.jpg

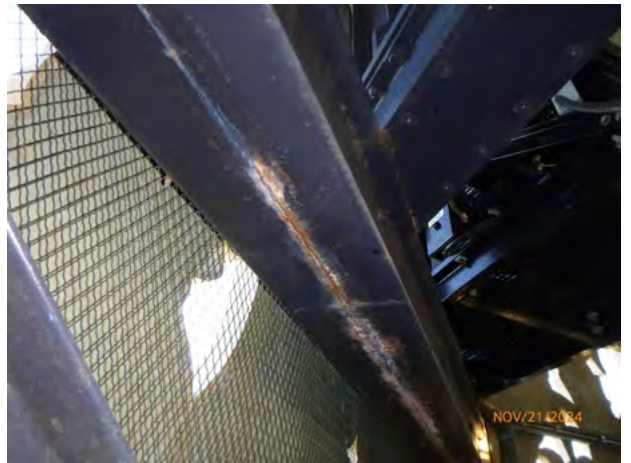
657-144 ArchMetal\_Coating Coating Failed 2024-4.jpg

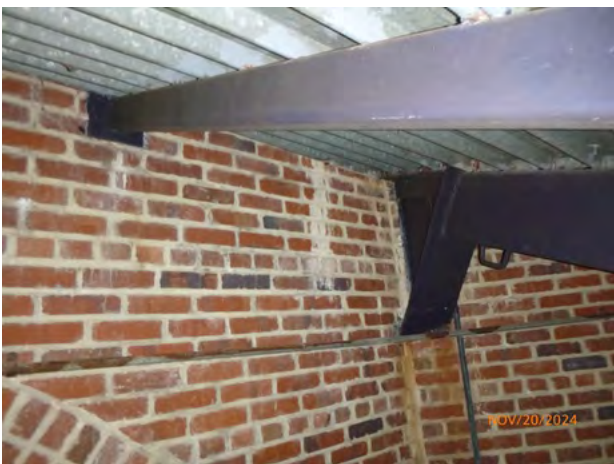
657-144 ArchMetal\_Coating Coating Failed 2024-5.jpg

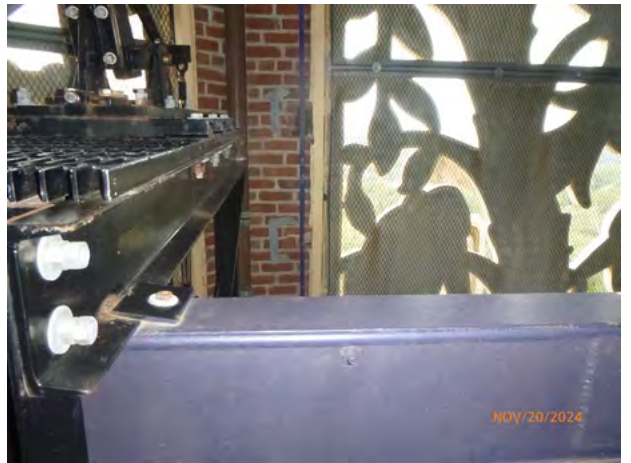
658-146 Brick\_Unsecured Missing 2024-1.jpg

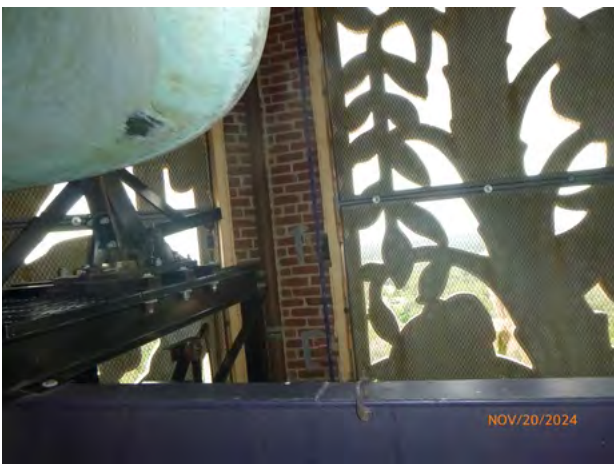
658-146 Brick\_Unsecured Missing 2024-2.jpg

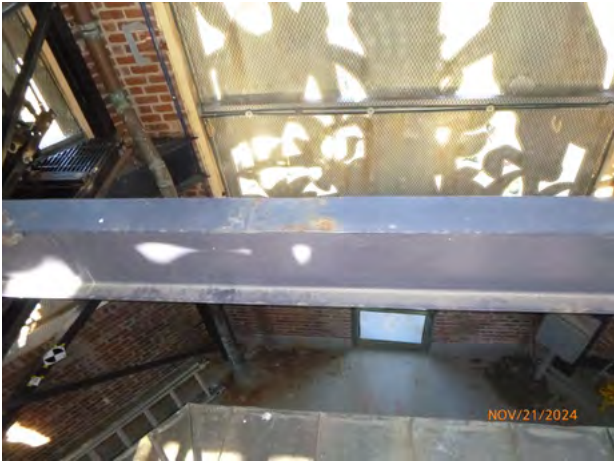
658-149 Brick\_Unsecured Missing 2024-2.jpg

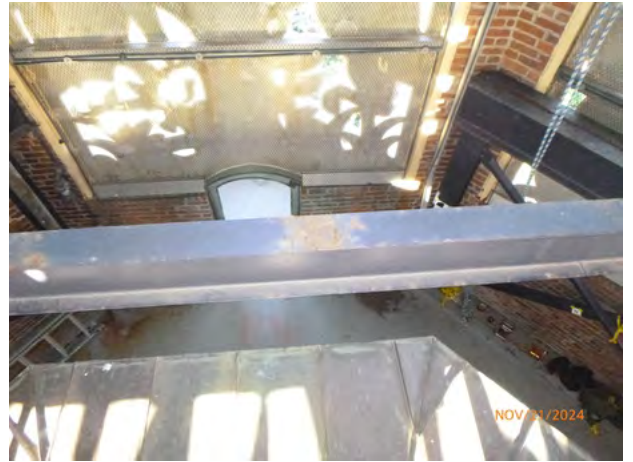
663-148 ArchMetal\_Coating Coating Failed 2024-1.jpg

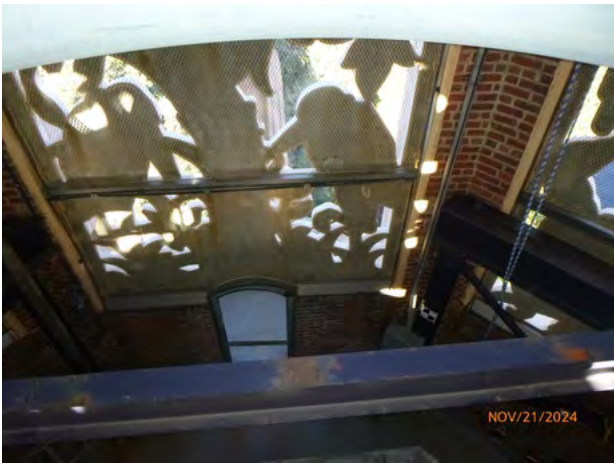
663-148 ArchMetal\_Coating Coating Failed 2024-2.jpg

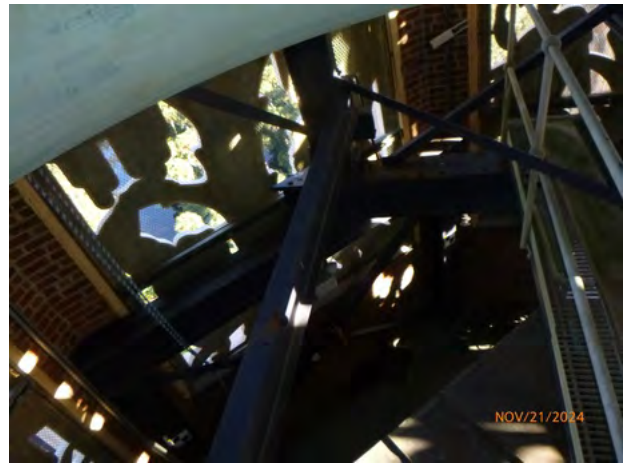
663-148 ArchMetal\_Coating Coating Failed 2024-3.jpg

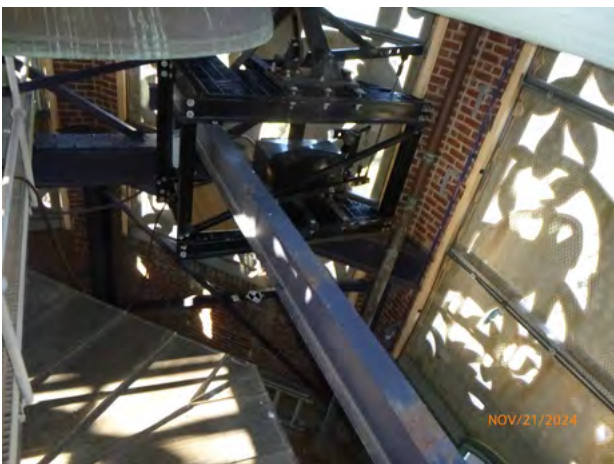
663-148 ArchMetal\_Coating Coating Failed 2024-4.jpg

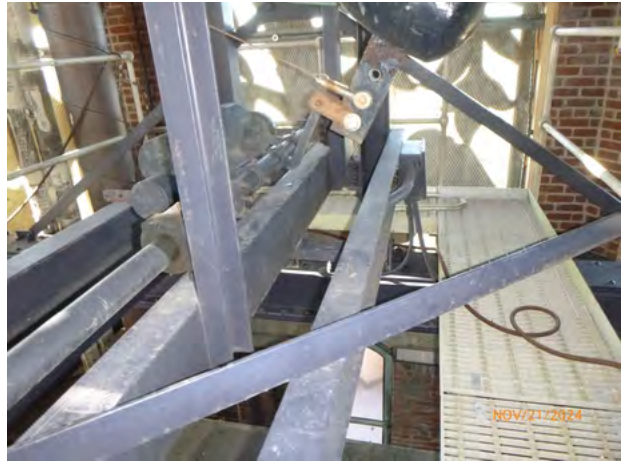
664-149 ArchMetal\_Coating Coating Failed 2024-2.jpg

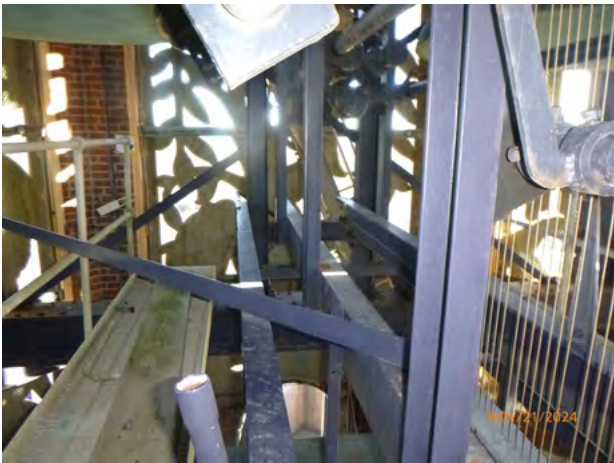
664-149 ArchMetal\_Coating Coating Failed 2024-3.jpg

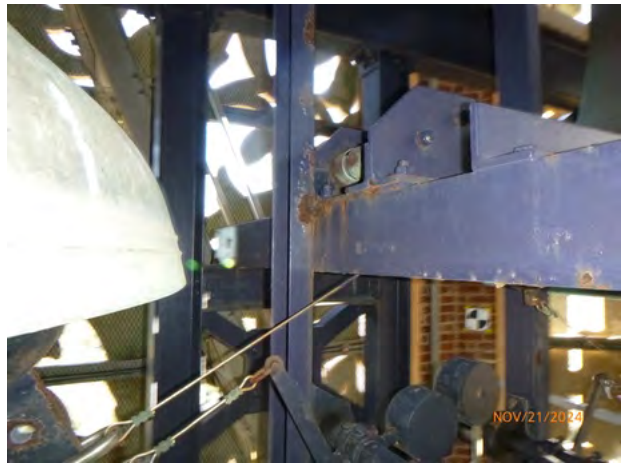
664-149 ArchMetal\_Coating Coating Failed 2024-4.jpg

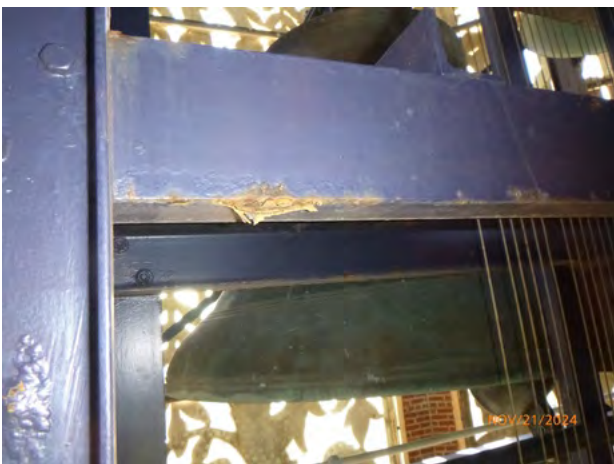
664-151 ArchMetal\_Coating Coating Failed 2024-1.jpg

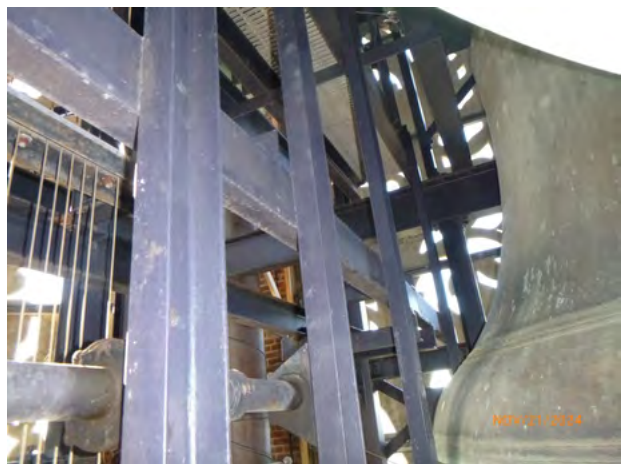
664-151 ArchMetal\_Coating Coating Failed 2024-2.jpg

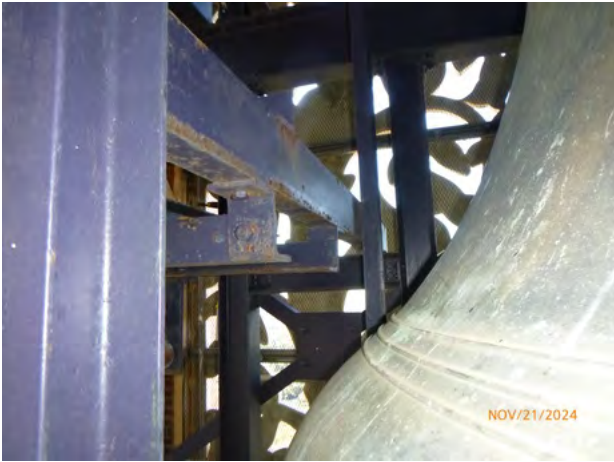
664-151 ArchMetal\_Coating Coating Failed 2024-3.jpg

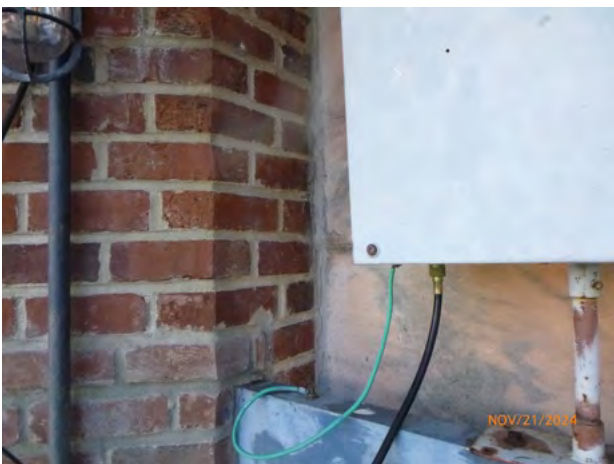
664-197 Stone\_Displacement Horizontal 2024-2.jpg

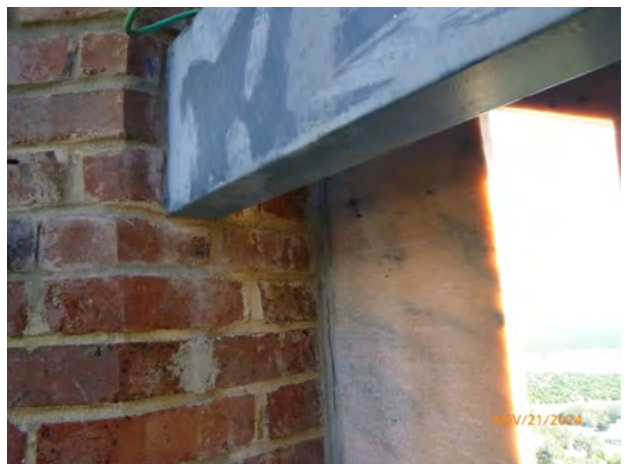
734-190 Brick\_Joints Mortar Failed 2024-1.jpg

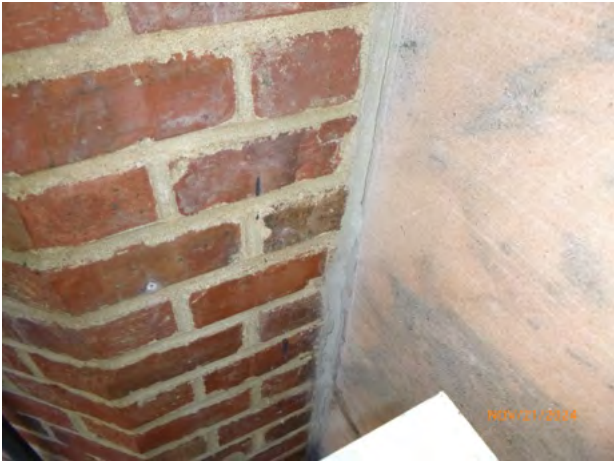
734-190 Brick\_Joints Mortar Failed 2024-2.jpg

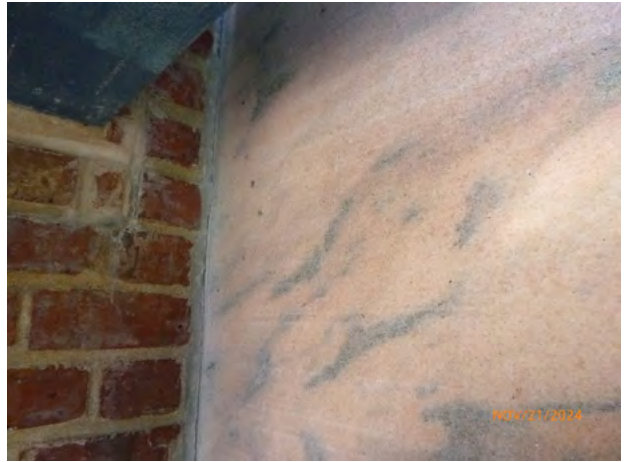
734-190 Brick\_Joints Mortar Failed 2024-3.jpg

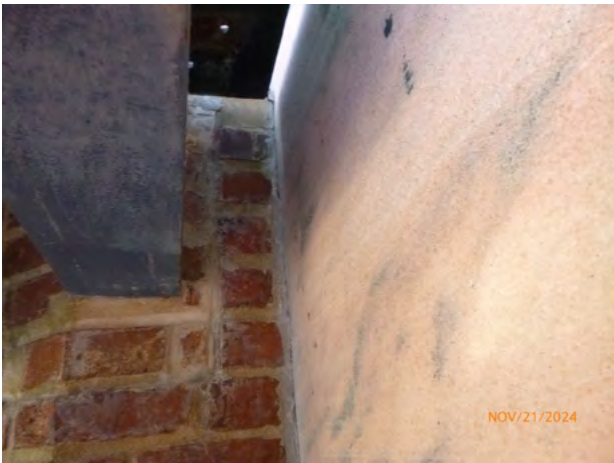
734-190 Brick\_Joints Mortar Failed 2024-4.jpg

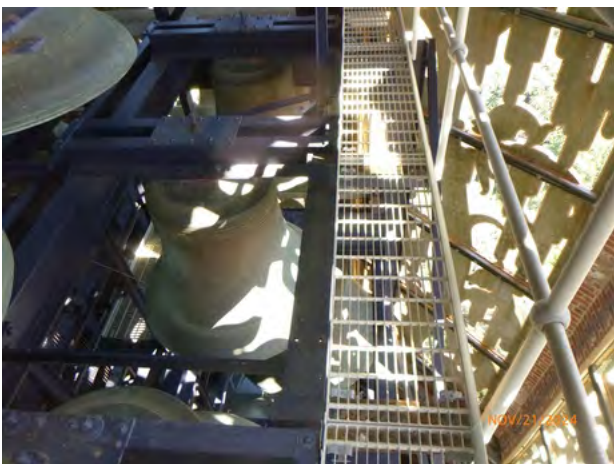
741-169 ArchMetal\_Coating Coating Failed 2024-1.jpg

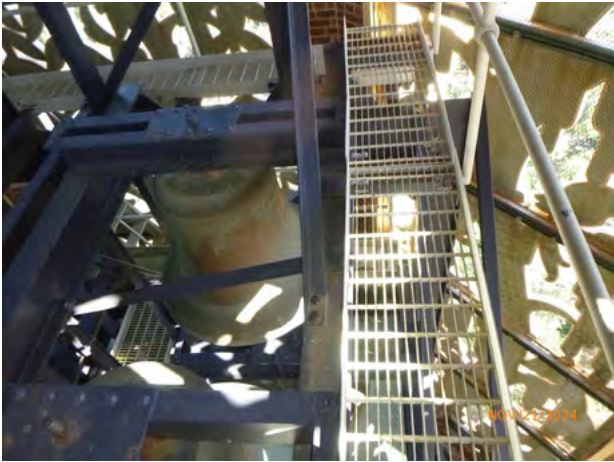
741-169 ArchMetal\_Coating Coating Failed 2024-3.jpg

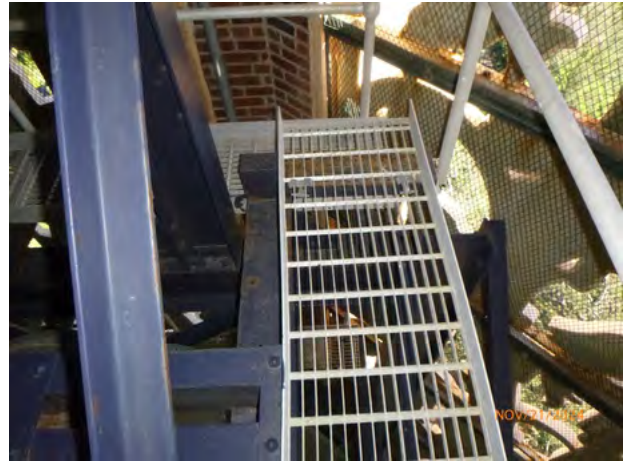
741-169 ArchMetal\_Coating Coating Failed 2024-4.jpg

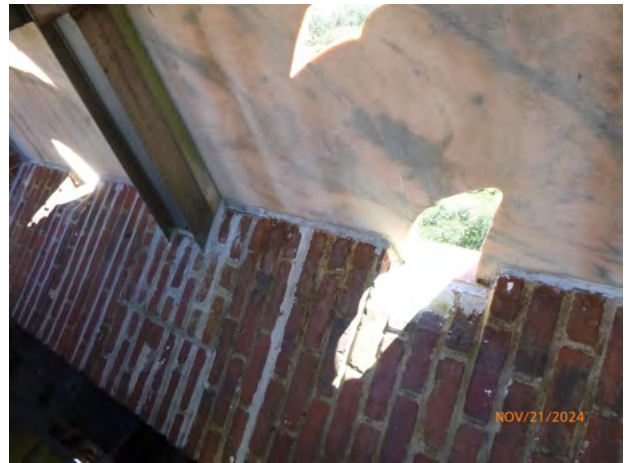
741-184 Brick\_Joints Sealant Failed 2024-1.jpg

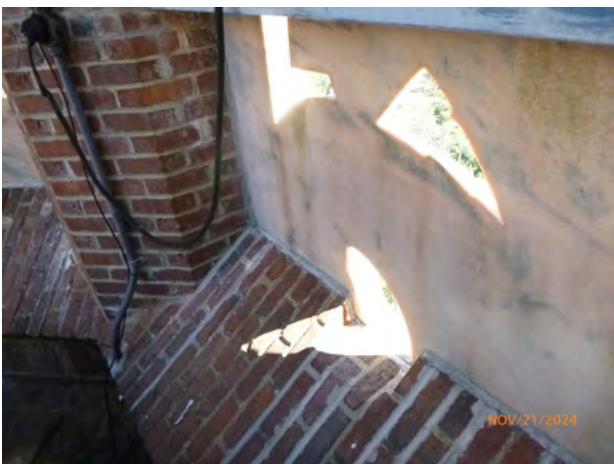
741-184 Brick\_Joints Sealant Failed 2024-2.jpg

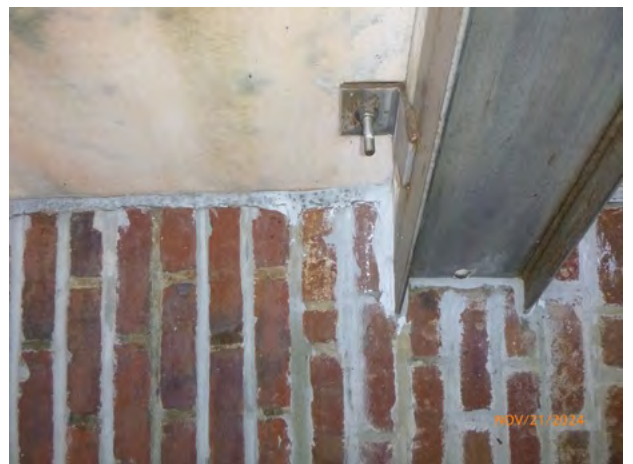
741-184 Brick\_Joints Sealant Failed 2024-3.jpg

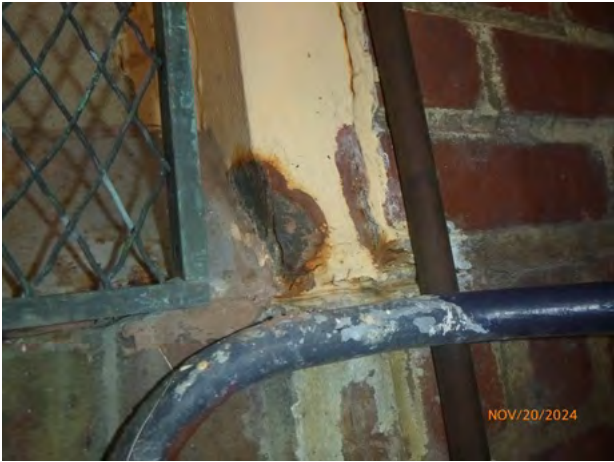
741-184 Brick\_Joints Sealant Failed 2024-4.jpg

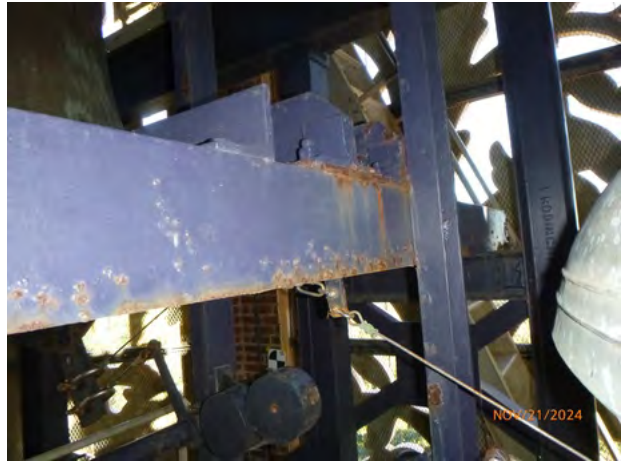
742-144 ArchMetal\_Corrosion Pitted 2024-1.jpg

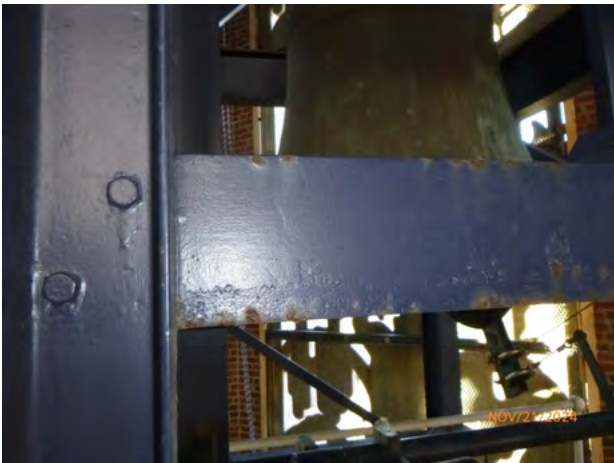
742-150 ArchMetal\_Coating Coating Failed 2024-1.jpg

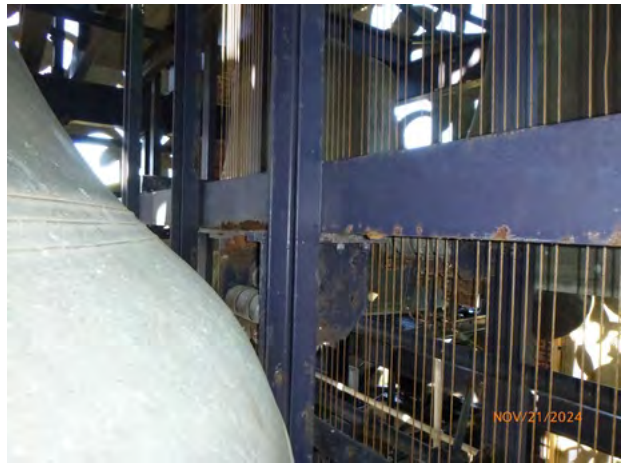
742-150 ArchMetal\_Coating Coating Failed 2024-2.jpg

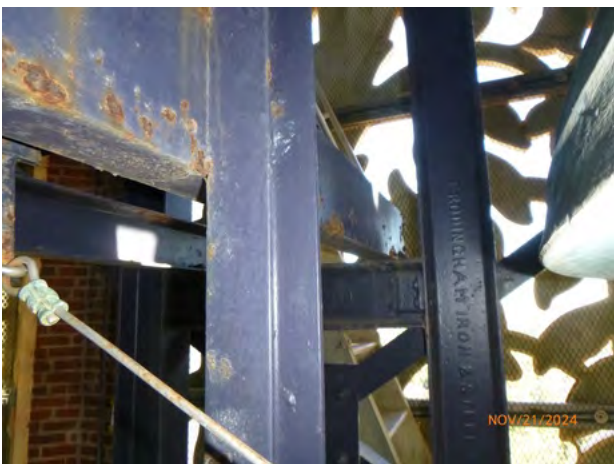
742-150 ArchMetal\_Coating Coating Failed 2024-3.jpg

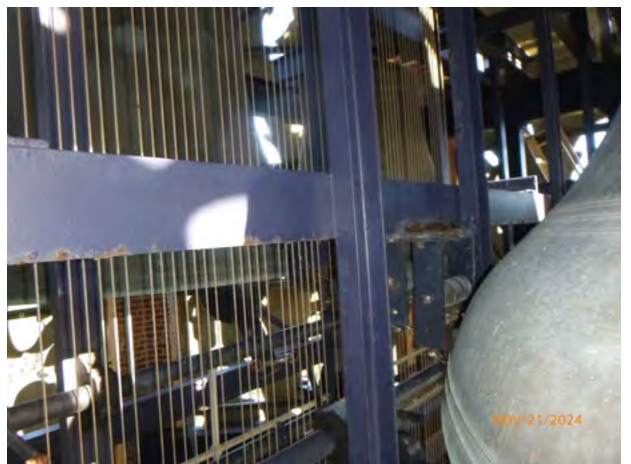
742-150 ArchMetal\_Coating Coating Failed 2024-4.jpg

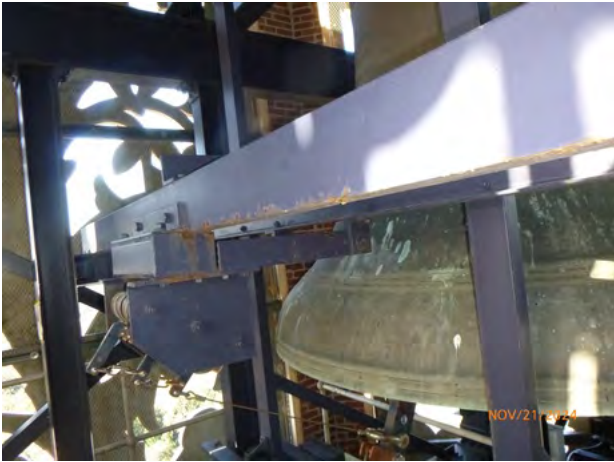
742-150 ArchMetal\_Coating Coating Failed 2024-5.jpg

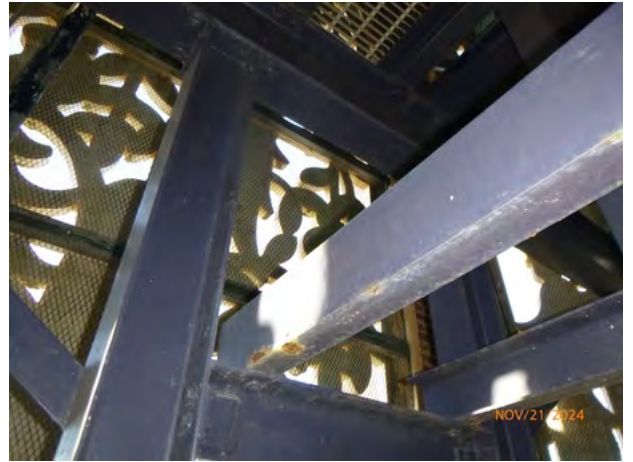
742-150 ArchMetal\_Coating Coating Failed 2024-6.jpg

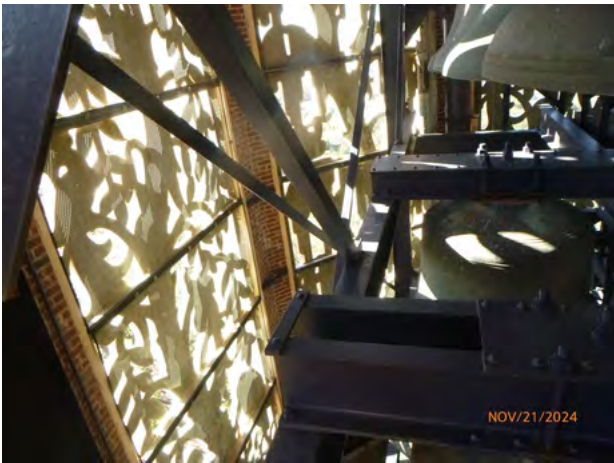
742-150 ArchMetal\_Coating Coating Failed 2024-7.jpg

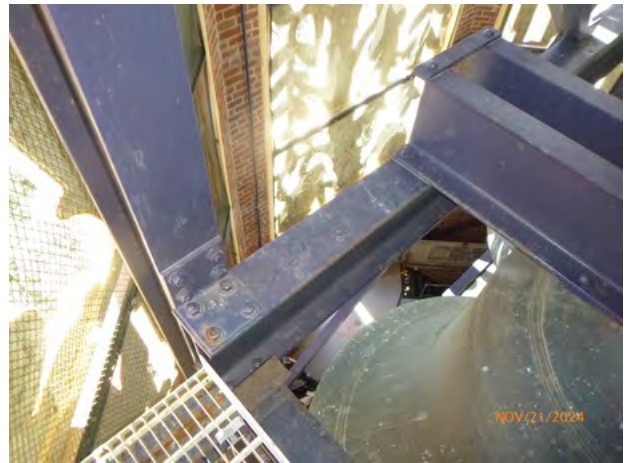
743-157 ArchMetal\_Coating Coating Failed 2024-1.jpg

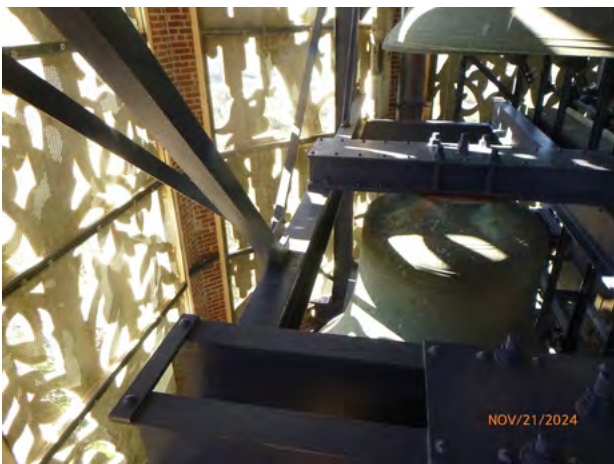
743-157 ArchMetal\_Coating Coating Failed 2024-2.jpg

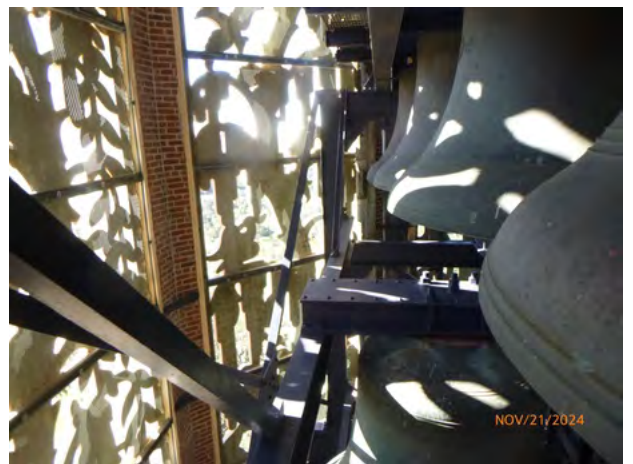
743-157 ArchMetal\_Coating Coating Failed 2024-3.jpg

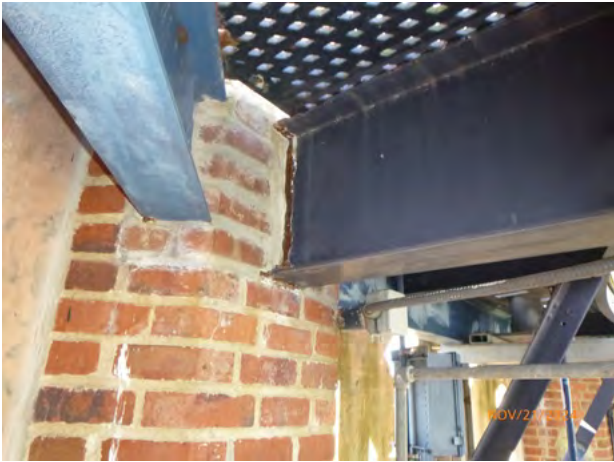
743-157 ArchMetal\_Coating Coating Failed 2024-4.jpg

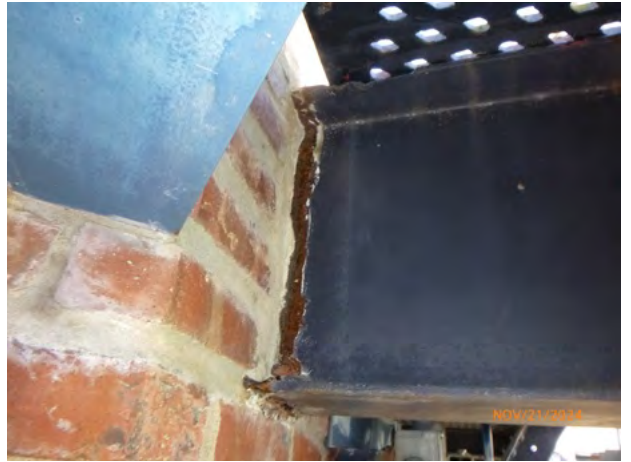
743-190 ArchMetal\_Corrosion Surface 2024-1.jpg
