### ***Bok Singing Tower Roof Restoration and Replacement***

# Bok Singing Tower Conditions Assessment

T.Y. Lin (formerly Silman) was contracted to perform a conditions assessment of the Bok Singing Tower at Bok Tower Gardens in Lake Wales, Florida. The Singing Tower stands 205 feet tall at the southwest corner of the gardens. A moat surrounds the base of the tower with two bridges to access the island. The tower houses a 60-bell carillon, associated carillonneur studio and library spaces, the Bok Tower Gardens Chao Research archive, and the Founder's Room. It is a steel frame construction clad in a masonry exterior of coquina and Georgia pink Etowah marble with brick masonry at the interior.

## **Bok Tower Focused Condition Assessment**

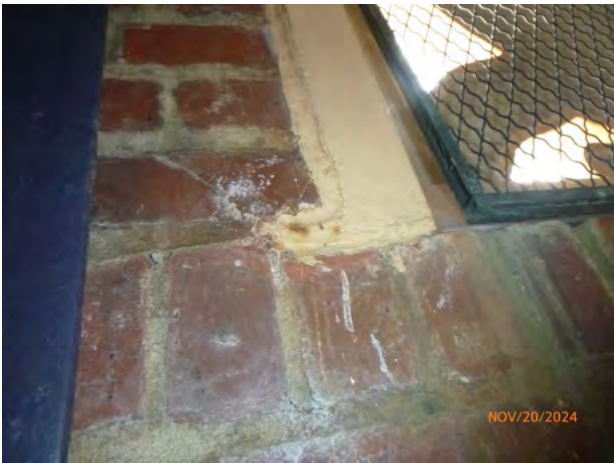
743-190 ArchMetal\_Corrosion Surface 2024-2.jpg

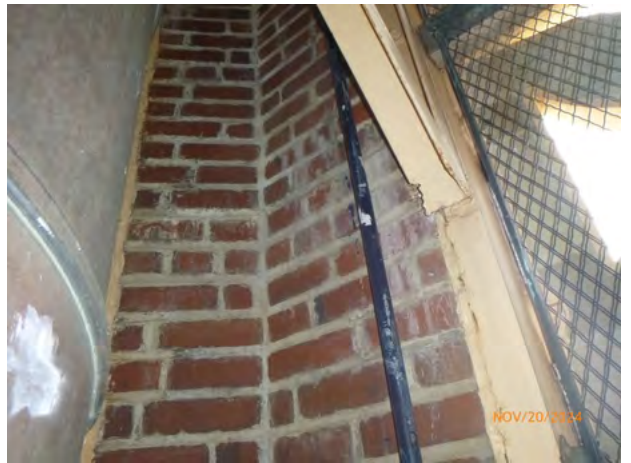
745-143 ArchMetal\_Corrosion Surface 2024-1.jpg

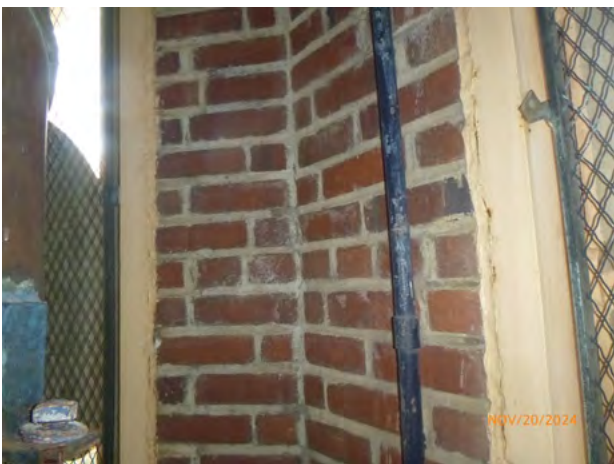
745-154 Brick\_SoilStain Cementitious 2024-1.jpg

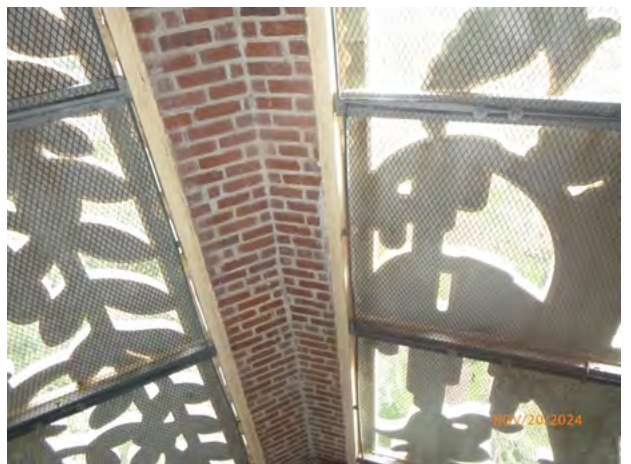
745-154 Brick\_SoilStain Cementitious 2024-2.jpg

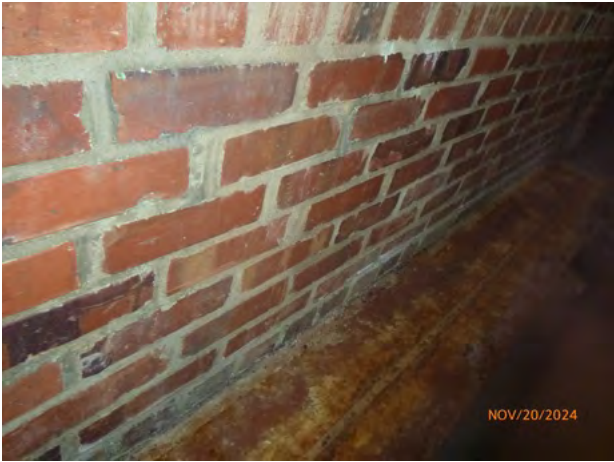
745-167 Brick\_SoilStain Paint 2024-1.jpg

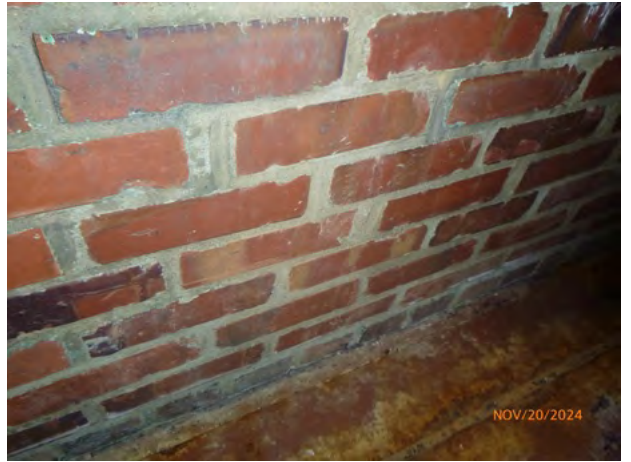
746-139 Brick\_Spall Missing 2024-1.jpg

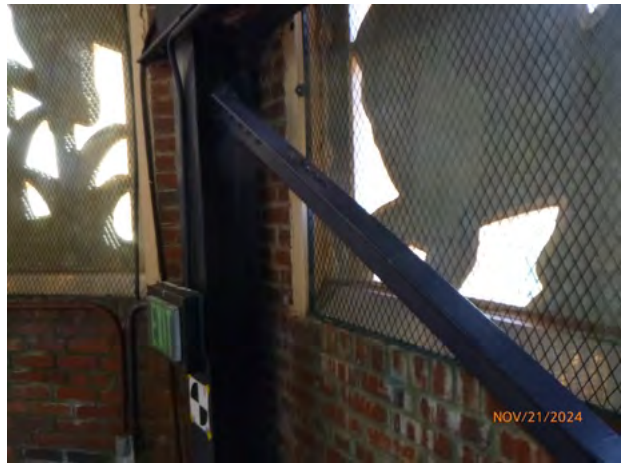
746-144 ArchMetal\_Coating Coating Failed 2024-2.jpg

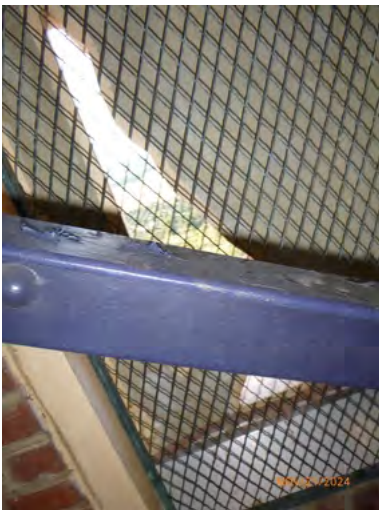
746-144 ArchMetal\_Coating Coating Failed 2024-3.jpg

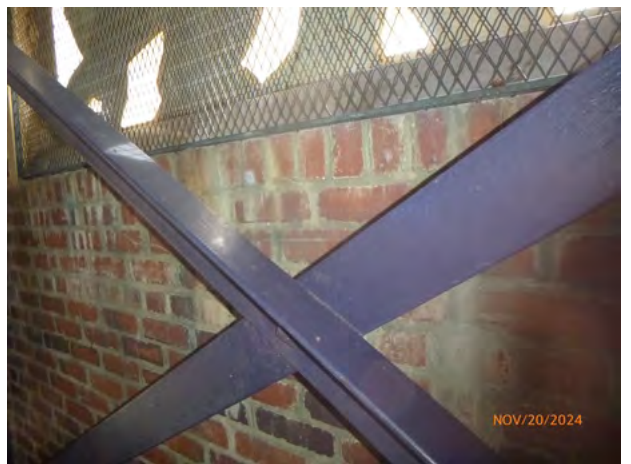
751-143 Brick\_Crack System units and joints 2024-1.jpg

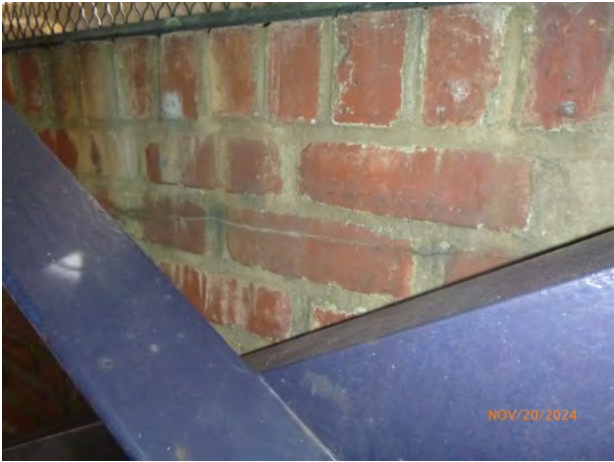
751-143 Brick\_Crack System units and joints 2024-2.jpg

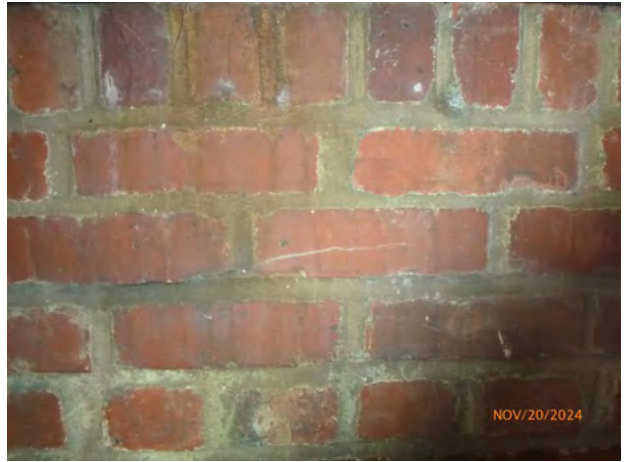
753-143 Brick\_Crack System units and joints 2024-1.jpg

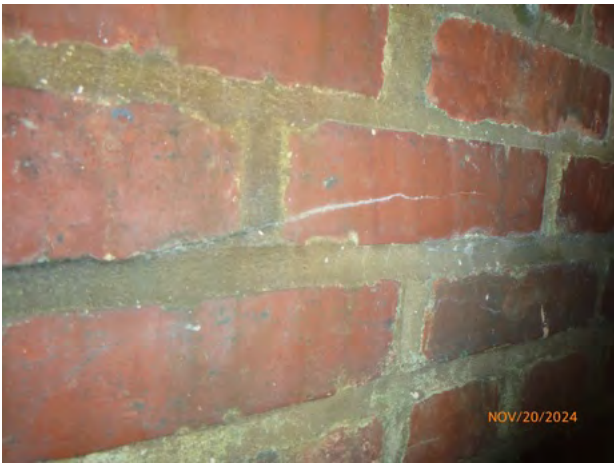
753-143 Brick\_Crack System units and joints 2024-2.jpg

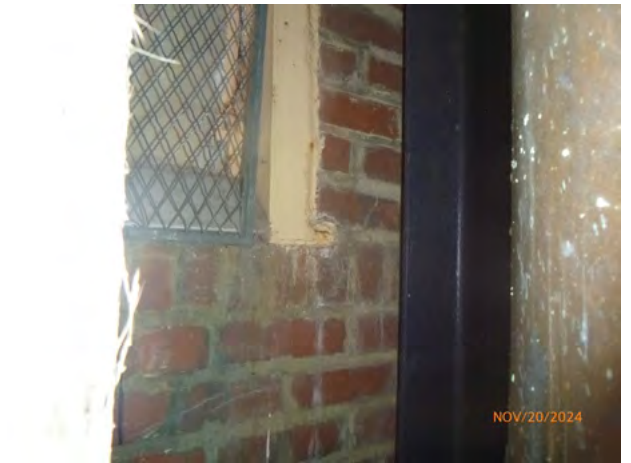
755-143 ArchMetal\_Corrosion Surface 2024-1.jpg

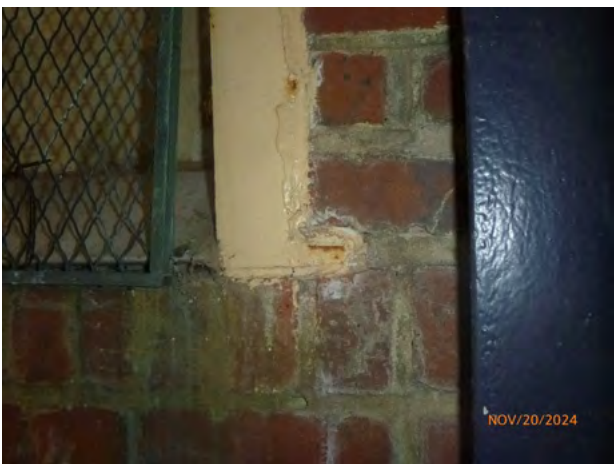
755-143 ArchMetal\_Corrosion Surface 2024-2.jpg

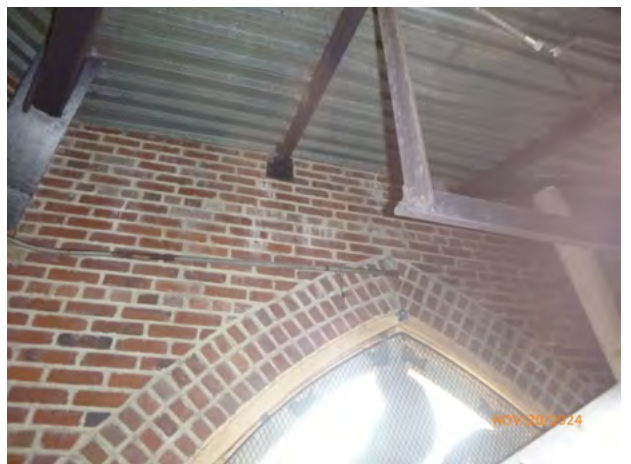
755-178 Brick\_SoilStain Leached Salts 2024-1.jpg

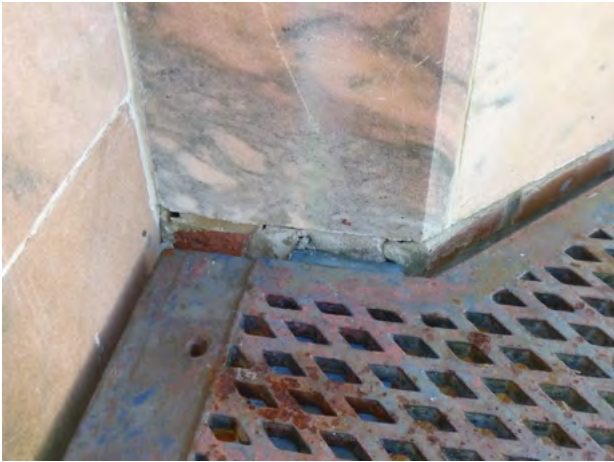
755-193 Stone\_Joints Mortar Failed 2024-1.jpg

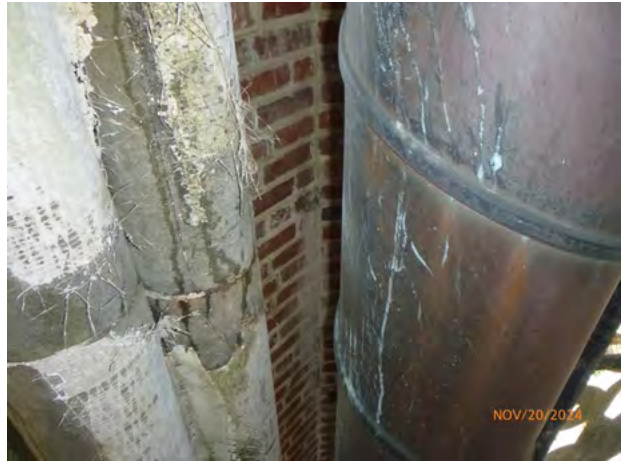
756-166 Brick\_SoilStain Paint 2024-1.jpg

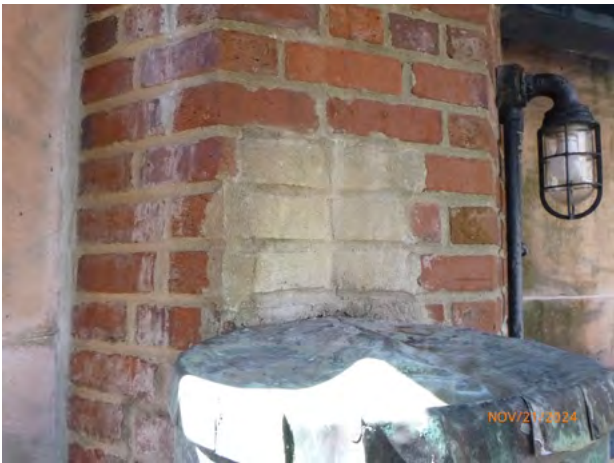
756-190 Brick\_Repair Patch Failed 2024-1.jpg

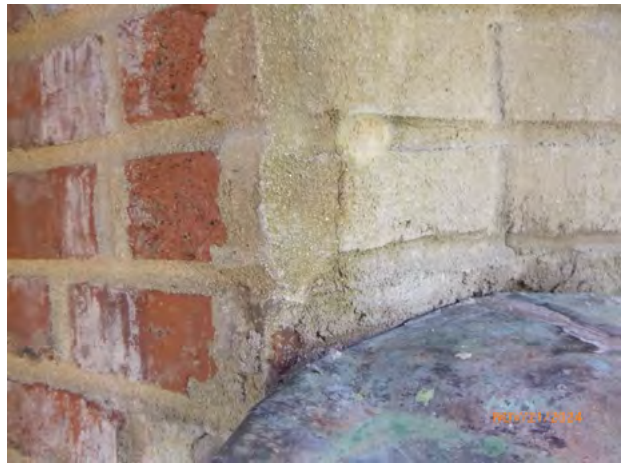
756-190 Brick\_Repair Patch Failed 2024-2.jpg

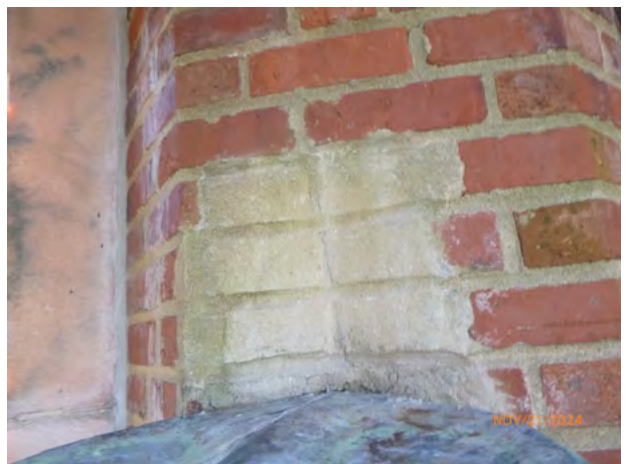
756-190 Brick\_Repair Patch Failed 2024-4.jpg

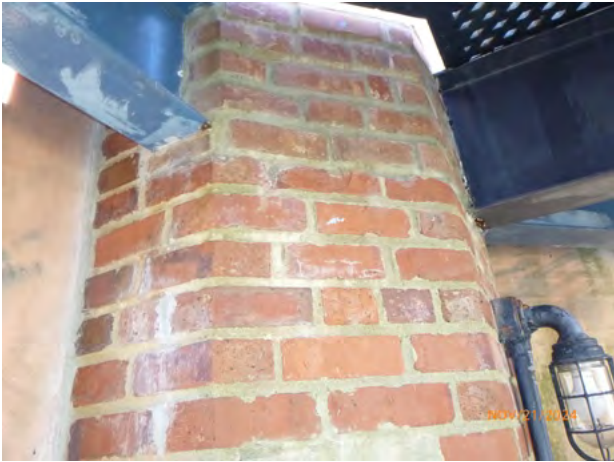
756-191 Brick\_SurfLoss Face spalled 2024-1.jpg

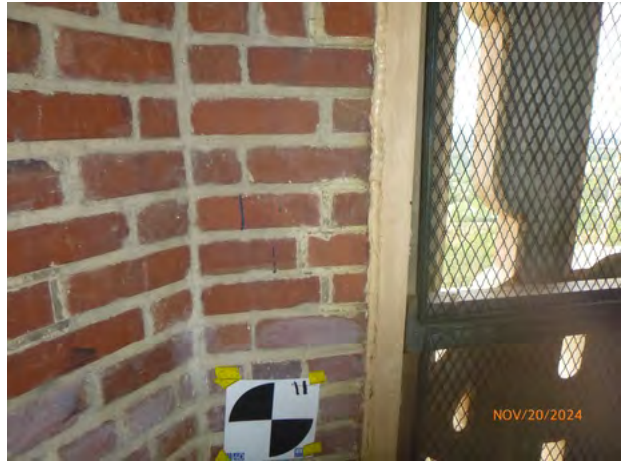
757-150 Brick\_Repair Patch Sound 2024-1.jpg

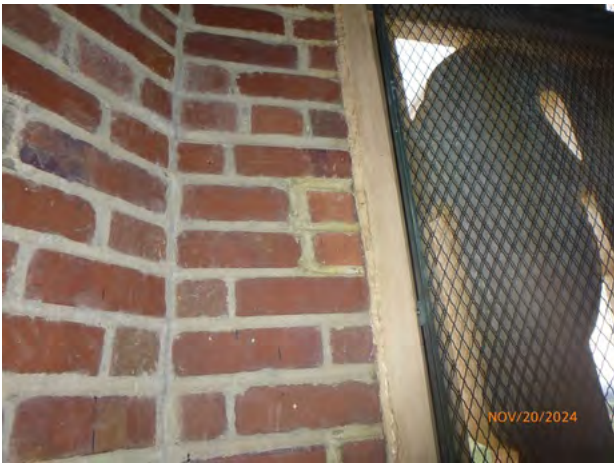
757-152 Brick\_Repair Patch Sound 2024-1.jpg

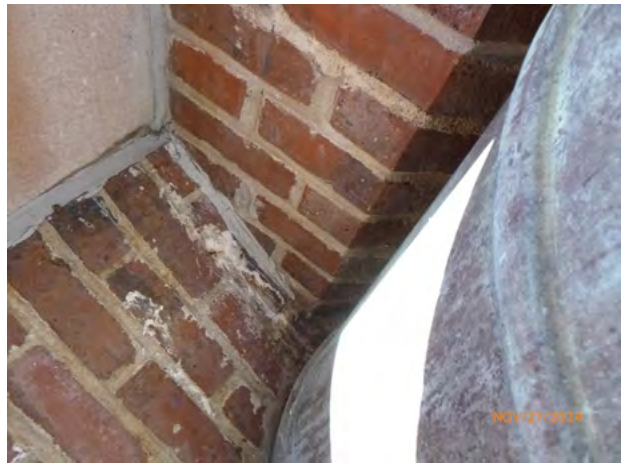
757-184 Brick\_Joints Sealant Failed 2024-1.jpg

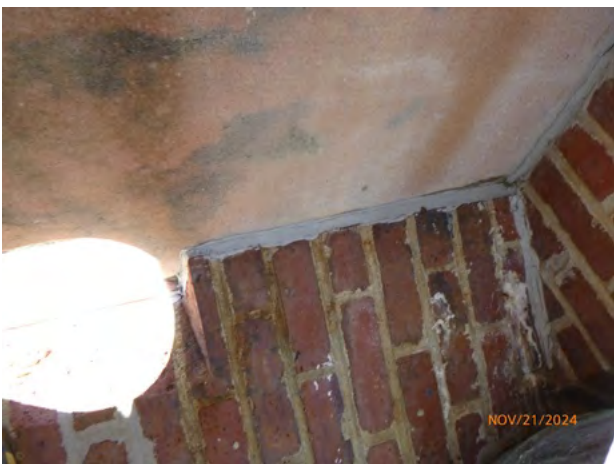
757-184 Brick\_Joints Sealant Failed 2024-2.jpg

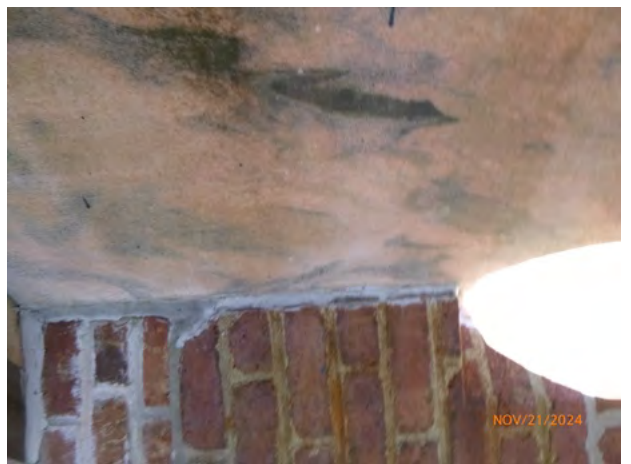
757-184 Brick\_Joints Sealant Failed 2024-3.jpg

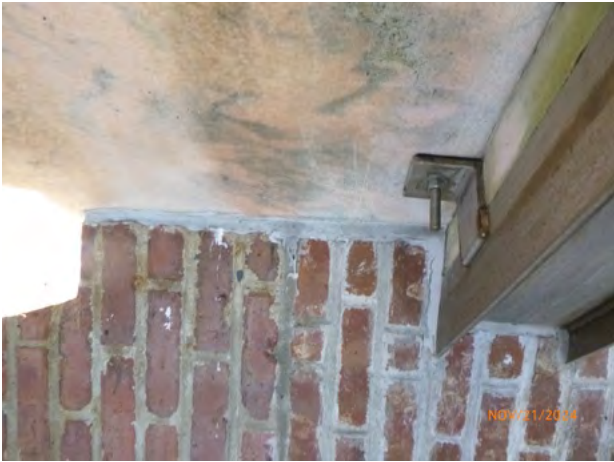
757-184 Brick\_Joints Sealant Failed 2024-4.jpg

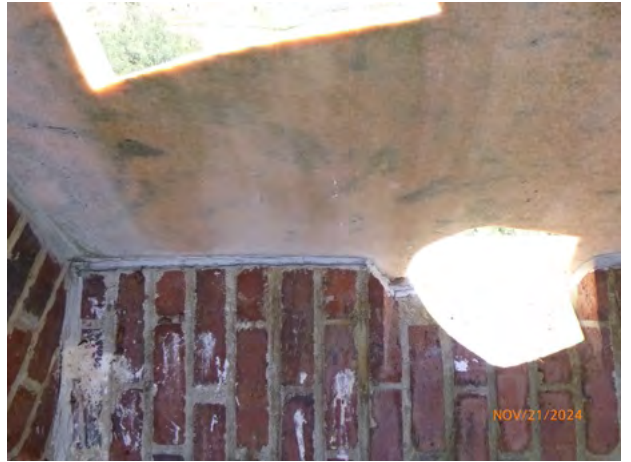
757-184 Brick\_Joints Sealant Failed 2024-5.jpg

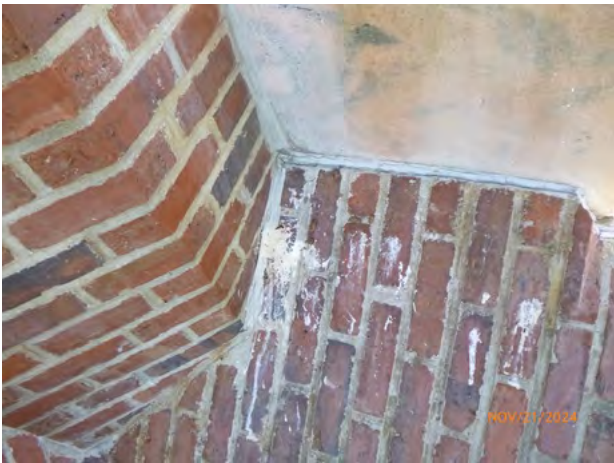
757-184 Brick\_Joints Sealant Failed 2024-6.jpg

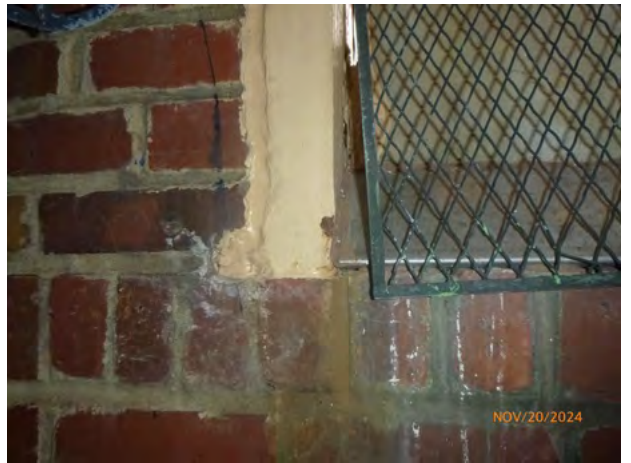
758-143 ArchMetal\_Corrosion Surface 2024-1.jpg

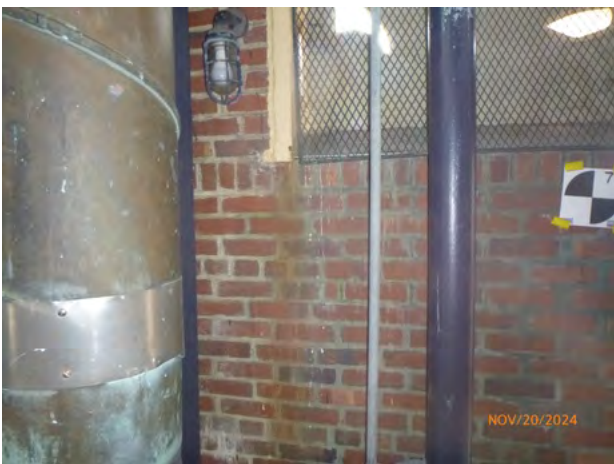
759-141 Brick\_SoilStain Rust 2024-1.jpg

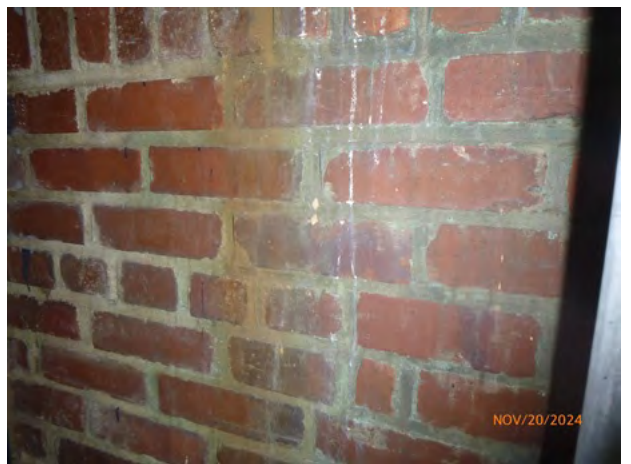
759-141 Brick\_SoilStain Rust 2024-2.jpg

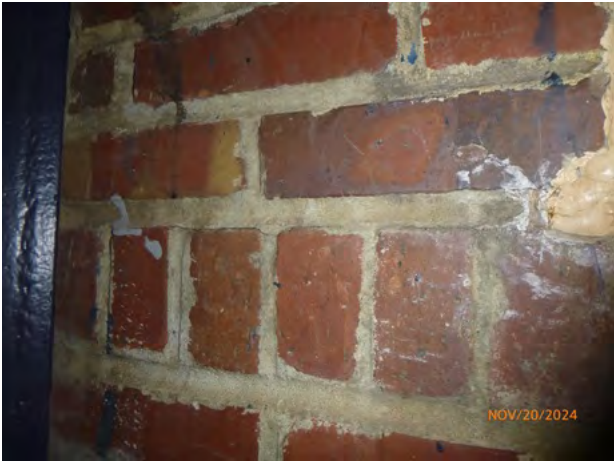
759-143 Brick\_Joints Mortar Failed 2024-1.jpg

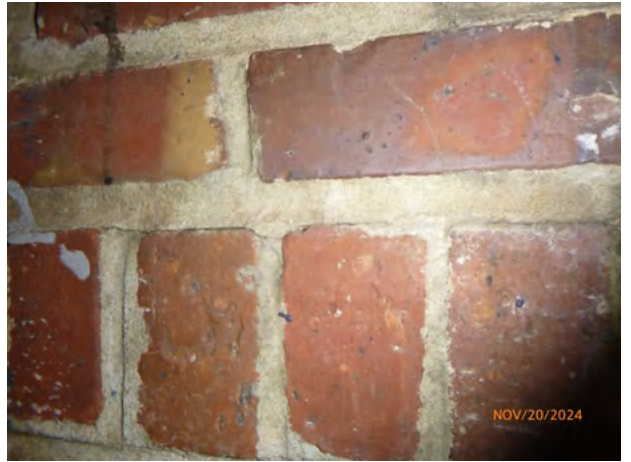
759-143 Brick\_Joints Mortar Failed 2024-2.jpg

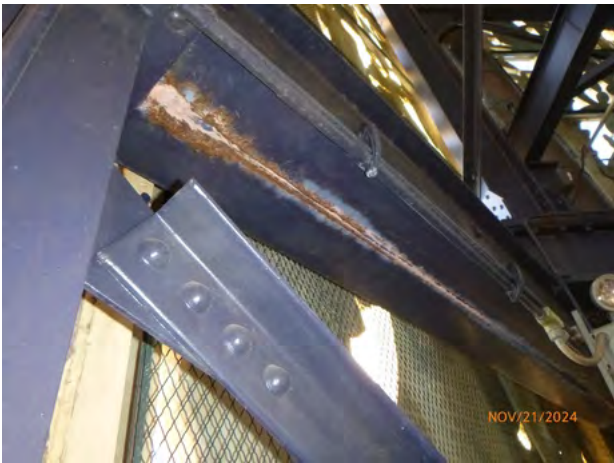
760-145 ArchMetal\_Coating Coating Failed 2024-1.jpg

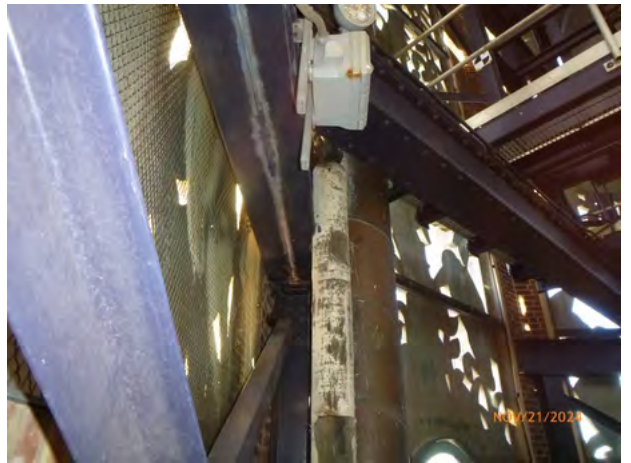
760-145 ArchMetal\_Coating Coating Failed 2024-2.jpg

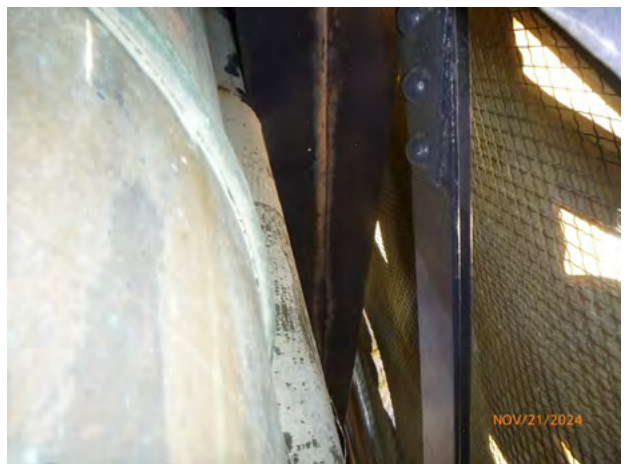
760-145 ArchMetal\_Coating Coating Failed 2024-4.jpg

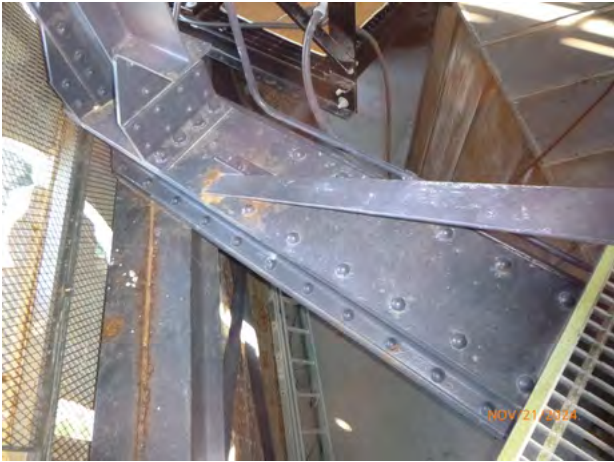
763-147 ArchMetal\_Coating Coating Failed 2024-1.jpg

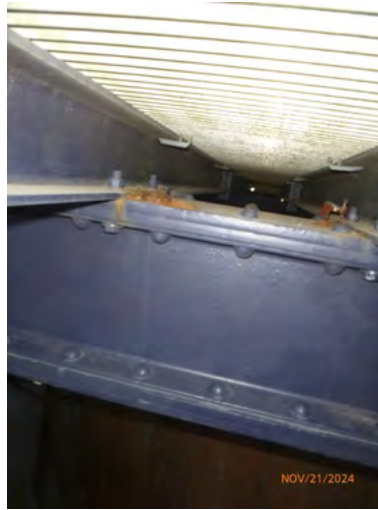
763-147 ArchMetal\_Coating Coating Failed 2024-2.jpg

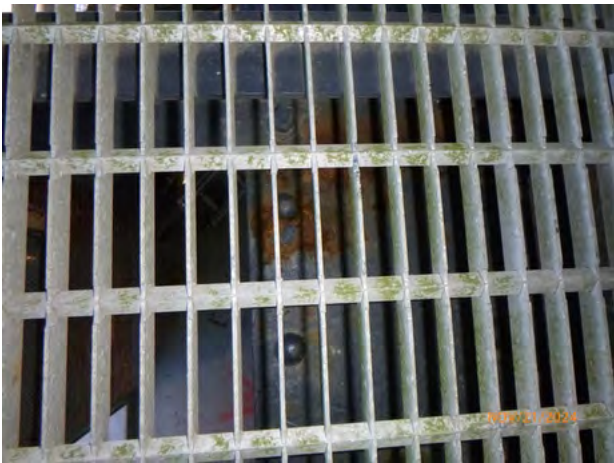
763-147 ArchMetal\_Coating Coating Failed 2024-3.jpg

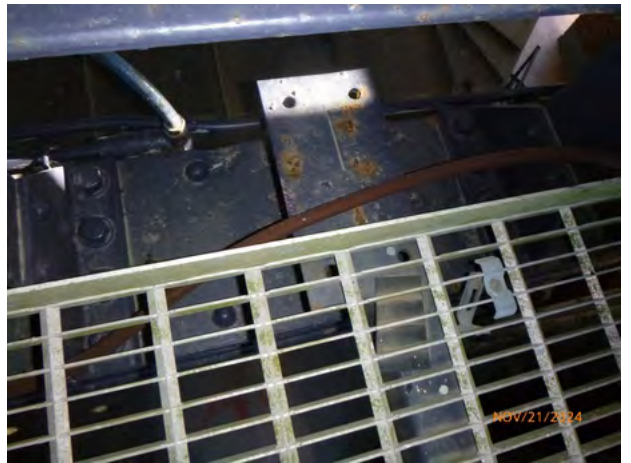
763-147 ArchMetal\_Coating Coating Failed 2024-4.jpg

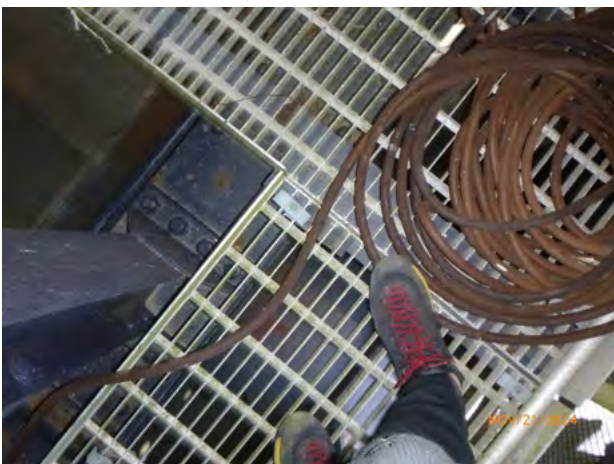
763-147 ArchMetal\_Coating Coating Failed 2024-5.jpg

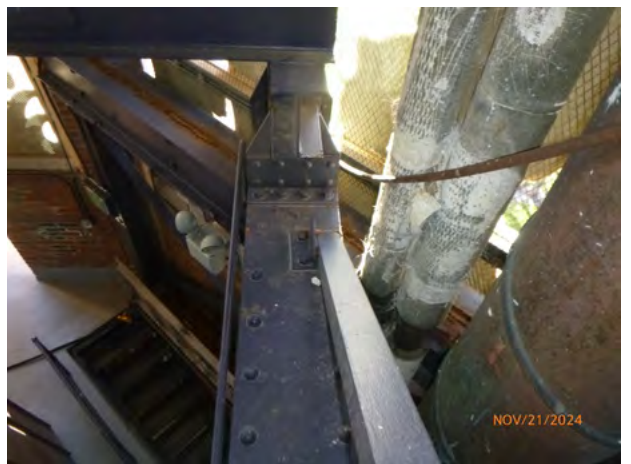
763-147 ArchMetal\_Coating Coating Failed 2024-6.jpg

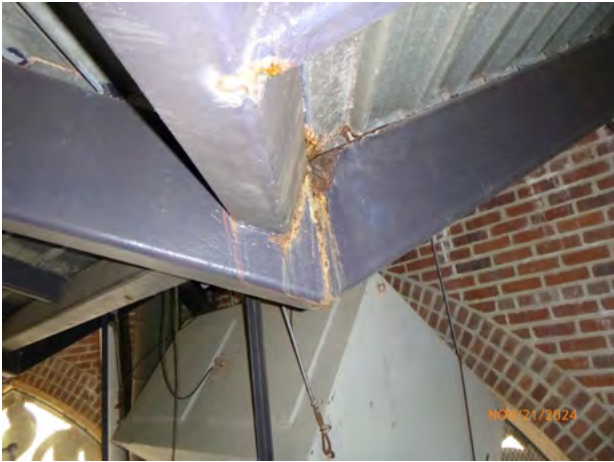
763-180 ArchMetal\_Corrosion Surface 2024-1.jpg

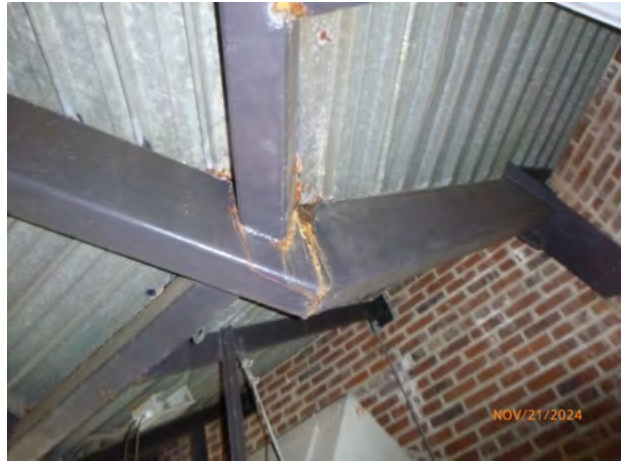
763-180 ArchMetal\_Corrosion Surface 2024-2.jpg

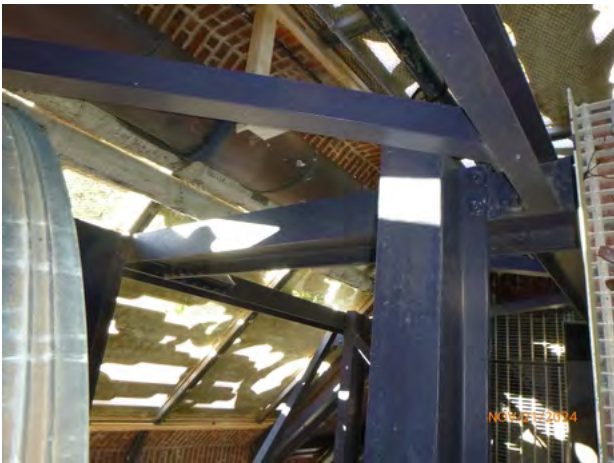
764-157 ArchMetal\_Coating Coating Failed 2024-1.jpg

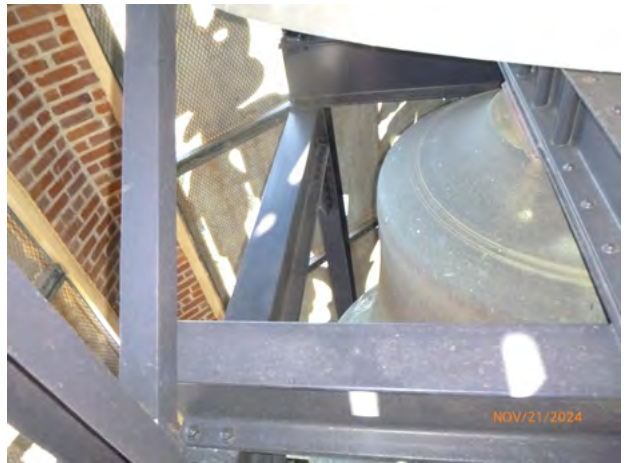
764-157 ArchMetal\_Coating Coating Failed 2024-2.jpg

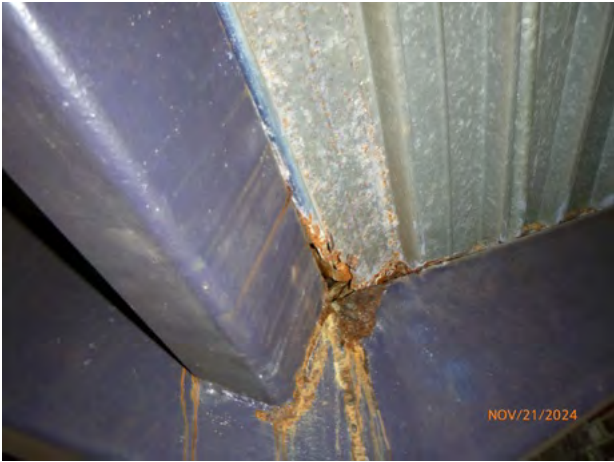
765-182 SheetMetal\_Corrosion Perforated 2024-1.jpg

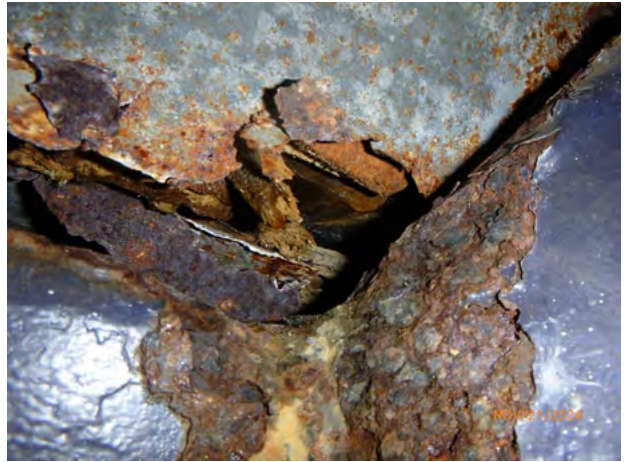
765-182 SheetMetal\_Corrosion Perforated 2024-2.jpg

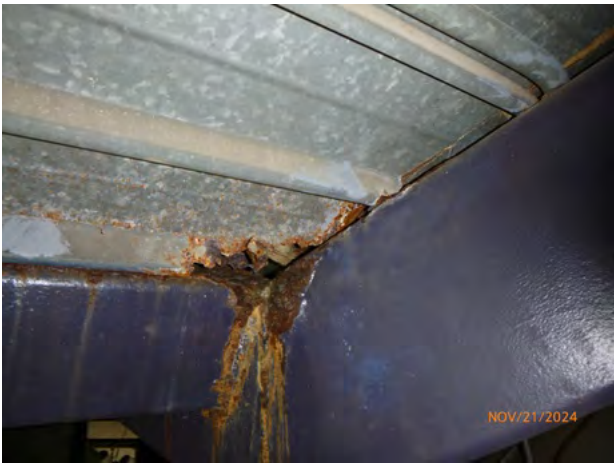
765-182 SheetMetal\_Corrosion Perforated 2024-3.jpg

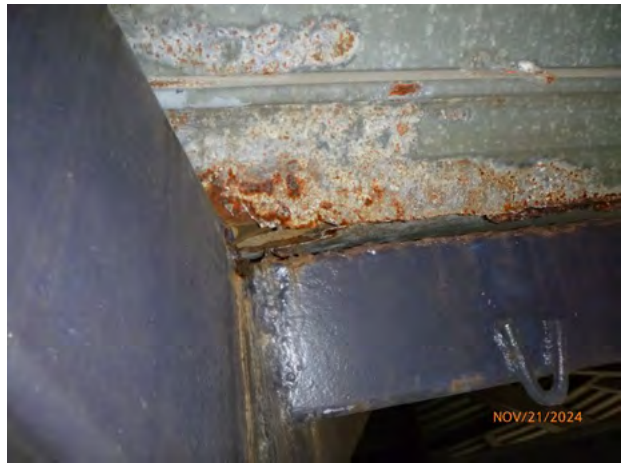
765-182 SheetMetal\_Corrosion Perforated 2024-4.jpg

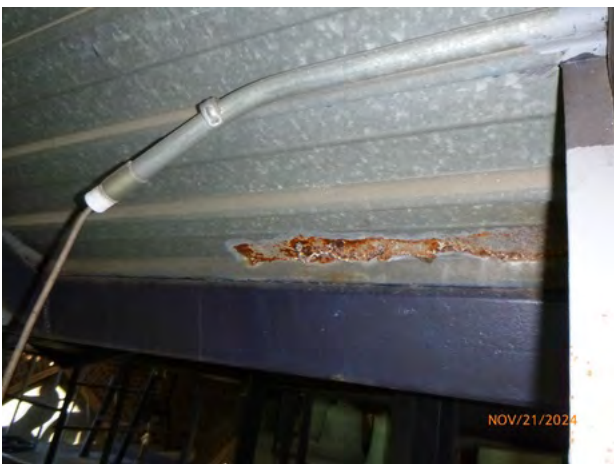
765-182 SheetMetal\_Corrosion Perforated 2024-5.jpg

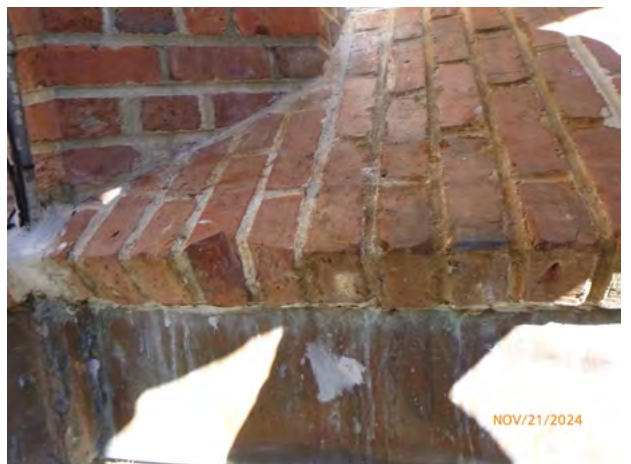
836-184 Brick\_Spall Missing 2024-1.jpg

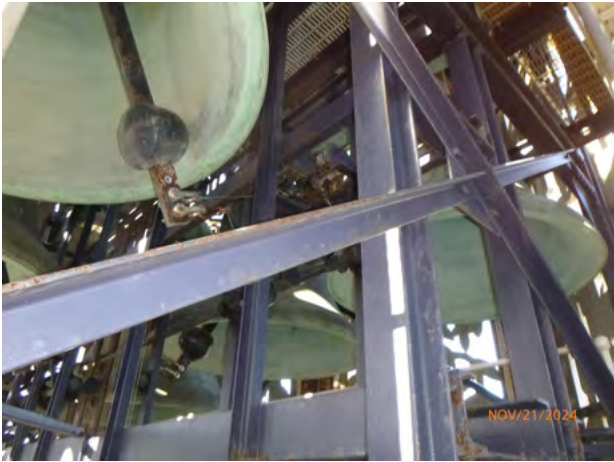
841-150 ArchMetal\_Coating Coating Failed 2024-1.jpg

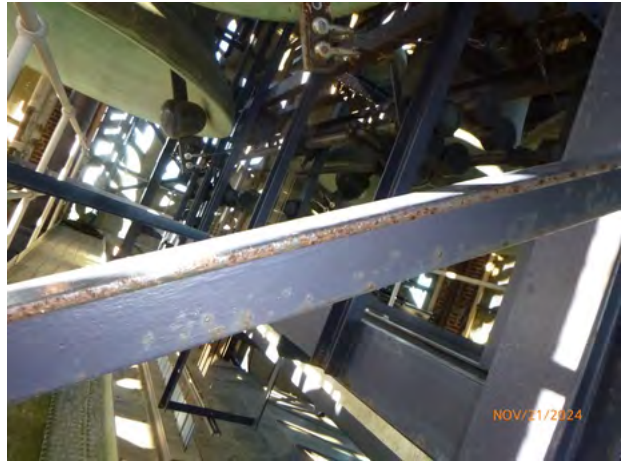
841-150 ArchMetal\_Coating Coating Failed 2024-2.jpg

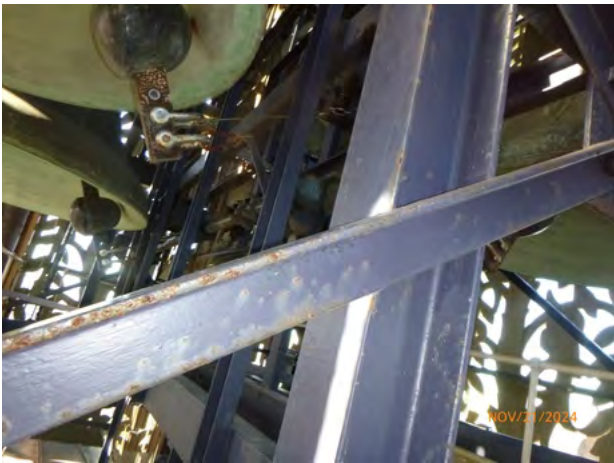
841-150 ArchMetal\_Coating Coating Failed 2024-3.jpg

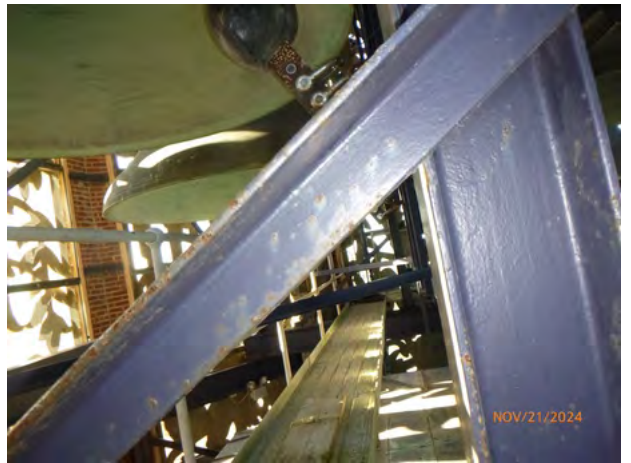
841-150 ArchMetal\_Coating Coating Failed 2024-4.jpg

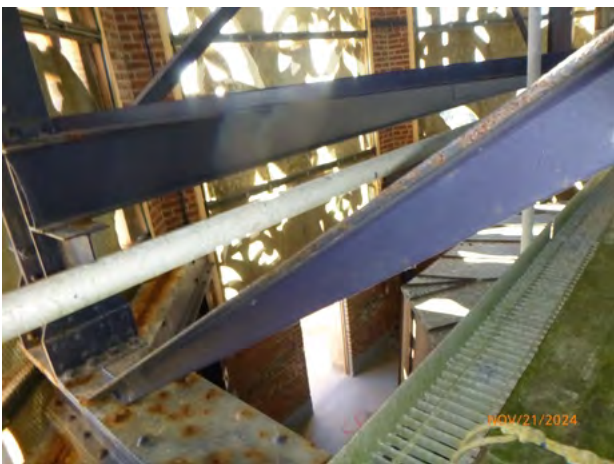
841-150 ArchMetal\_Coating Coating Failed 2024-5.jpg

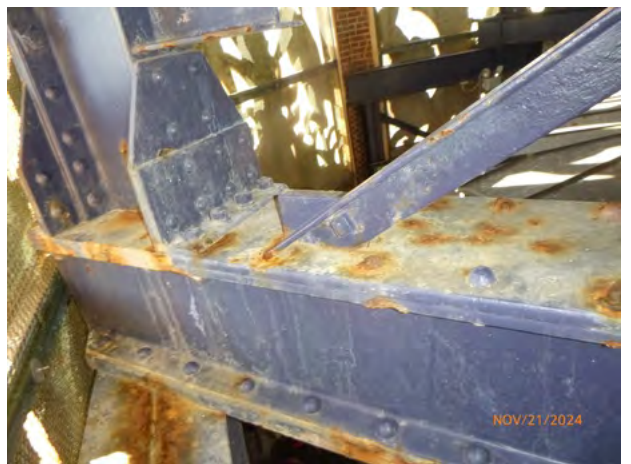
844-147 ArchMetal\_Corrosion Fastener rusted 2024-1.jpg

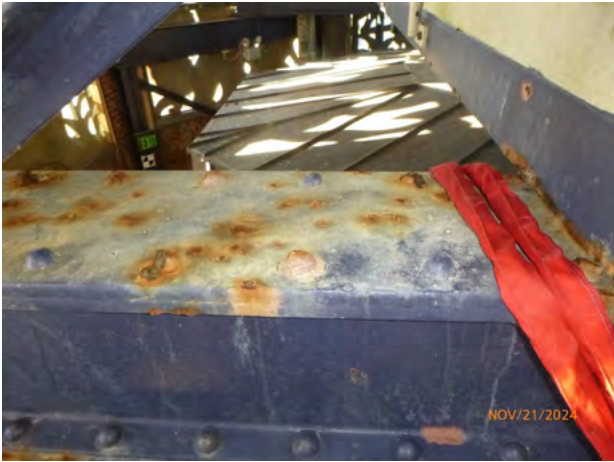
844-147 ArchMetal\_Corrosion Fastener rusted 2024-2.jpg

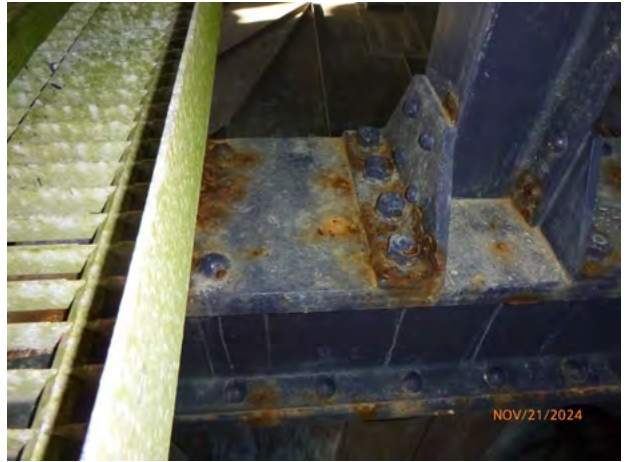
844-147 ArchMetal\_Corrosion Fastener rusted 2024-3.jpg

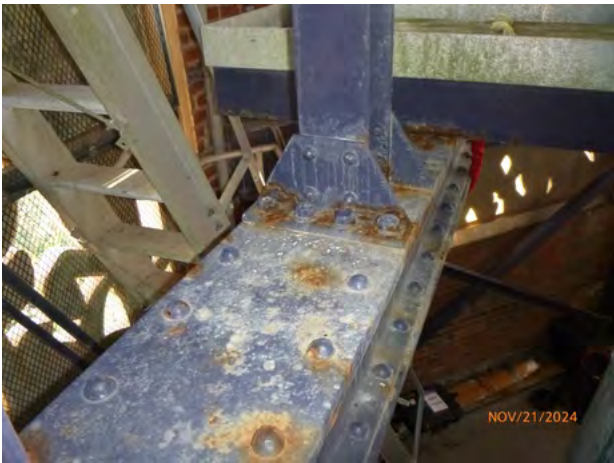
844-147 ArchMetal\_Corrosion Fastener rusted 2024-4.jpg

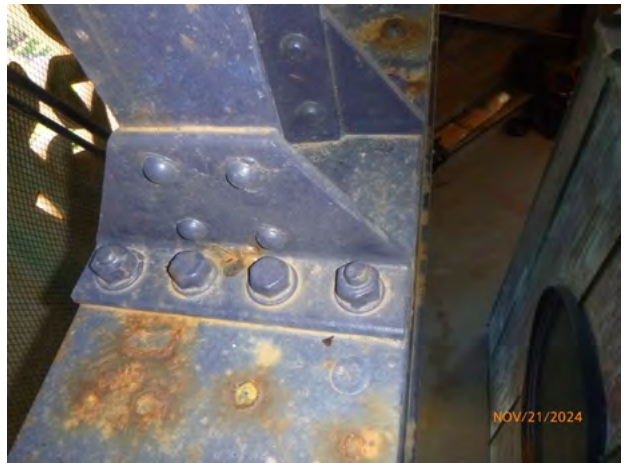
844-147 ArchMetal\_Corrosion Fastener rusted 2024-5.jpg

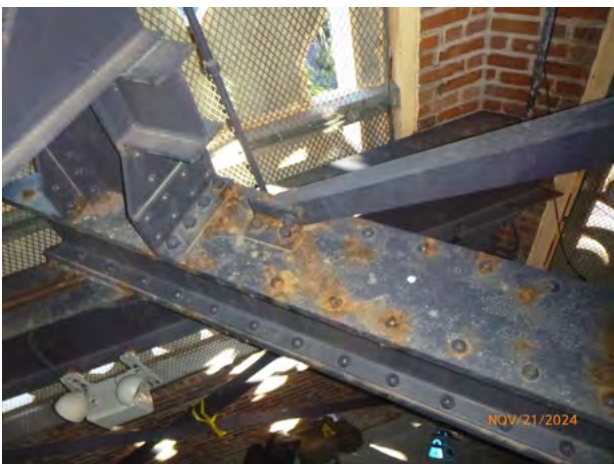
844-147 ArchMetal\_Corrosion Fastener rusted 2024-6.jpg

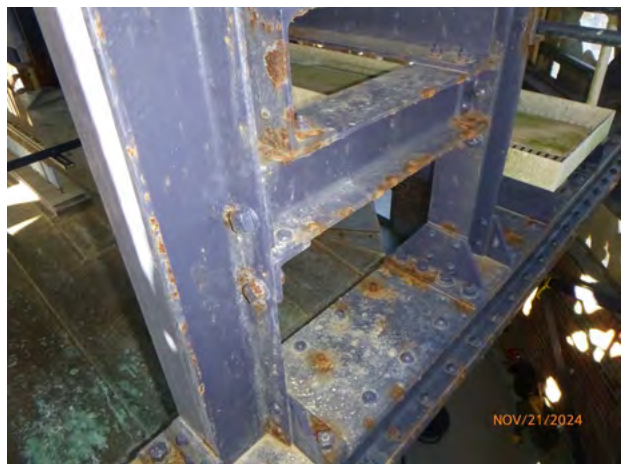
844-147 ArchMetal\_Corrosion Fastener rusted 2024-7.jpg

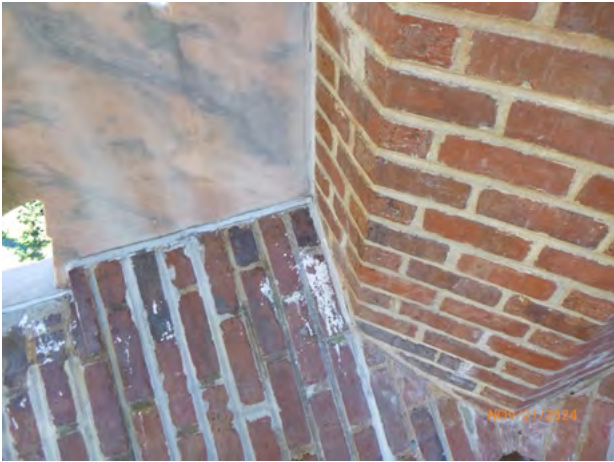
844-184 Brick\_Joints Sealant Failed 2024-1.jpg

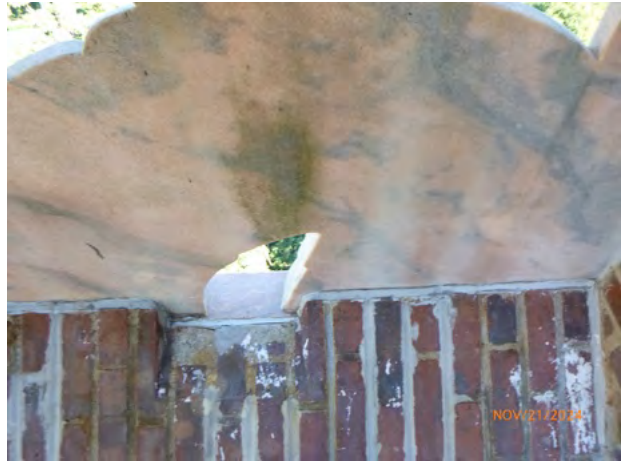
844-184 Brick\_Joints Sealant Failed 2024-2.jpg

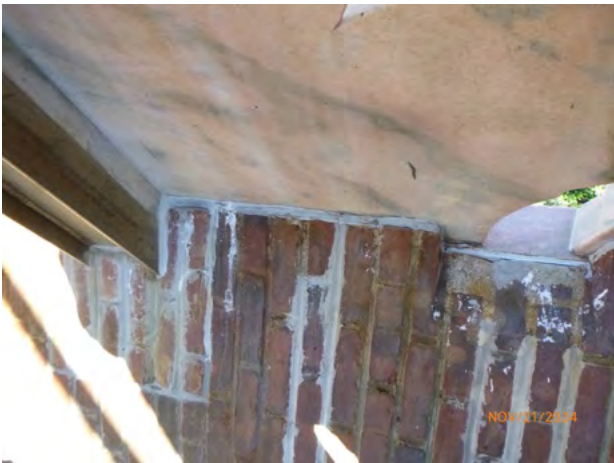
844-184 Brick\_Joints Sealant Failed 2024-3.jpg

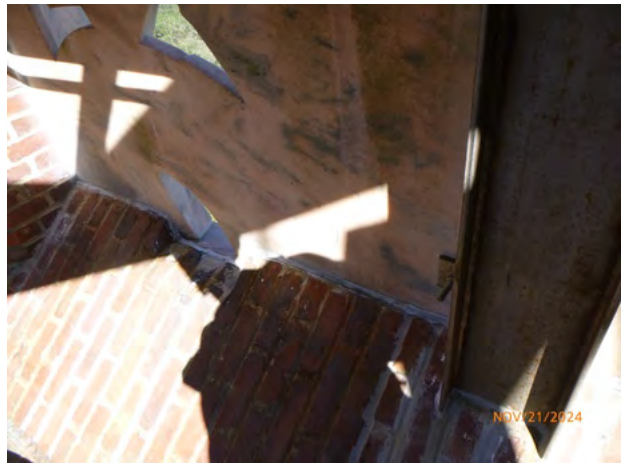
844-184 Brick\_Joints Sealant Failed 2024-4.jpg

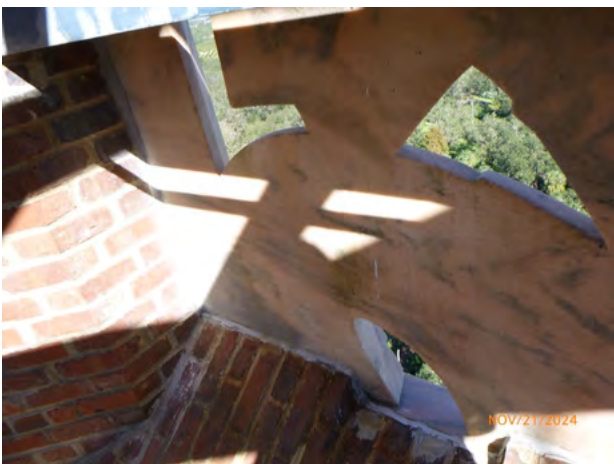
844-184 Brick\_Joints Sealant Failed 2024-5.jpg

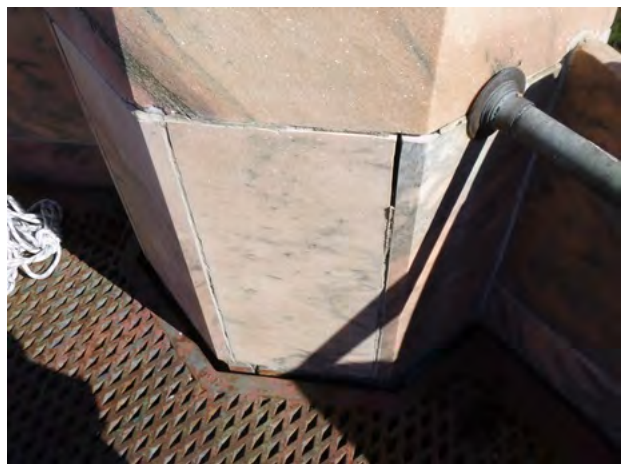
844-193 Stone\_Joints Mortar Failed 2024-1.jpg

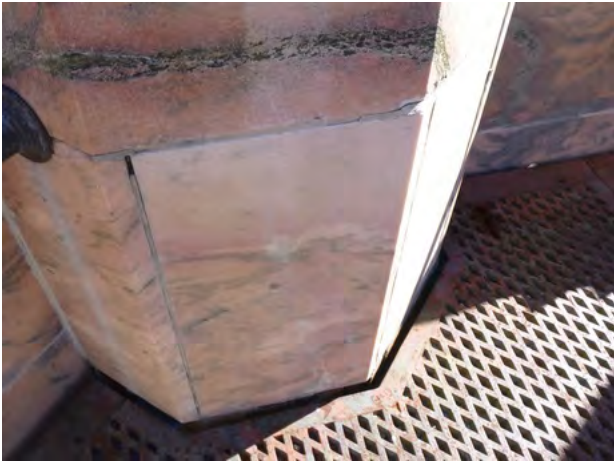
844-193 Stone\_Joints Mortar Failed 2024-2.jpg

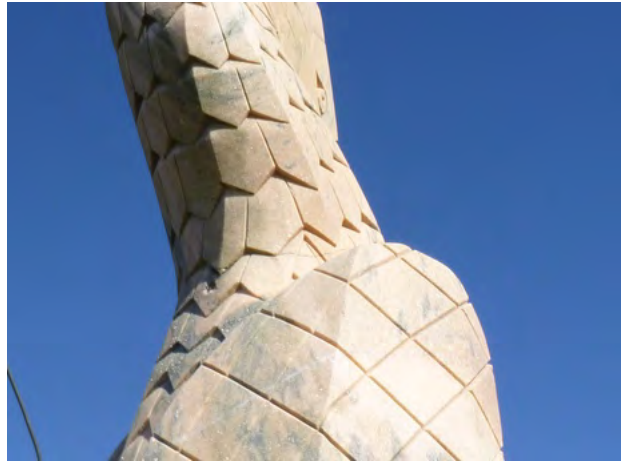
844-205 Stone\_Crack Single unit 2024-1.jpg

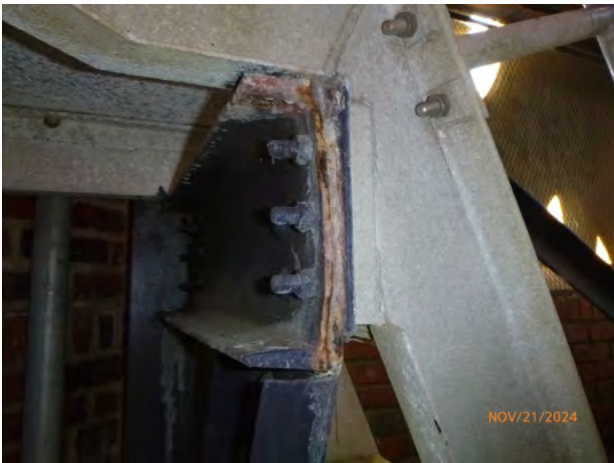
846-142 ArchMetal\_Coating Coating Failed 2024-1.jpg

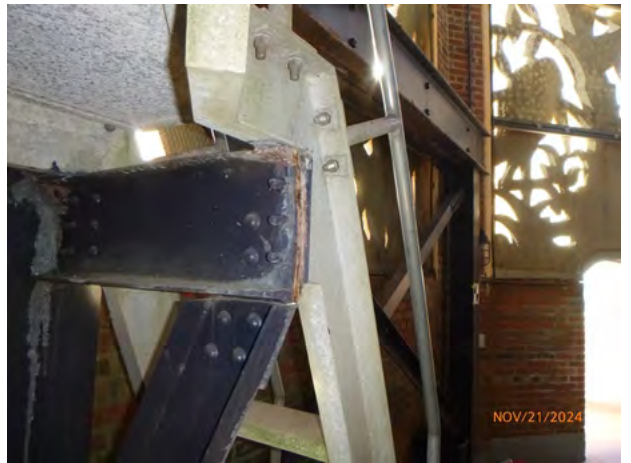
846-142 ArchMetal\_Coating Coating Failed 2024-2.jpg

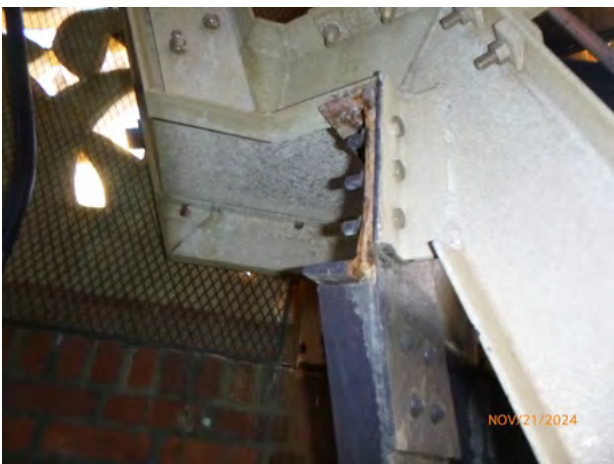
846-142 ArchMetal\_Coating Coating Failed 2024-3.jpg

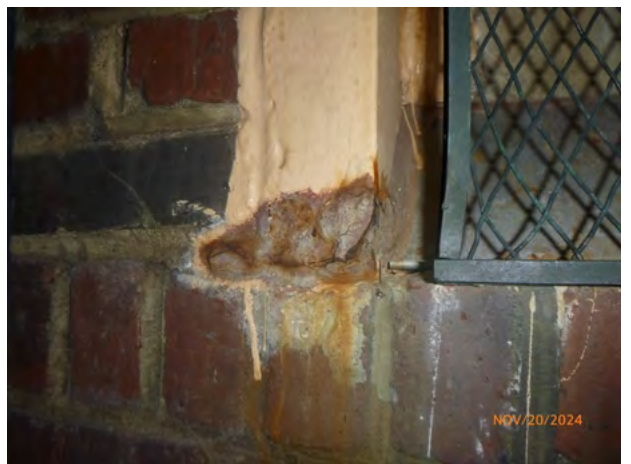
847-143 ArchMetal\_Corrosion Pitted 2024-1.jpg
