### ***Bok Singing Tower Roof Restoration and Replacement***

# Bok Singing Tower Conditions Assessment

T.Y. Lin (formerly Silman) was contracted to perform a conditions assessment of the Bok Singing Tower at Bok Tower Gardens in Lake Wales, Florida. The Singing Tower stands 205 feet tall at the southwest corner of the gardens. A moat surrounds the base of the tower with two bridges to access the island. The tower houses a 60-bell carillon, associated carillonneur studio and library spaces, the Bok Tower Gardens Chao Research archive, and the Founder's Room. It is a steel frame construction clad in a masonry exterior of coquina and Georgia pink Etowah marble with brick masonry at the interior.

## **Bok Tower Focused Condition Assessment**

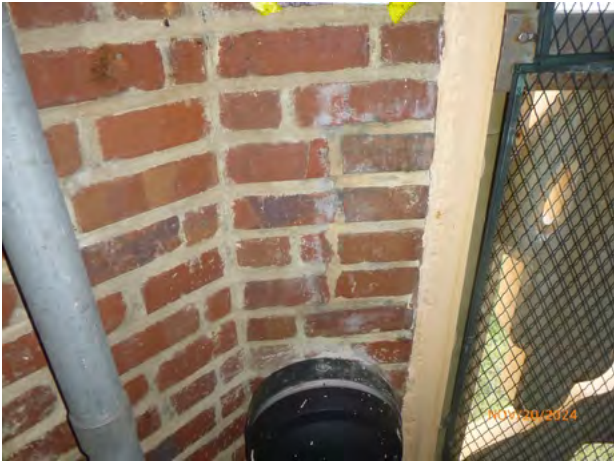
847-152 Brick\_Crack System units and joints 2024-1.jpg

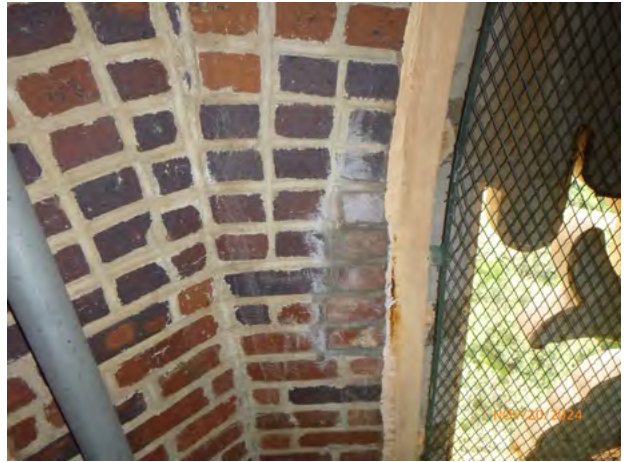
847-172 Brick\_Repair Patch Sound 2024-1.jpg

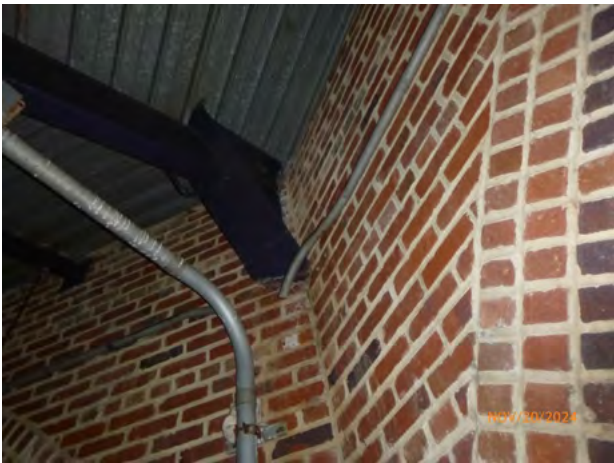
847-178 Brick\_SoilStain Leached Salts 2024-1.jpg

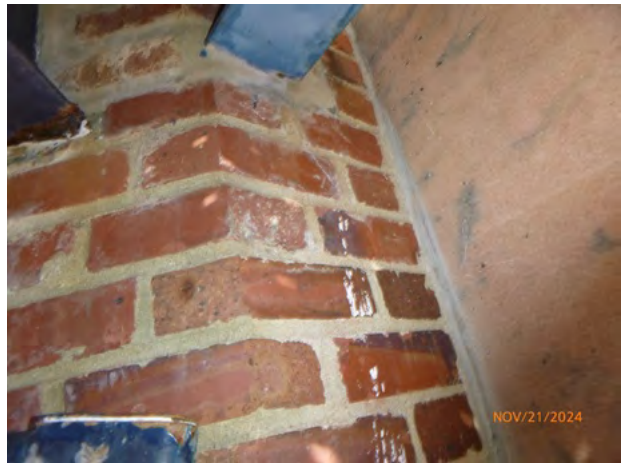
847-190 Brick\_SurfLoss Face spalled 2024-1.jpg

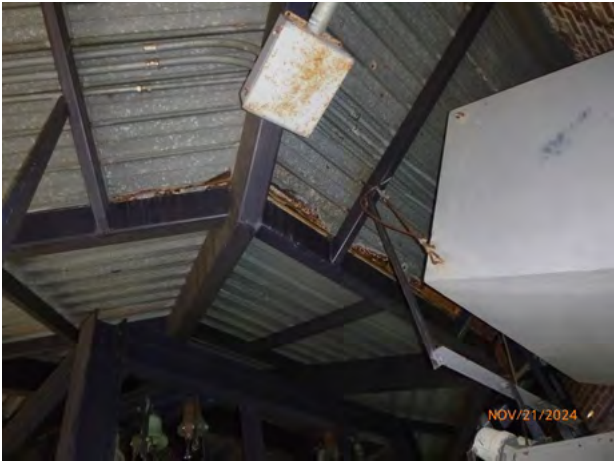
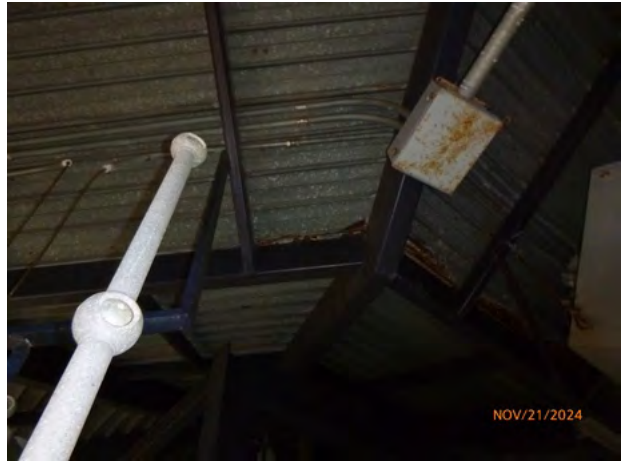
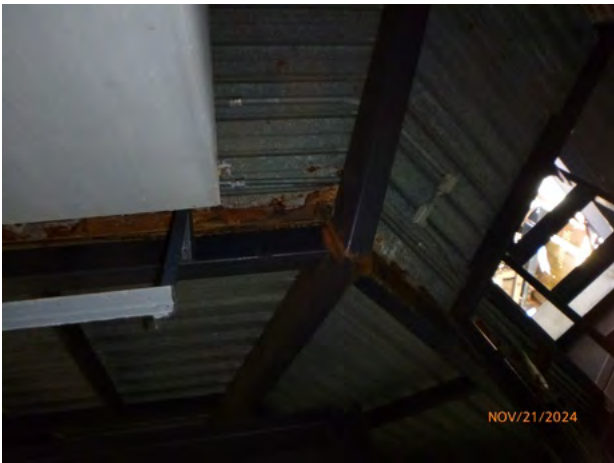
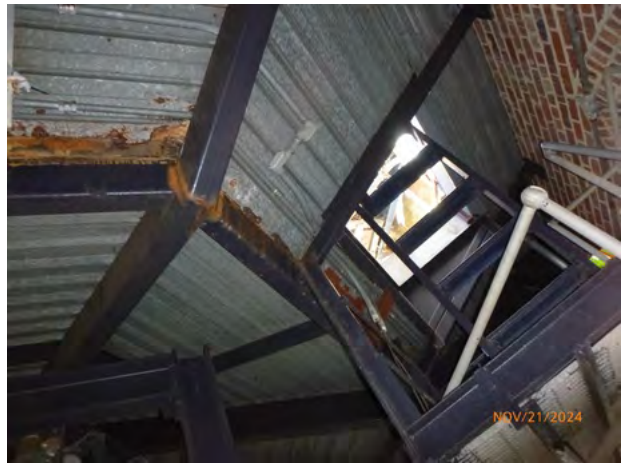
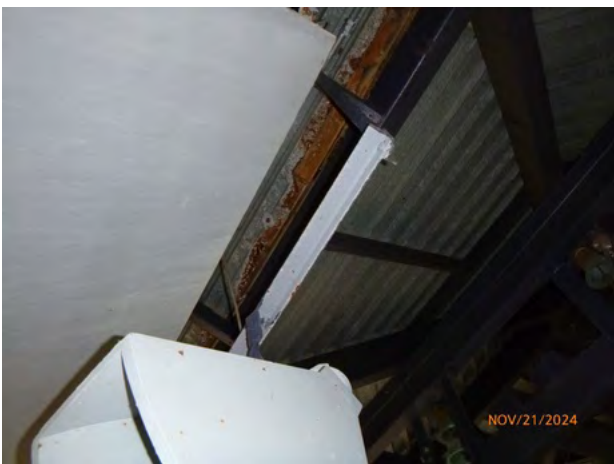
848-180 ArchMetal\_Corrosion Perforated 2024-1.jpg

848-180 ArchMetal\_Corrosion Perforated 2024-2.jpg

848-180 ArchMetal\_Corrosion Perforated 2024-3.jpg

848-180 ArchMetal\_Corrosion Perforated 2024-4.jpg

848-180 ArchMetal\_Corrosion Perforated 2024-5.jpg

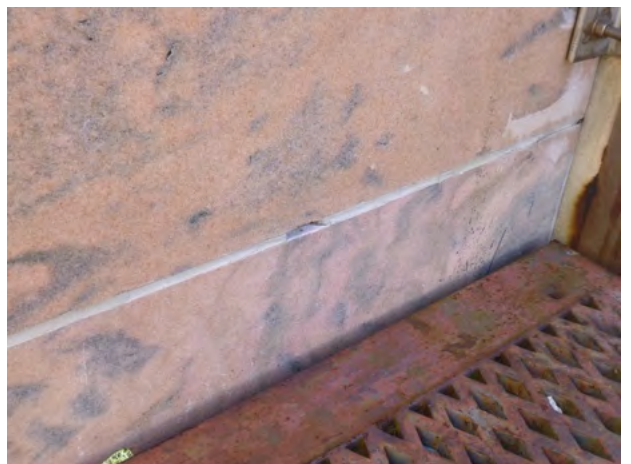
848-194 Stone\_Joints Mortar Failed 2024-1.jpg

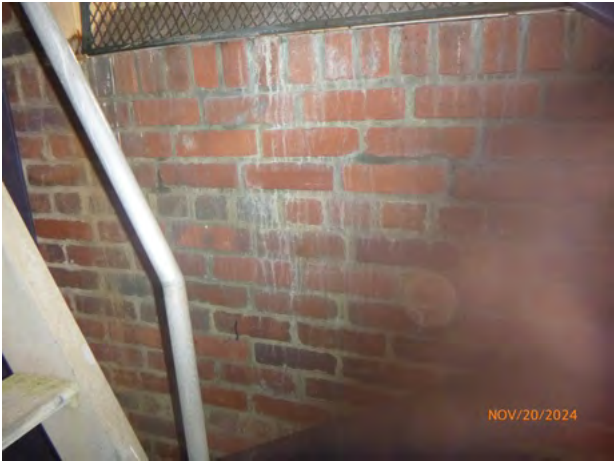
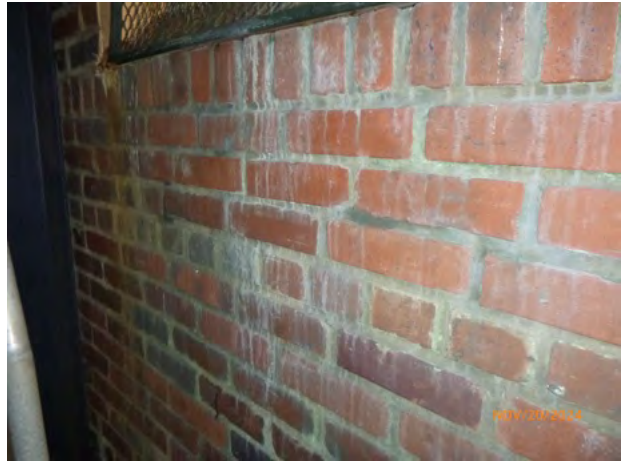
849-142 Brick\_SoilStain Leached Salts 2024-1.jpg

849-142 Brick\_SoilStain Leached Salts 2024-2.jpg

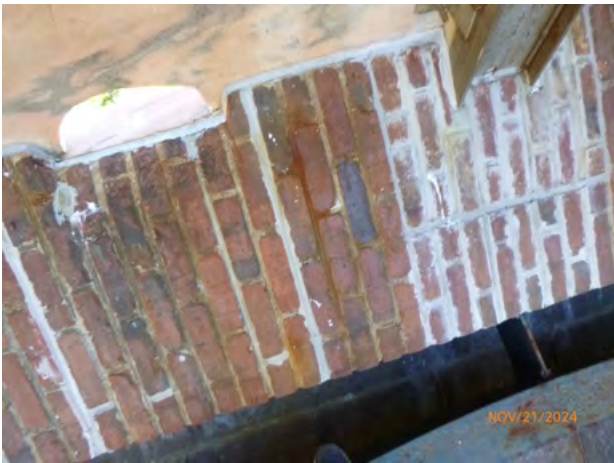
851-184 Brick\_SoilStain Rust 2024-1.jpg

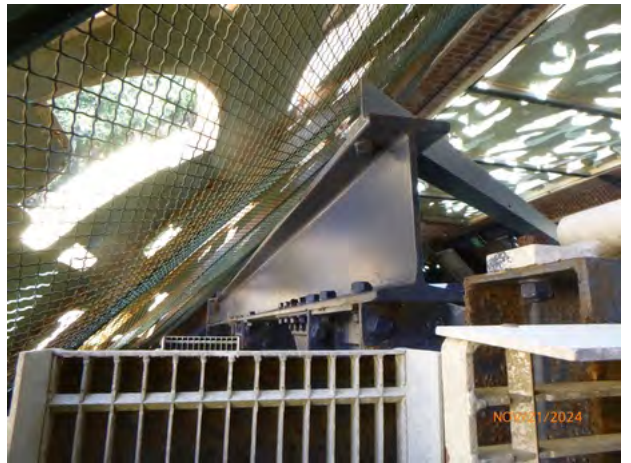
852-160 ArchMetal\_Coating Coating Failed 2024-1.jpg

852-160 ArchMetal\_Coating Coating Failed 2024-2.jpg

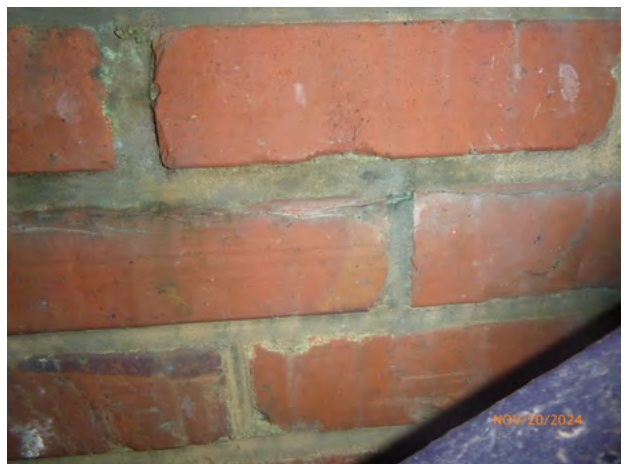
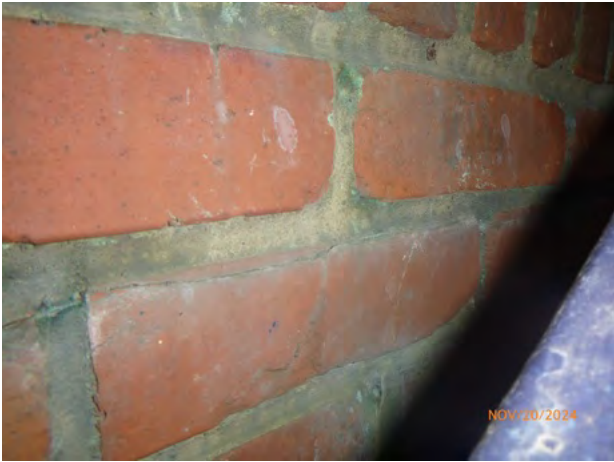
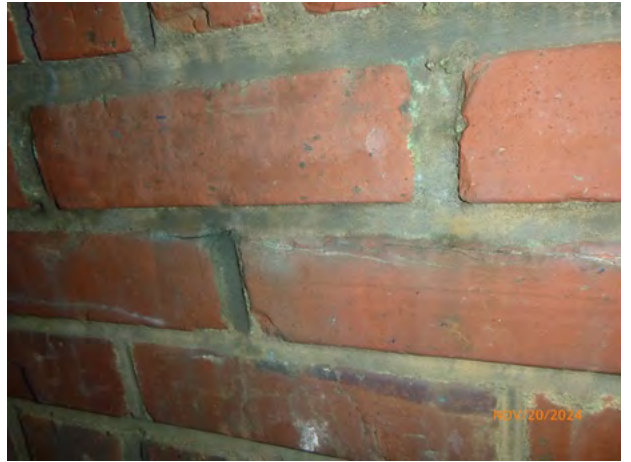
854-143 Brick\_Crack System units and joints 2024-1.jpg

854-143 Brick\_Crack System units and joints 2024-2.jpg

854-143 Brick\_Crack System units and joints 2024-3.jpg

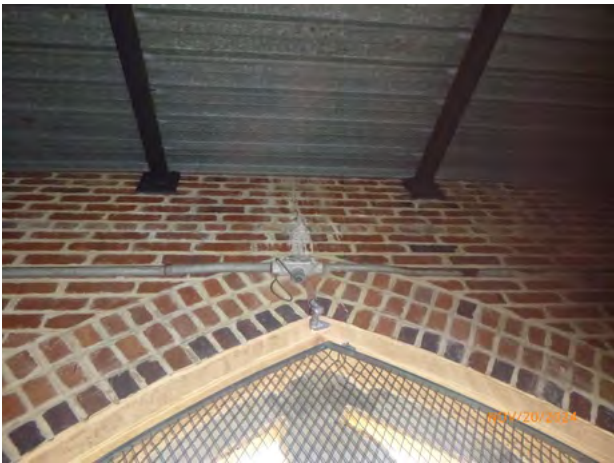
854-180 Brick\_SoilStain Leached Salts 2024-1.jpg

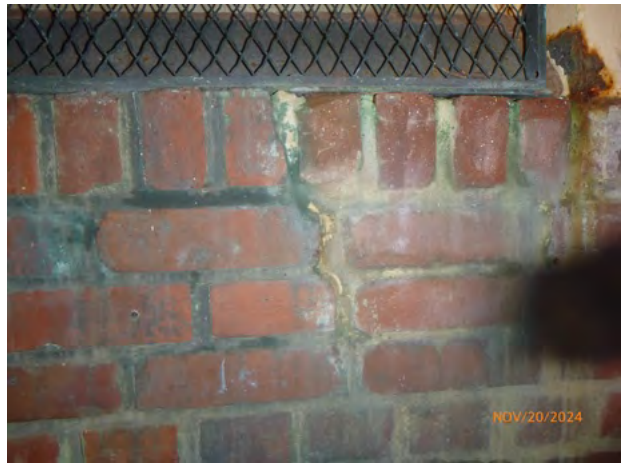
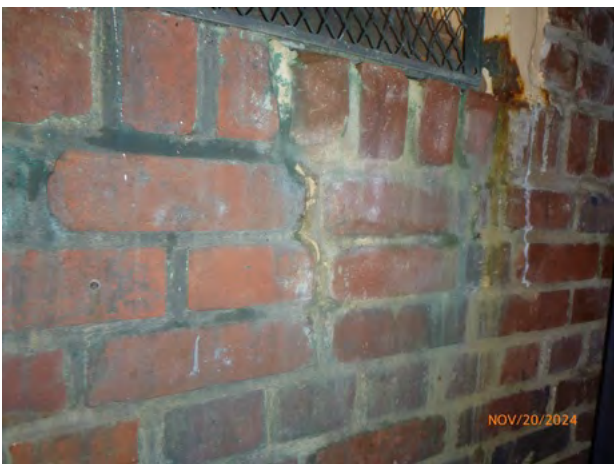
856-143 Brick\_Repair Patch Failed 2024-1.jpg

856-143 Brick\_Repair Patch Failed 2024-2.jpg

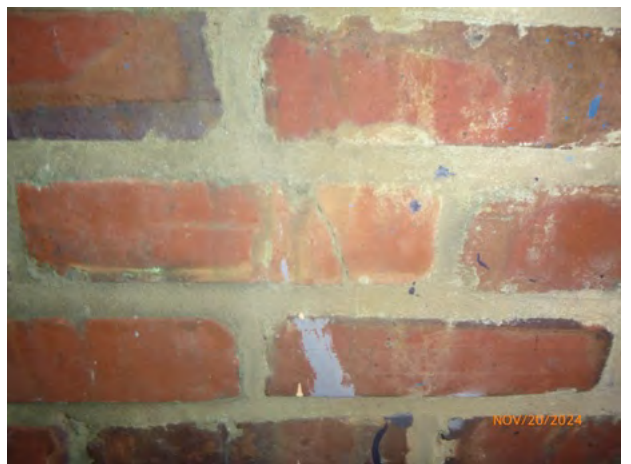
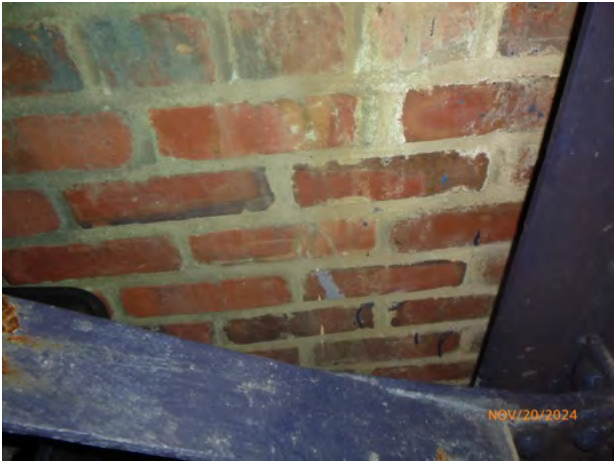
857-139 Brick\_Crack Single unit 2024-1.jpg

857-139 Brick\_Crack Single unit 2024-2.jpg

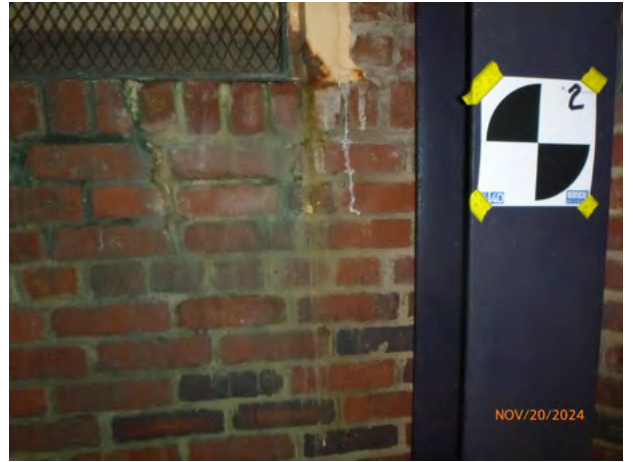
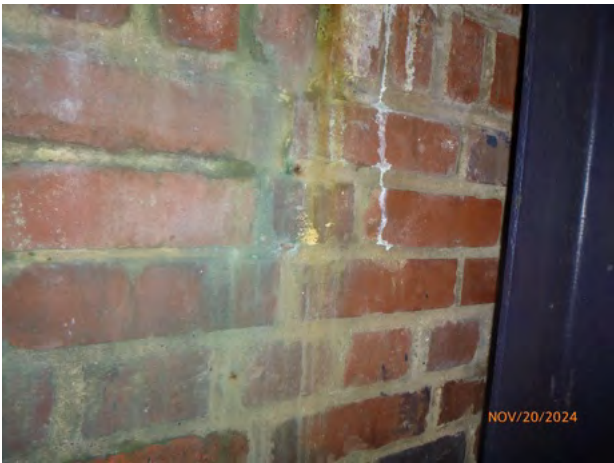
857-140 Brick\_SoilStain Rust 2024-1.jpg

857-140 Brick\_SoilStain Rust 2024-2.jpg

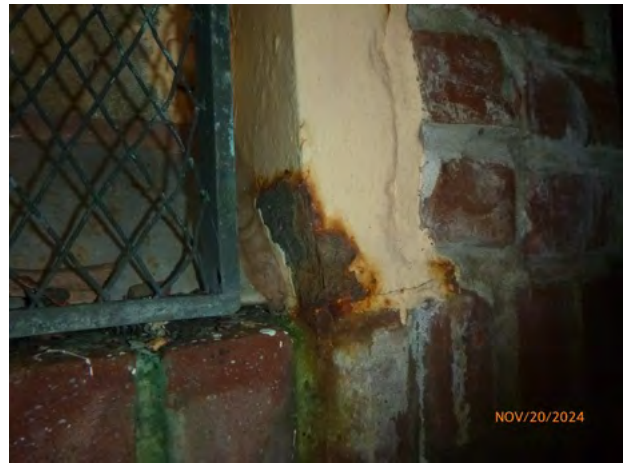
857-143 ArchMetal\_Corrosion Pitted 2024-1.jpg

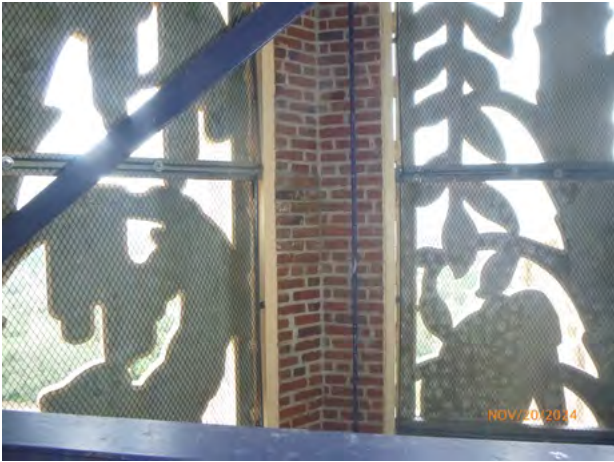
858-151 Brick\_Repair Patch Failed 2024-1.jpg

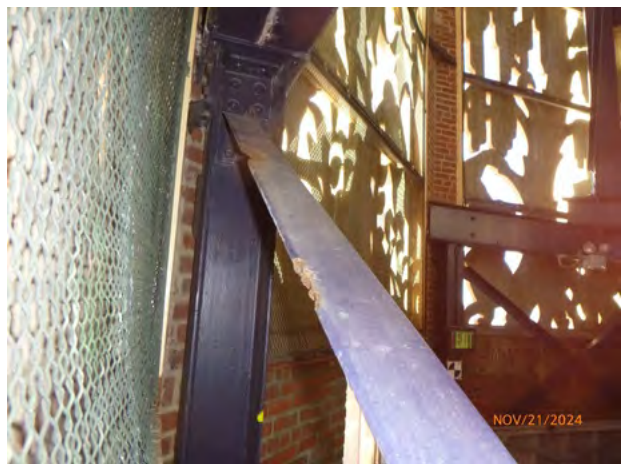
859-145 ArchMetal\_Damaged Dented 2024-1.jpg

859-145 ArchMetal\_Damaged Dented 2024-2.jpg

859-145 ArchMetal\_Damaged Dented 2024-3.jpg

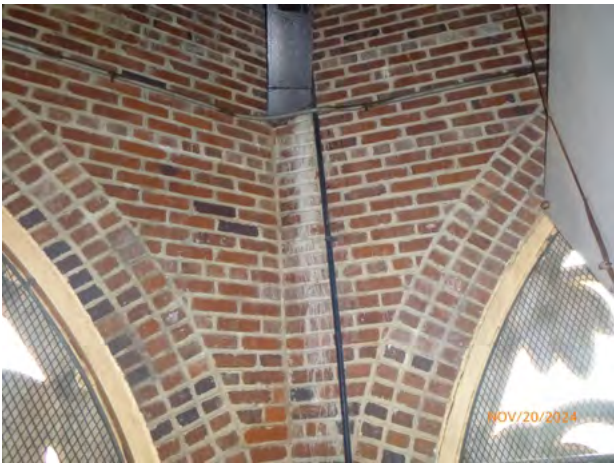
860-177 Brick\_SoilStain Leached Salts 2024-1.jpg

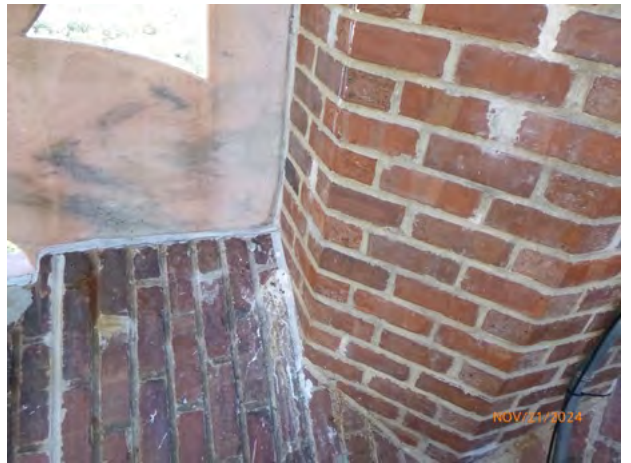
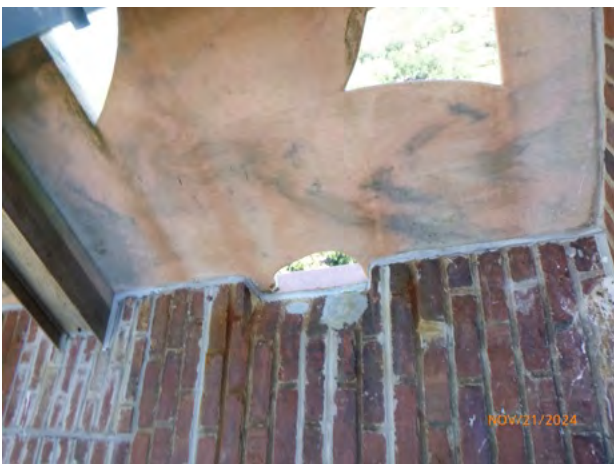
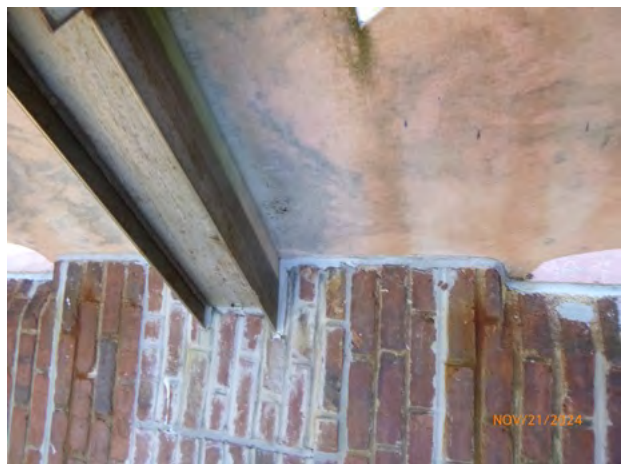
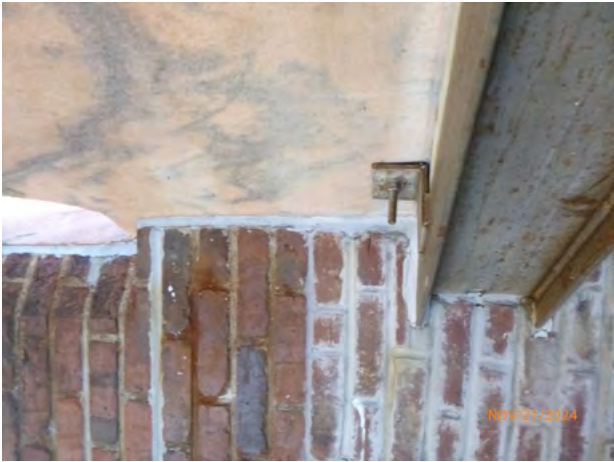
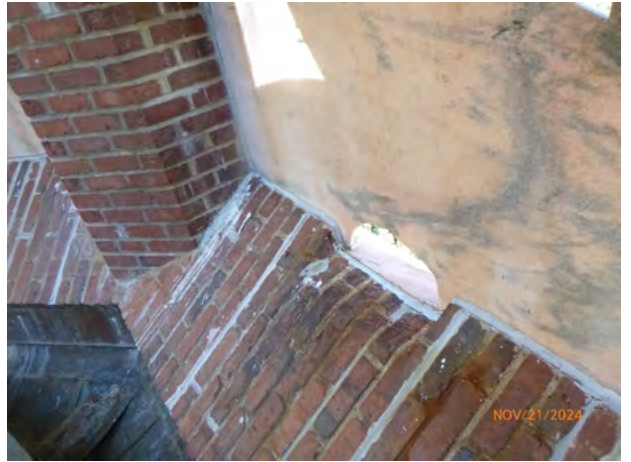
860-184 Brick\_Joints Sealant Failed 2024-1.jpg

860-184 Brick\_Joints Sealant Failed 2024-2.jpg

860-184 Brick\_Joints Sealant Failed 2024-3.jpg

860-184 Brick\_Joints Sealant Failed 2024-4.jpg

860-184 Brick\_Joints Sealant Failed 2024-5.jpg

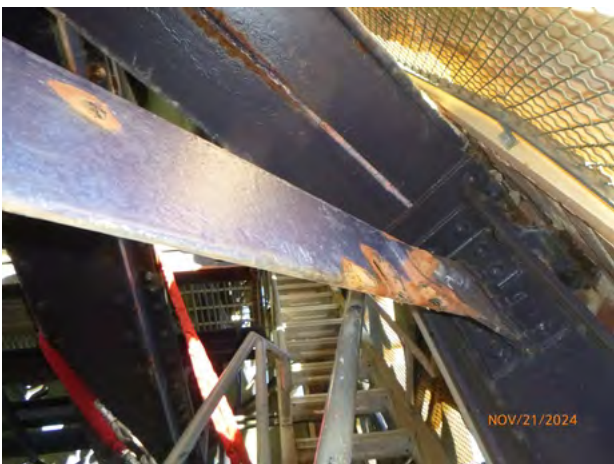
861-137 ArchMetal\_Coating Coating Failed 2024-2.jpg

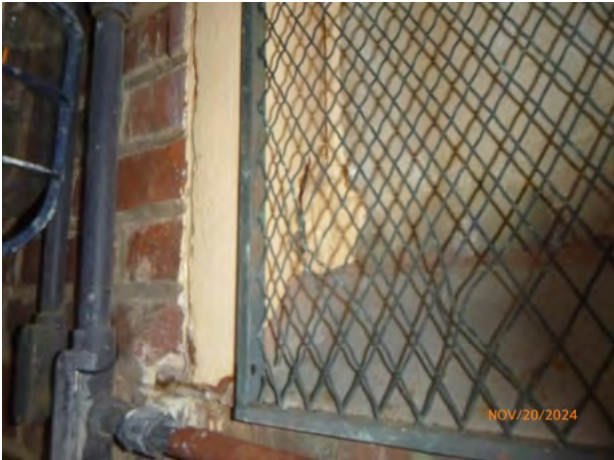
861-143 ArchMetal\_Corrosion Pitted 2024-1.jpg

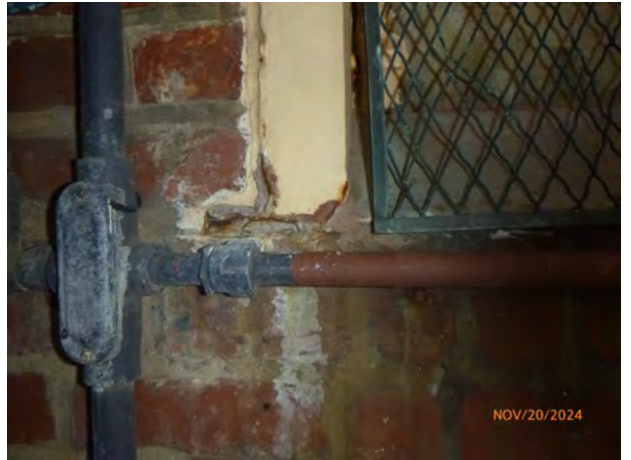
861-143 ArchMetal\_Corrosion Pitted 2024-2.jpg

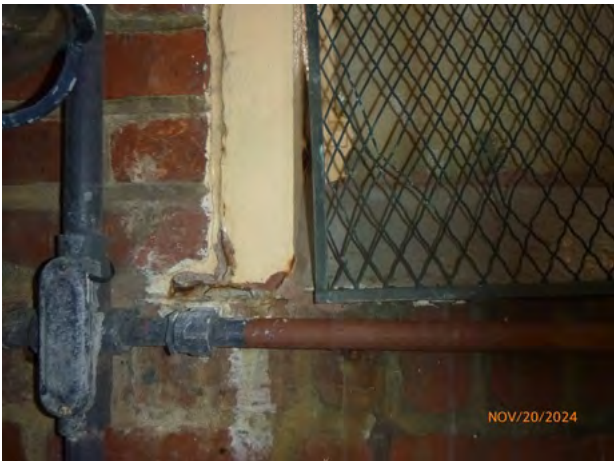
861-143 ArchMetal\_Corrosion Pitted 2024-3.jpg

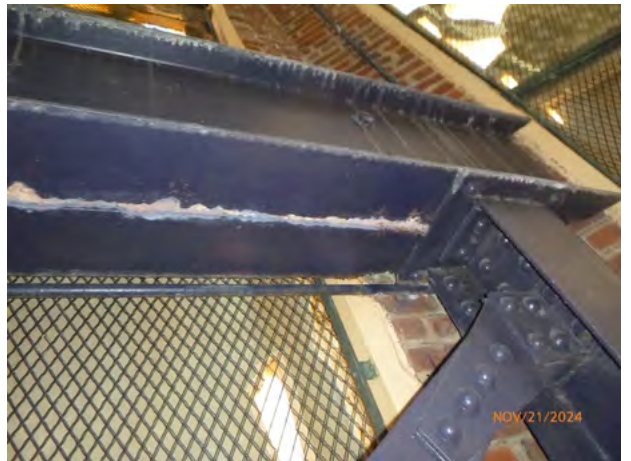
861-145 ArchMetal\_Coating Coating Failed 2024-1.jpg

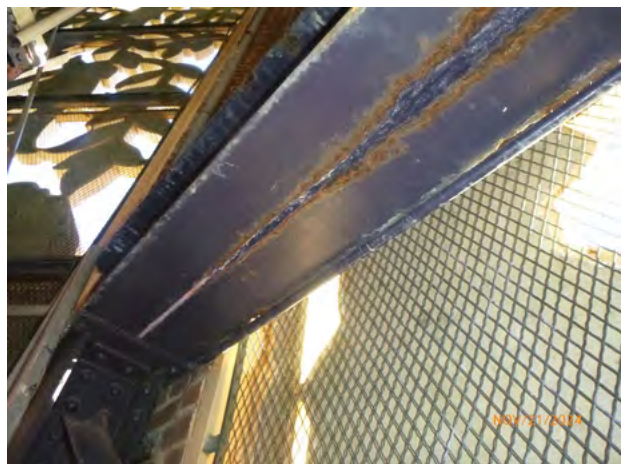
861-145 ArchMetal\_Coating Coating Failed 2024-3.jpg

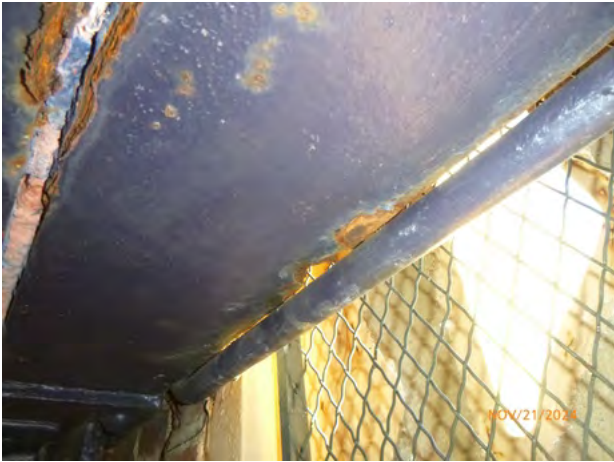
861-145 ArchMetal\_Coating Coating Failed 2024-4.jpg

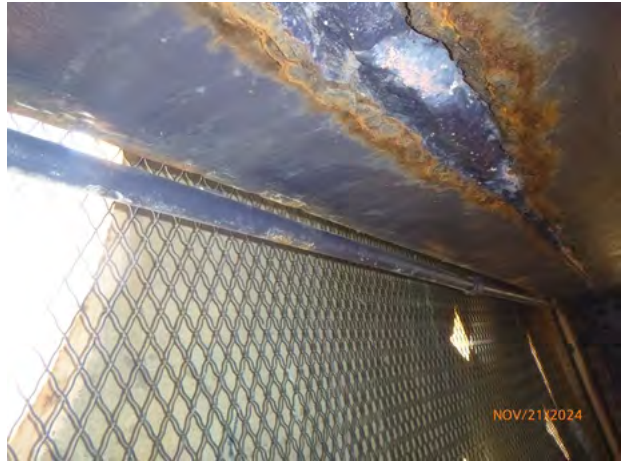
861-145 ArchMetal\_Coating Coating Failed 2024-5.jpg

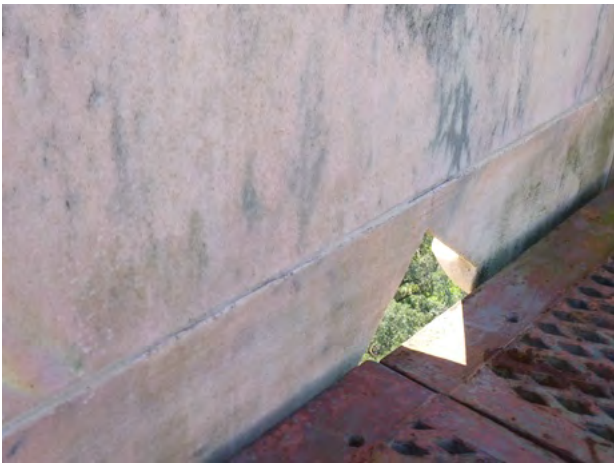
862-194 Stone\_Crack System joints 2024-1.jpg

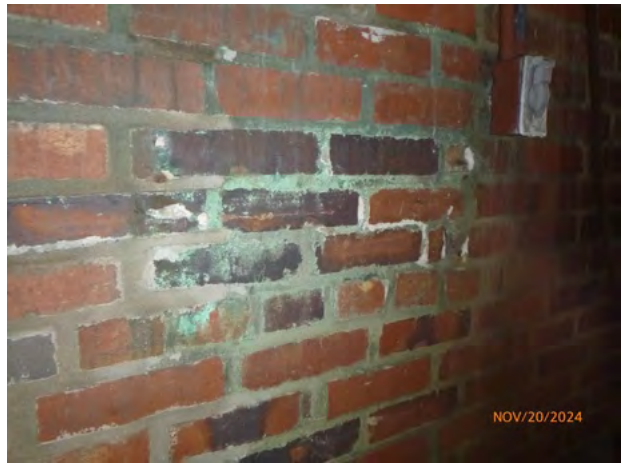
866-141 Brick\_Joints Sealant Failed 2024-1.jpg

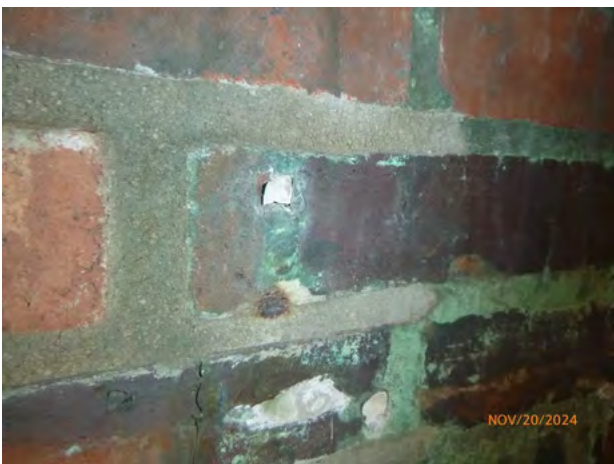
866-141 Brick\_Joints Sealant Failed 2024-2.jpg

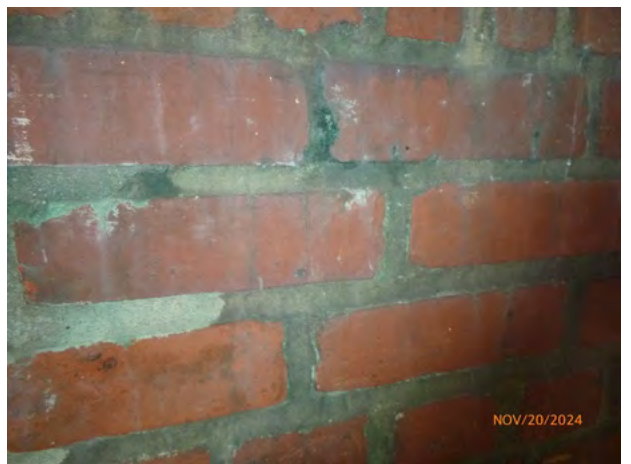
866-143 Brick\_Crack Single unit 2024-1.jpg

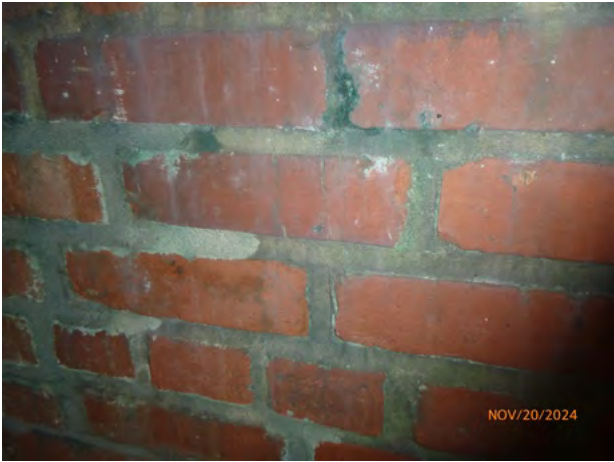
866-143 Brick\_Crack Single unit 2024-2.jpg

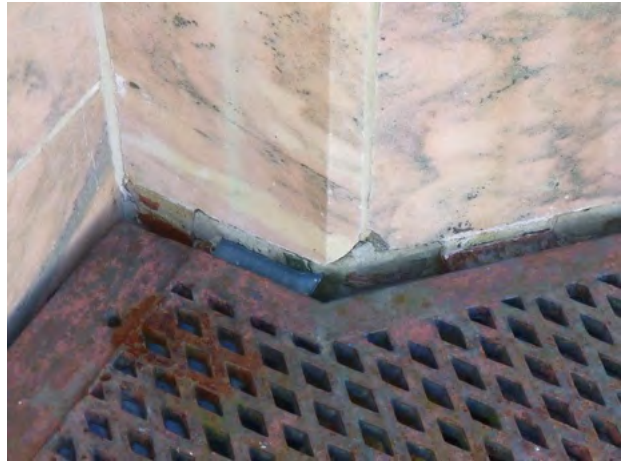
866-193 Stone\_Joints Mortar Failed 2024-1.jpg

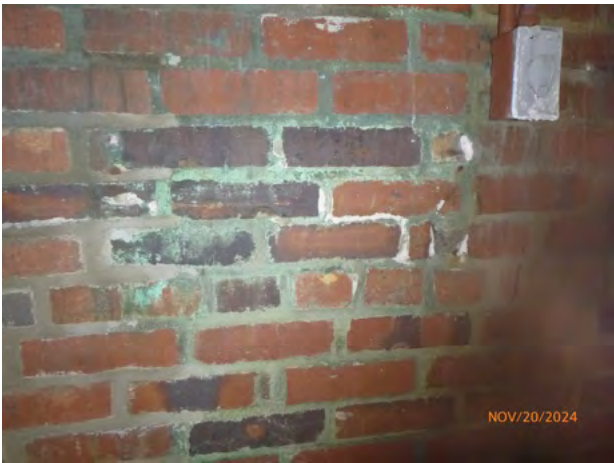
867-140 Brick\_SoilStain Copper 2024-1.jpg

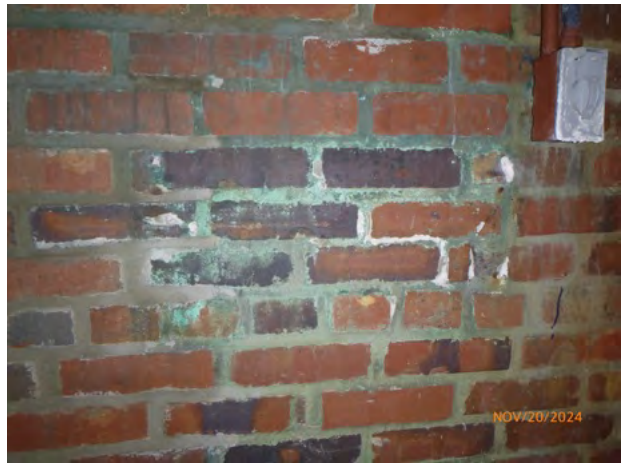
867-140 Brick\_SoilStain Copper 2024-2.jpg

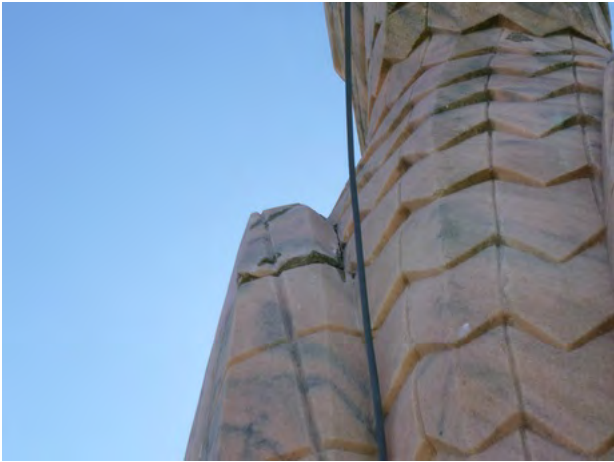
868-203 Stone\_Repair Patch Failed 2024-2.jpg
