### ***Bok Singing Tower Roof Restoration and Replacement***

# Bok Singing Tower Conditions Assessment

T.Y. Lin (formerly Silman) was contracted to perform a conditions assessment of the Bok Singing Tower at Bok Tower Gardens in Lake Wales, Florida. The Singing Tower stands 205 feet tall at the southwest corner of the gardens. A moat surrounds the base of the tower with two bridges to access the island. The tower houses a 60-bell carillon, associated carillonneur studio and library spaces, the Bok Tower Gardens Chao Research archive, and the Founder's Room. It is a steel frame construction clad in a masonry exterior of coquina and Georgia pink Etowah marble with brick masonry at the interior.

## **Bok Tower Focused Condition Assessment**

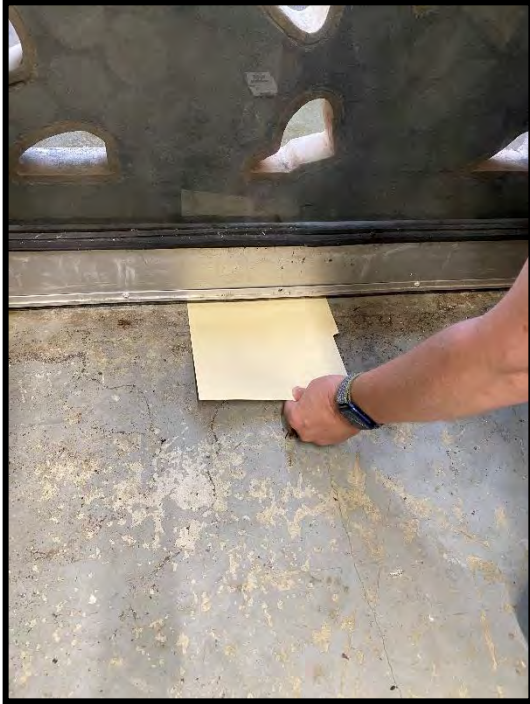
At Level 5, the Library Addition archival drawings show that rainwater from the exterior balconies is channeled inside and below a raised floor system to interior drains. This was confirmed on site through a hatch in the floor. The water is corroding steel elements of the raised floor system and effecting the conditioned environment of the library (**Figure 23** and **Figure 24**).

**Figure 24** Demonstration of unsealed storefront

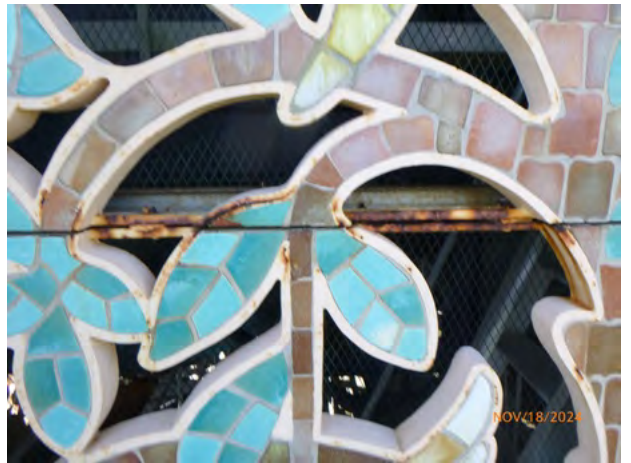
13-175 TerraCotta\_Crack Single unit 2024-2.jpg

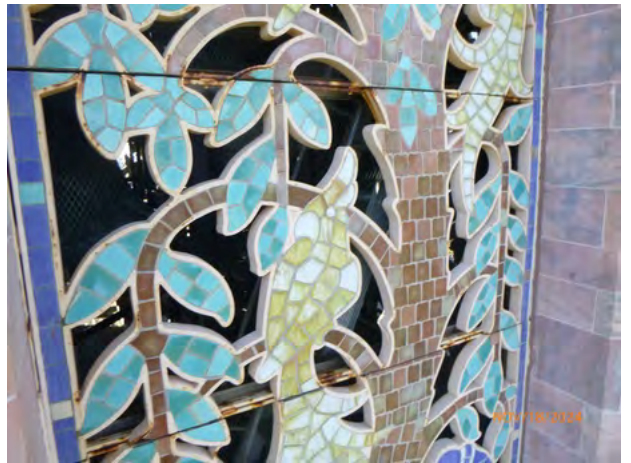
18-145 ArchMetal\_Corrosion Pitted 2024-1.jpg

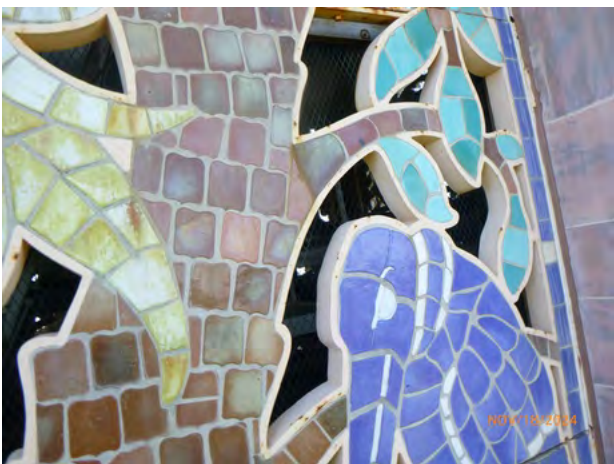
19-150 ArchMetal\_Note Photo-general 2024-3.jpg

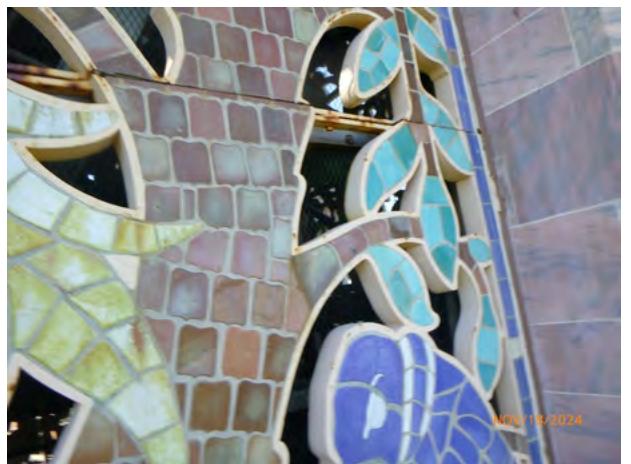
19-150 ArchMetal\_Note Photo-general 2024-4.jpg

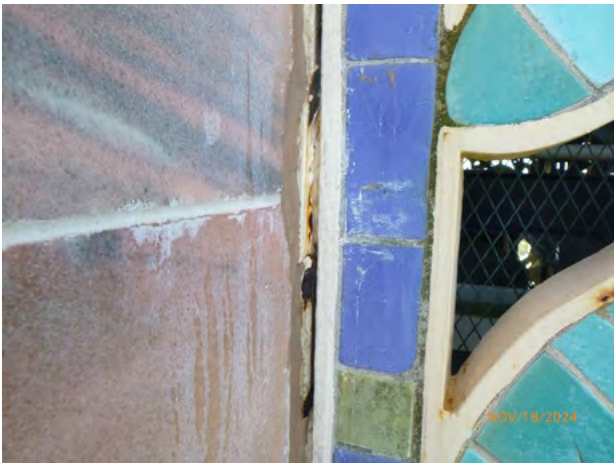
19-158 ArchMetal\_Note Photo-general 2024-2.jpg

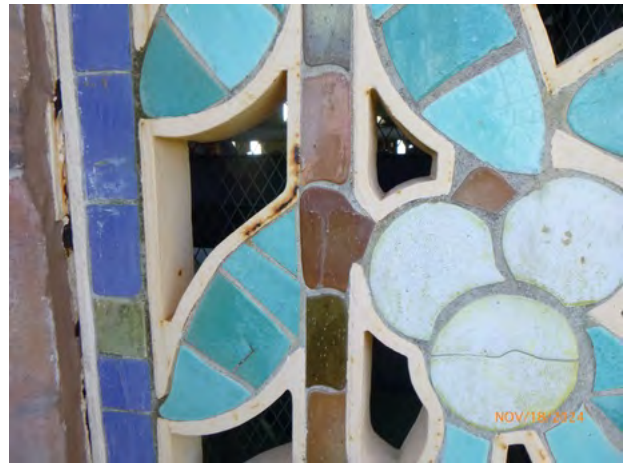
19-158 ArchMetal\_Note Photo-general 2024-3.jpg

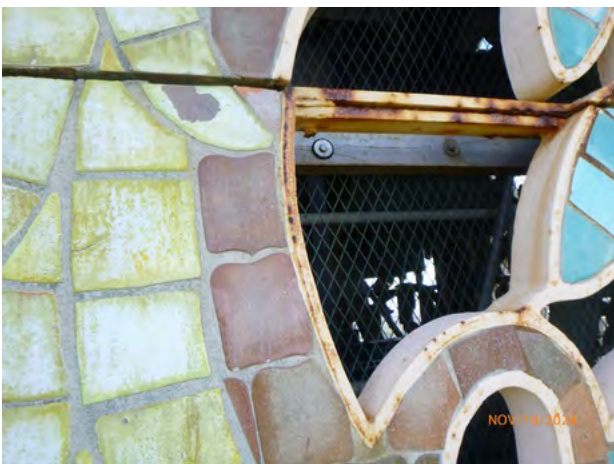
19-158 ArchMetal\_Note Photo-general 2024-4.jpg

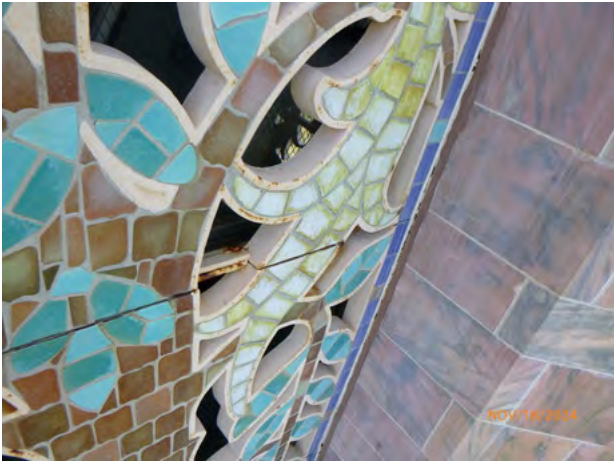
19-158 ArchMetal\_Note Photo-general 2024-6.jpg

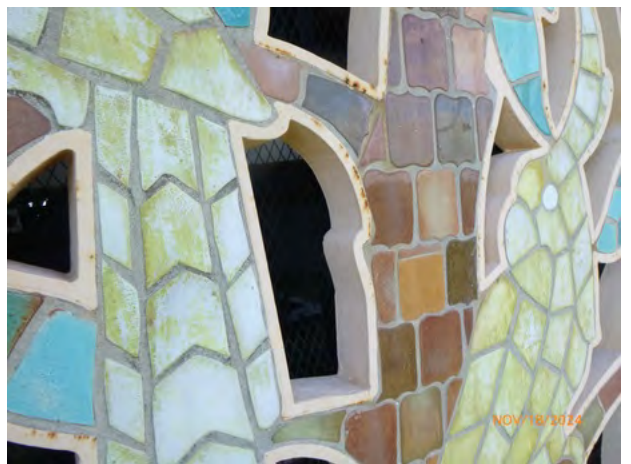
19-164 ArchMetal\_Note Photo-general 2024-2.jpg

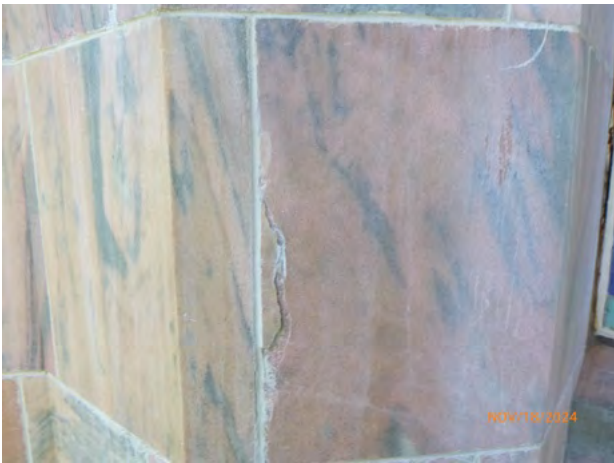
33-142 Stone\_SurfLoss Chipped 2024-2.jpg

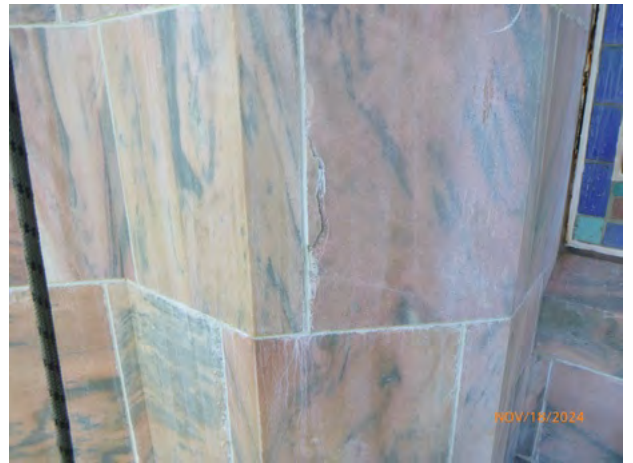
33-146 Stone\_Spall Bonded 2024-1.jpg

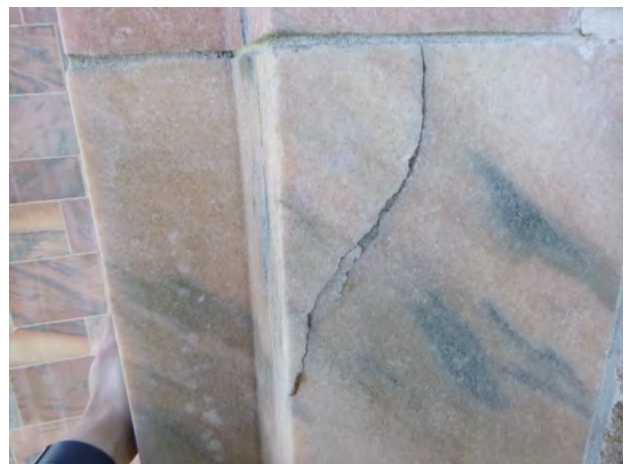
34-186 Stone\_SoilStain Leached Salts 2024-1.jpg

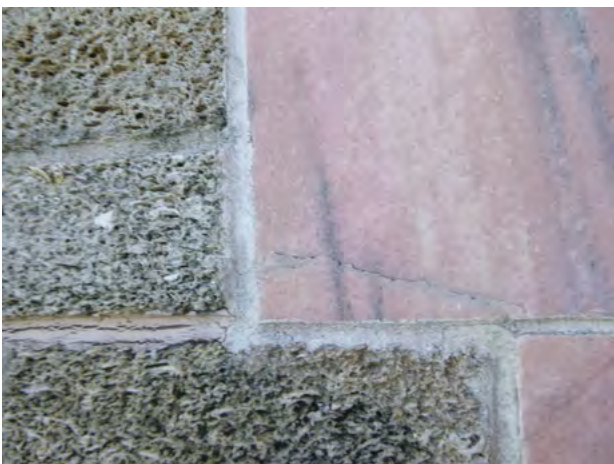
39-91 Stone\_Spall Bonded 2024-1.jpg

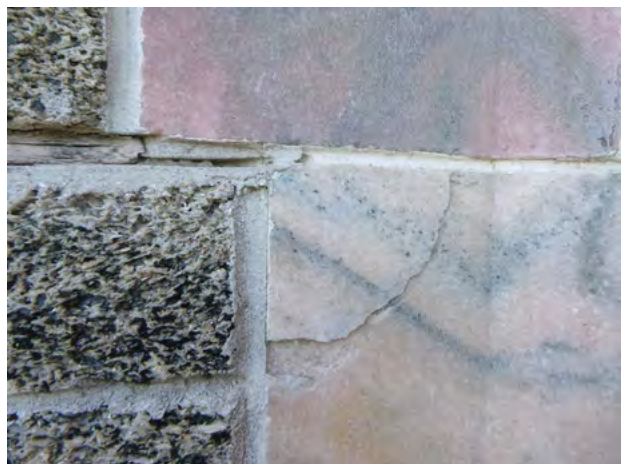
40-82 Stone\_Spall Bonded 2024-1.jpg

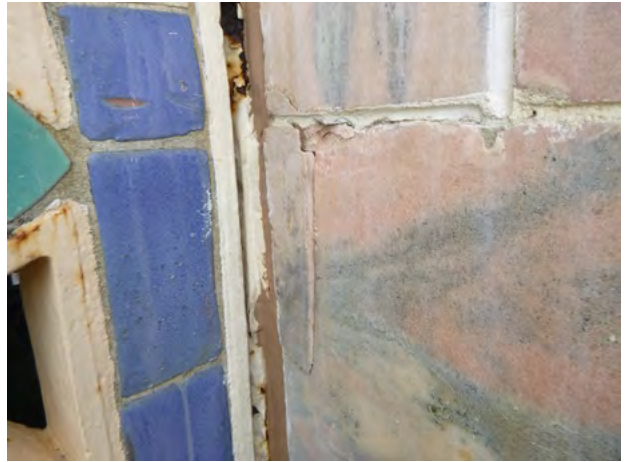
41-172 Stone\_Spall Bonded 2024-1.jpg

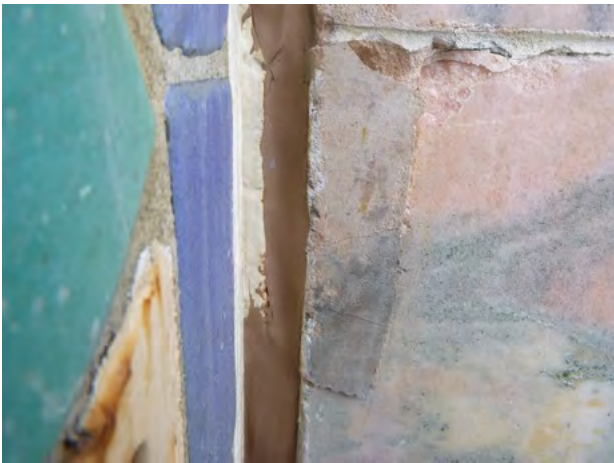
41-172 Stone\_Spall Bonded 2024-2.jpg

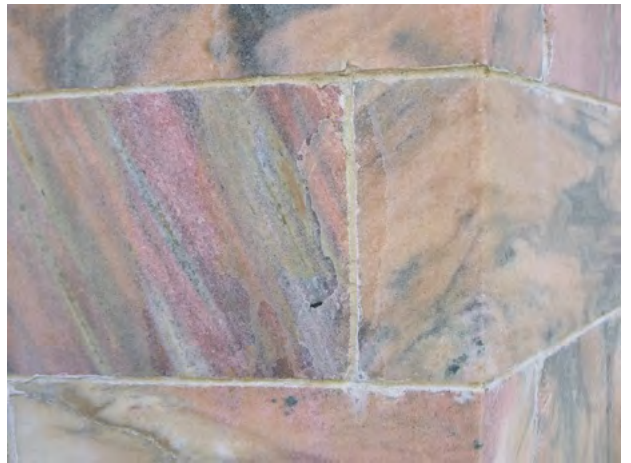
41-180 Stone\_SurfLoss Friable 2024-1.jpg

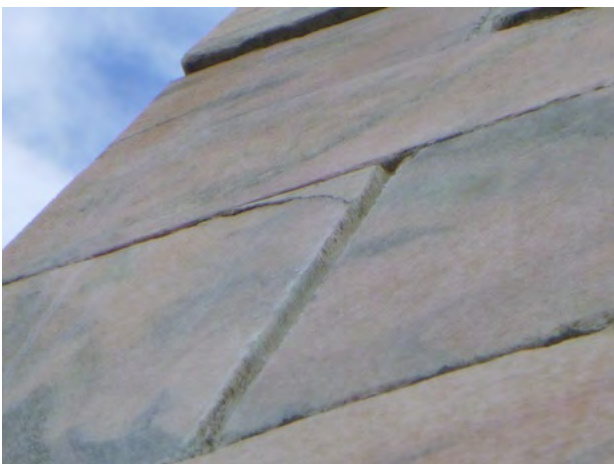
42-152 Stone\_Spall Bonded 2024-1.jpg

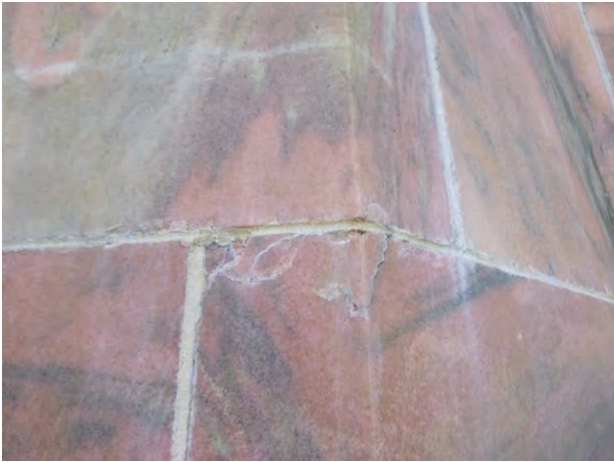
42-171 Stone\_Spall Bonded 2024-1.jpg

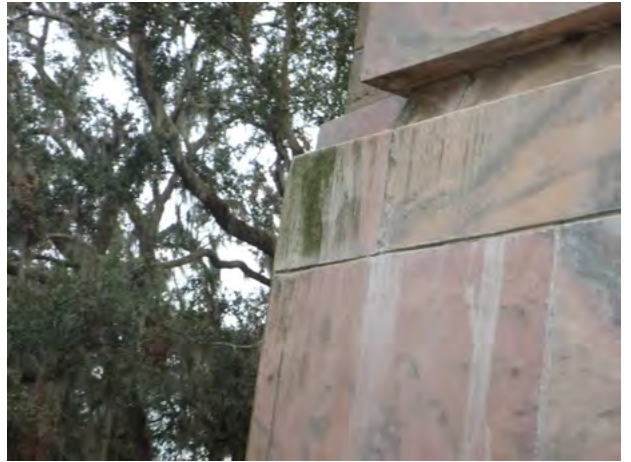
43-26 Stone\_SoilStain Biological 2024-1.jpg

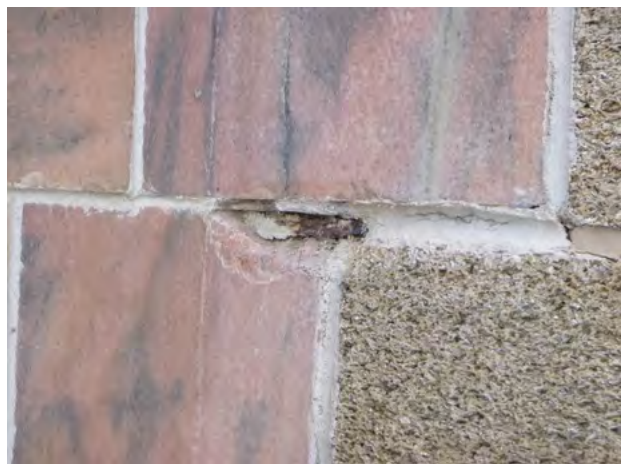
45-93 Stone\_Embedment Ferrous Embedment 2024-1.jpg

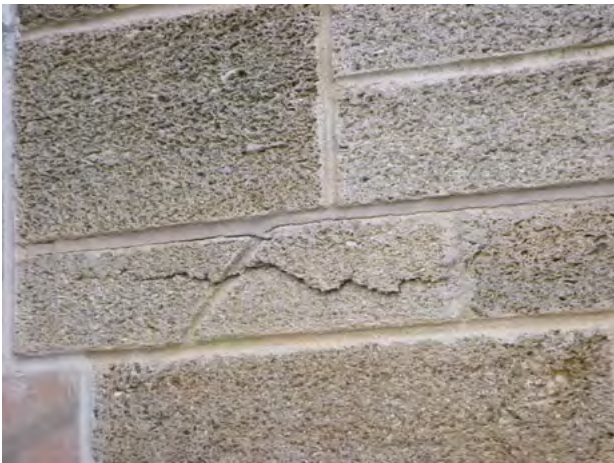
46-101 Stone\_Spall Bonded 2024-1.jpg

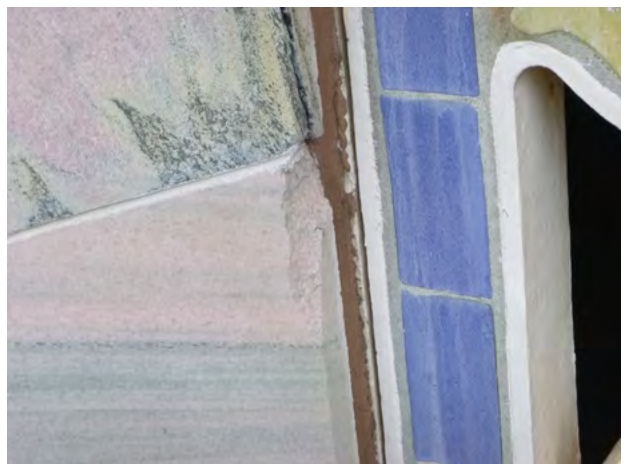
48-108 Stone\_Crack Single unit 2024-1.jpg

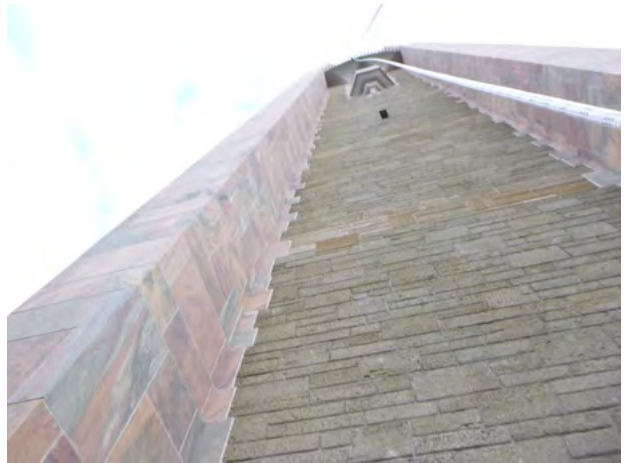
49-30 Stone\_Crack Repair failed 2024-3.jpg

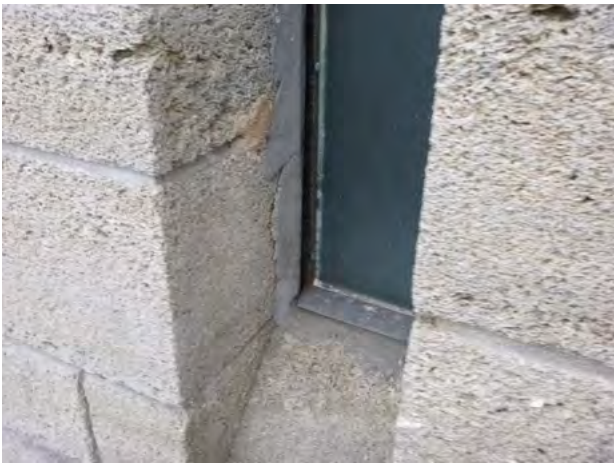
50-87 Stone\_Spall Bonded 2024-1.jpg

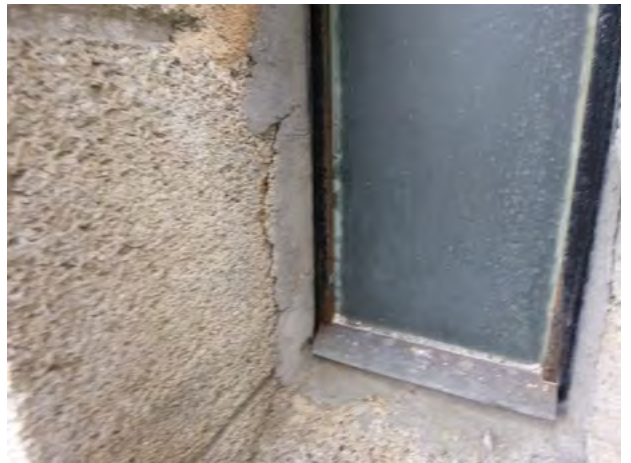
50-87 Stone\_Spall Bonded 2024-2.jpg

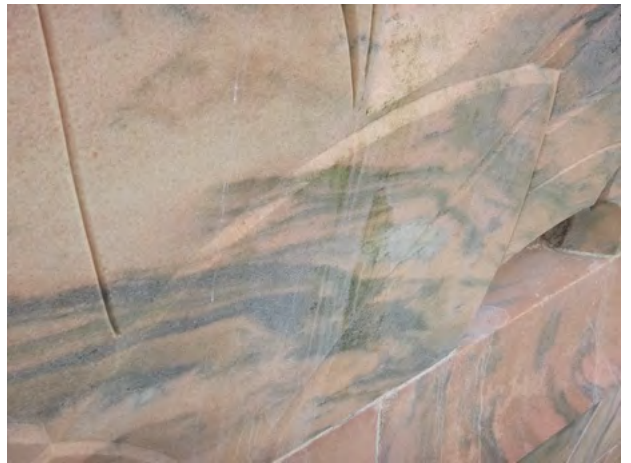
50-187 Stone\_SoilStain Biological 2024-1.jpg

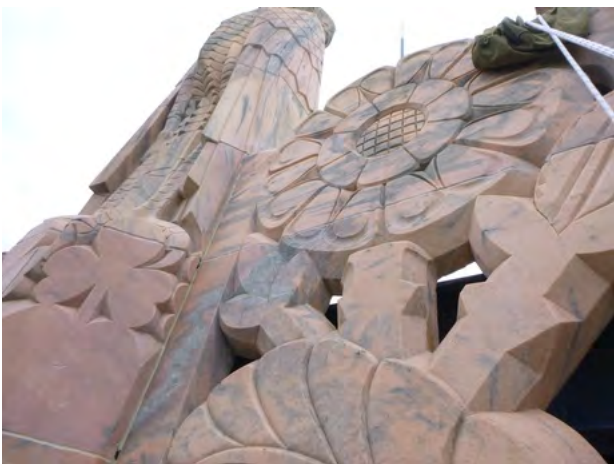
50-187 Stone\_SoilStain Biological 2024-2.jpg

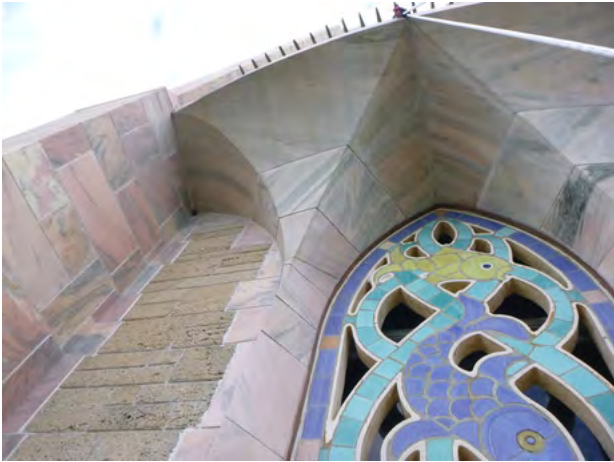
51-87 Stone\_Spall Removed + Steel 2024-4.jpg

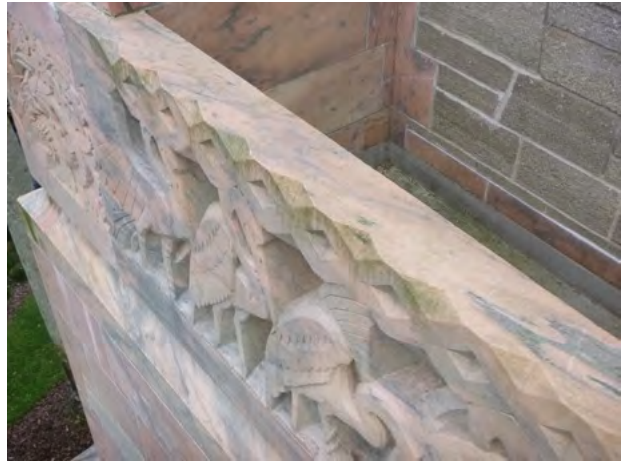
51-193 Stone\_SoilStain Biological 2024-1.jpg

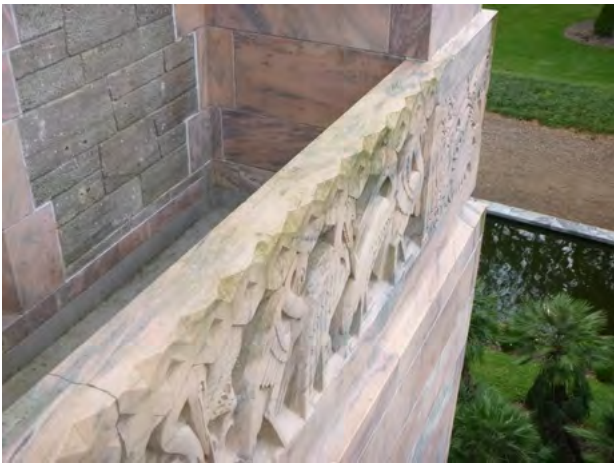
52-31 Stone\_SoilStain Biological 2024-1.jpg

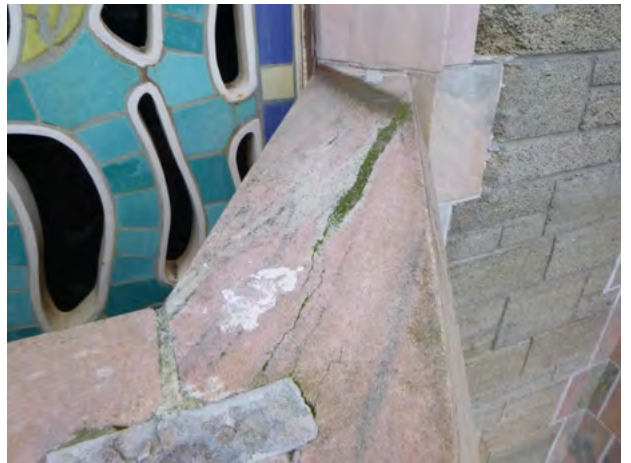
52-31 Stone\_SoilStain Biological 2024-2.jpg

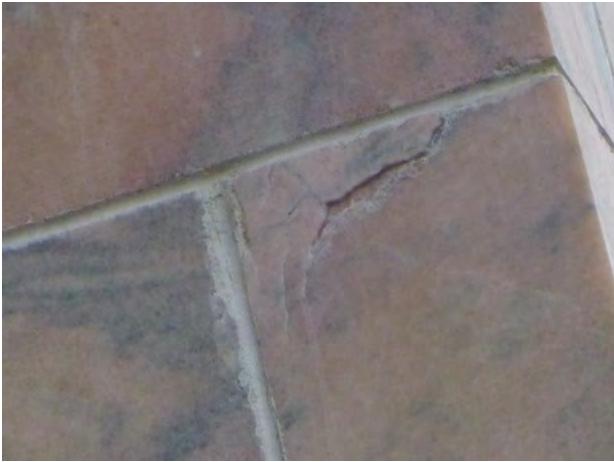
55-1 Stone\_Joints Mortar Failed 2024-5.jpg

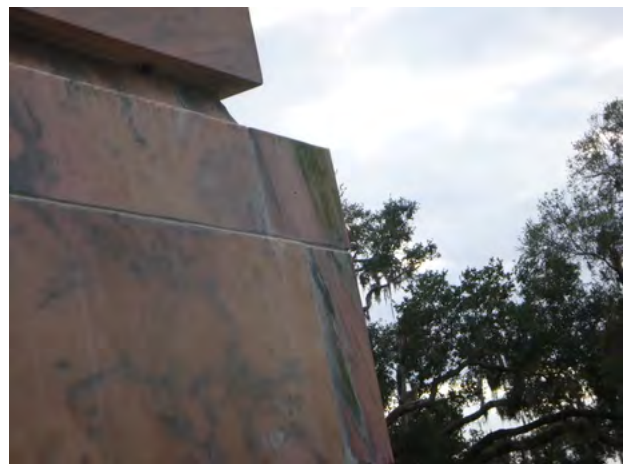
58-157 Stone\_Joints Mortar Failed 2024-3.jpg

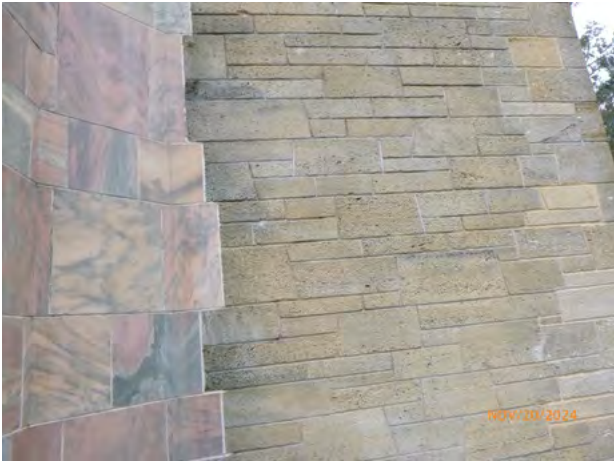
60-139 Stone\_Repair Patch Removed 2024-2.jpg

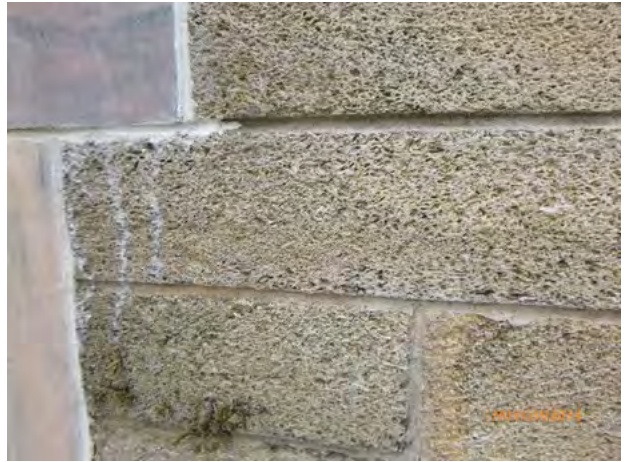
61-13 Stone\_SoilStain Biological 2024-1.jpg

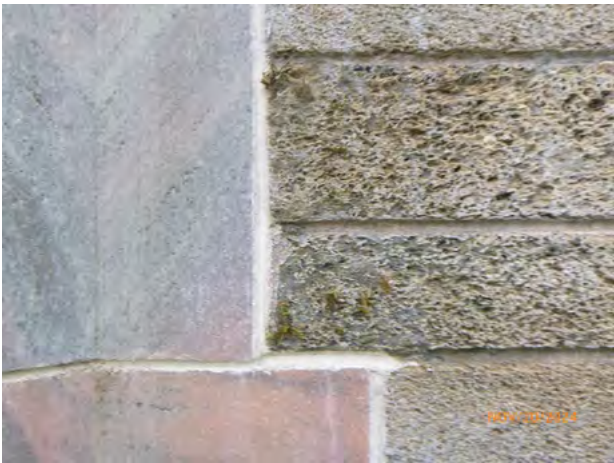
61-13 Stone\_SoilStain Biological 2024-2.jpg

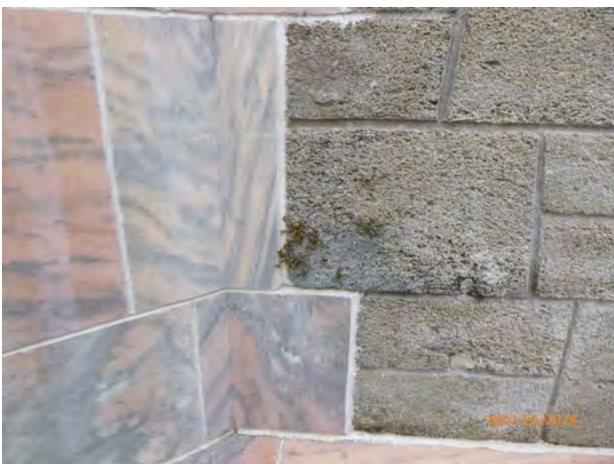
61-13 Stone\_SoilStain Biological 2024-4.jpg

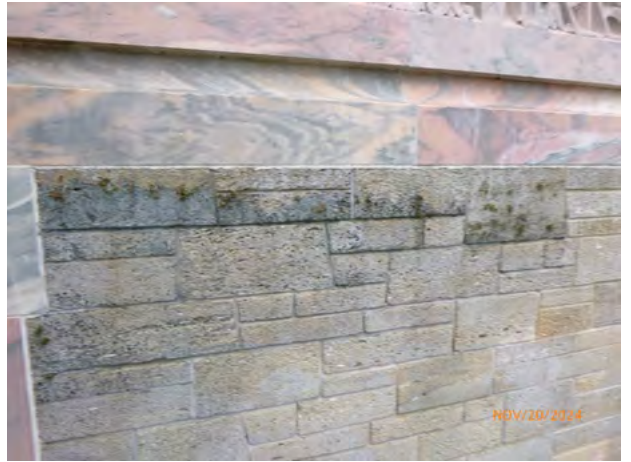
61-127 Stone\_Joints Sealant Failed 2024-3.jpg

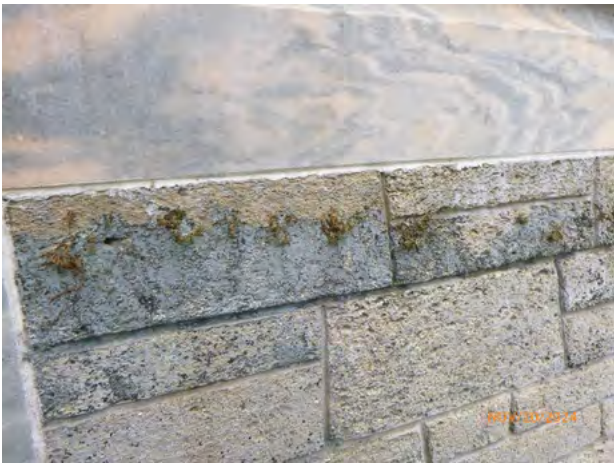
62-26 Stone\_SoilStain Biological 2024-1.jpg

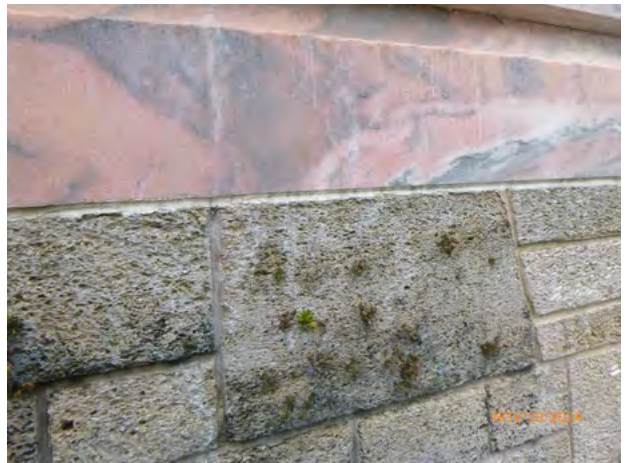
62-26 Stone\_SoilStain Biological 2024-2.jpg

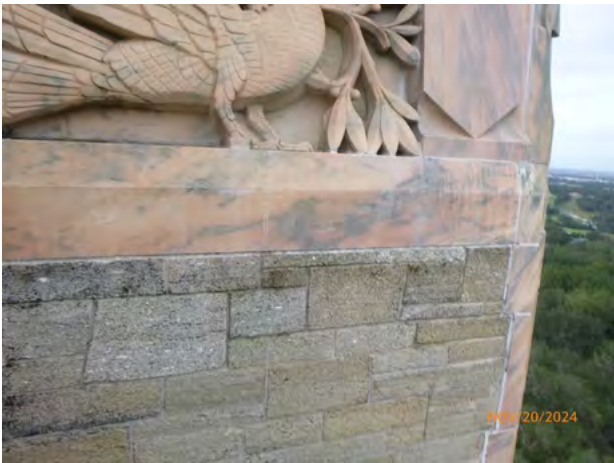
65-136 Stone\_SoilStain Biological 2024-1.jpg

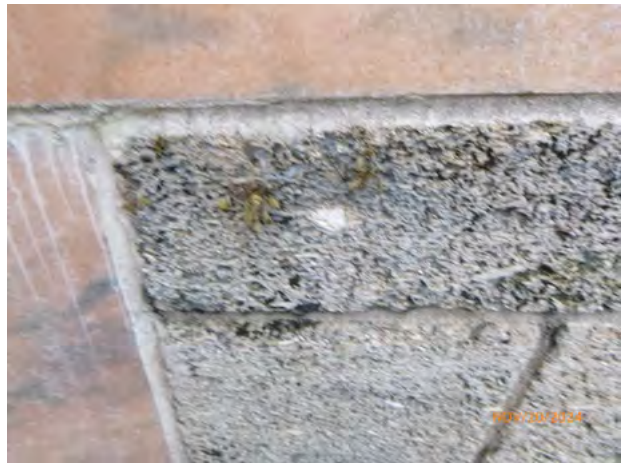
65-136 Stone\_SoilStain Biological 2024-2.jpg

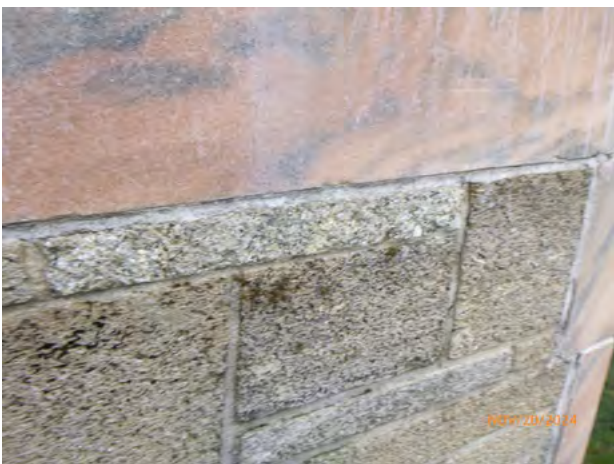
65-136 Stone\_SoilStain Biological 2024-3.jpg

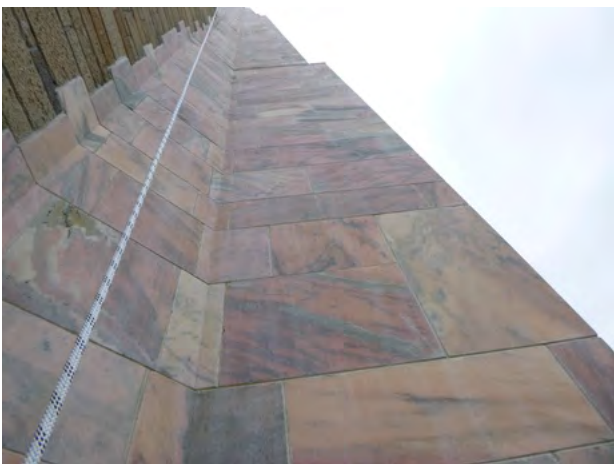
68-104 Stone\_Note Photo-general 2024-1.jpg

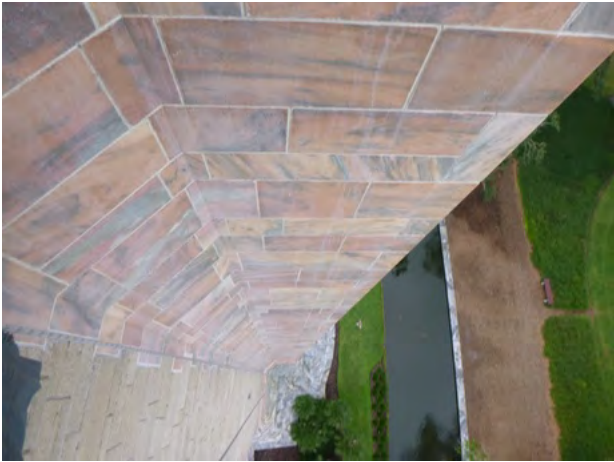
68-104 Stone\_Note Photo-general 2024-3.jpg

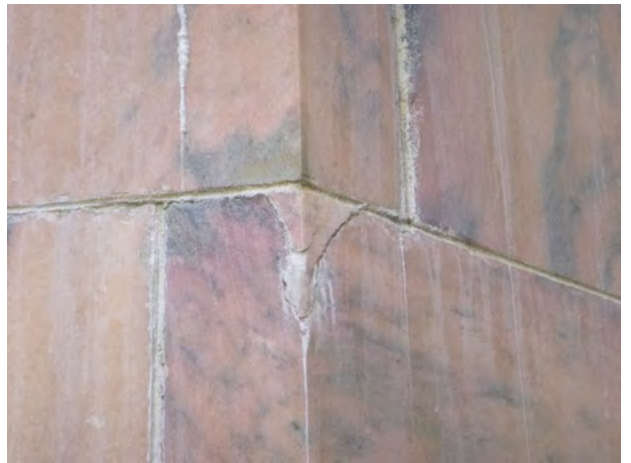
79-161 Stone\_Spall Bonded 2024-1.jpg

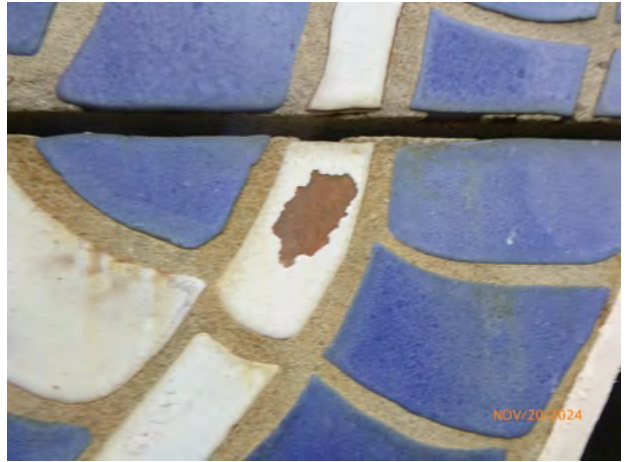
111-149 TerraCotta\_SurfLoss Glaze loss 2024-2.jpg

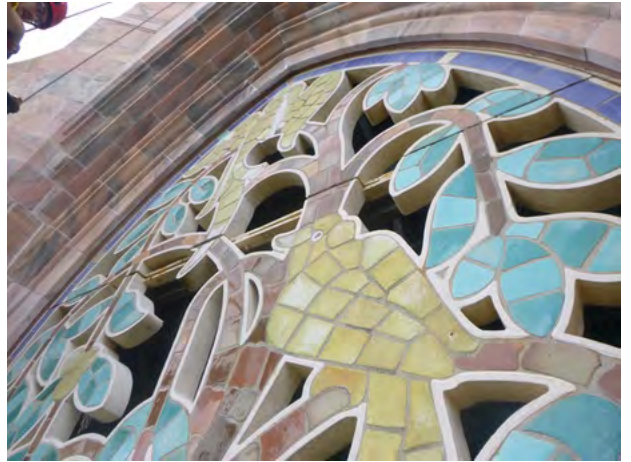
114-170 ArchMetal\_Note Photo-general 2024-1.jpg

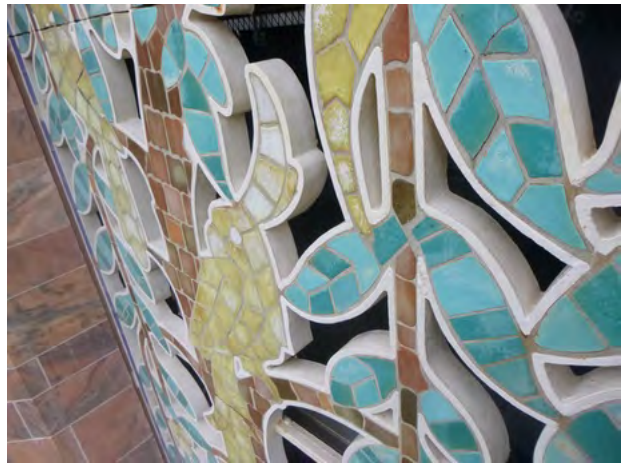
114-170 ArchMetal\_Note Photo-general 2024-2.jpg

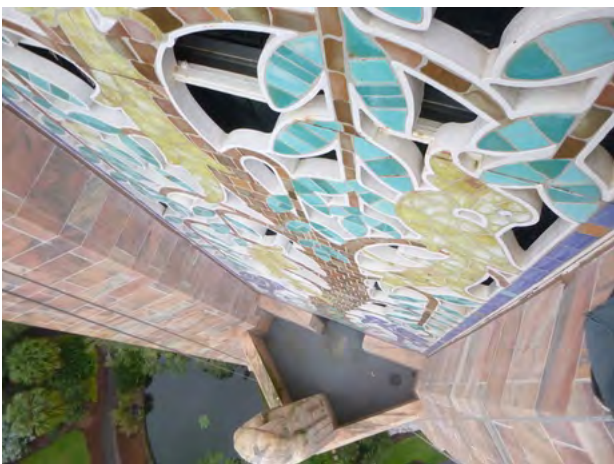
114-170 ArchMetal\_Note Photo-general 2024-3.jpg

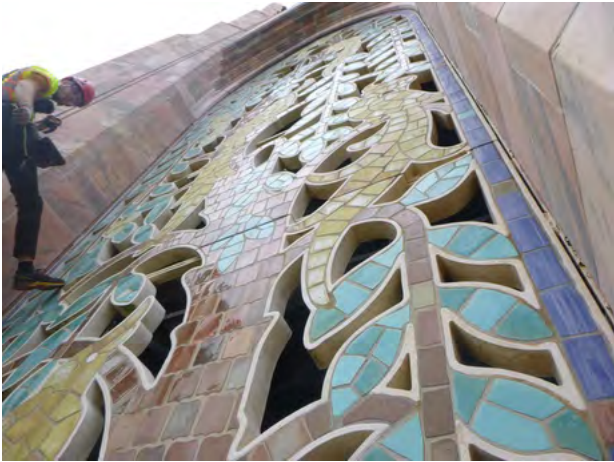
114-172 ArchMetal\_Corrosion Surface 2024-1.jpg

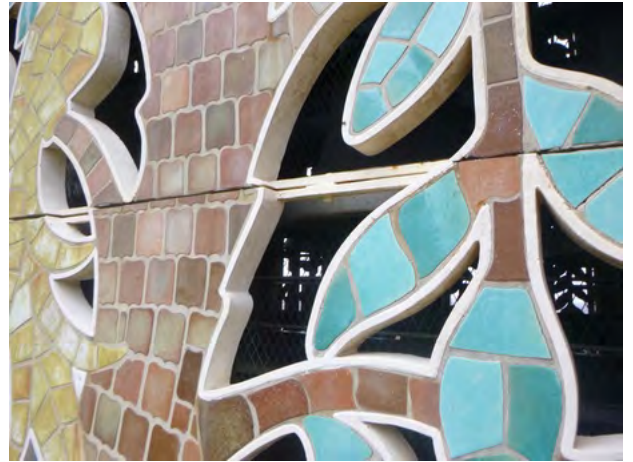
115-150 TerraCotta\_Note Photo-general 2024-1.jpg

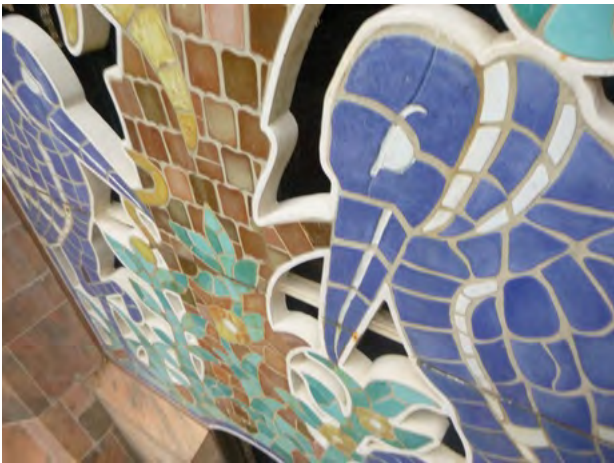
115-150 TerraCotta\_Note Photo-general 2024-2.jpg

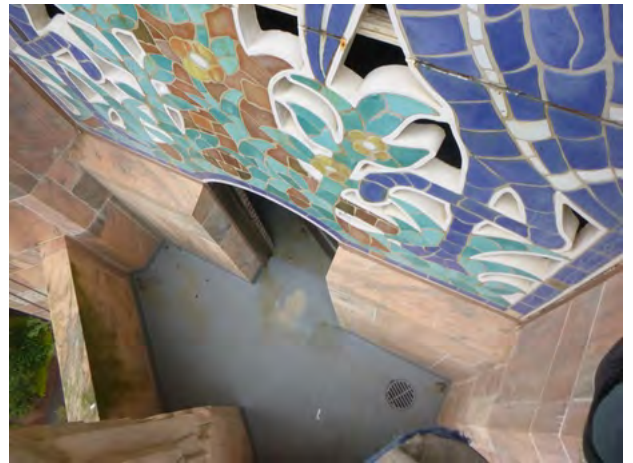
115-150 TerraCotta\_Note Photo-general 2024-3.jpg

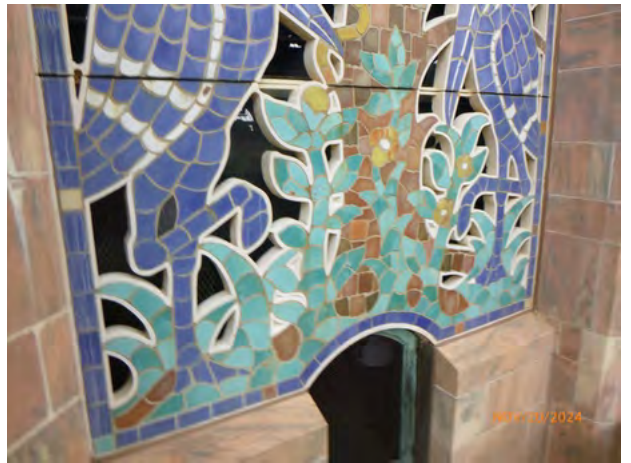
118-167 ArchMetal\_Corrosion Pitted 2024-2.jpg

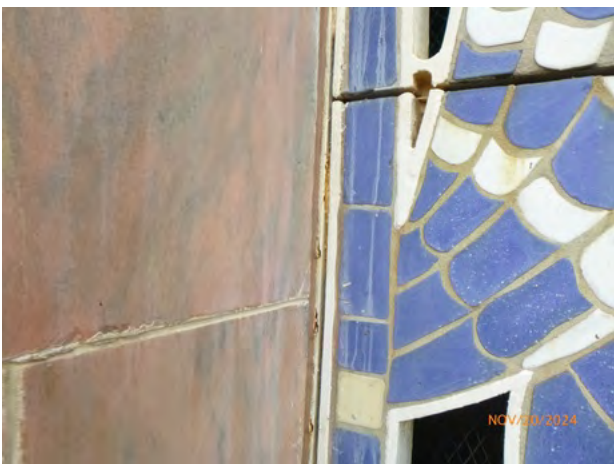
119-145 ArchMetal\_Note Photo-general 2024-1.jpg

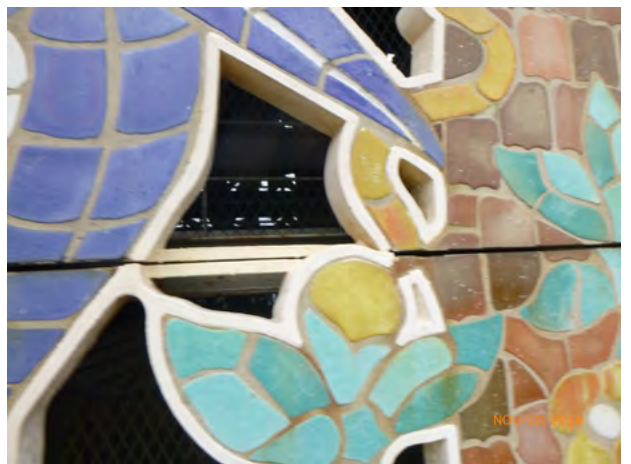
119-145 ArchMetal\_Note Photo-general 2024-2.jpg

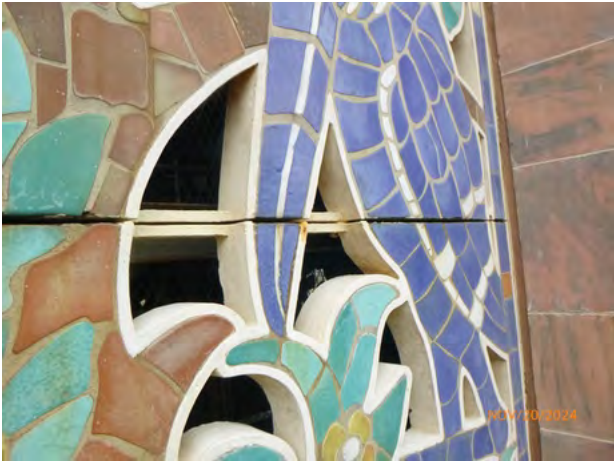
119-145 ArchMetal\_Note Photo-general 2024-3.jpg

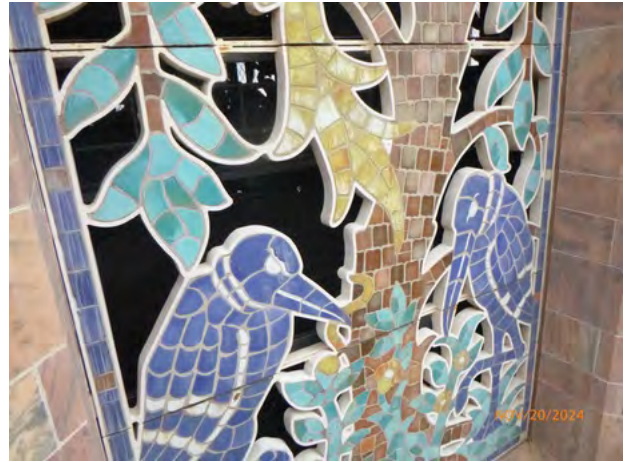
119-145 ArchMetal\_Note Photo-general 2024-4.jpg

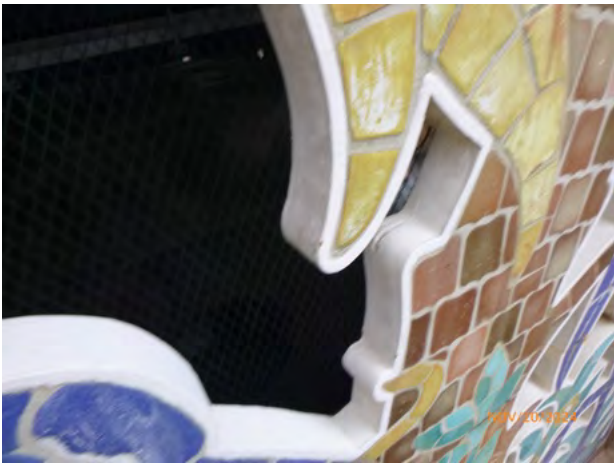
119-150 ArchMetal\_Note Photo-general 2024-1.jpg

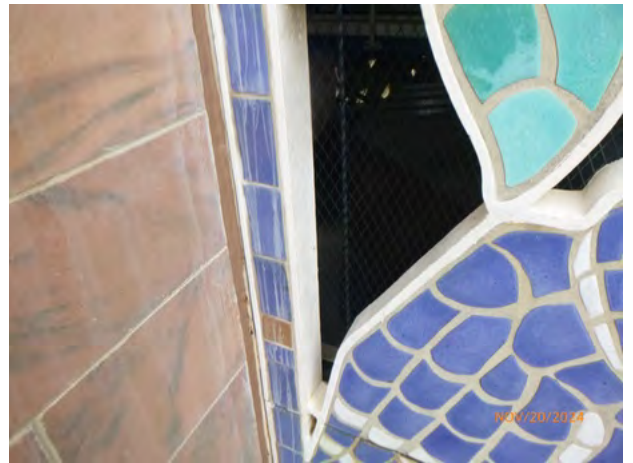
119-150 ArchMetal\_Note Photo-general 2024-2.jpg

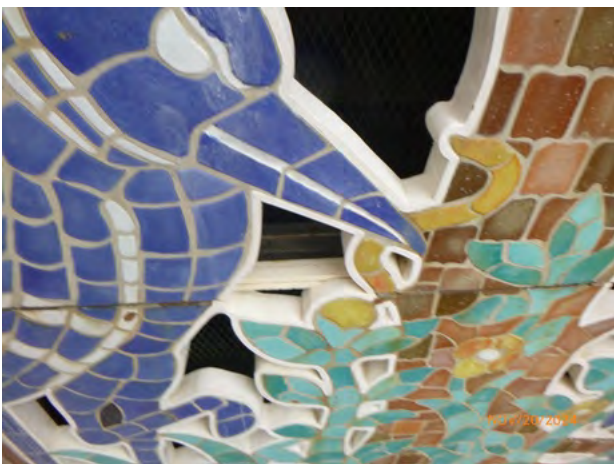
119-150 ArchMetal\_Note Photo-general 2024-3.jpg

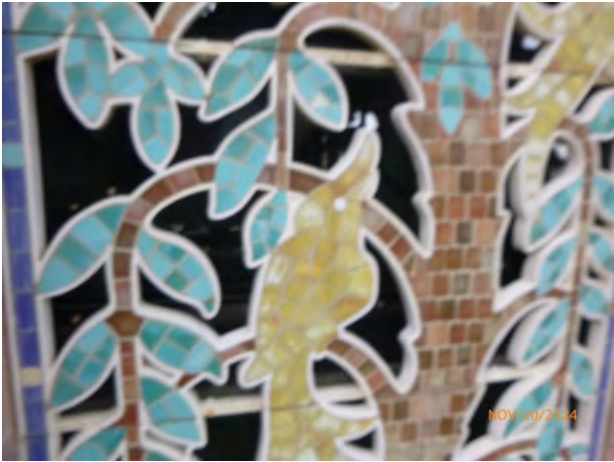
119-150 ArchMetal\_Note Photo-general 2024-5.jpg

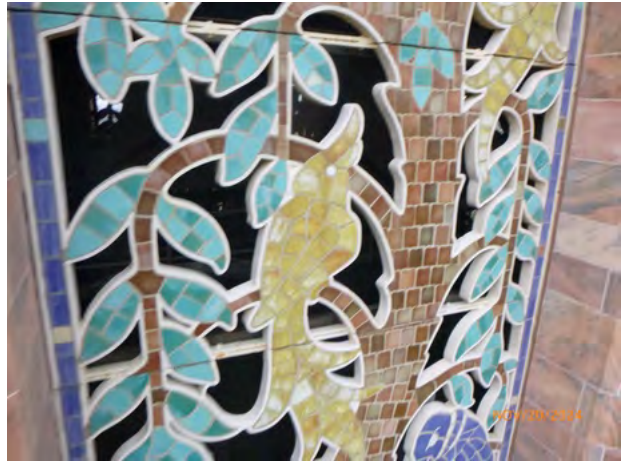
119-155 ArchMetal\_Note Photo-general 2024-1.jpg

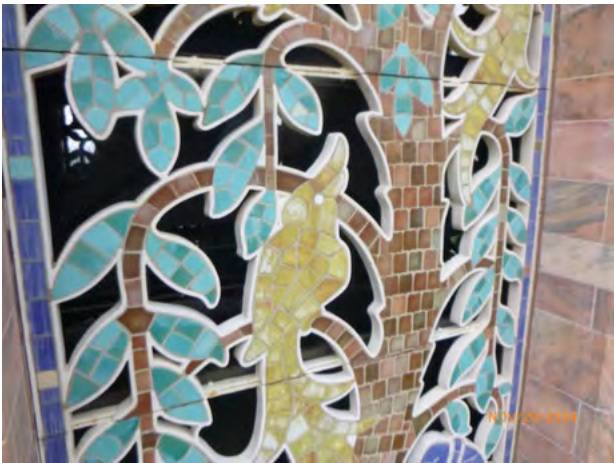
119-155 ArchMetal\_Note Photo-general 2024-2.jpg

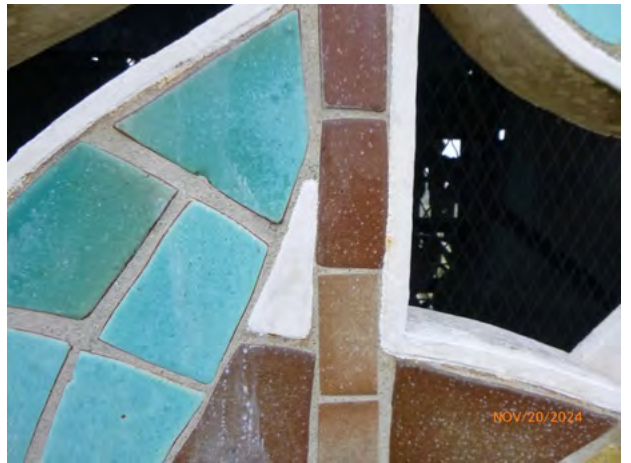
119-155 ArchMetal\_Note Photo-general 2024-3.jpg

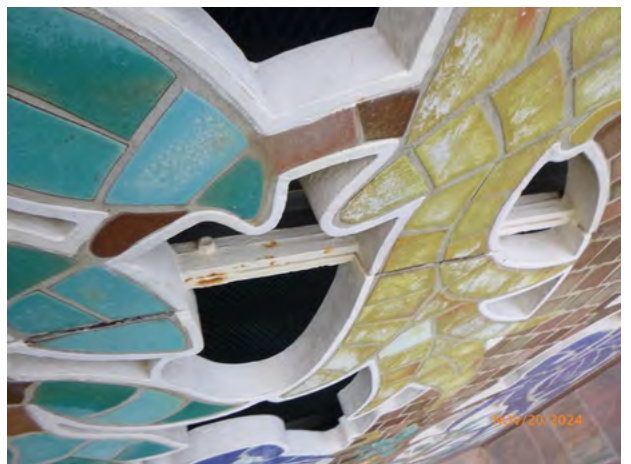
119-155 ArchMetal\_Note Photo-general 2024-5.jpg

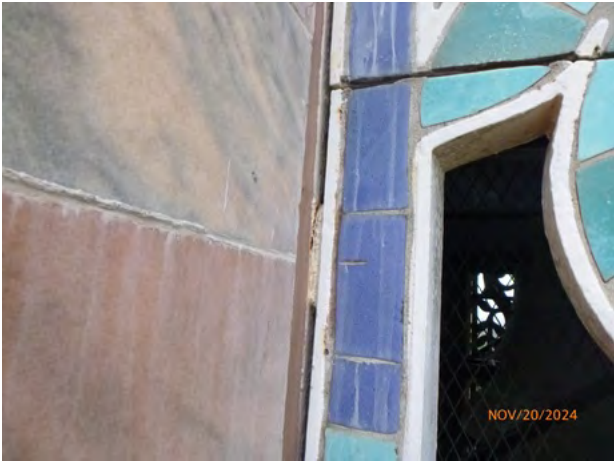
119-155 ArchMetal\_Note Photo-general 2024-6.jpg

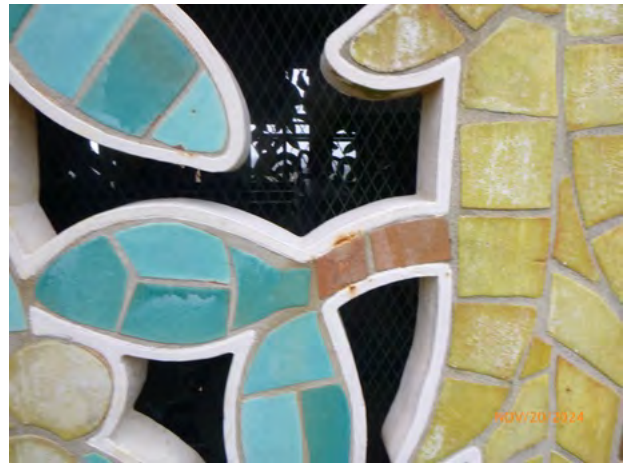
119-159 ArchMetal\_Note Photo-general 2024-2.jpg

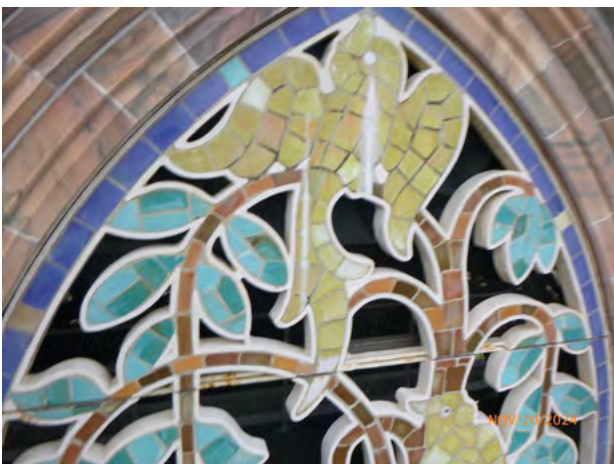
119-159 ArchMetal\_Note Photo-general 2024-3.jpg

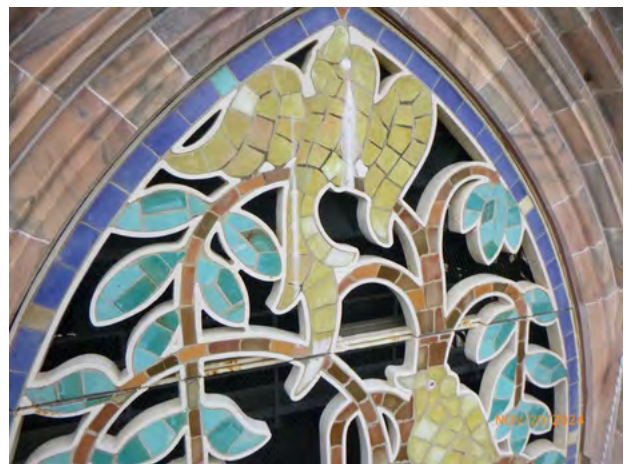
119-173 ArchMetal\_Note Photo-general 2024-1.jpg

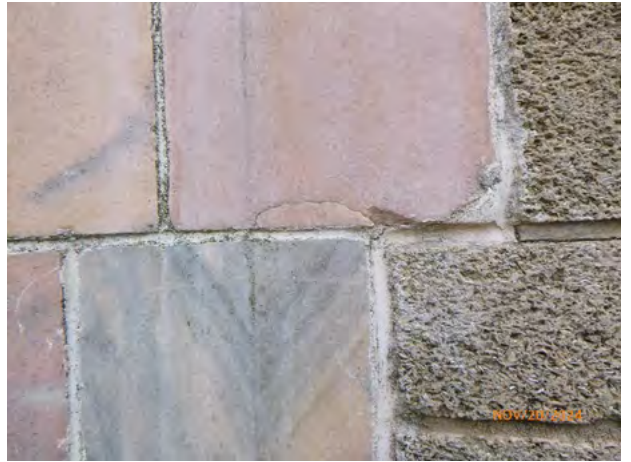
132-181 Stone\_Joints Mortar Removed 2024-3.jpg

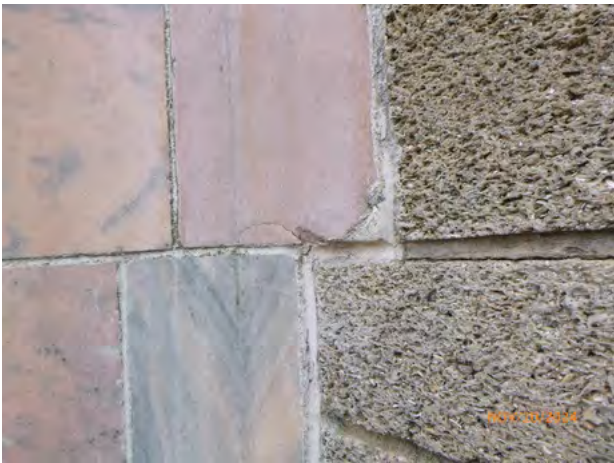
133-46 Stone\_Spall Bonded 2024-1.jpg

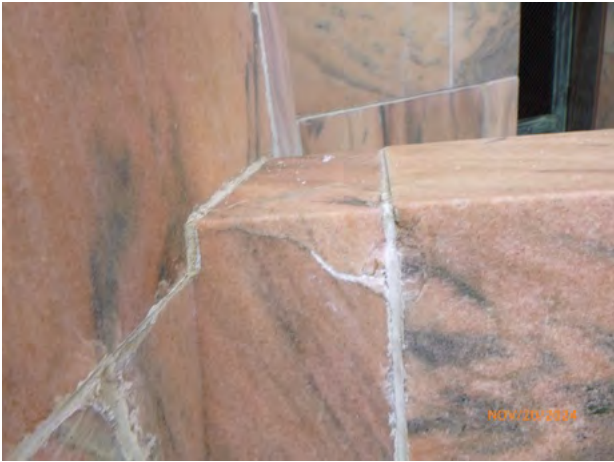
133-139 Stone\_SurfLoss Chipped 2024-3.jpg
