### ***Bok Singing Tower Roof Restoration and Replacement***

# Bok Singing Tower Conditions Assessment

T.Y. Lin (formerly Silman) was contracted to perform a conditions assessment of the Bok Singing Tower at Bok Tower Gardens in Lake Wales, Florida. The Singing Tower stands 205 feet tall at the southwest corner of the gardens. A moat surrounds the base of the tower with two bridges to access the island. The tower houses a 60-bell carillon, associated carillonneur studio and library spaces, the Bok Tower Gardens Chao Research archive, and the Founder's Room. It is a steel frame construction clad in a masonry exterior of coquina and Georgia pink Etowah marble with brick masonry at the interior.

## **Bok Tower Focused Condition Assessment**

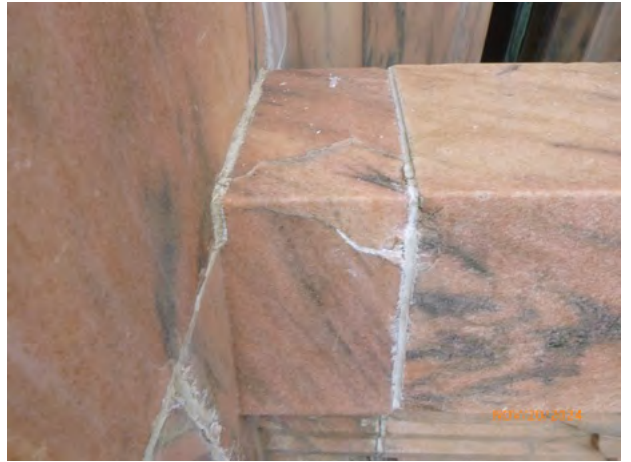
133-141 Stone\_Spall Bonded 2024-1.jpg

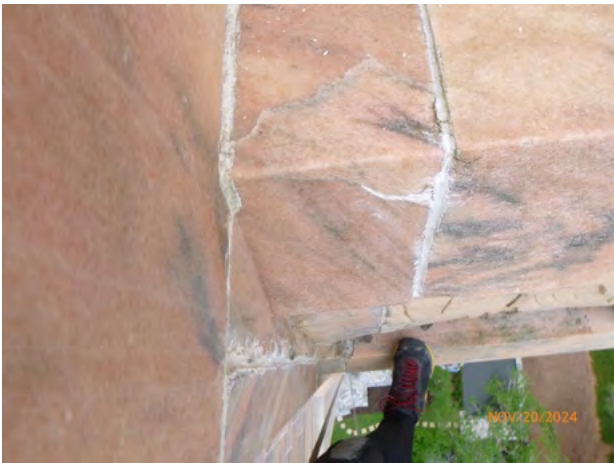
133-141 Stone\_Spall Bonded 2024-2.jpg

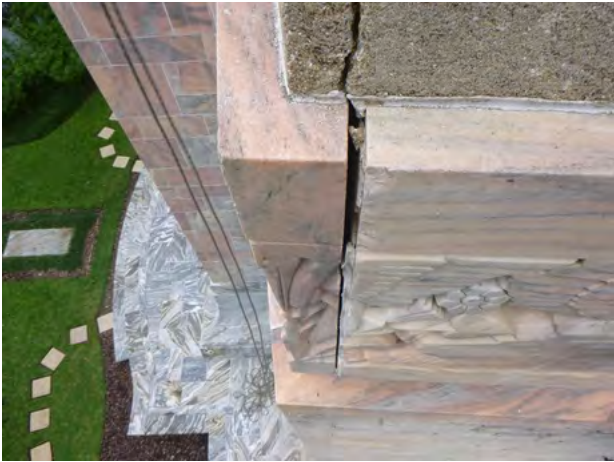
133-179 Stone\_SurfLoss Chipped 2024-1.jpg

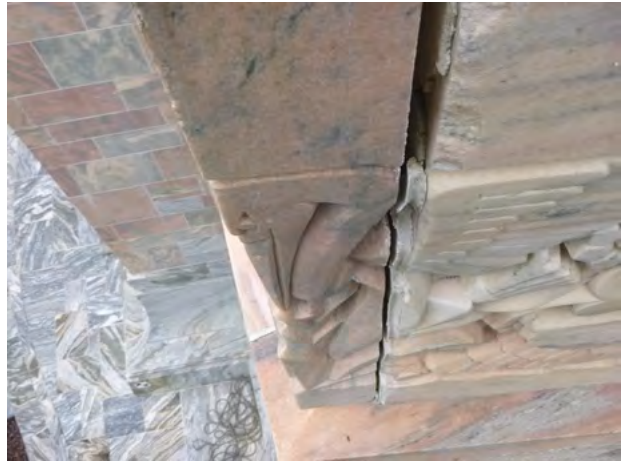
134-30 Stone\_Displacement Horizontal 2024-1.jpg

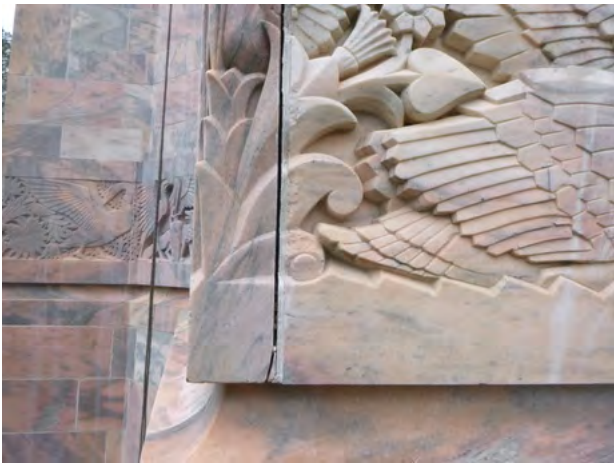
134-30 Stone\_Displacement Horizontal 2024-2.jpg

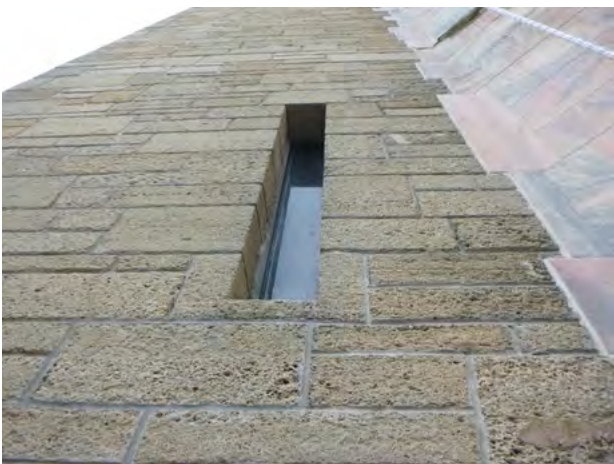
137-51 Stone\_Joints Sealant Failed 2024-1.jpg

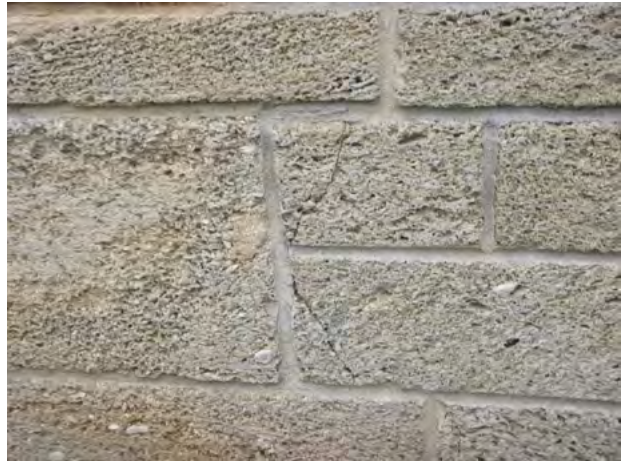
137-68 Stone\_Joints Sealant Failed 2024-2.jpg

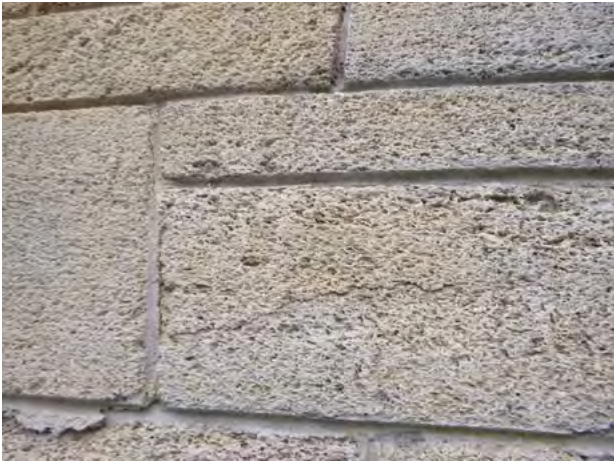
137-182 Stone\_Spall Removed 2024-3.jpg

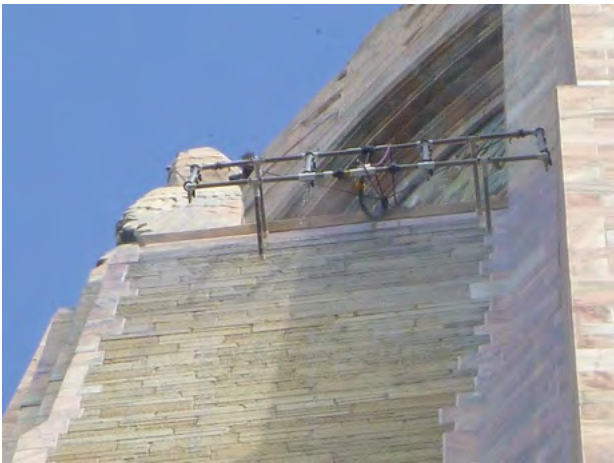
138-118 Stone\_Crack System units and joints 2024-3.jpg

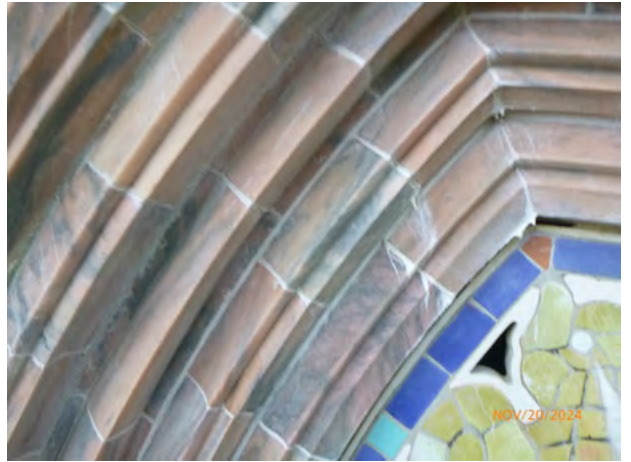
138-179 Stone\_SoilStain Leached Salts 2024-4.jpg

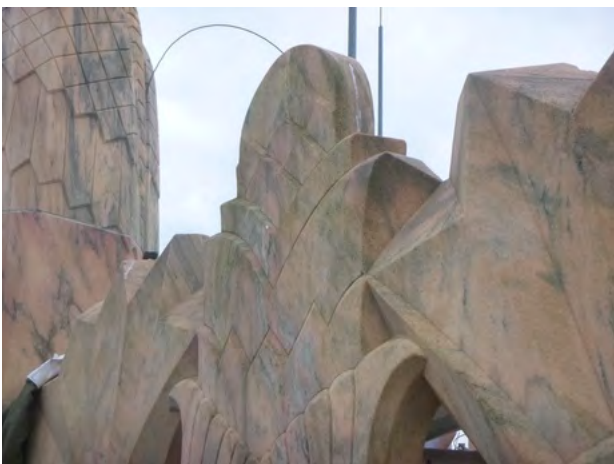
138-179 Stone\_SoilStain Leached Salts 2024-7.jpg

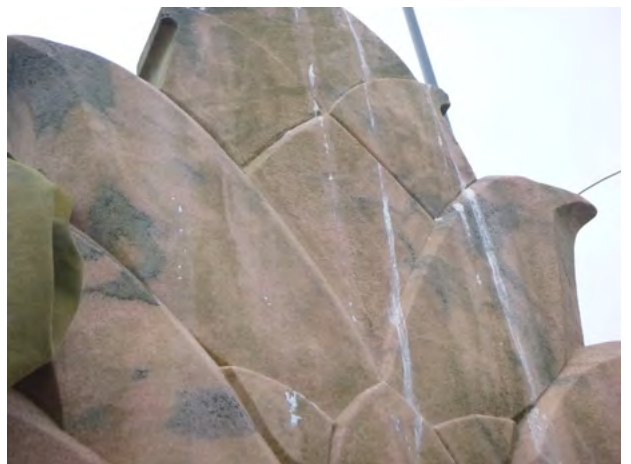
150-140 Stone\_SurfLoss Chipped 2024-1.jpg

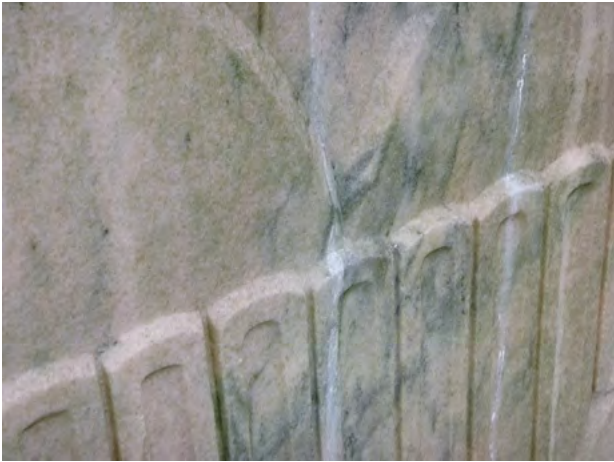
150-194 Stone\_SoilStain Biological 2024-1.jpg

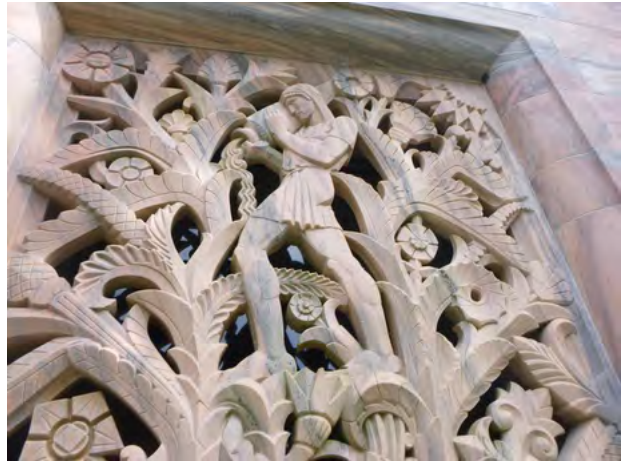
150-194 Stone\_SoilStain Biological 2024-2.jpg

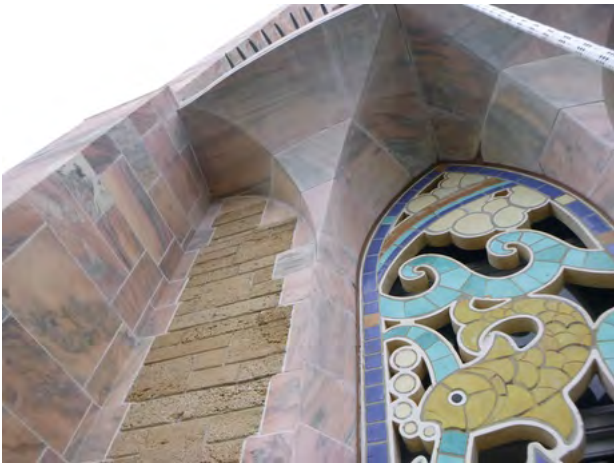
151-91 Stone\_Spall Missing + Steel 2024-1.jpg

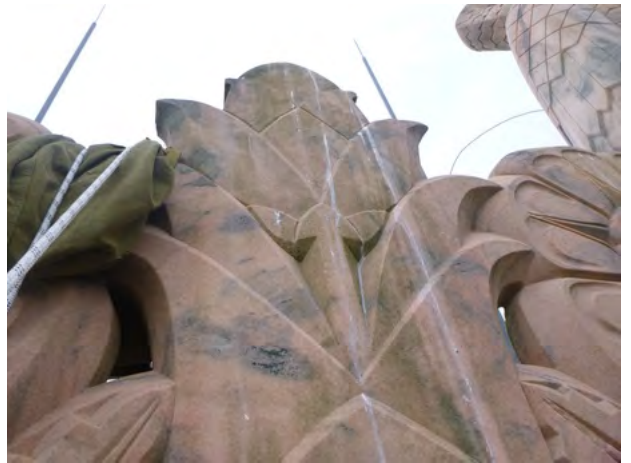
151-182 Stone\_SoilStain Guano 2024-1.jpg

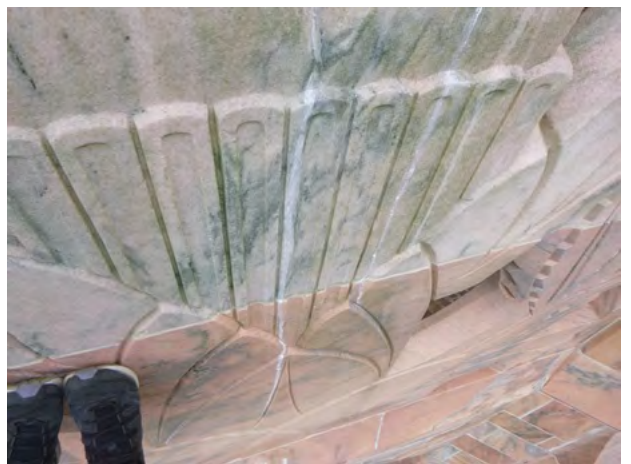
151-193 Stone\_SoilStain Guano 2024-2.jpg

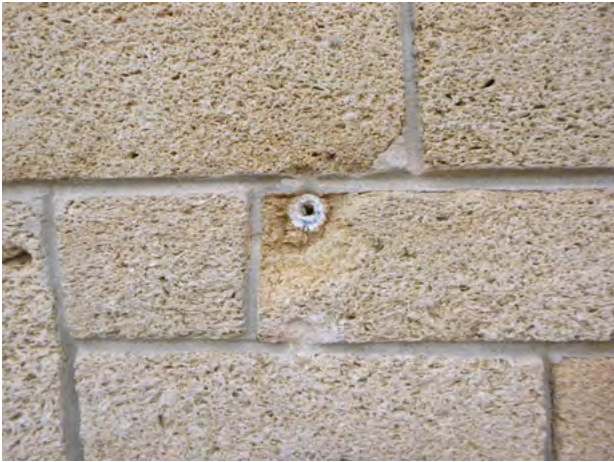
151-193 Stone\_SoilStain Guano 2024-3.jpg

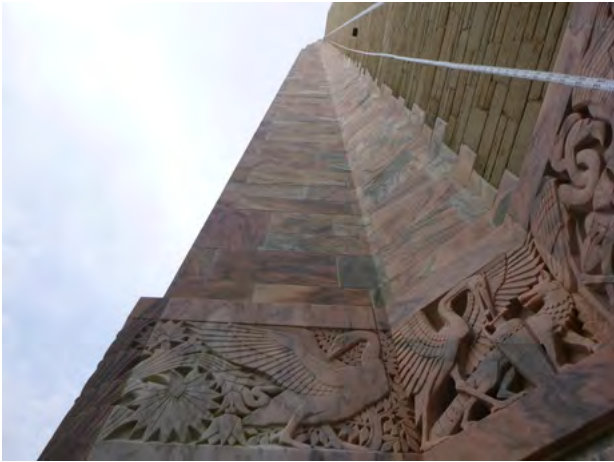
229-157 Stone\_Spall Removed 2024-1.jpg

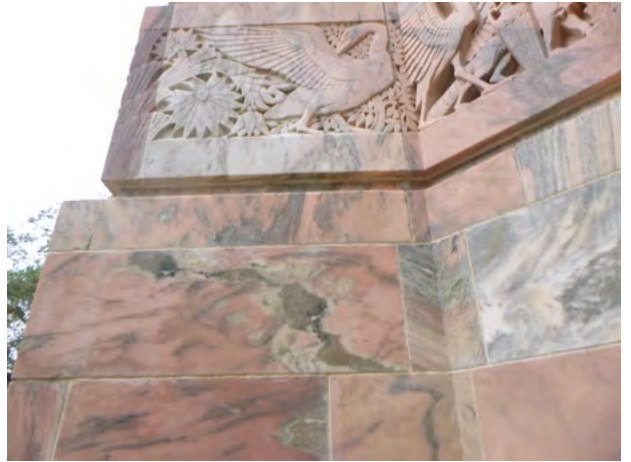
230-16 Stone\_Note Photo-general 2024-1.jpg

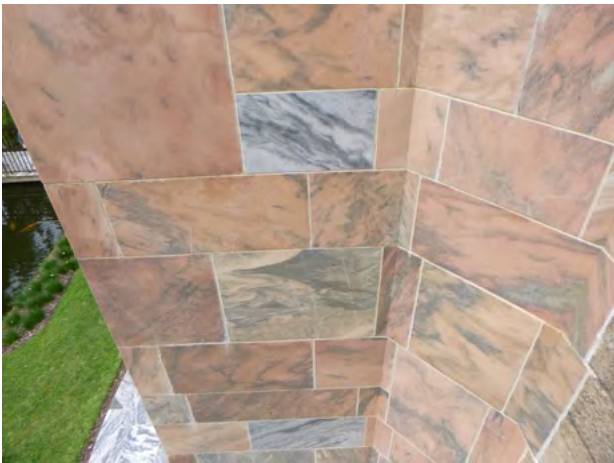
230-16 Stone\_Note Photo-general 2024-2.jpg

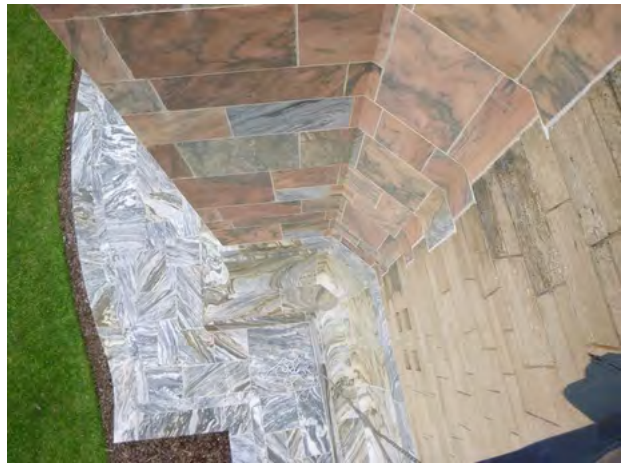
230-16 Stone\_Note Photo-general 2024-3.jpg

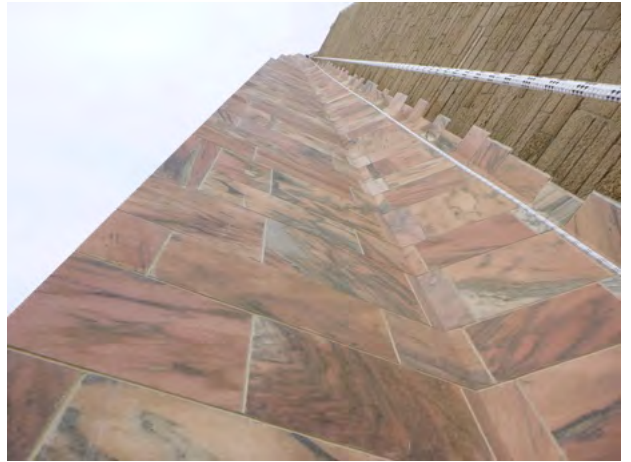
230-51 Stone\_Crack System units and joints 2024-2.jpg

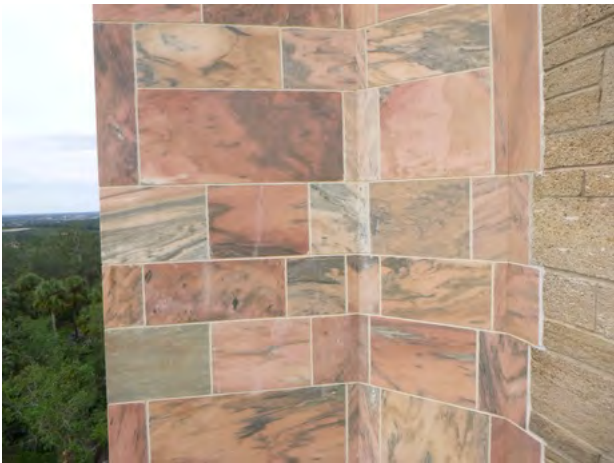
230-71 Stone\_Note Photo-general 2024-1.jpg

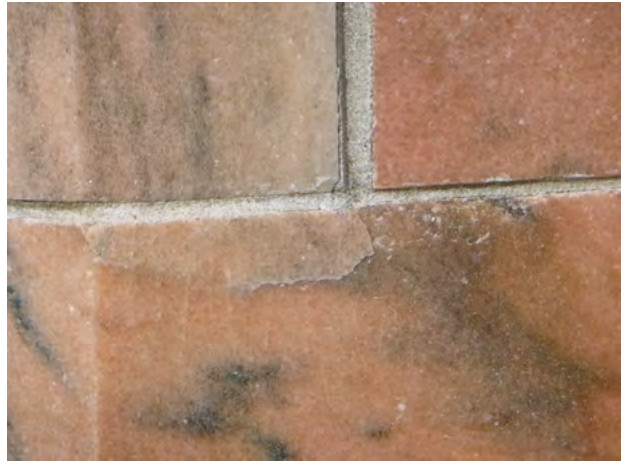
234-183 Stone\_SoilStain Leached Salts 2024-1.jpg

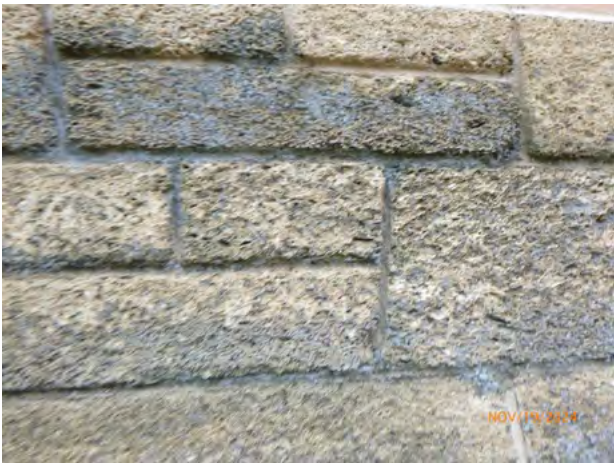
241-23 Stone\_SoilStain Paint 2024-2.jpg

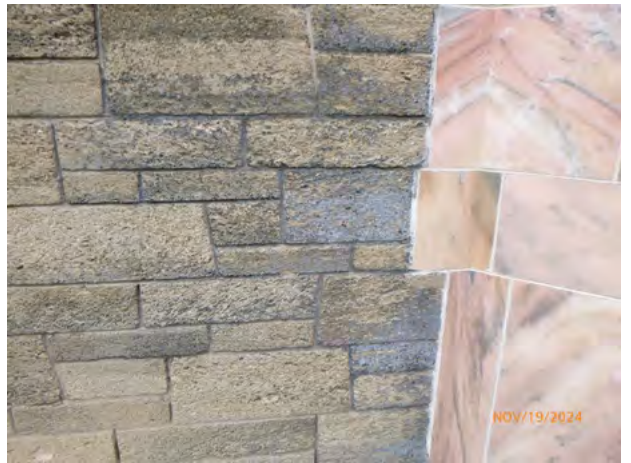
241-23 Stone\_SoilStain Paint 2024-3.jpg

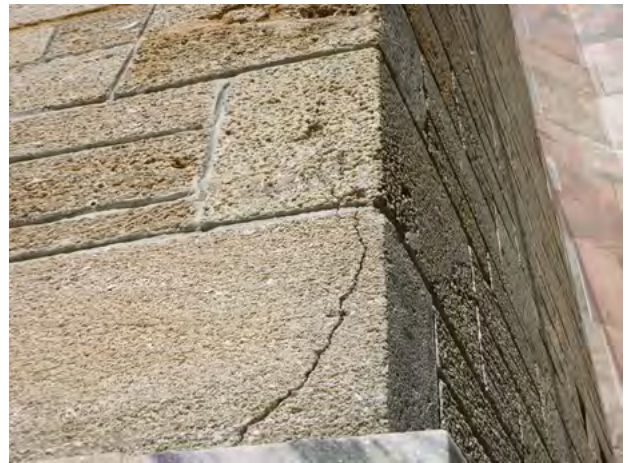
272-156 Stone\_SoilStain Leached Salts 2024-3.jpg

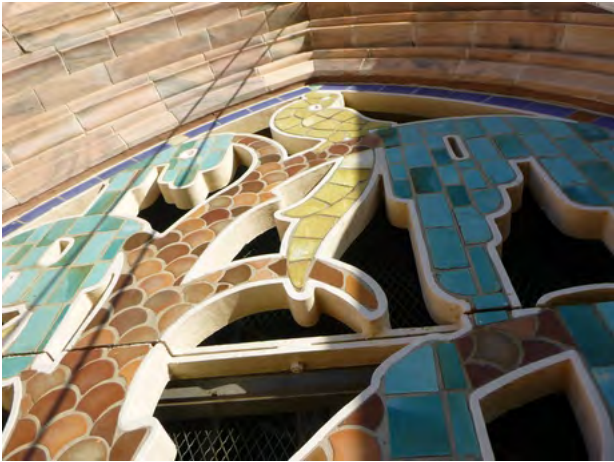
287-149 ArchMetal\_Corrosion Surface 2024-1.jpg

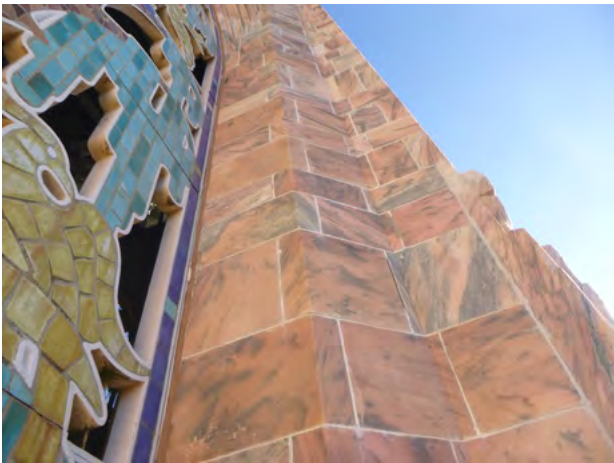
290-173 ArchMetal\_Coating Coating Failed 2024-1.jpg

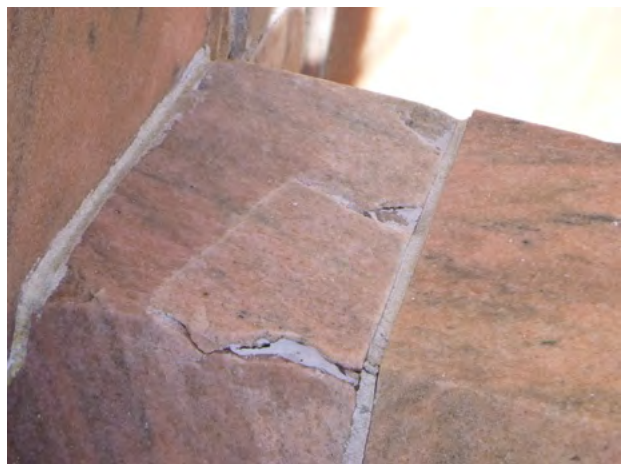
334-142 Stone\_Spall Bonded 2024-1.jpg

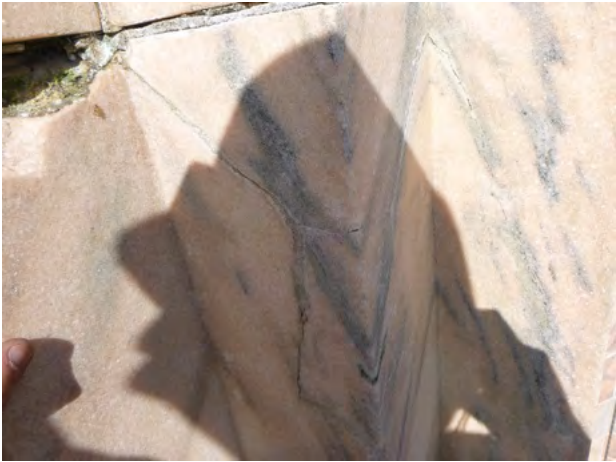
335-135 Stone\_Spall Bonded 2024-1.jpg

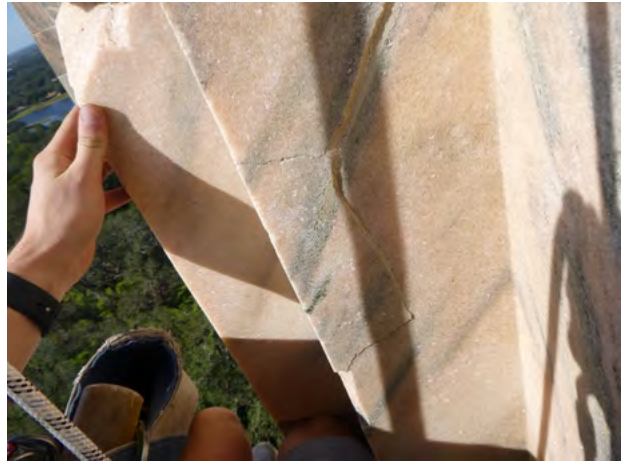
335-135 Stone\_Spall Bonded 2024-2.jpg

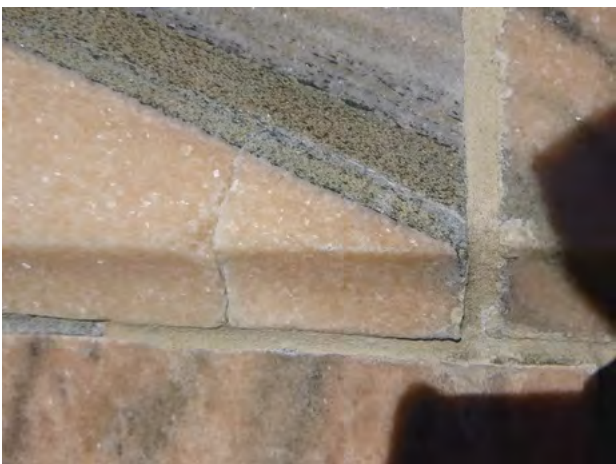
335-184 Stone\_Spall Bonded 2024-1.jpg

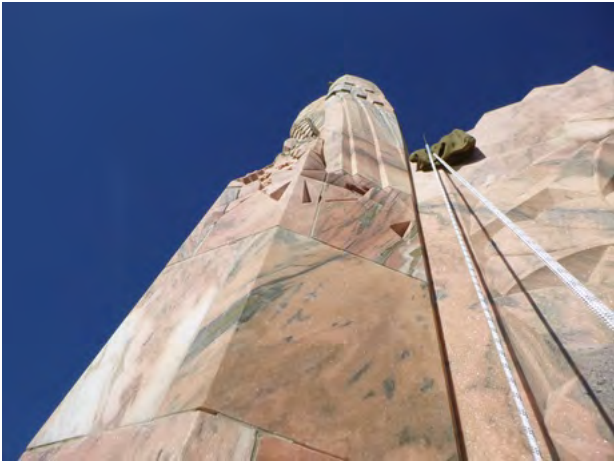
338-184 Stone\_Joints Mortar Failed 2024-3.jpg

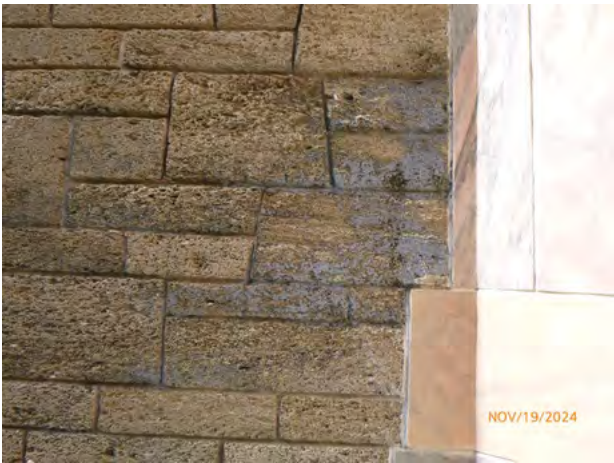
339-14 Stone\_Crack System units and joints 2024-1.jpg

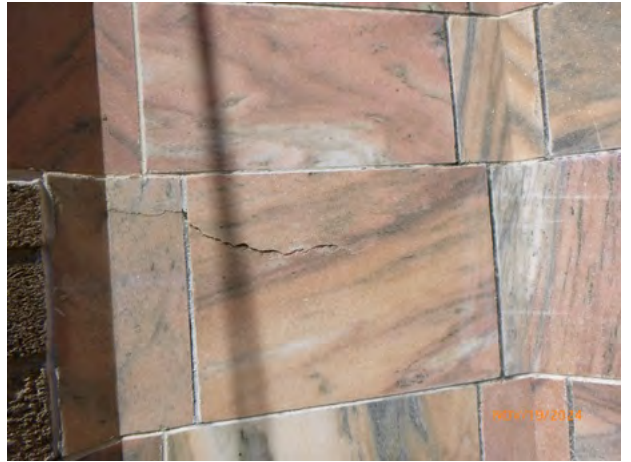
340-45 Stone\_Spall Bonded 2024-1.jpg

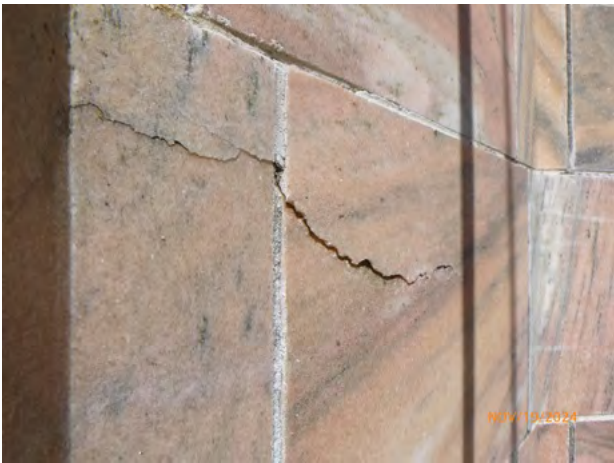
340-45 Stone\_Spall Bonded 2024-2.jpg

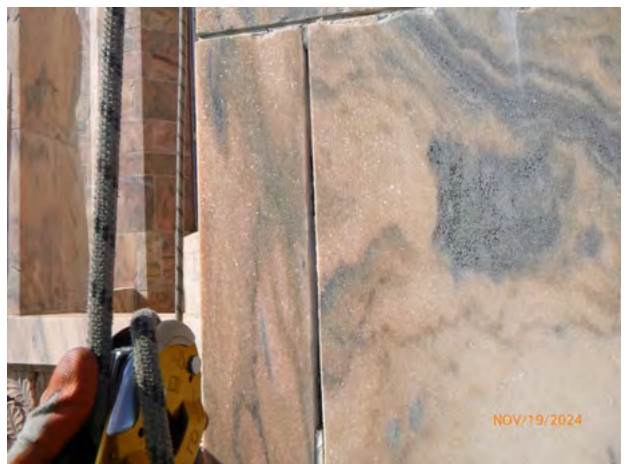
344-141 Stone\_Joints Mortar Failed 2024-2.jpg

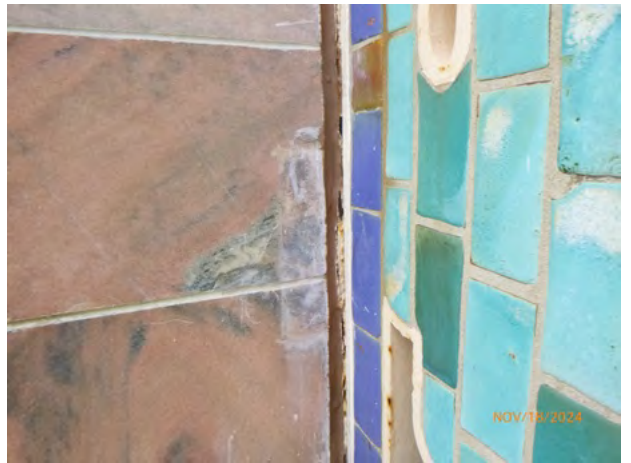
346-162 Stone\_SurfLoss Chipped 2024-2.jpg

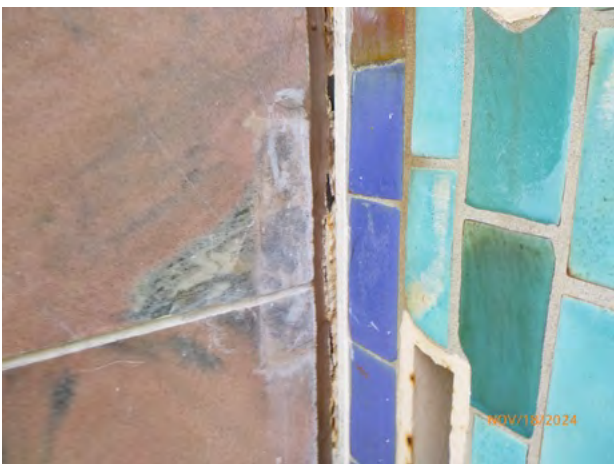
346-164 Stone\_Repair Dutchman Sound 2024-1.jpg

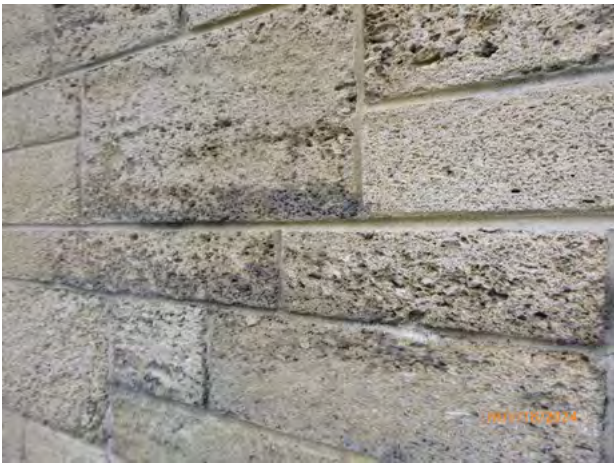
355-90 Stone\_Spall Missing 2024-3.jpg

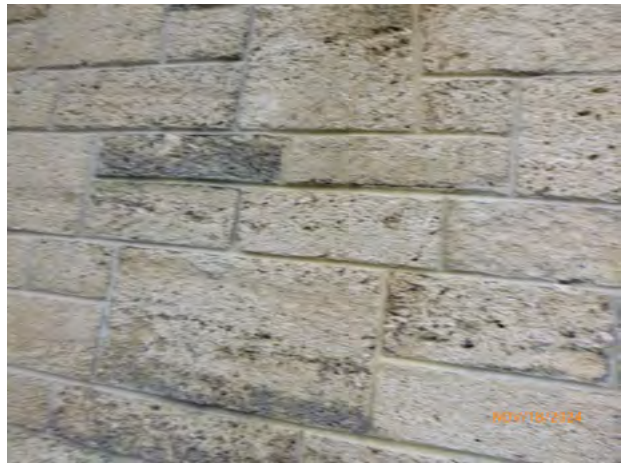
355-92 Stone\_SoilStain Black Crusts 2024-1.jpg

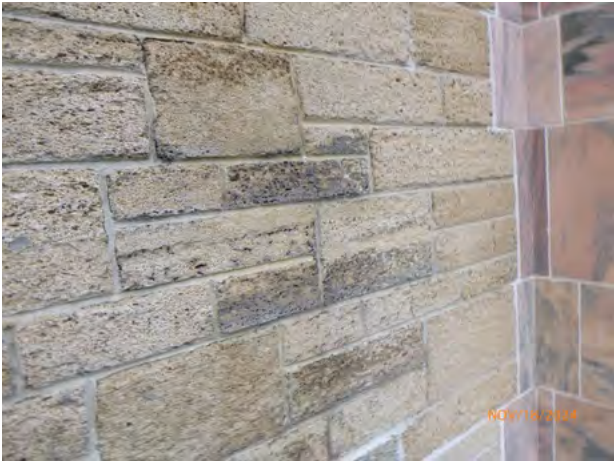
355-92 Stone\_SoilStain Black Crusts 2024-4.jpg

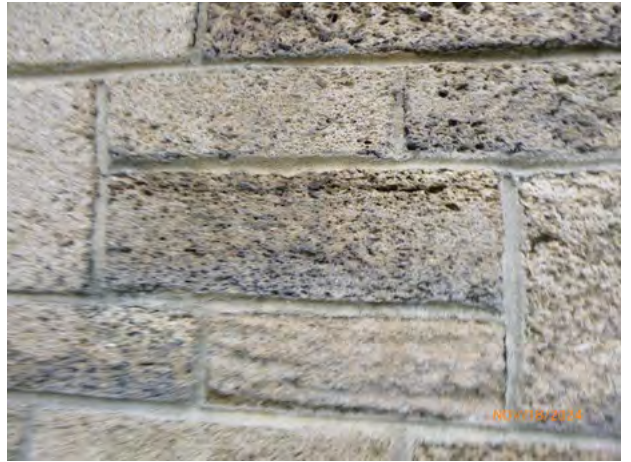
355-92 Stone\_SoilStain Black Crusts 2024-5.jpg

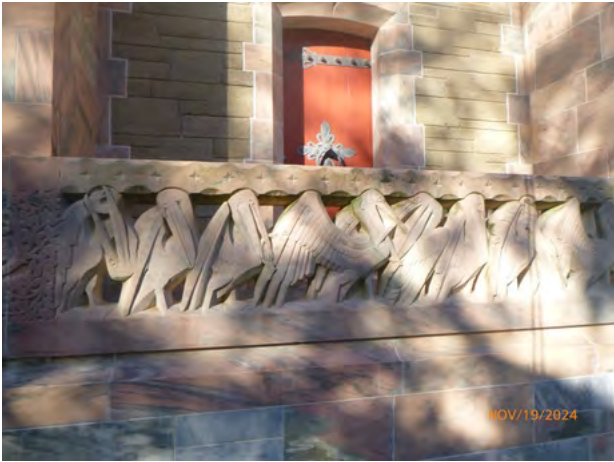
355-181 Stone\_SurfLoss Chipped 2024-3.jpg

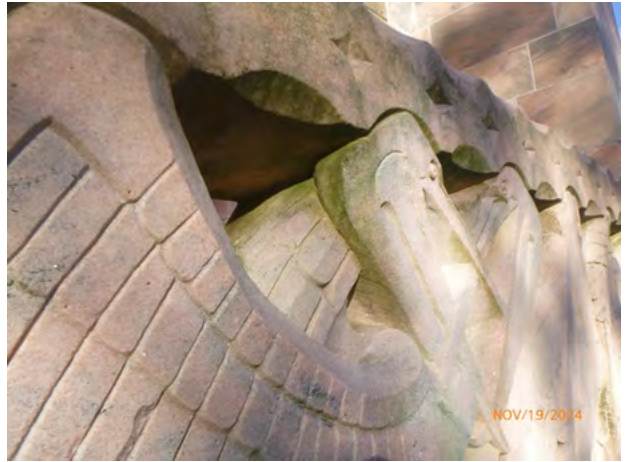
356-29 Stone\_SoilStain Biological 2024-1.jpg

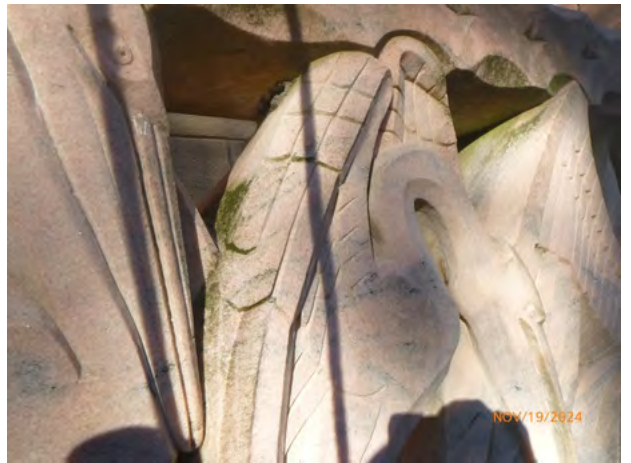
356-29 Stone\_SoilStain Biological 2024-3.jpg

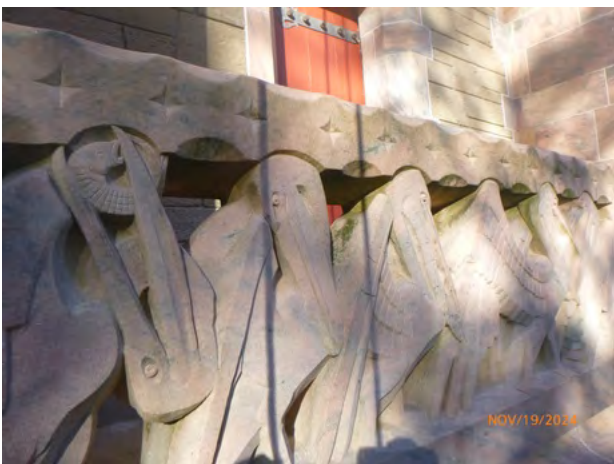
356-29 Stone\_SoilStain Biological 2024-4.jpg

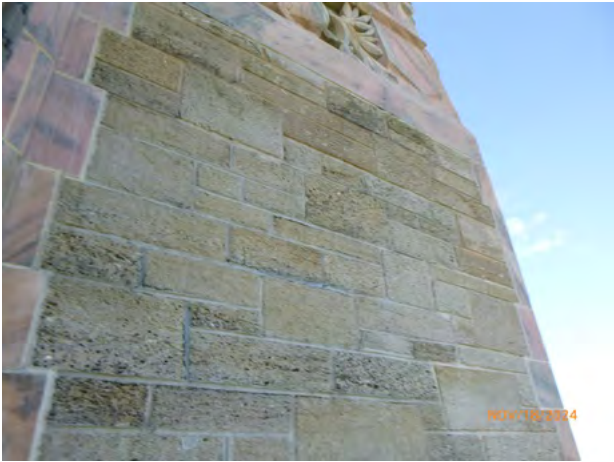
362-131 Stone\_Note Photo-general 2024-2.jpg

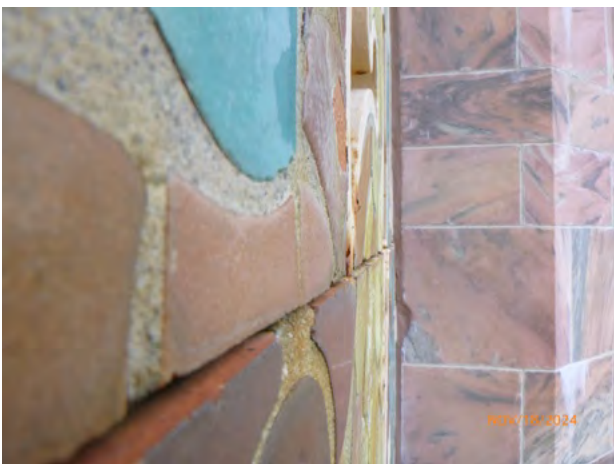
392-153 TerraCotta\_Displacement Horizontal 2024-1.jpg

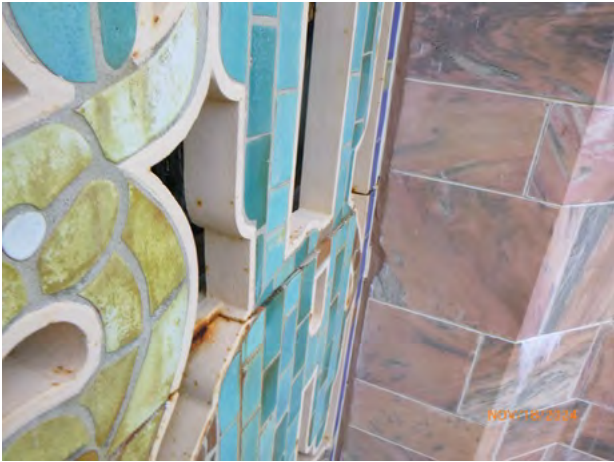
392-153 TerraCotta\_Displacement Horizontal 2024-3.jpg

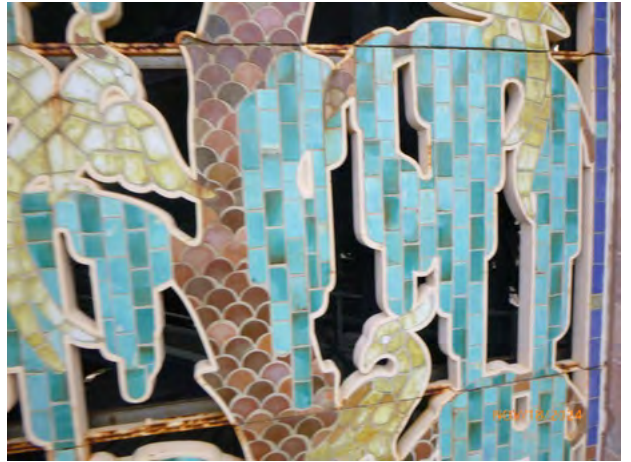
392-153 TerraCotta\_Displacement Horizontal 2024-4.jpg

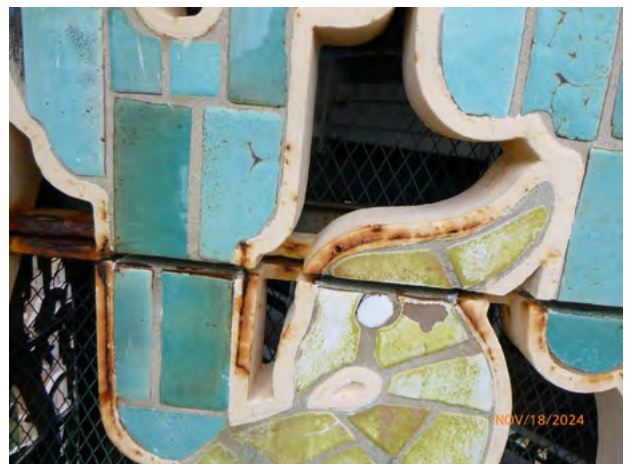
392-174 ArchMetal\_Coating Coating Failed 2024-5.jpg

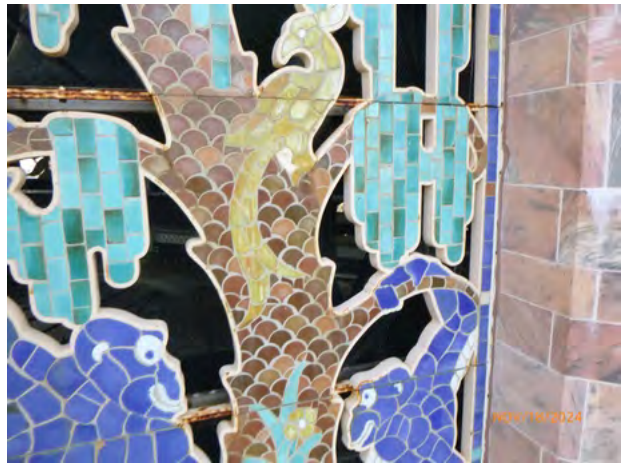
392-174 ArchMetal\_Coating Coating Failed 2024-9.jpg

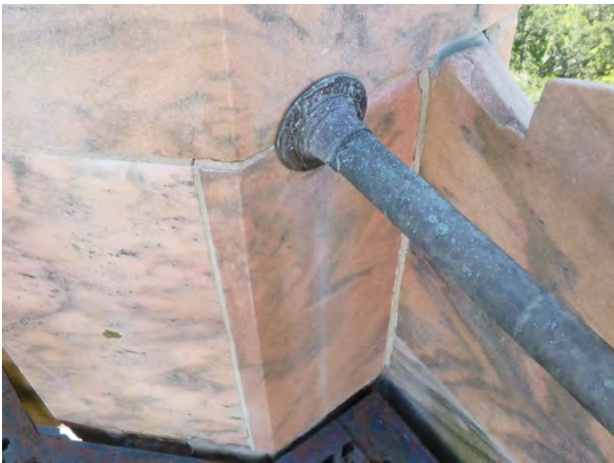
633-196 Stone\_Displacement Horizontal 2024-1.jpg

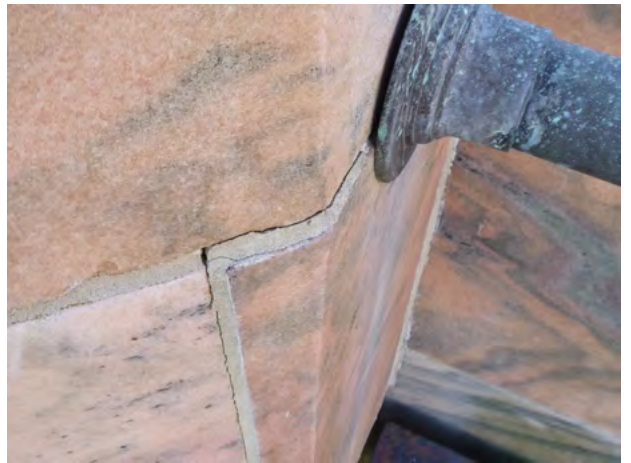
633-196 Stone\_Displacement Horizontal 2024-2.jpg

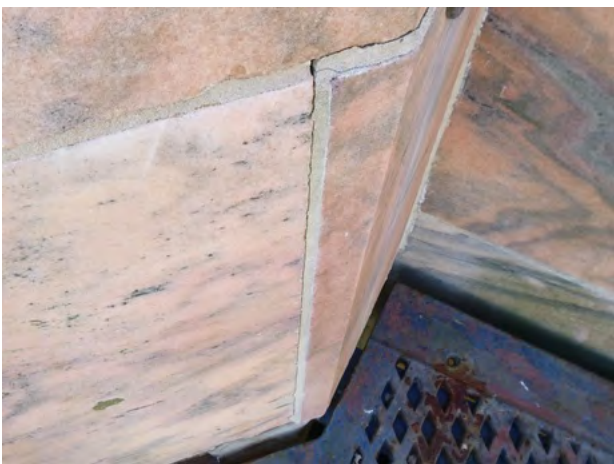
633-196 Stone\_Displacement Horizontal 2024-3.jpg

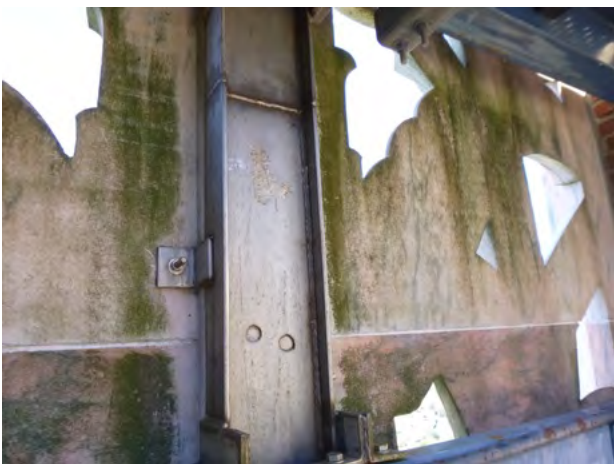
646-190 Stone\_SoilStain Biological 2024-1.jpg

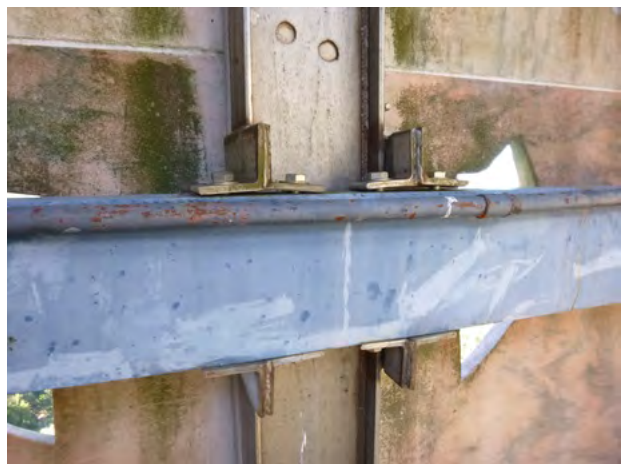
649-189 ArchMetal\_Note Photo-connections askew 2024-1.jpg

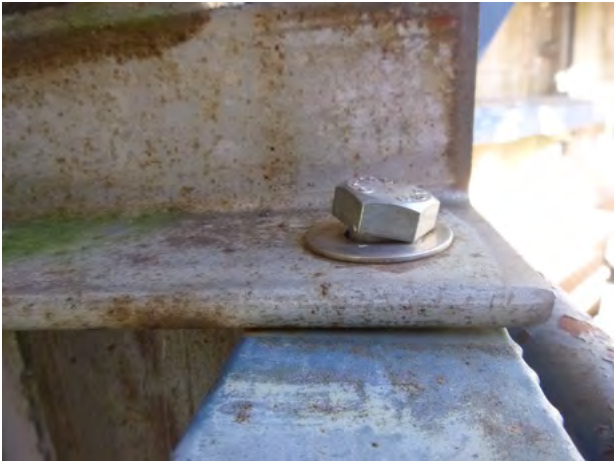
649-189 ArchMetal\_Note Photo-connections askew 2024-2.jpg

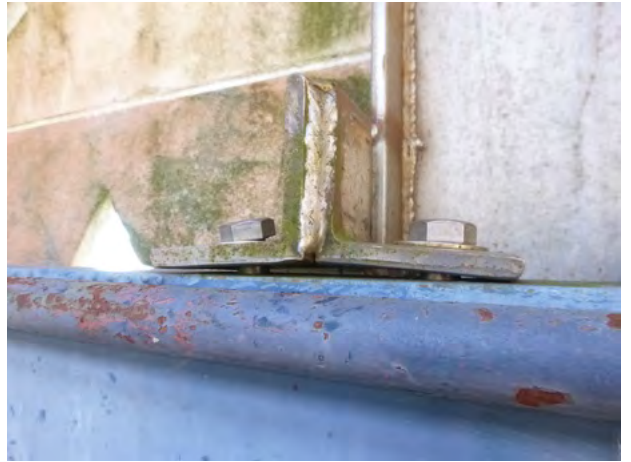
649-189 ArchMetal\_Note Photo-connections askew 2024-3.jpg

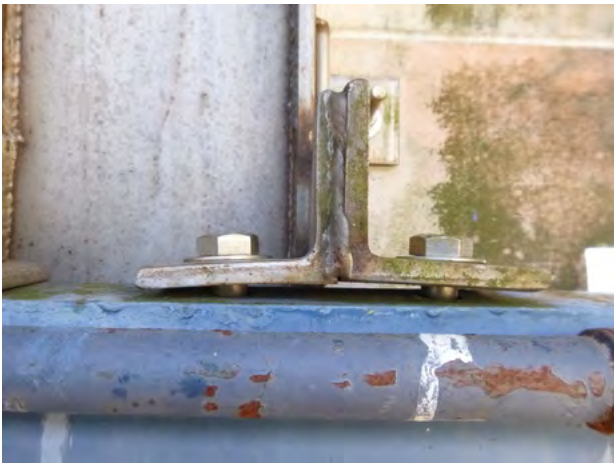
649-189 ArchMetal\_Note Photo-connections askew 2024-4.jpg

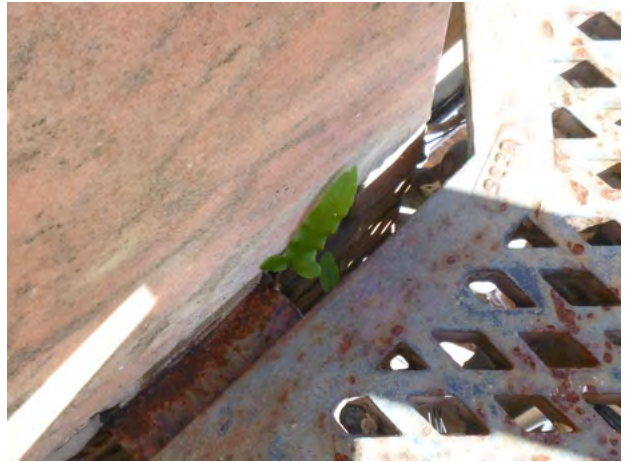
664-151 ArchMetal\_Coating Coating Failed 2024-4.jpg

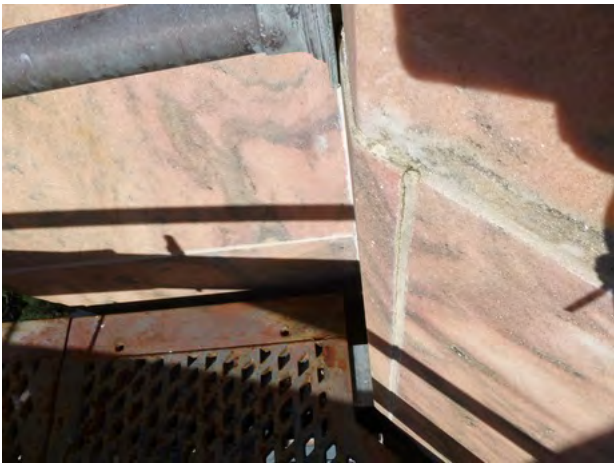
664-194 Stone\_SoilStain Biological 2024-1.jpg

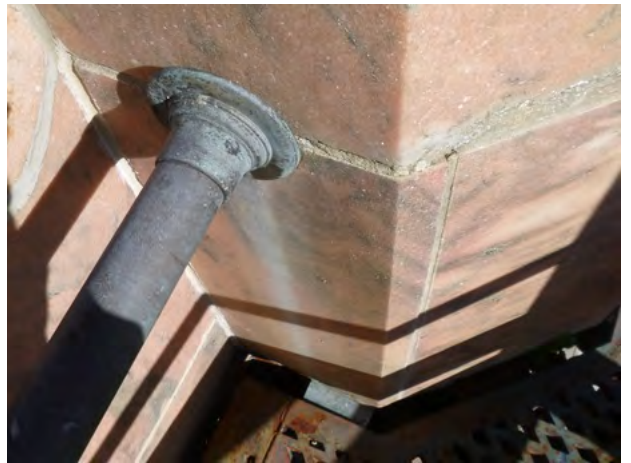
664-197 Stone\_Displacement Horizontal 2024-1.jpg

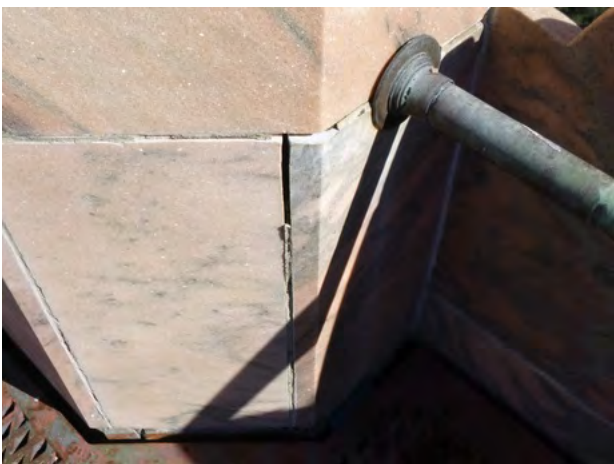
847-198 Stone\_Displacement Horizontal 2024-1.jpg

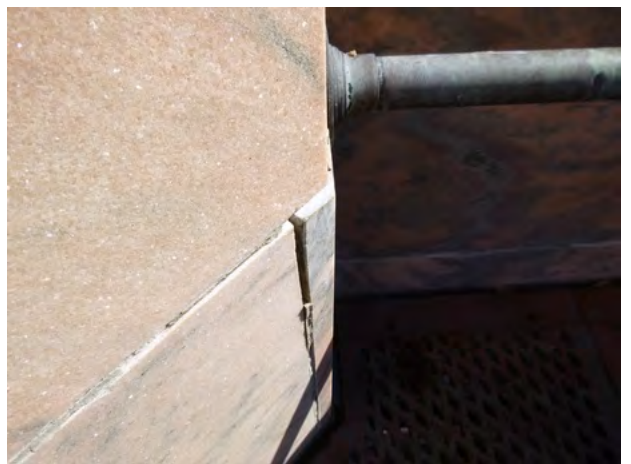
847-198 Stone\_Displacement Horizontal 2024-2.jpg

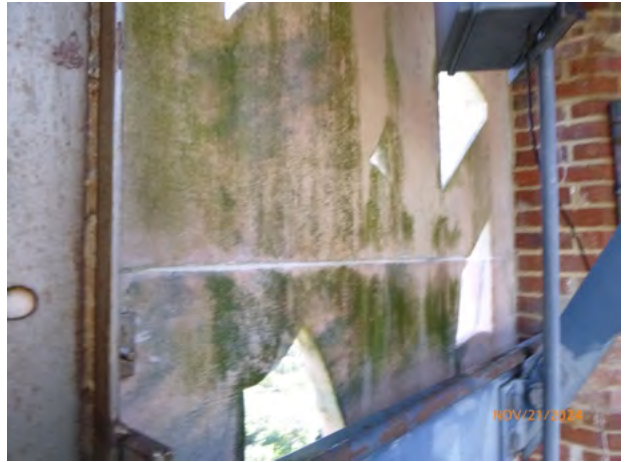
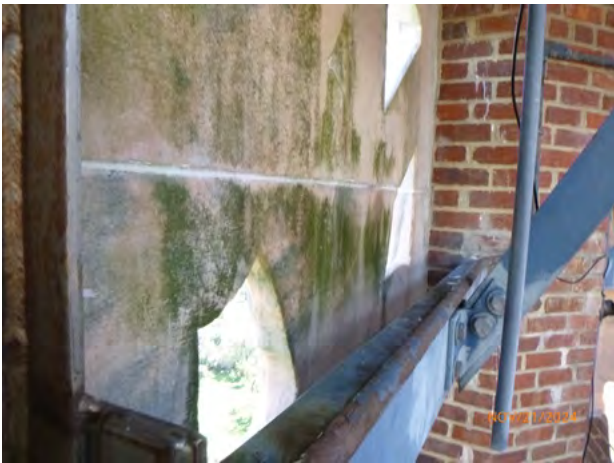
858-188 Stone\_SoilStain Biological 2024-1.jpg

858-188 Stone\_SoilStain Biological 2024-2.jpg

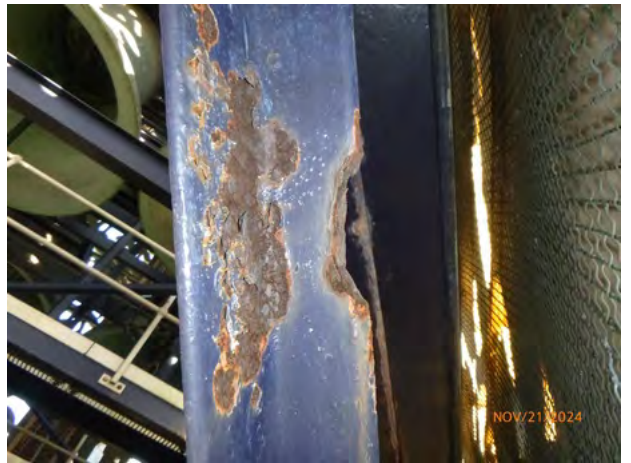
859-145 ArchMetal\_Damaged Dented 2024-1.jpg

859-145 ArchMetal\_Damaged Dented 2024-2.jpg

859-145 ArchMetal\_Damaged Dented 2024-3.jpg

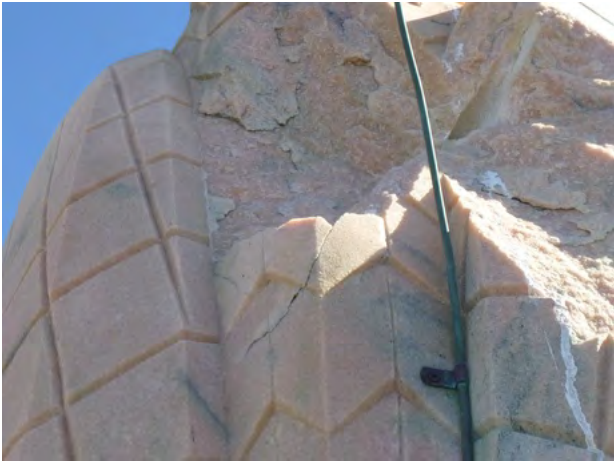
859-202 Stone\_Spall Incipient 2024-1.jpg

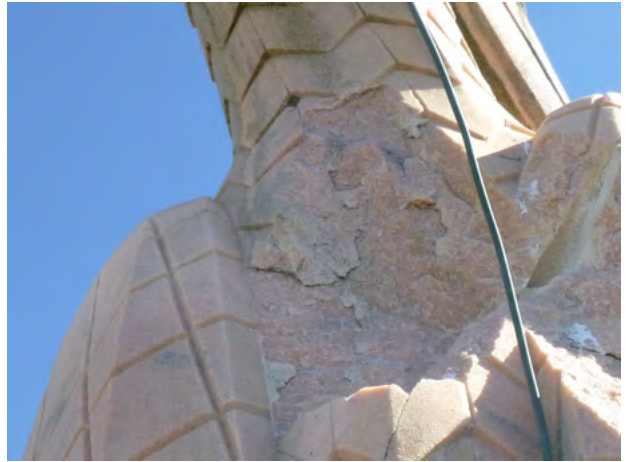
859-203 Stone\_Spall Incipient 2024-1.jpg

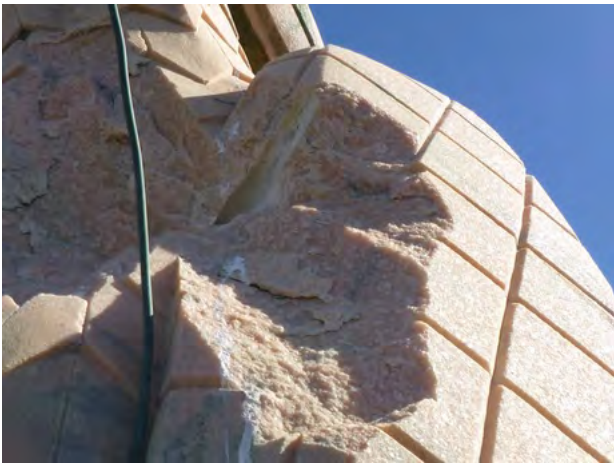
860-202 Stone\_Spall Incipient 2024-1.jpg

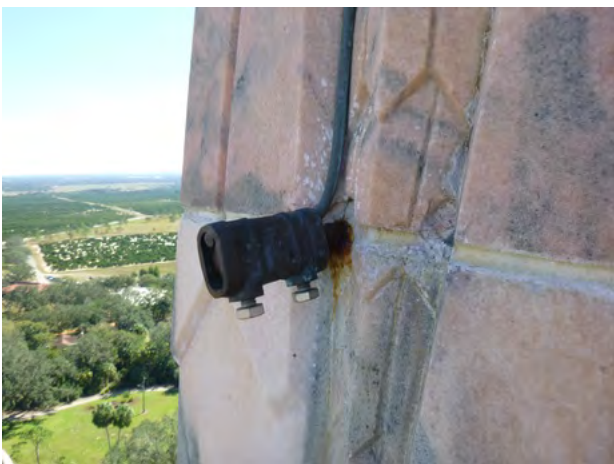
867-200 Stone\_Embedment Ferrous Embedment 2024-1.jpg
